**ENGINEERING SURVEY OF
U.S. NAVY PETROLEUM FACILITIES
AT PEARL HARBOR**

BECHTEL CORPORATION

12, May 1949

From: Bechtel Corporation, Contract NCy 16535
To: Officer in Charge, Contract NCy 16535
Subj: Engineering Survey of U. S. Navy Petroleum Facilities
at Pearl Harbor, Report on
Ref: (a) SCinC ltr NT4-9/JJ7 430 CF 13896 to CinC,
NCy 16535 dated 15 Nov 1948
(b) CinC ltr NOy 16535 (80:D) dated 9 March 1949 to
Bechtel Corp
(c) CinC ltr NCy 16535 (80:D) dated 7 Feb 1949 to
Bechtel Corp

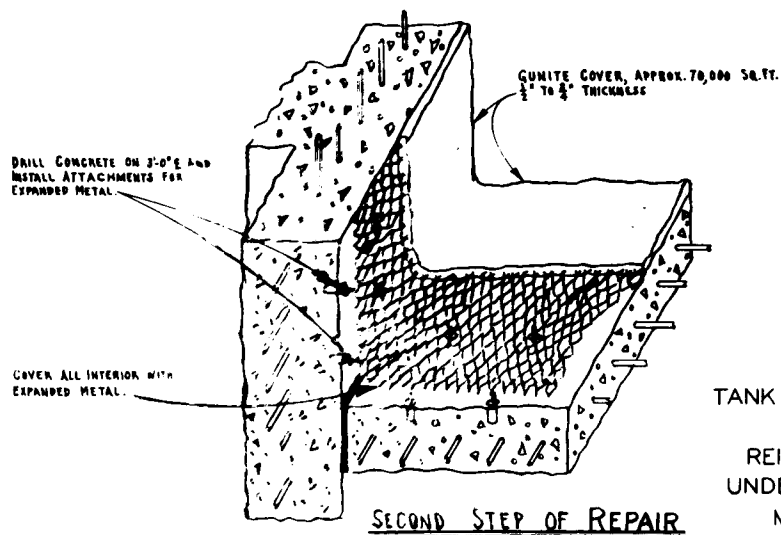
SECT. VI
TANK INSPECTION SKETCH 5
REPAIRS TO
REINFORCED CONCRETE
UNDERGROUND RESERVOIR
MIDDLE TANK FARM

The underground 195,000 barrel reinforced reservoir located in the Middle Tank Farm was constructed about 1920. Inspection revealed that the concrete was cracked in numerous places, and when empty the leakage rate back into the reservoir from the oil soaked ground was several barrels per day. This unit appears to be one of the major sources contributing to the oil underlying the Merry Point area of the Navy Yard.

It is recommended that this reservoir be repaired as follows:

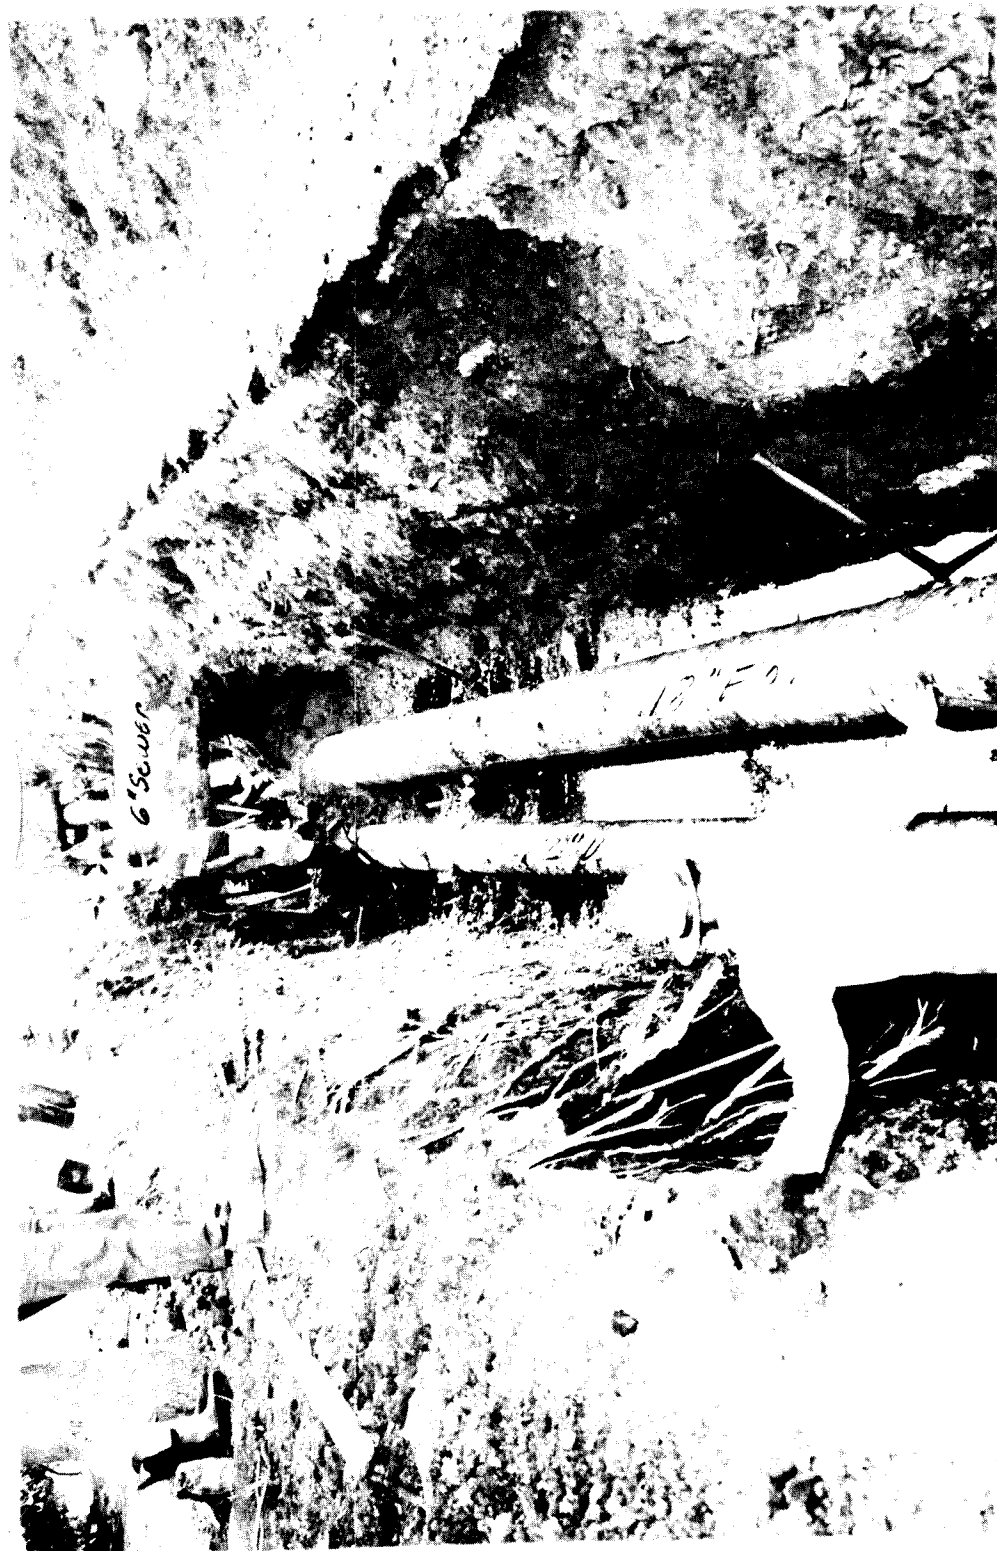
VI - 3

EXCAVATION OF OIL LINES
IN SUBMARINE BASE AREA.
SHOWING SOIL CONDITIONS
AND COATING FAILURE
