**DEPARTMENT OF THE NAVY**

SUBJECT: ADMINISTRATIVE ORDER ON CONSENT (AOC) STATEMENT OF WORK (SOW) SECTION 5 CORROSION AND METAL FATIGUE PRACTICES, DESTRUCTIVE TESTING RESULTS REPORT, RED HILL BULK FUEL STORAGE FACILITY (RED HILL), JOINT BASE PEARL HARBOR-HICKAM, OAHU, HAWAII

In 2018, ten coupons were removed from Tank 14, so that a metallurgical and corrosion analysis of the coupons could be undertaken, with the primary aim of validating non-destructive examination (NDE) results. The steel coupons, concrete powder samples, and corrosion product were submitted to a certified third-party laboratory to perform this analysis.

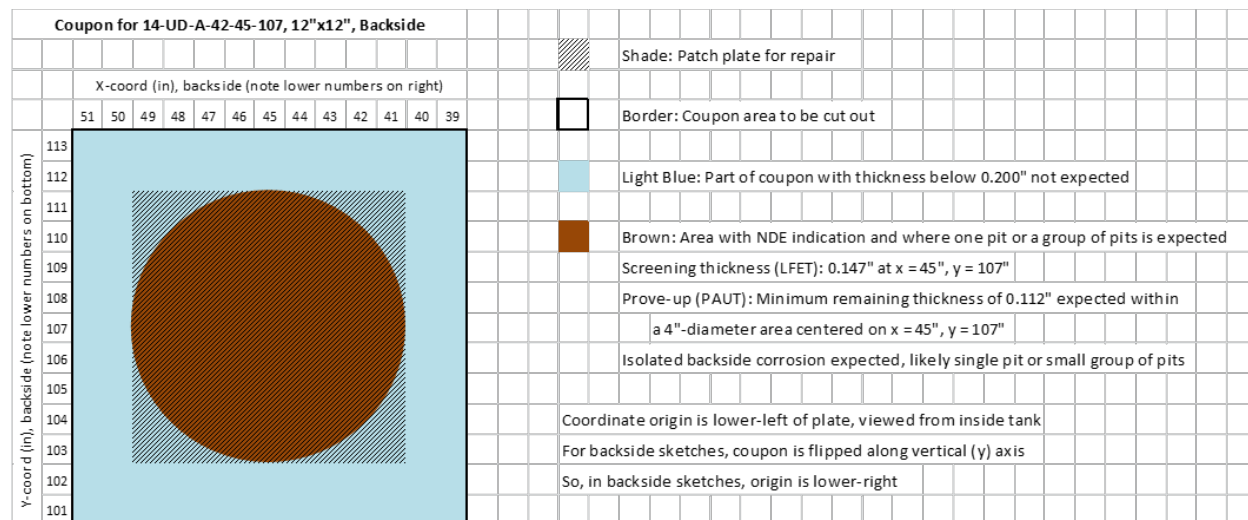
**Figure 4-1 Expected Results from NDE Spreadsheet Data, Coupon 1**

Destructive testing found pitting and minimum wall thickness of 0.208 inch. Remaining wall thickness greater than expected (208 mils vs. 112 mils). This deviation exceeded the 20 mils accuracy range for pitting.

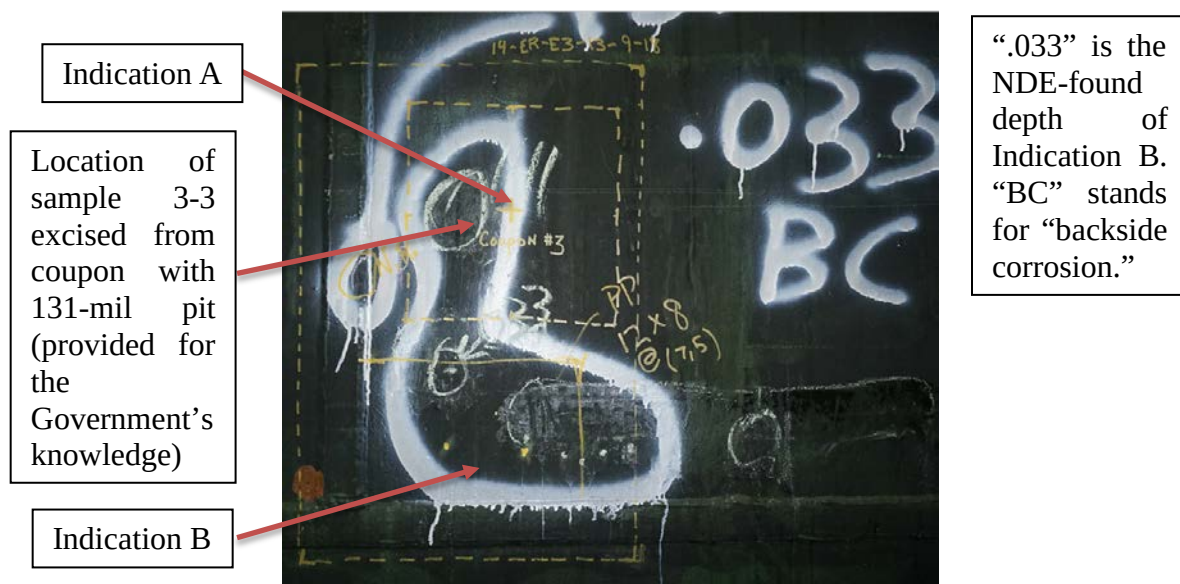
**Figure 4-7 Location of Coupon 3 Prior to Removal**

Laboratory results from Coupon 3 showed an area of remaining thickness of 131 mils, which is actionable. This thickness is within the layout area of Indication B.

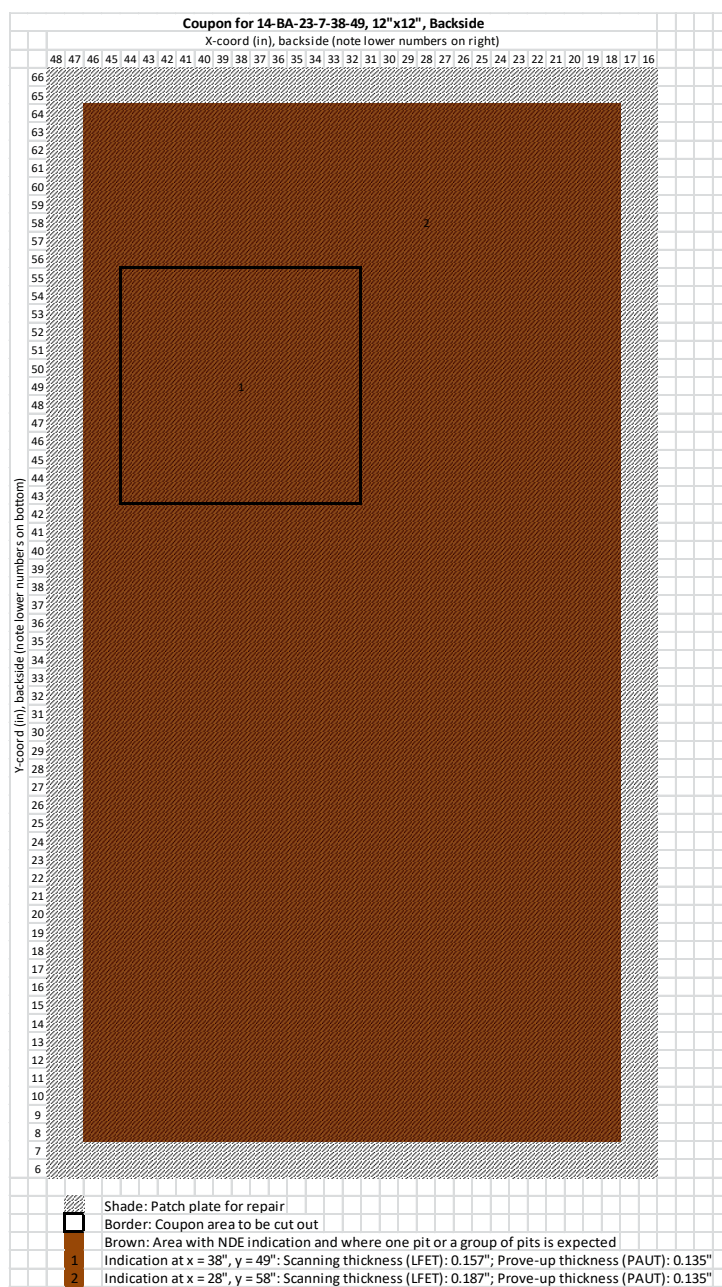
**Figure 4-13 Expected Results from NDE Spreadsheet Data, Coupon 7**

Destructive testing found pitting and a minimum wall thickness of 0.164 inch. The remaining wall thickness was within the 20-mil range for pitting but thicker than expected for the prove-up testing (164 mils vs. 135 mils).

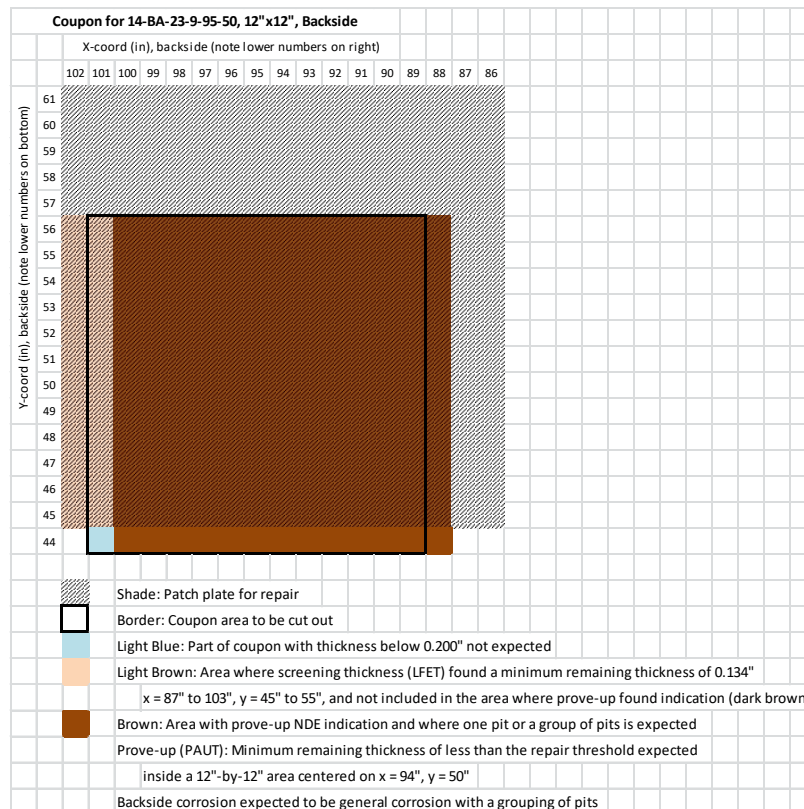
**Figure 4-19 Expected Results from NDE Spreadsheet Data, Coupon A1**

Destructive testing found pitting and minimum wall thickness of 0.122 inch. The remaining wall thickness was as expected. The LFET thickness fell within the 20-mil accuracy range.

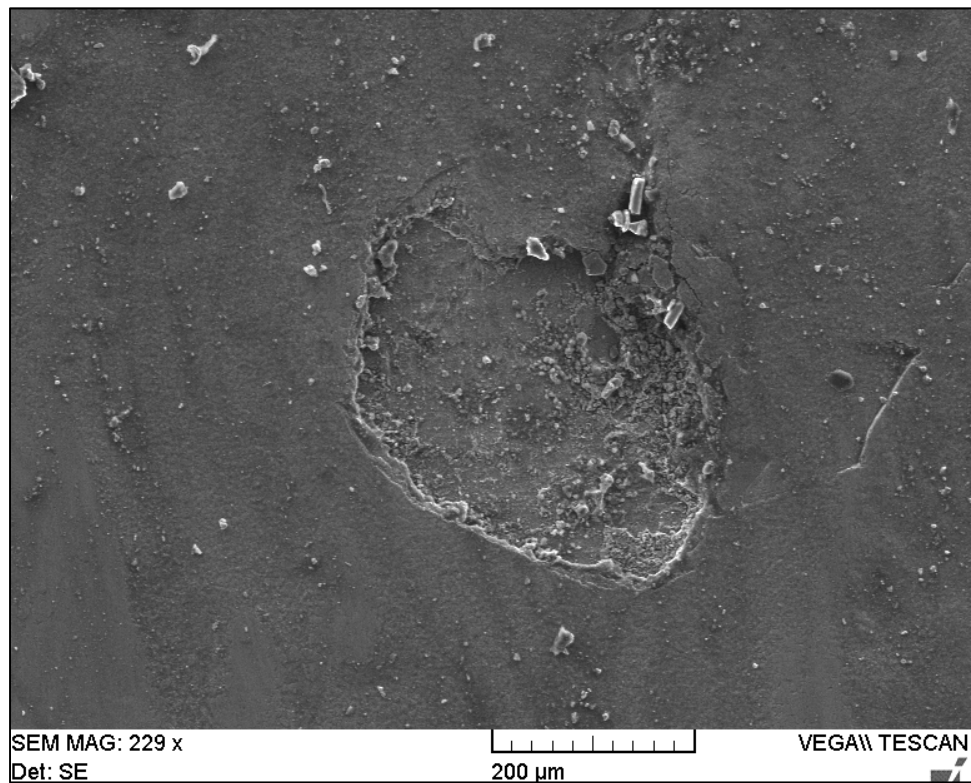
**Figure 63.** A representative SEM image of a pit on a specimen excised from Coupon 10 labeled as 10-2, prior to cleaning. (SEM, 135X)

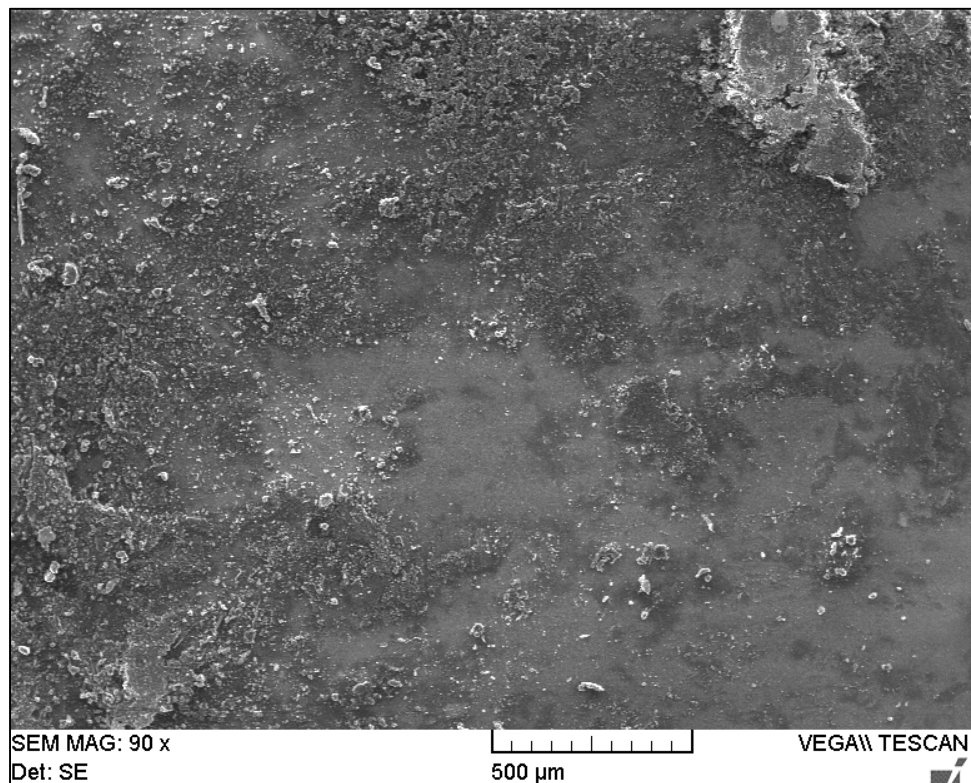
**Figure 64.** A representative SEM image of the surface on a specimen excised from Coupon 10 labeled as 10-3, prior to cleaning. No pit was observed in this location. (SEM, 53X)

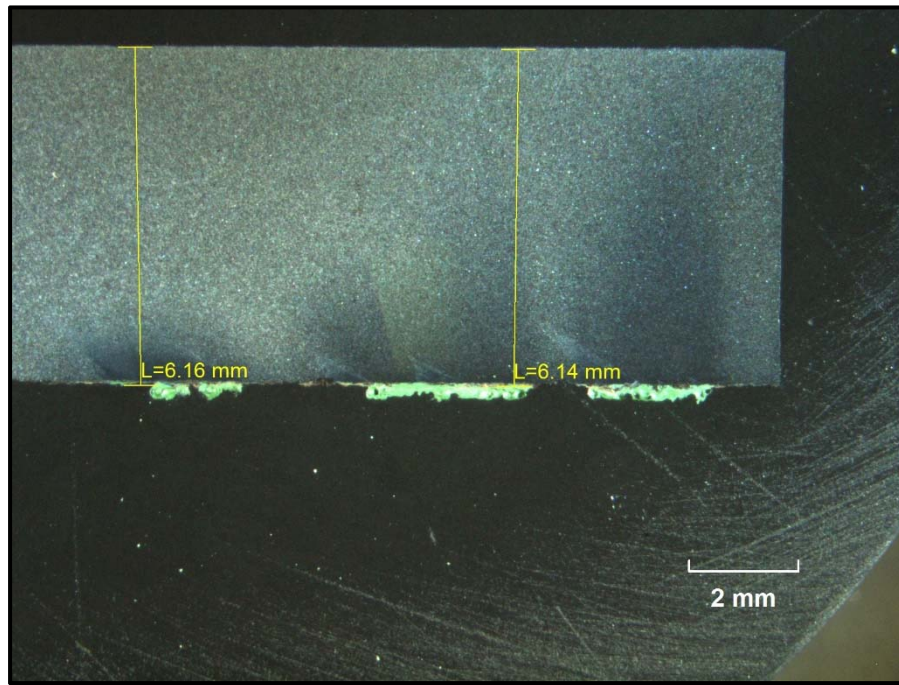
**Figure 201.** The prepared metallographic cross-section from Sample 10-2 is shown during examination with a stereomicroscope. The thickest location(s) are shown. No pitting was observed. (7X)

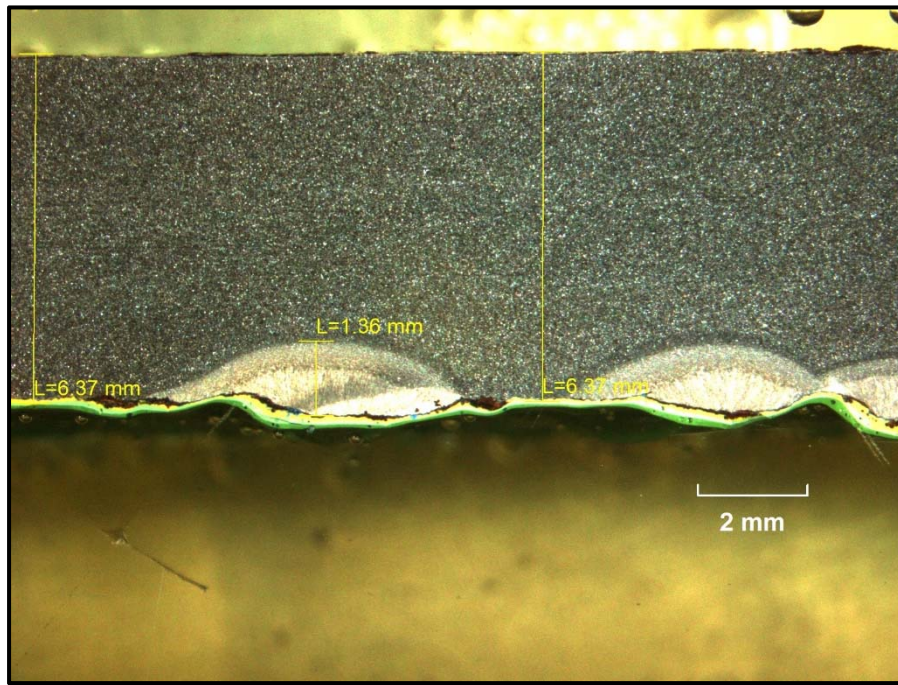
**Figure 207.** The prepared metallographic cross-section from Sample A2-4 is shown during examination with a stereomicroscope. The NDE indication was most likely locations of melting/re-solidification underneath the painted surface. No pitting was observed. (7X)
