SUBJECT: JTF-RH's Responses to DOH's Additional Requests for Information Regarding Red Hill Bulk Fuel Storage Facility Defueling Plan

BORESCOPE INSPECTION REPORT

Borescope Internal Inspection of Buried Section of FOR Piping at ADIT 3

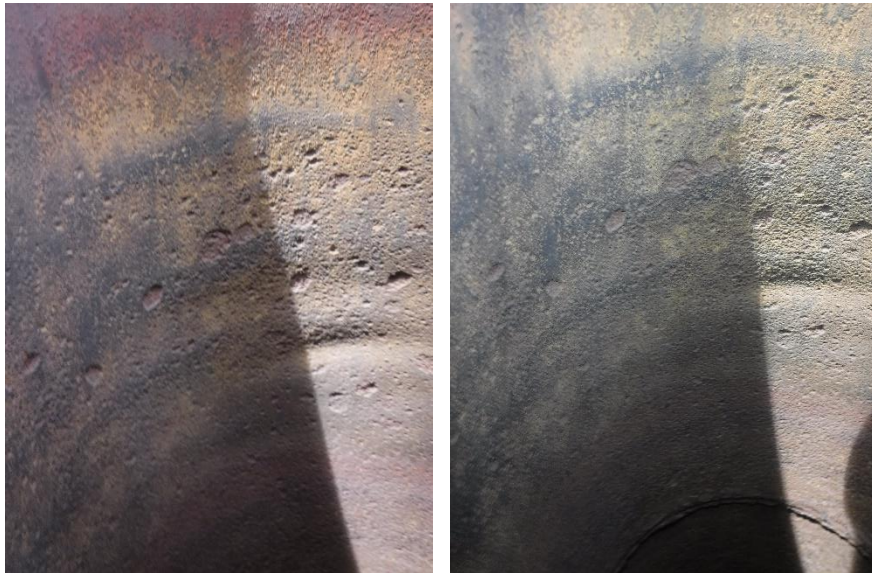
C.5 Interior portion of pipe just below tee (entry point A)

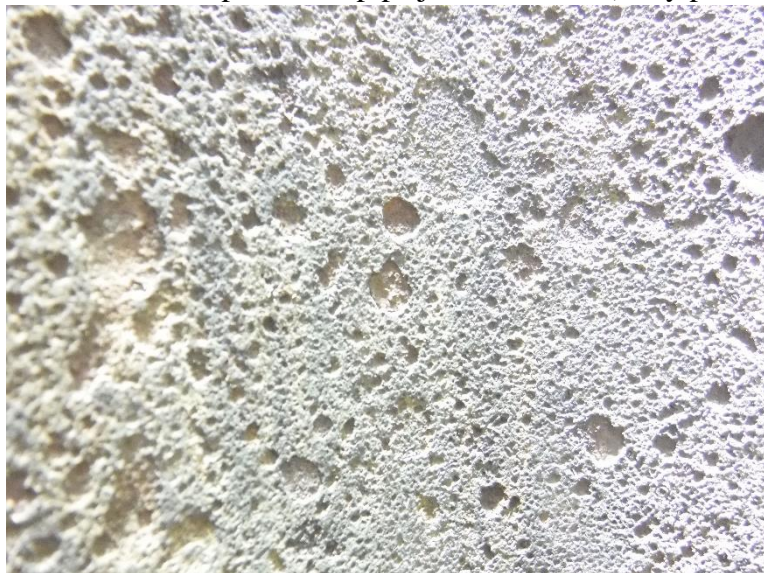
C.6 Close up of internal pitting just below tee

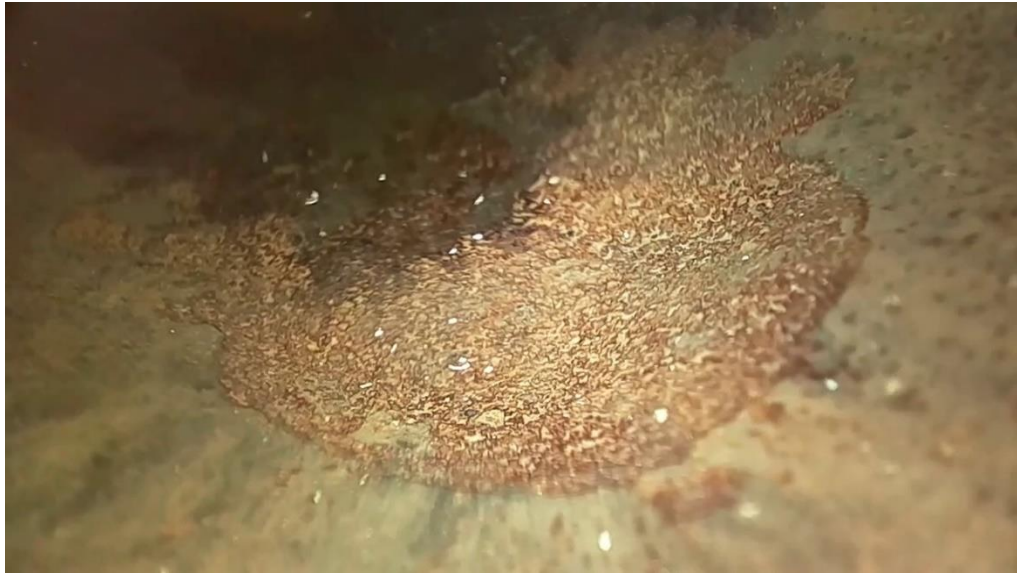
C.10 Borescope inspection image of 1st elbow erosion (from entry point A)

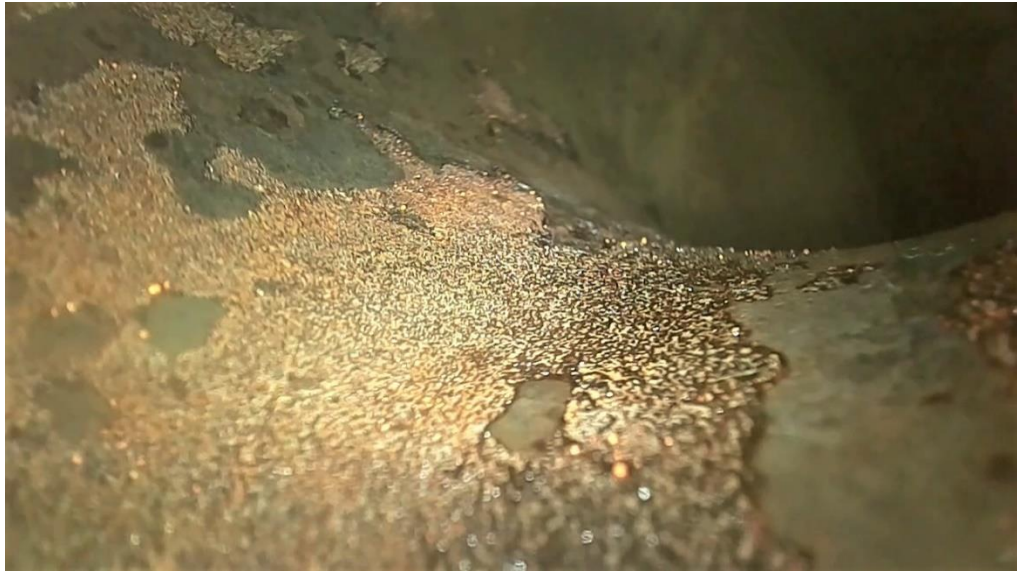
C.14 Second elbow 6 o'clock (minor erosion corrosion on inner radius) (from entry point A)

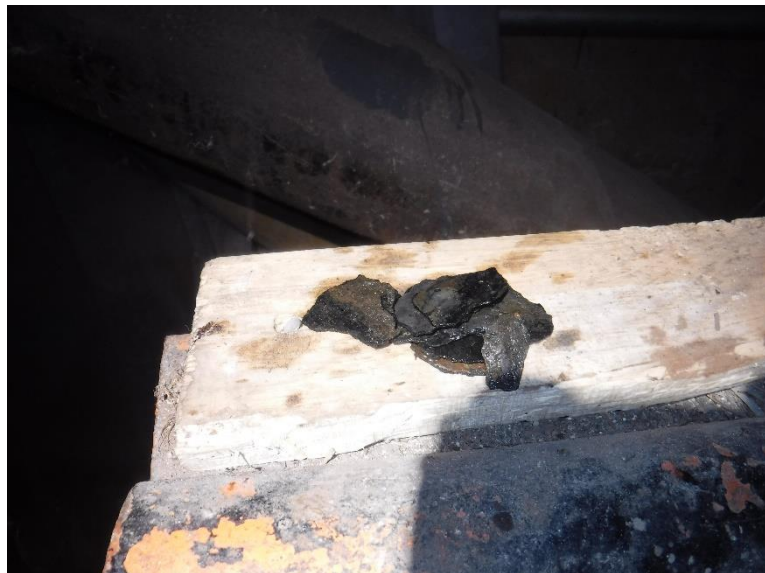
C.24 Entry Flange B (Scale and debris removed from pipe)

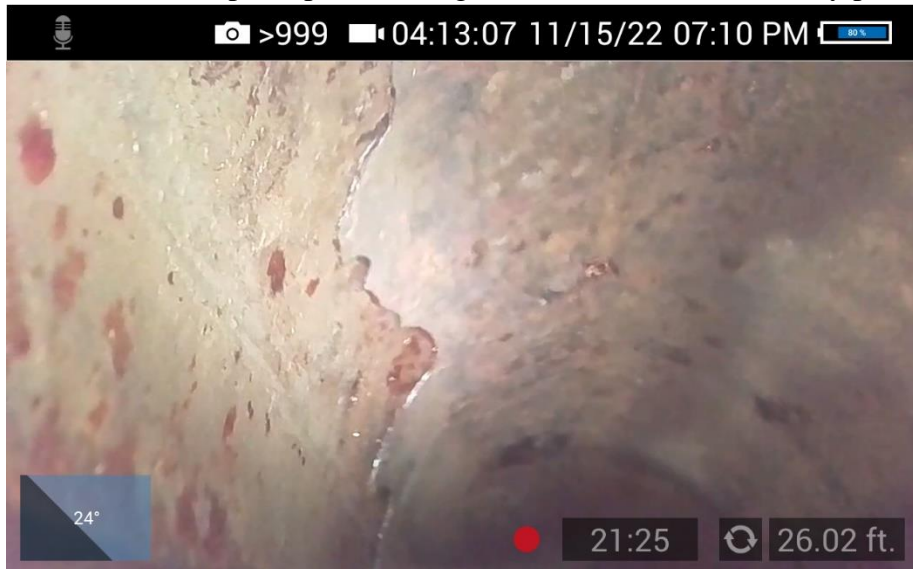
C.35 Borescope inspection image, ERW joint and mill scale (from entry point B)

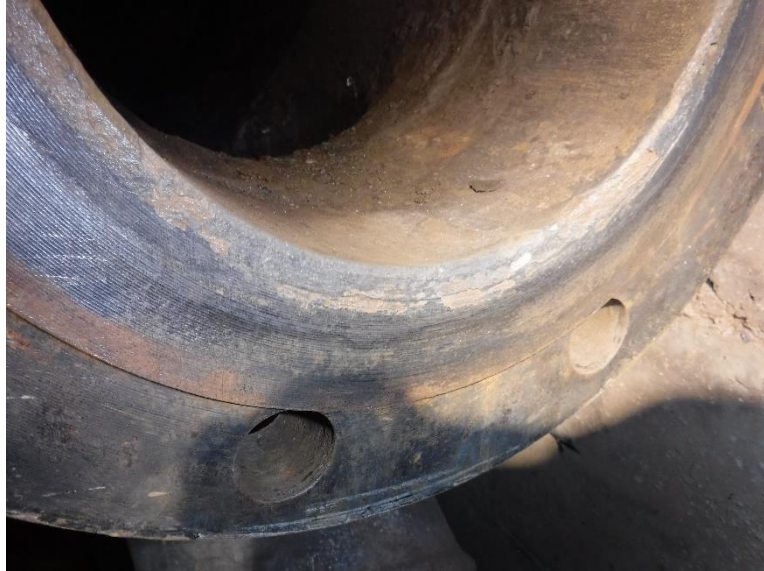
C.37 Crevice corrosion flange gasket face 0.030" to 0.040" deep (entry point B)
