## QUALITY VALIDATION (QV) REPORT

### Red Hill Bulk Fuel Storage Facility Defuel

# Memorandum

Subject: Recommended Repairs at Two Concrete Pipe Anchor Bulkheads Prior to Defueling (NDAA Deficiency Item Nos. PSC.44A and PSC.71A)

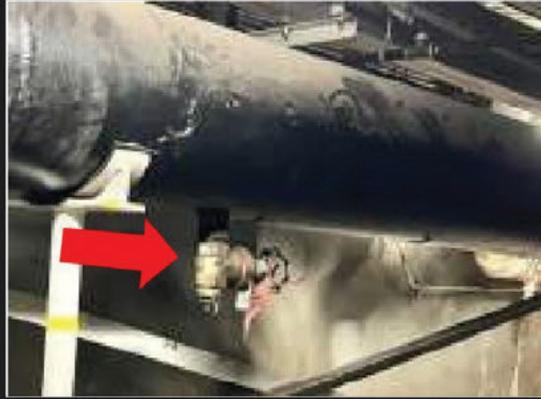
Before Repair

The Public Works Department provided a F-24 valve protection cage.

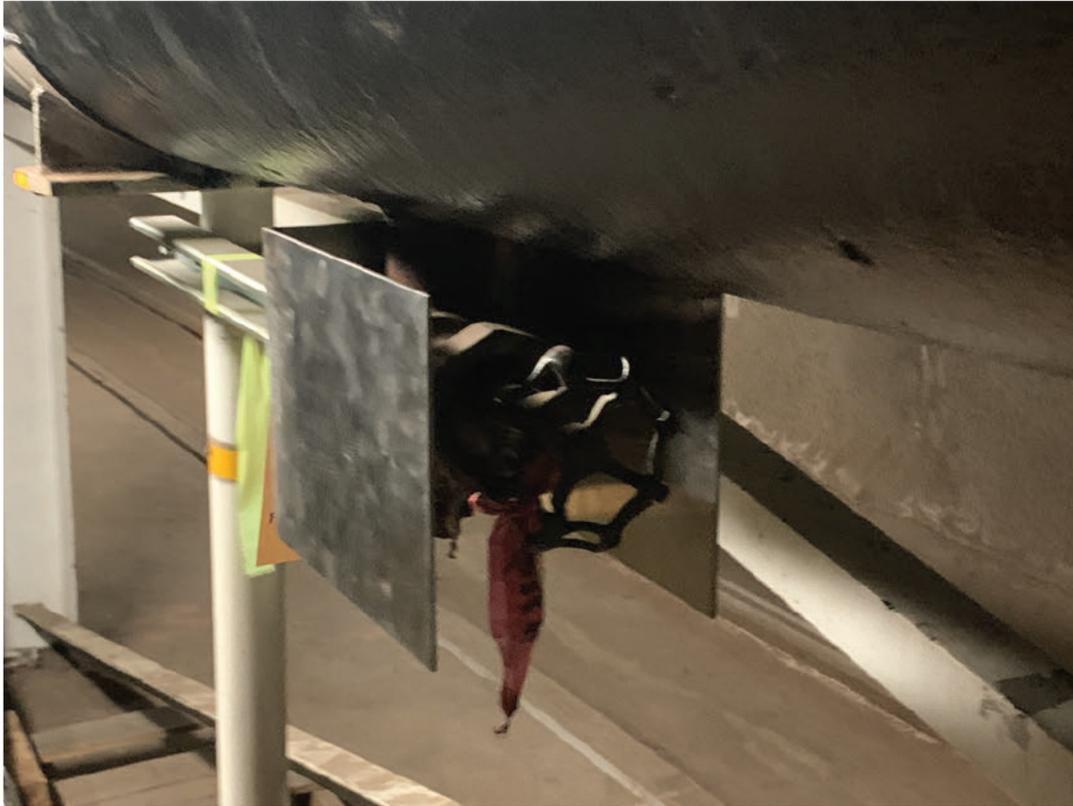
Completed Repair

Reference: Field verified on 08 FEB 23.
