QUALITY VALIDATION (QV) REPORT

Red Hill Bulk Fuel Storage Facility Defuel

Validation Firm	HDR Environmental, Operations and Construction, Inc.	Repair No.	058		
Address	9781 S. Meridian Blvd., Suite 400, Englewood, CO 80112	Repair ID	PS (b) (3) (A)		
Contract No.	FA890315D0007, D.O. FA8903-19-F-0027	Report Date	06 JUN 2023		
QV Engineer	(b) (6)	Phone	(b) (6)	Email	(b) (6)@hdrinc.com

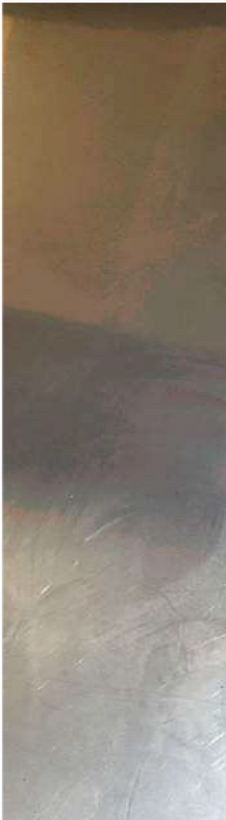
Close-up of upper wall anchor of replacement (b) (3) (A)
