## QUALITY VALIDATION (QV) REPORT

### Red Hill Bulk Fuel Storage Facility Defuel

Validation Firm	<b>(b) (4)</b>	Repair No.	084	
Address	<b>(b) (4)</b>	Repair ID	JP5.026	
Contract No.	FA890315D0007, D.O. FA8903-19-F-0027		Report Date	02 SEP 2023
QV Engineer	<b>(b) (6)</b>

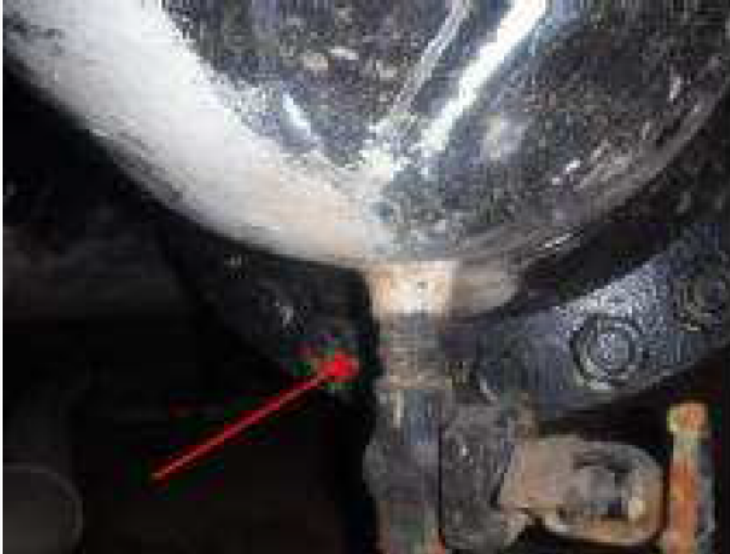
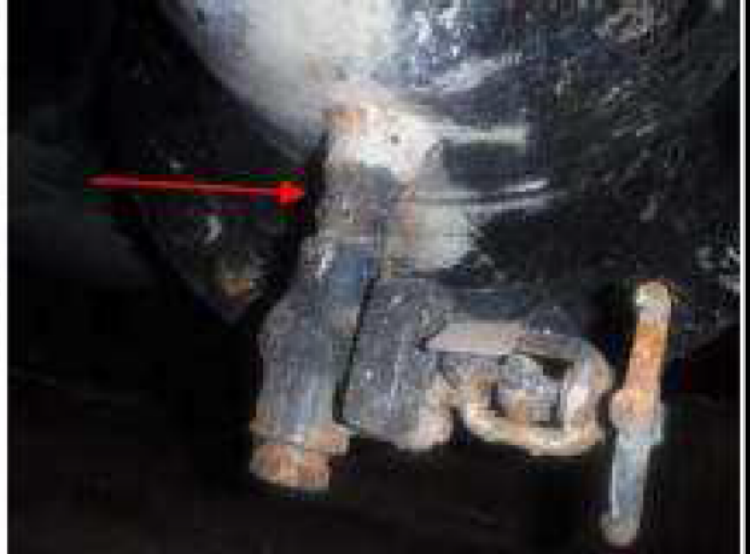
Repair Description cont. "Moderate corrosion was observed on low point drain piping adjacent to PS-690. Notable corrosion was observed on LPD pipe adjacent to isolation valve #0156. Valve classification is unknown. Replace."  
 UPDATE: During repacking, threaded connections were monitored for weeps. A drip developed on the threaded connection between the new LPD and the existing o-let. Crews attempted to remedy by applying additional sealants and tightening the connection to the extent possible. After cure time, the repair was re-inspected and judged to be insufficient. Crews isolated the segment of line between valves and drained using a diaphragm pump. Crews removed the LPD assembly, cleaned o-let threads, installed a new threaded plug with fuel-resistant sealant. Nitrogen test 1 hour/120 PSI no leaks noted.

Existing low point drain assemblies in need of service.

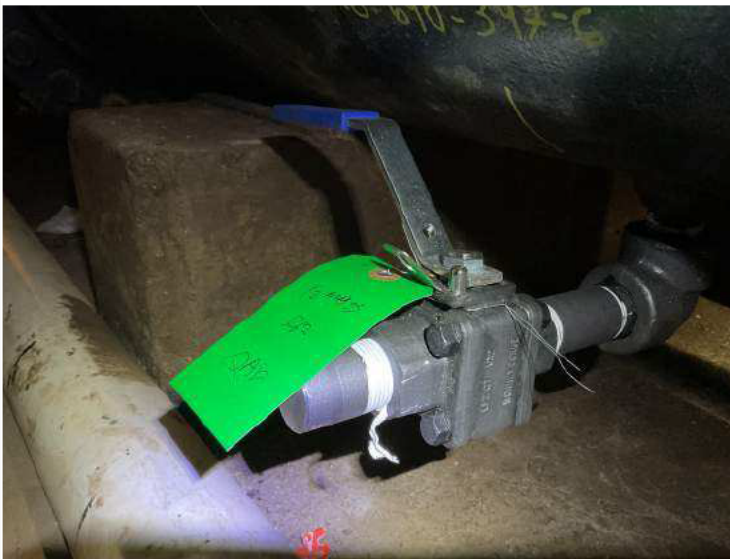
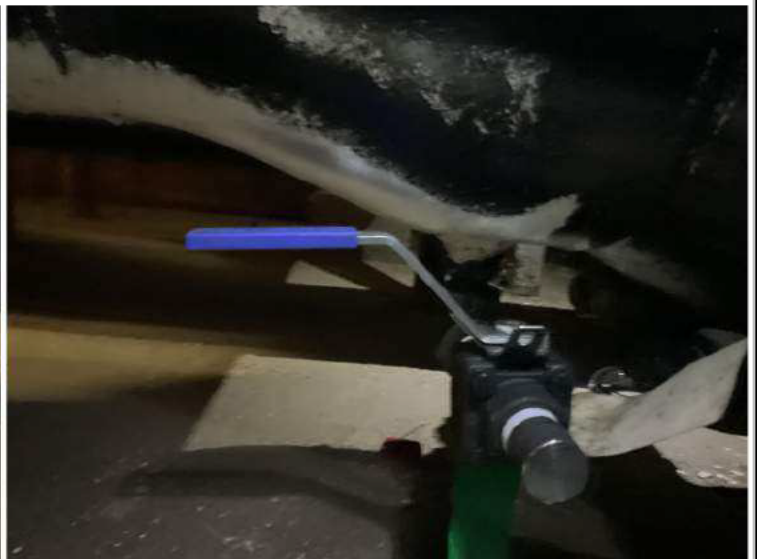
Replacement low point drain assemblies.

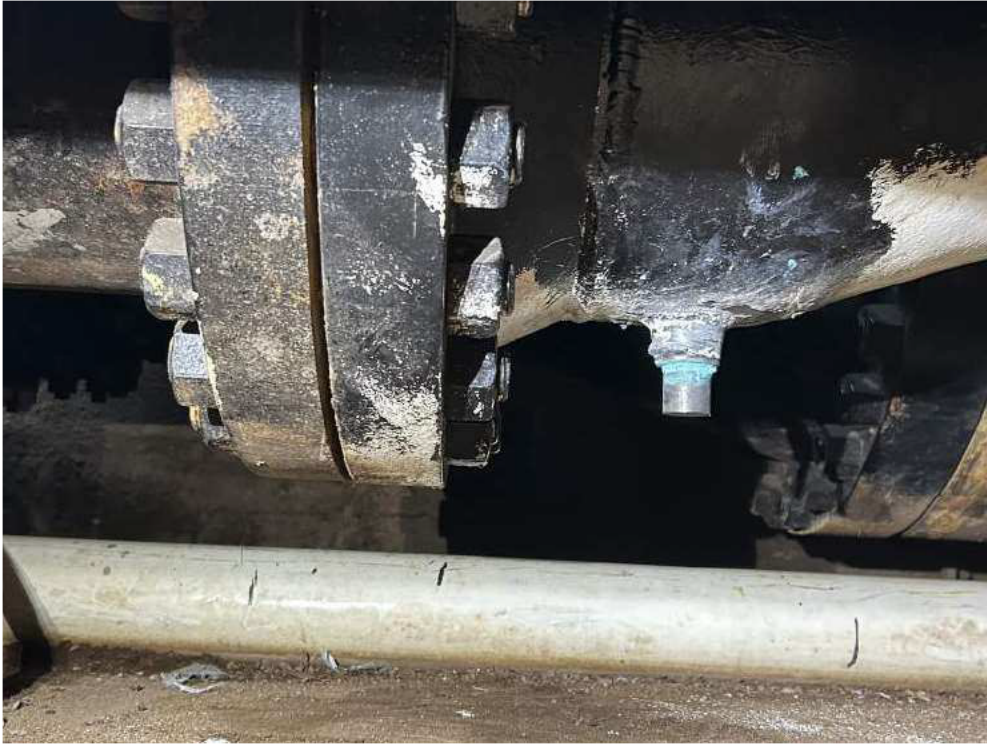
Low point drain assembly replaced with threaded plug after draining segment, cleaning threads and applying sealant.

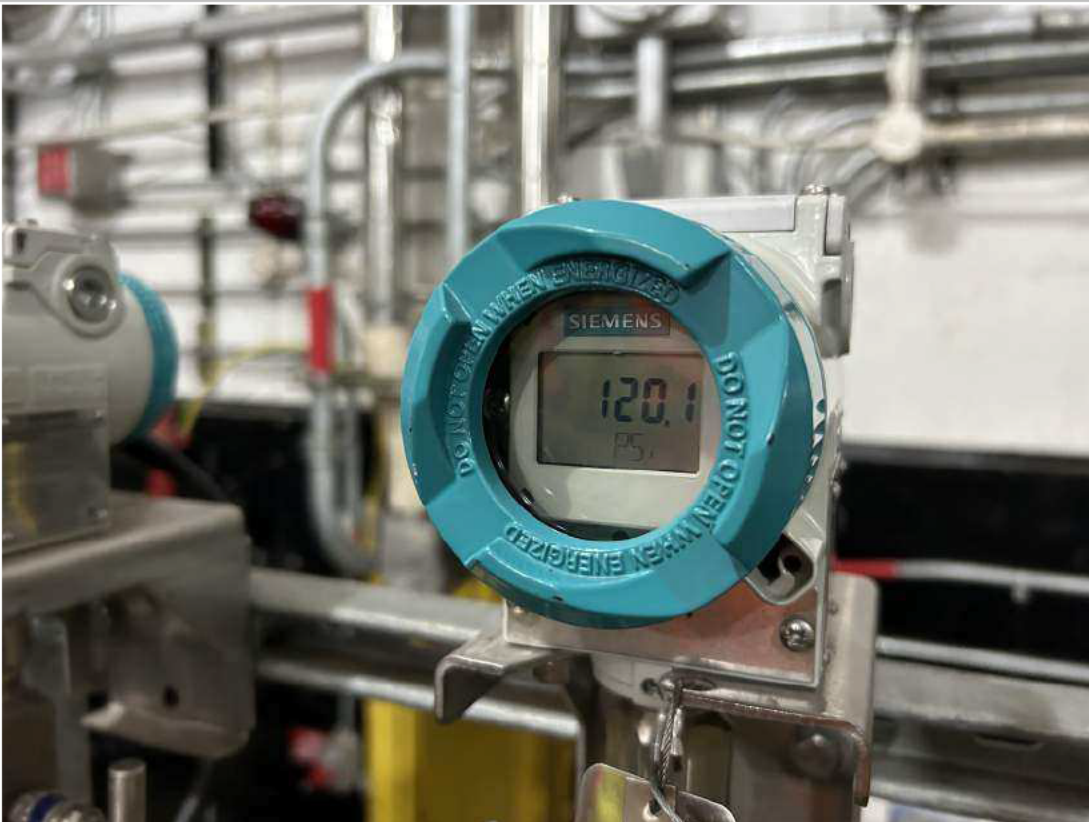
Line segment tested with Nitrogen at 120 psi for 1 hour, with soap testing at affected joints. No leaks noted.
