Joint Task Force-Red Hill

Bi-Monthly Quality Validation Working Group Meeting

22 June 2023

Red Hill Bulk Fuel Storage Facility Defuel

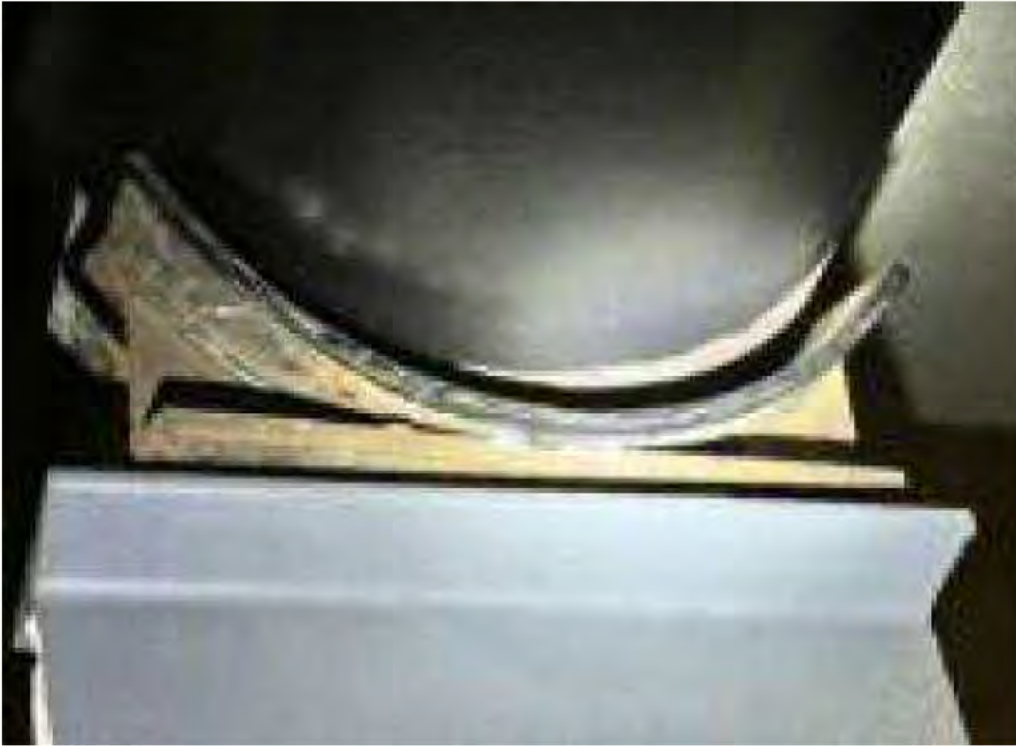
Existing condition at Pipe Support 73 prior to repair.

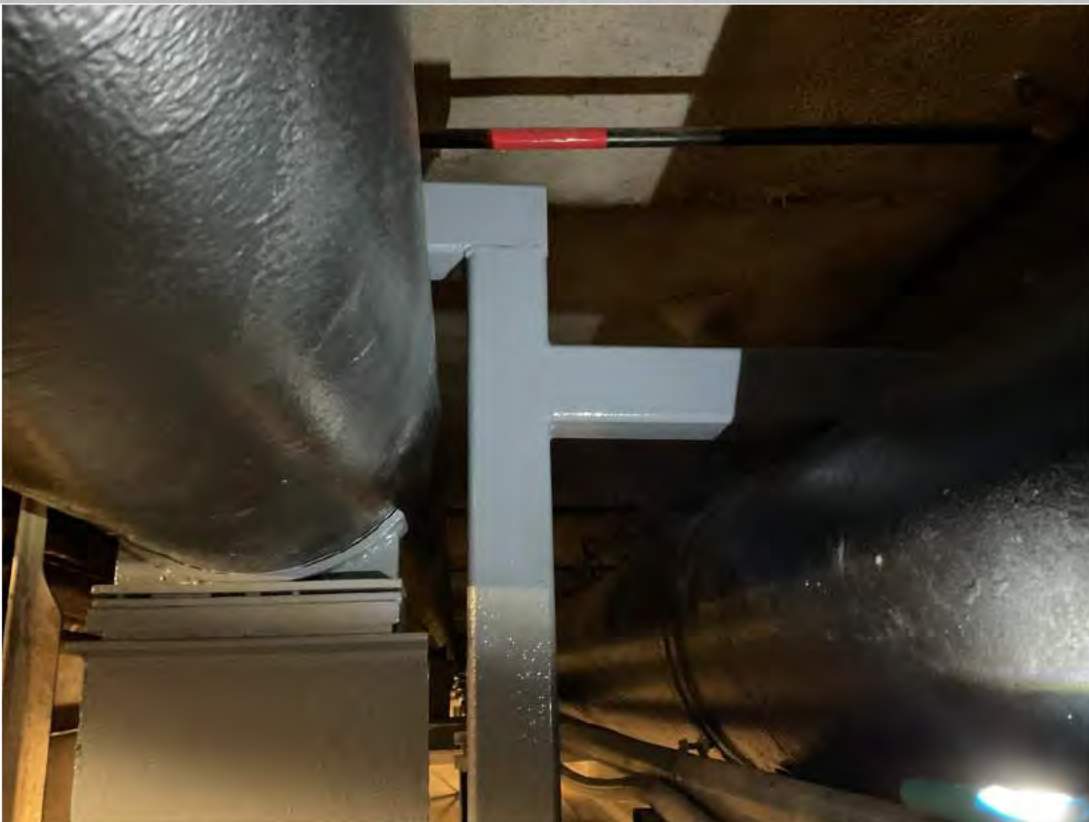
Existing Pipe Support 74.

Installed missing cradle and lateral stops at Pipe Support 74.

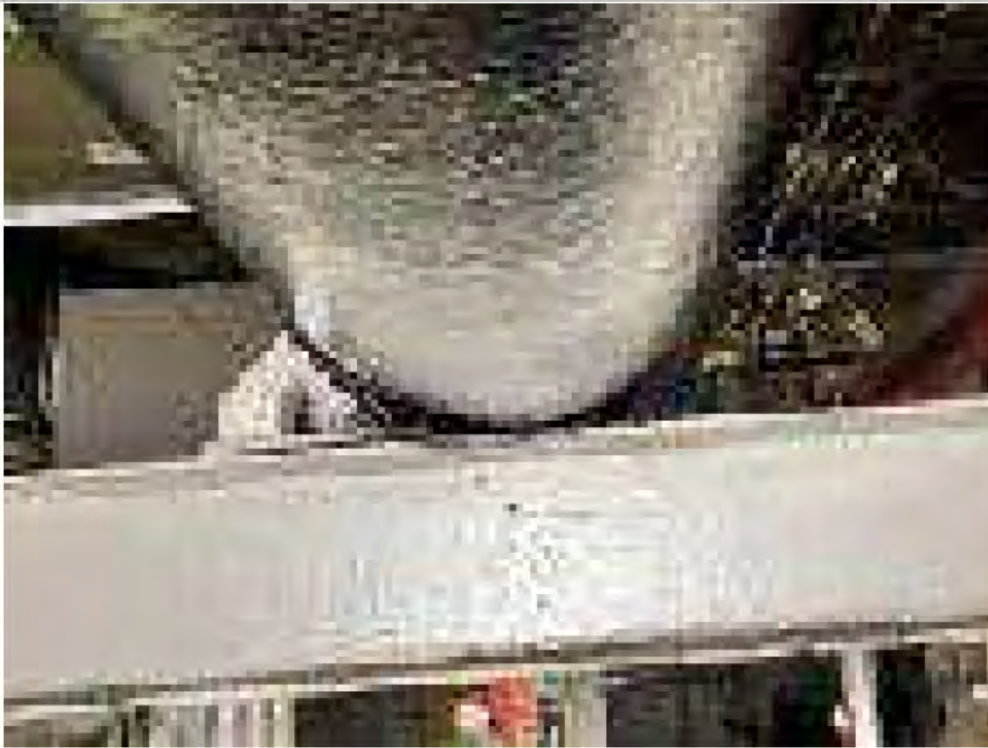
Previous condition at Pipe Support 6.

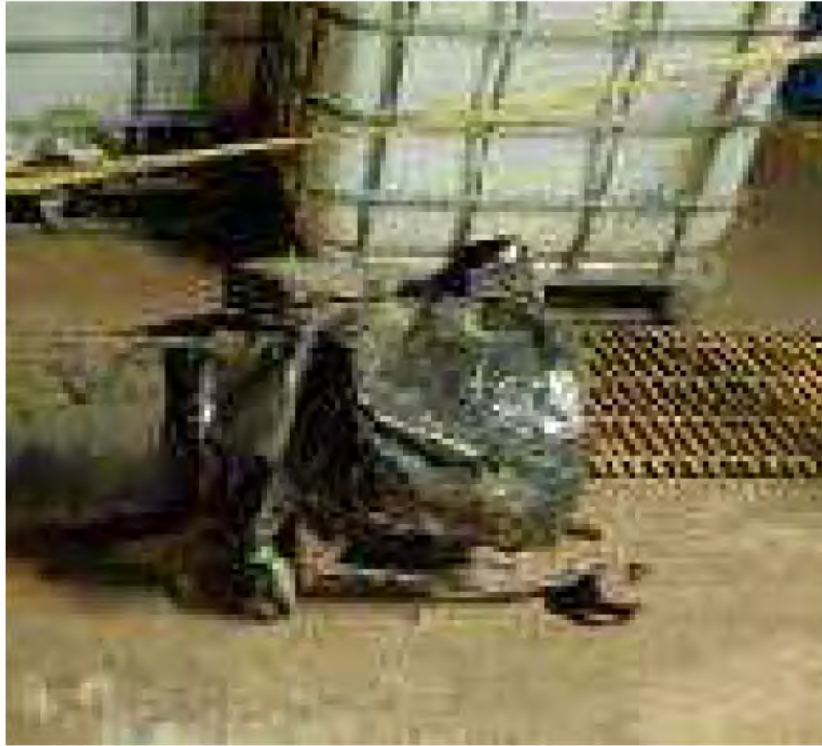
Previous condition: Dresser coupling removed at Tank 18.

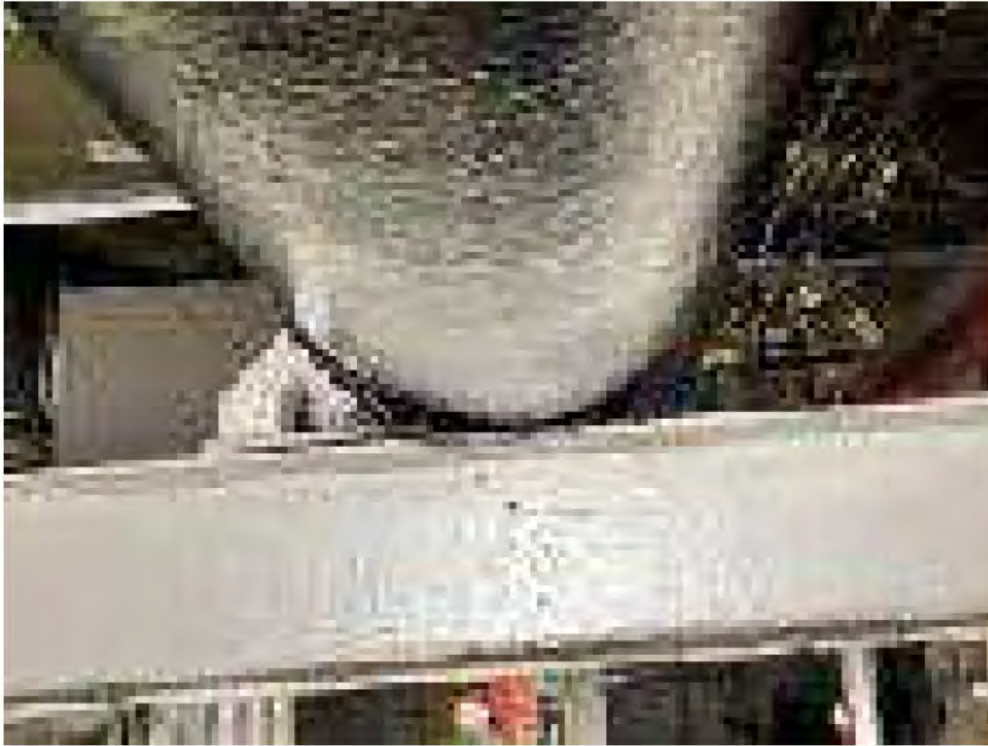
Previous condition at Pipe Support 6.

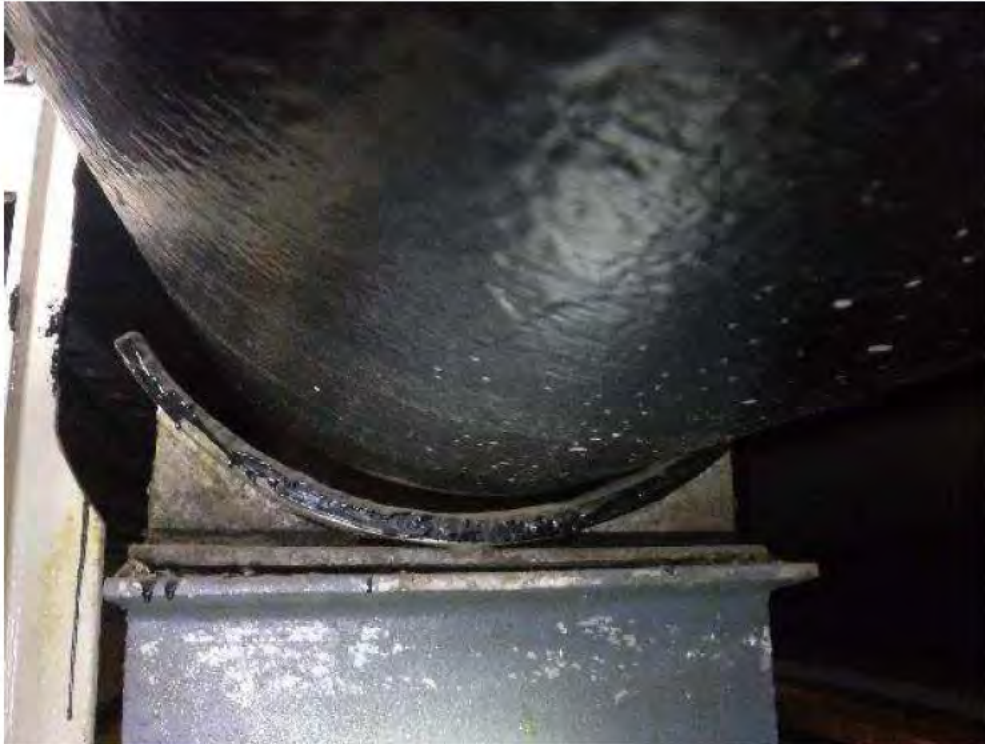
Representative photo of existing conditions within Pipe Support range.

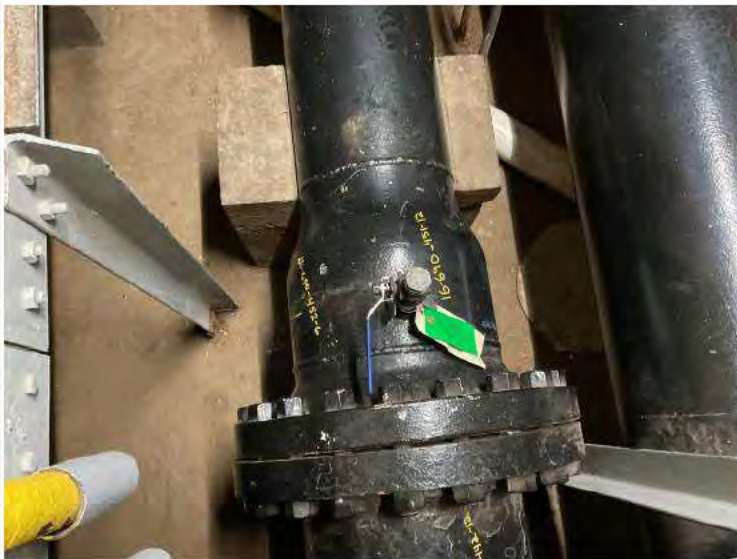
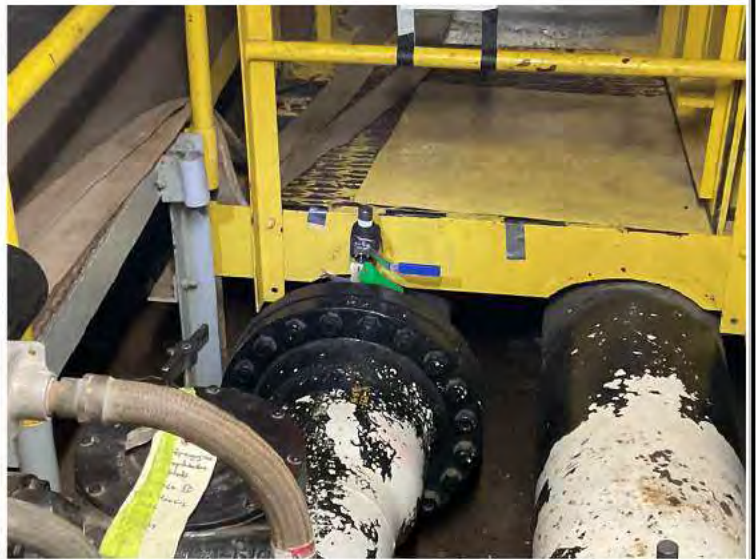
Existing threaded high point vent assembly at UGPH bulkhead.

Threaded connection repairs.

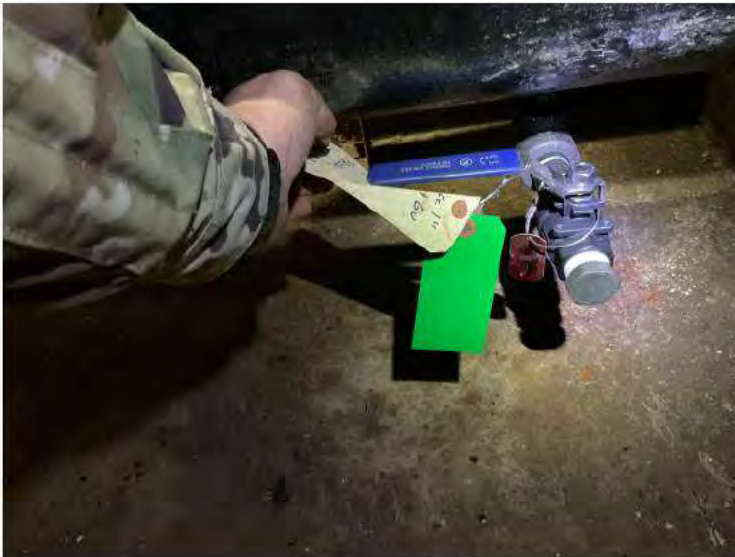
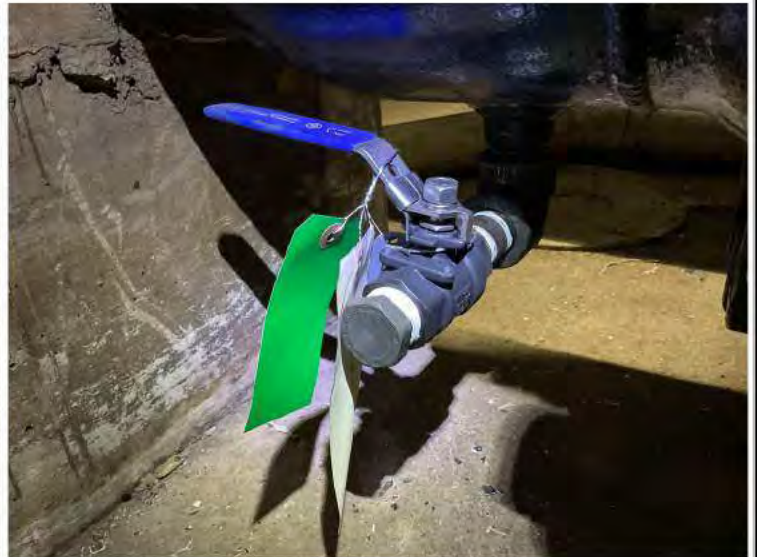
Existing threaded low point drain assembly at UGPH bulkhead.

Threaded connection repairs.

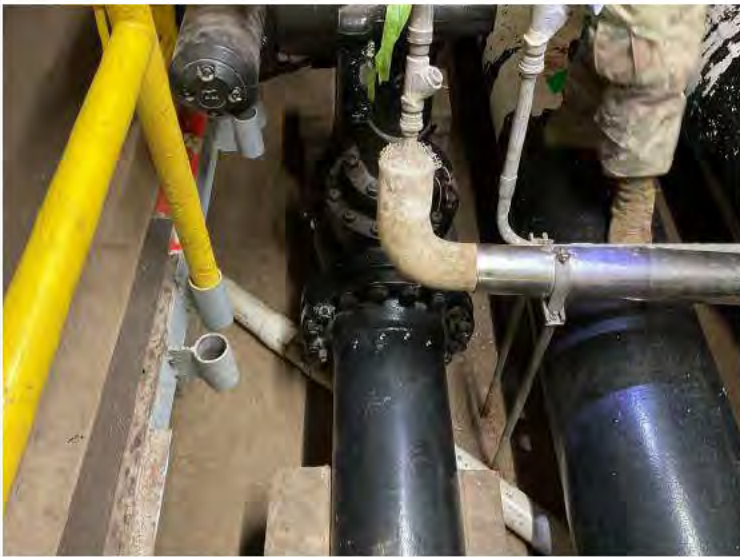
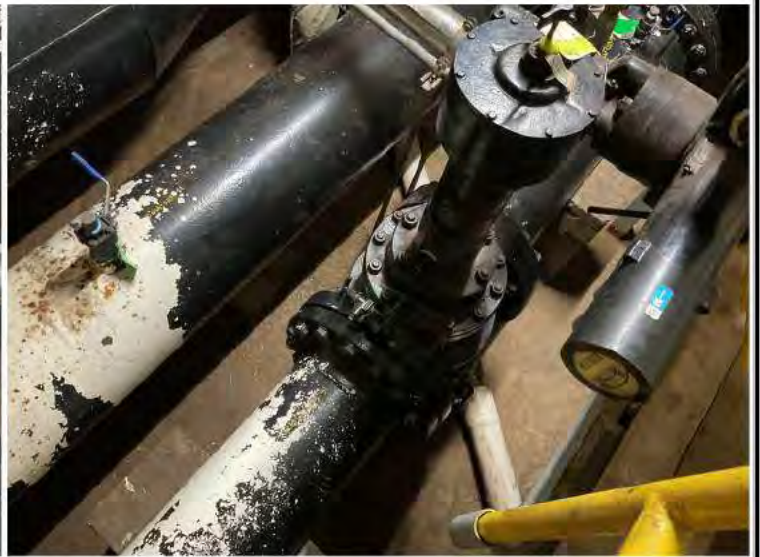
Existing fasteners at 16-inch flange not properly sized.

Fasteners replaced on both sides of flange.

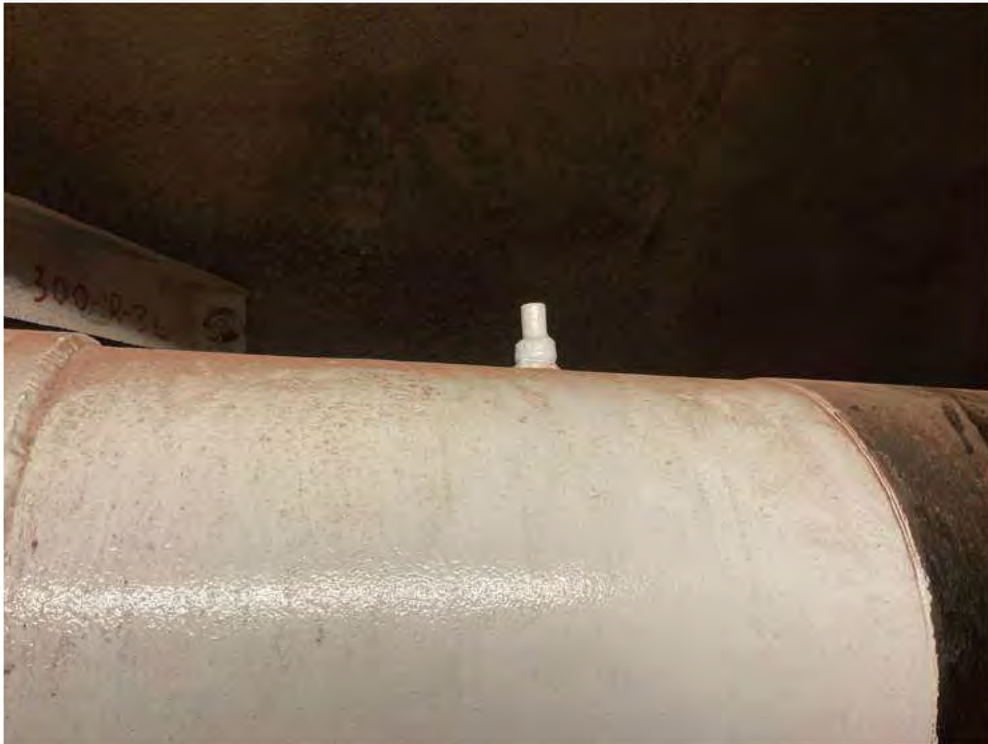
Existing plug at PS 144 seal welded; no repair performed.

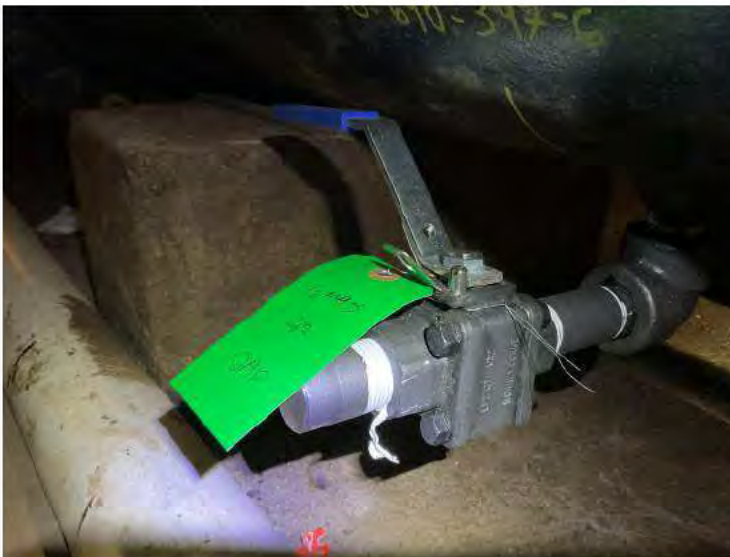
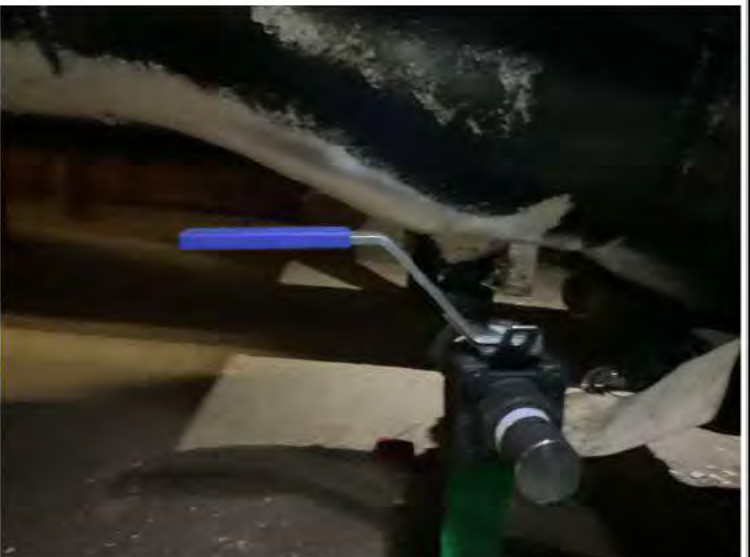
Existing low point drain assemblies in need of service.

Replacement low point drain assemblies.

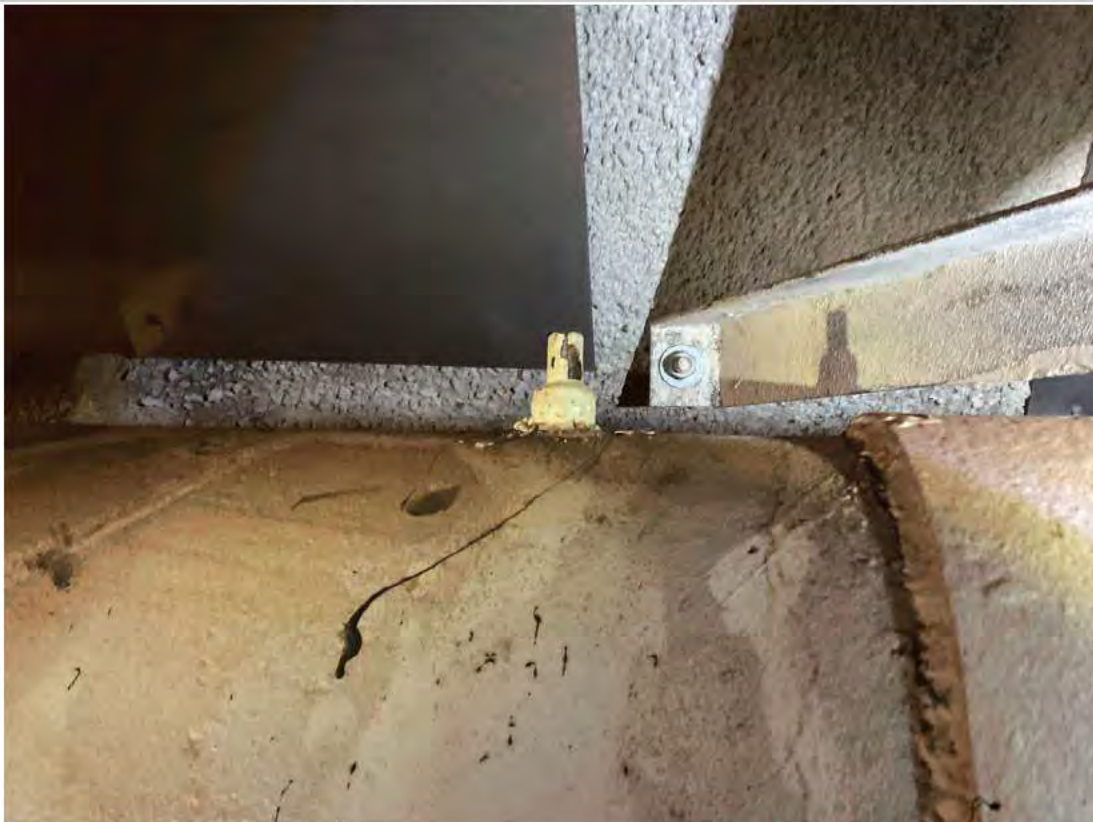
Seal welded assembly at PS 312; no repair performed.

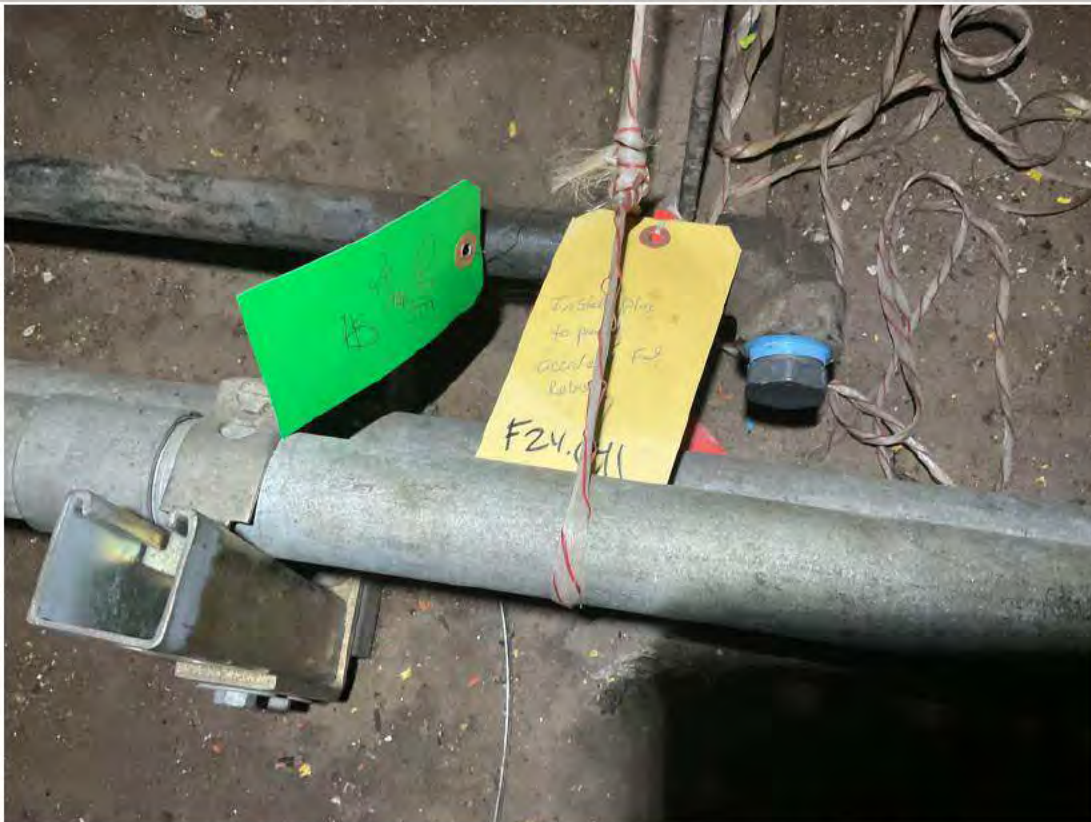
Existing condition (b) (3) (A) line unplugged

Threaded pipe (b) (3) (A) with fuel-resistant thread sealant.

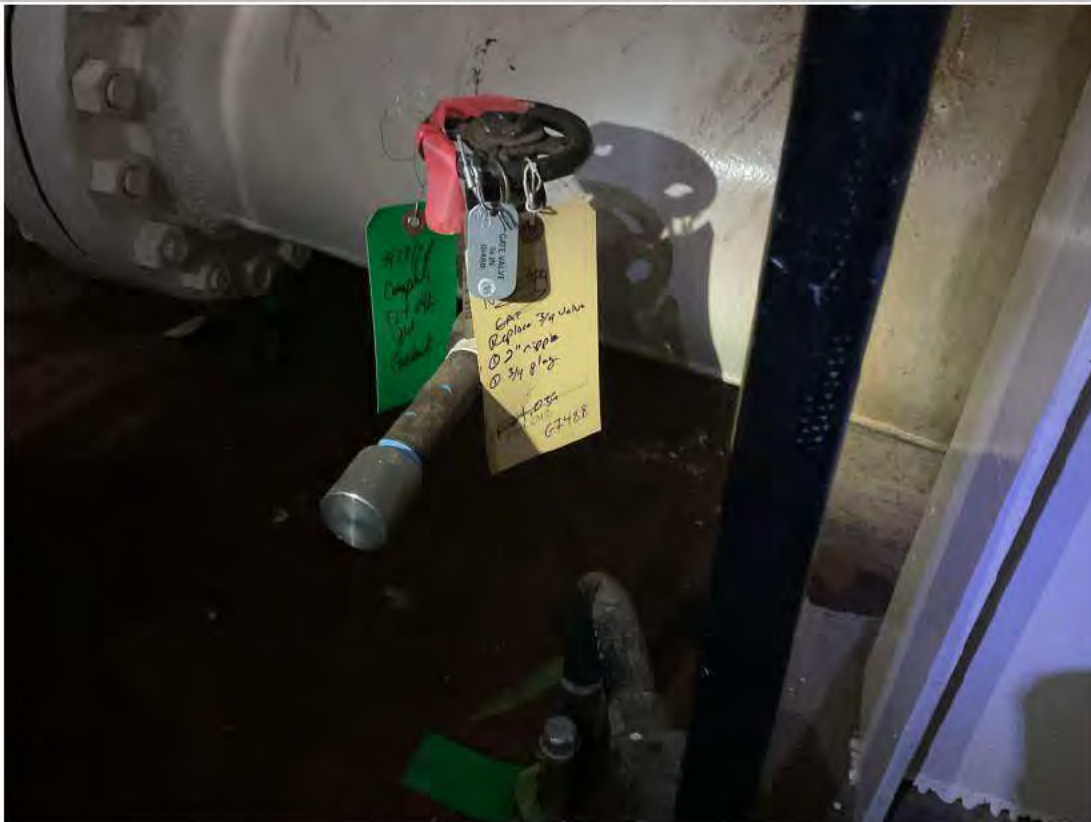
Existing condition: no plug/cap on pipeline nipple.

Installed threaded cap on pipeline nipple to prevent accidental discharge.

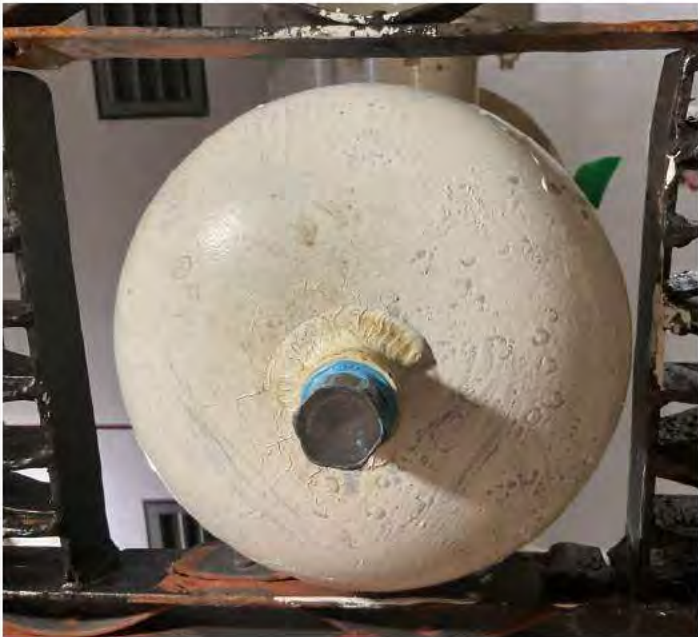
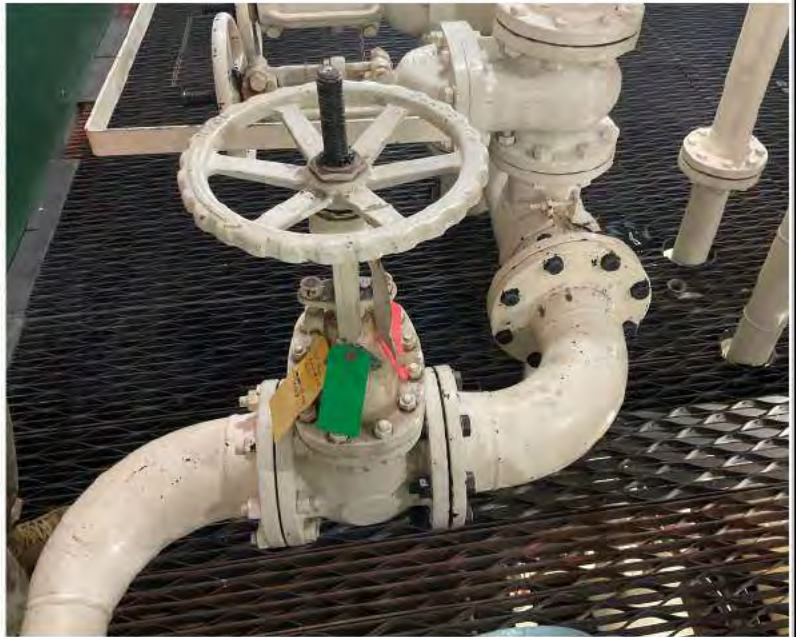
Representative photo of existing conditions: weeping on threaded connections on F-24 pressure relief system.

Replaced threaded plug of bottom of basket strainer, changed gaskets and bolts on spool for F-24 pressure relief system.

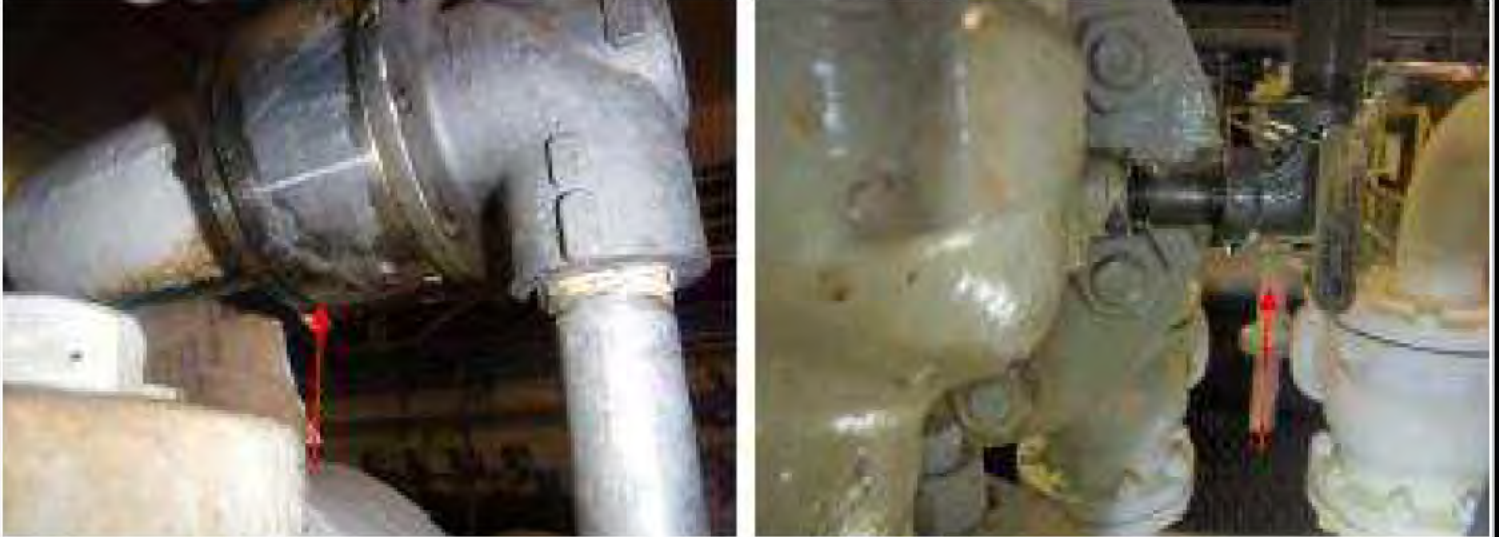
Existing condition: weeping threaded connections on pressure relief assemblies.

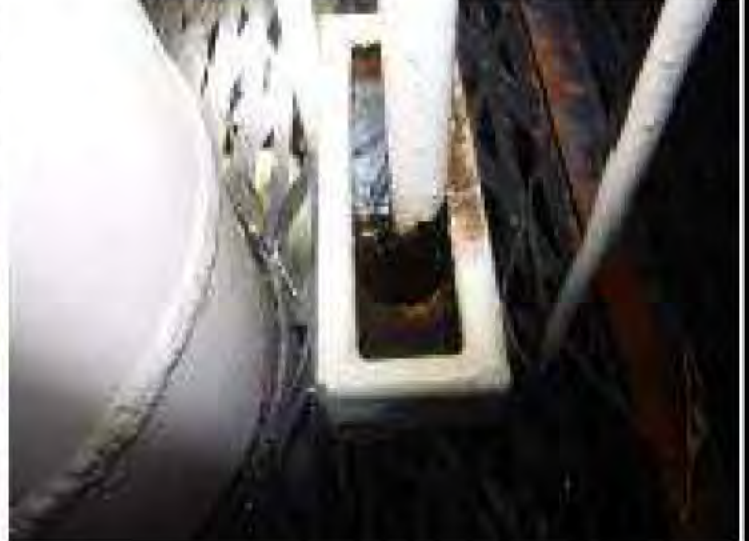
Existing condition: valve weeping by through grate into secondary containment trench.

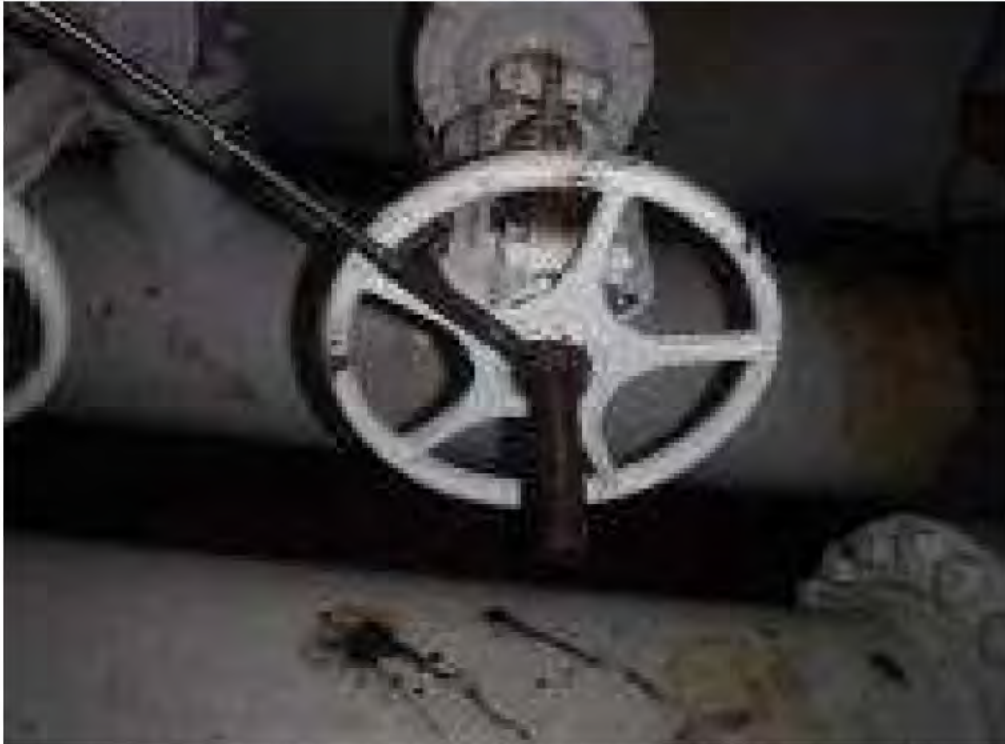
Existing condition: valve handwheel missing thread nut. Note: valve in open position in photograph.

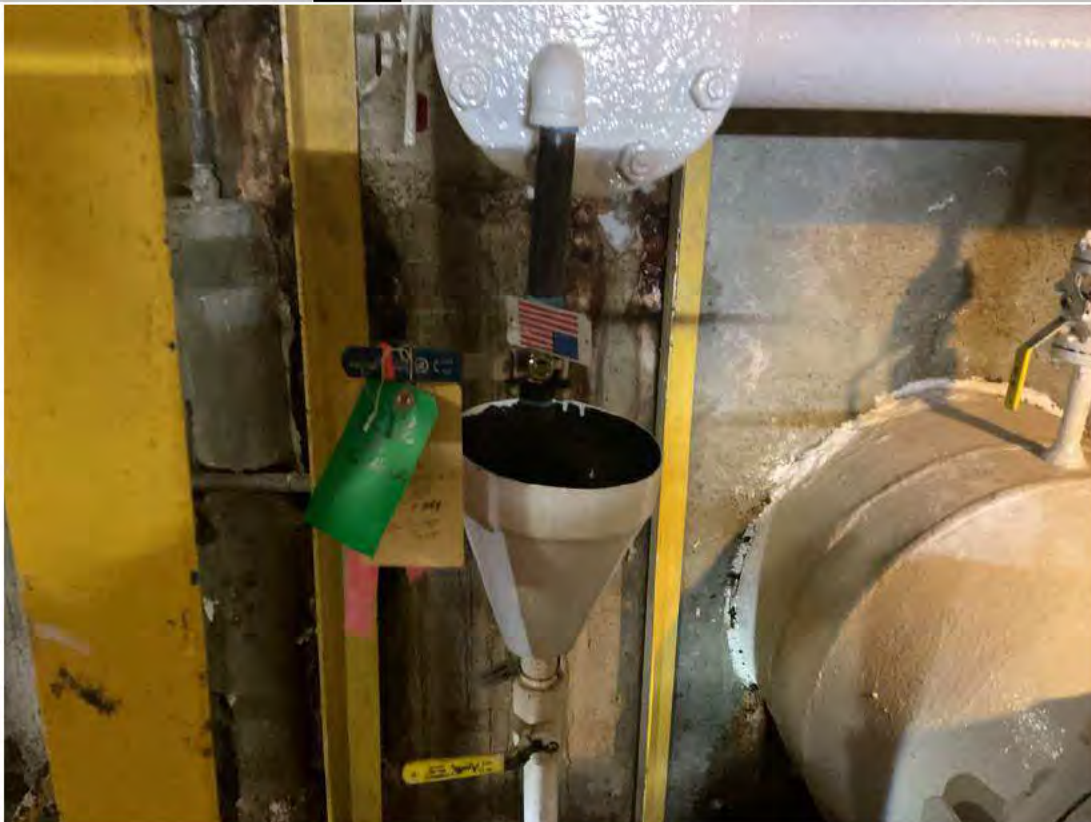
Existing condition: (b) (3) (A) ball valve on FOR line without plug at Surge Tank 3.

New nipple, ball valve and threaded plug installed on (b) (3) (A) nipple on FOR line at Surge Tank 3.

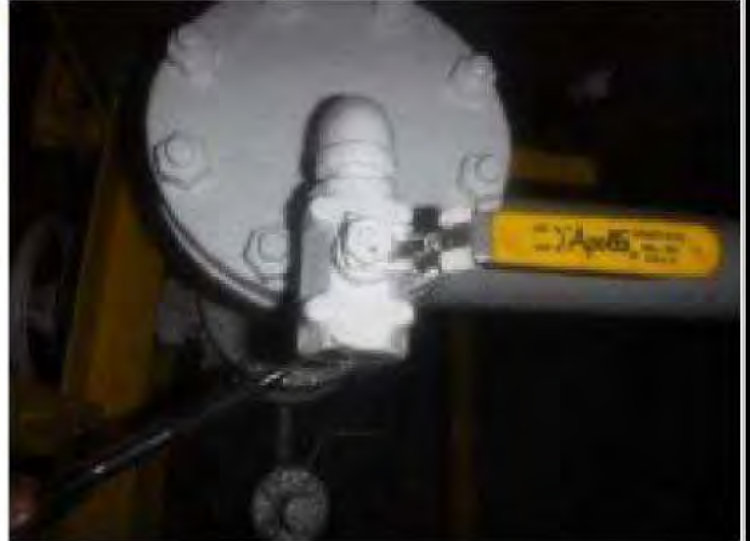
Existing condition (b) (3) (A) ball valve on FOR line without plug at Surge Tank 4.

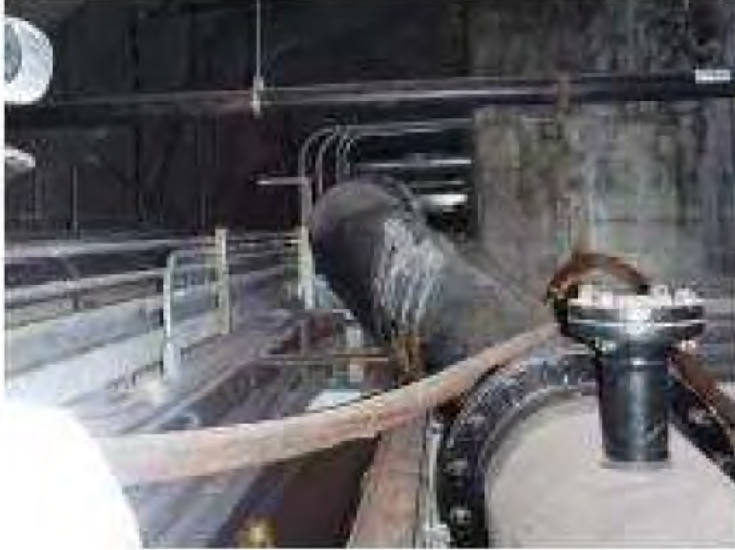
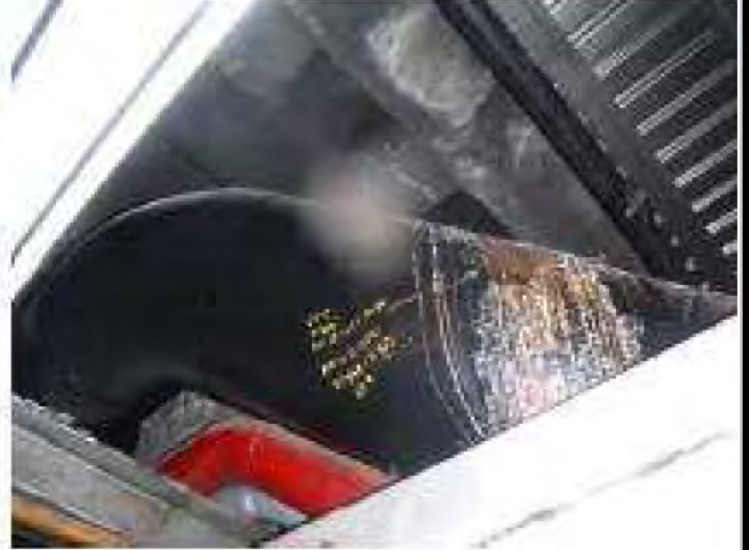
Existing condition of pipe at Pipe Support 20. Corrosion on offset alignment spool.

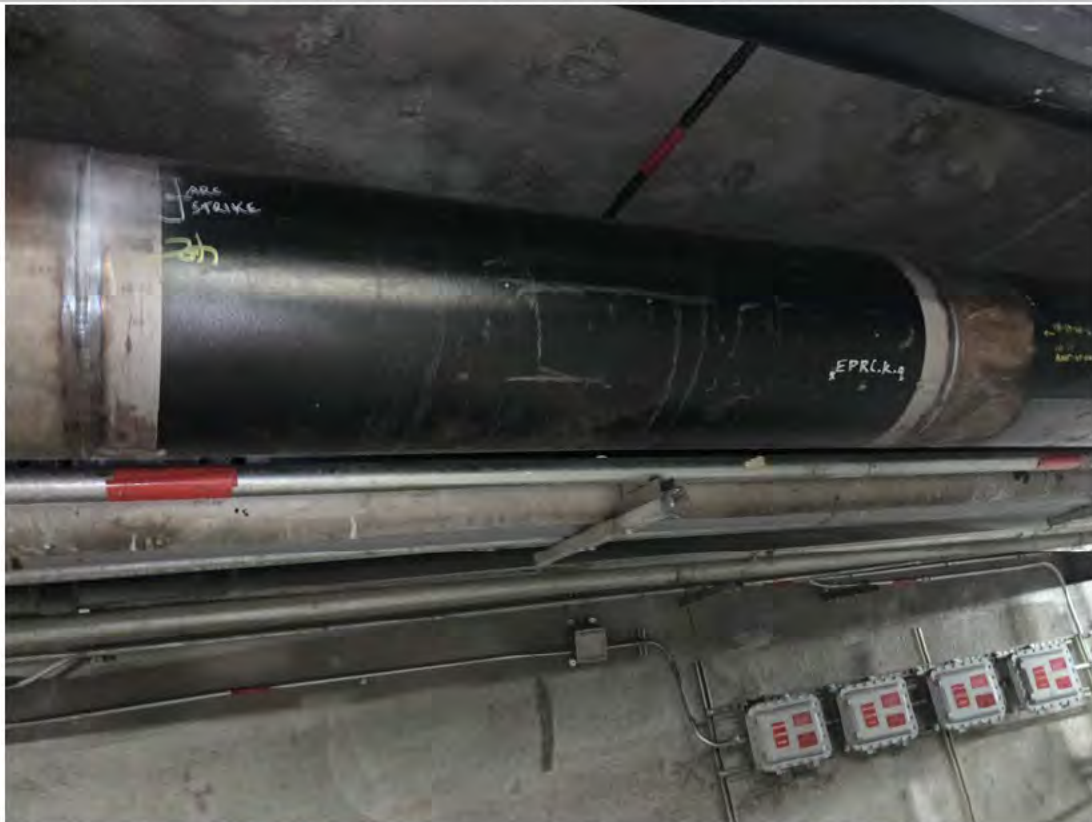
Existing condition of pipe at PS 59-60 of pipeline bell connection completed by fillet weld instead of butt welded connection.

Contractor installed 6 LF (b) (3) (A) JP-5 line between PS 59 and 60 to replace pipeline bell connection.

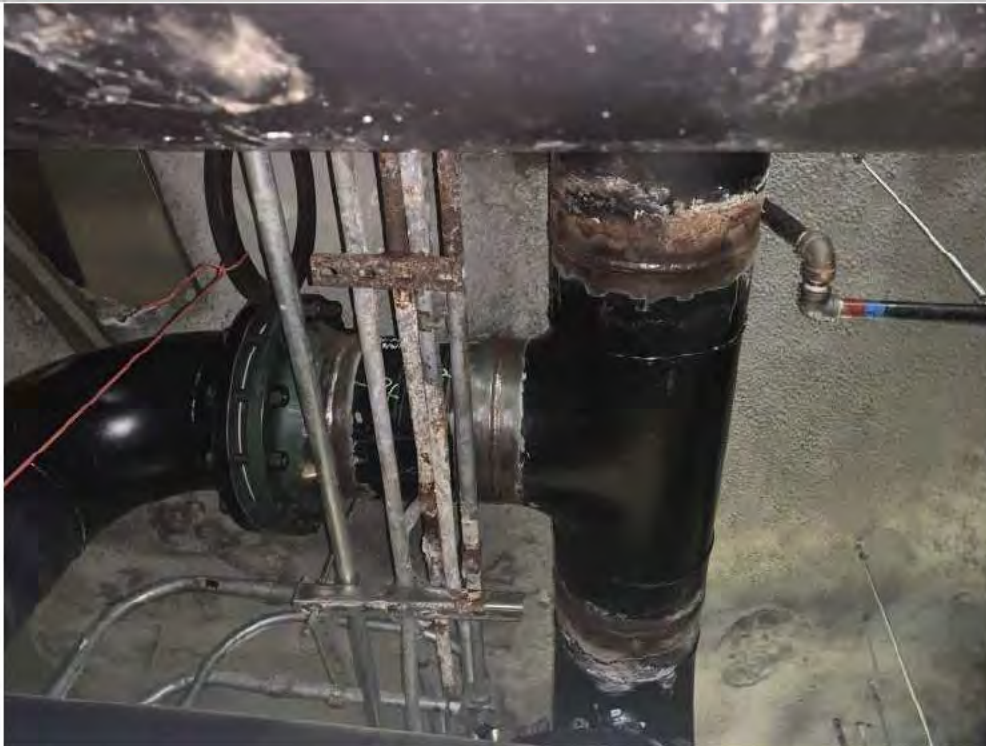
Branch connection to tank lateral piping. No existing condition photograph available.

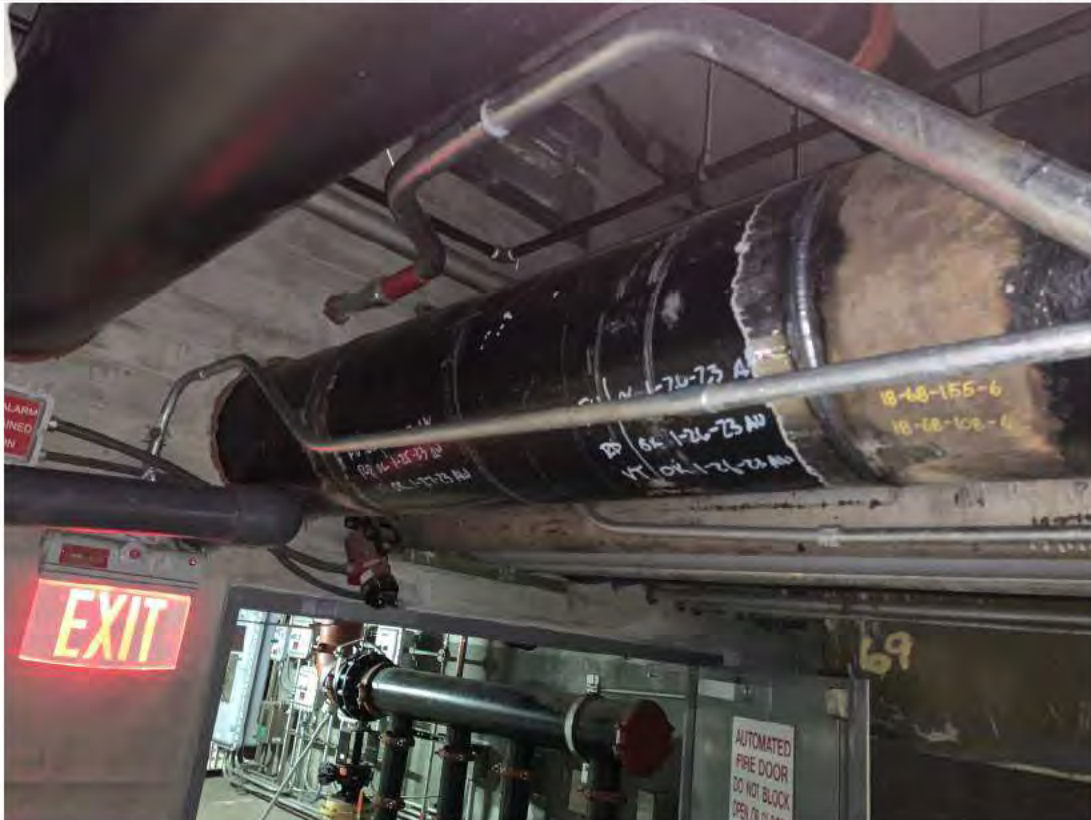
Uphill side of the Door 3 bulkhead penetration between PS 68 and 69; no existing photograph of bell connection available.

Downhill side of the Door 3 bulkhead penetration between PS 68 and 69; no existing photograph of bell connection available.
