QUALITY VALIDATION (QV) REPORT

Red Hill Bulk Fuel Storage Facility Defuel

Validation Firm	HDR Environmental, Operations and Construction, Inc.	Repair No.	DEF 001
Address	9781 S. Meridian Blvd., Suite 400, Englewood, CO 80112	Repair ID	FLC.FOR.VALVE
Contract No.	FA890315D0007, D.O. FA8903-19-F-0027	Report Date	03 NOV 2023
QV Engineer	(b) (6)

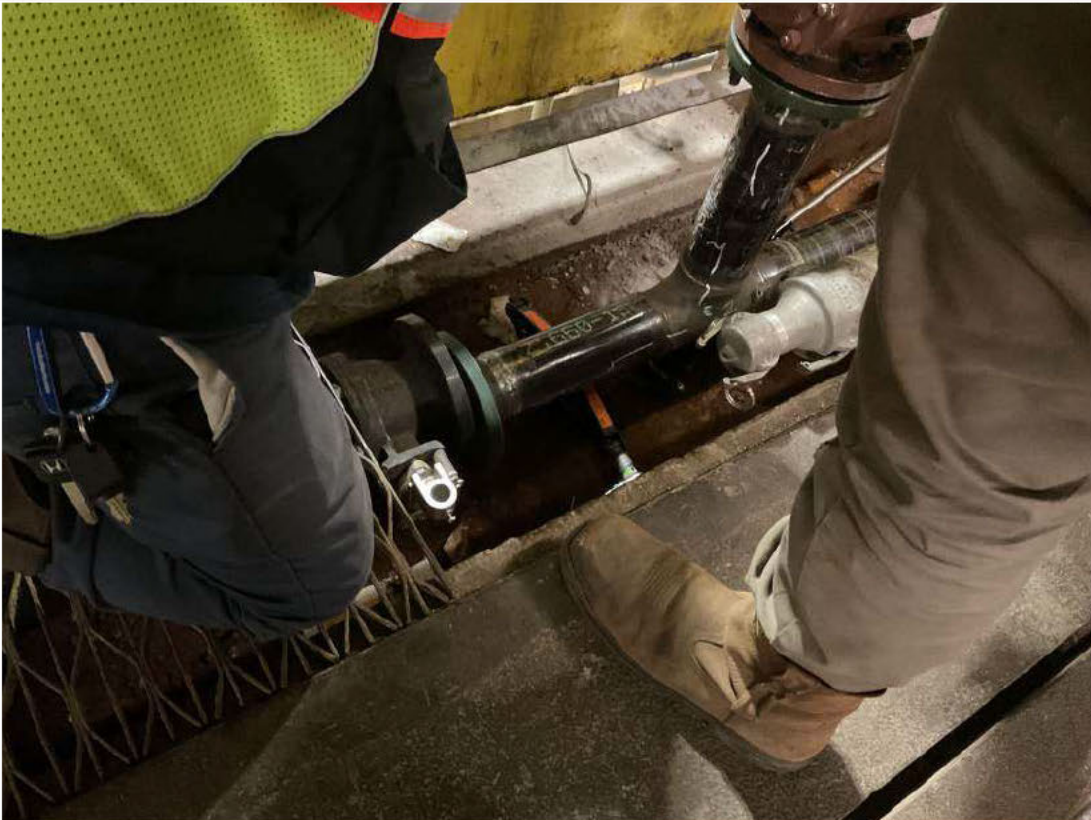
Ball valve installed downstream allowing simultaneous tank bottom draining via FOR line and groundwater through the Sump.

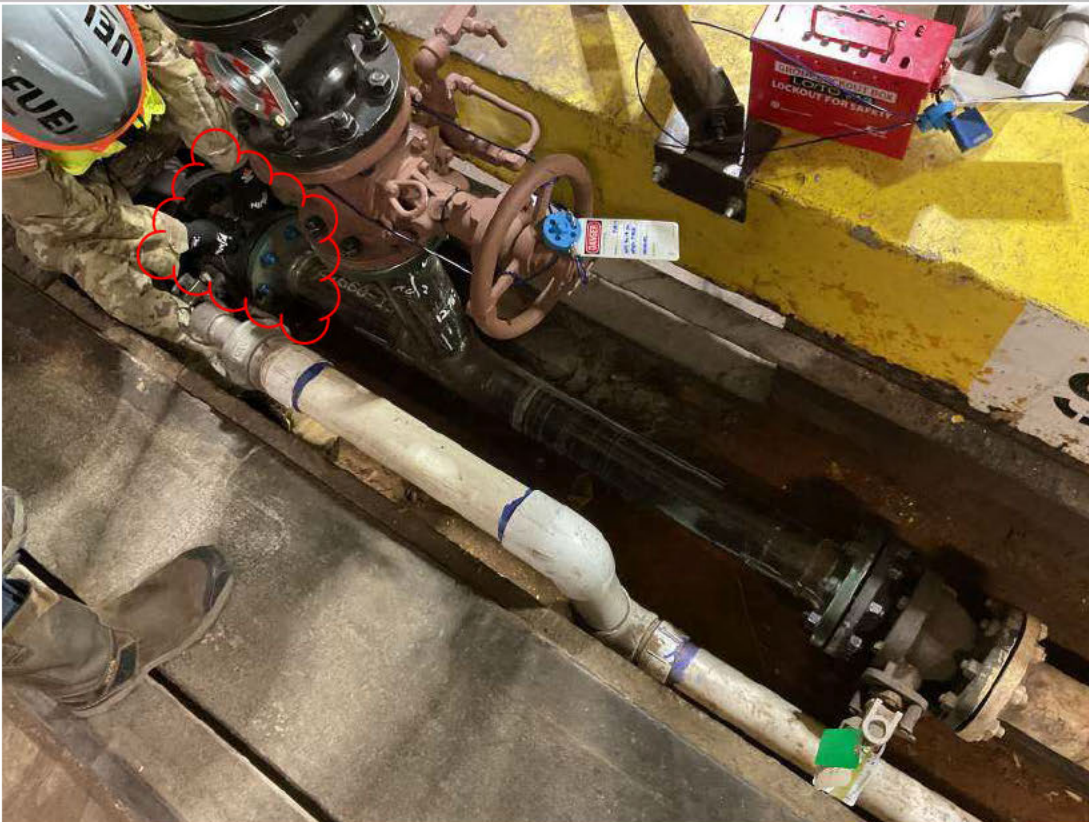
Completed installation of modified spool with new downstream ball valve to isolate; workers installing valve ID tag.
