## QUALITY VALIDATION (QV) REPORT

### Red Hill Bulk Fuel Storage Facility Defuel

Validation Firm	HDR Environmental, Operations and Construction, Inc.	Repair No.	DEF 002
Address	9781 S. Meridian Blvd., Suite 400, Englewood, CO 80112	Repair ID	RMMR.ZONE 7
Contract No.	FA890315D0007, D.O. FA8903-19-F-0027	Report Date	28 DEC 2023
QV Engineer	(b) (6)

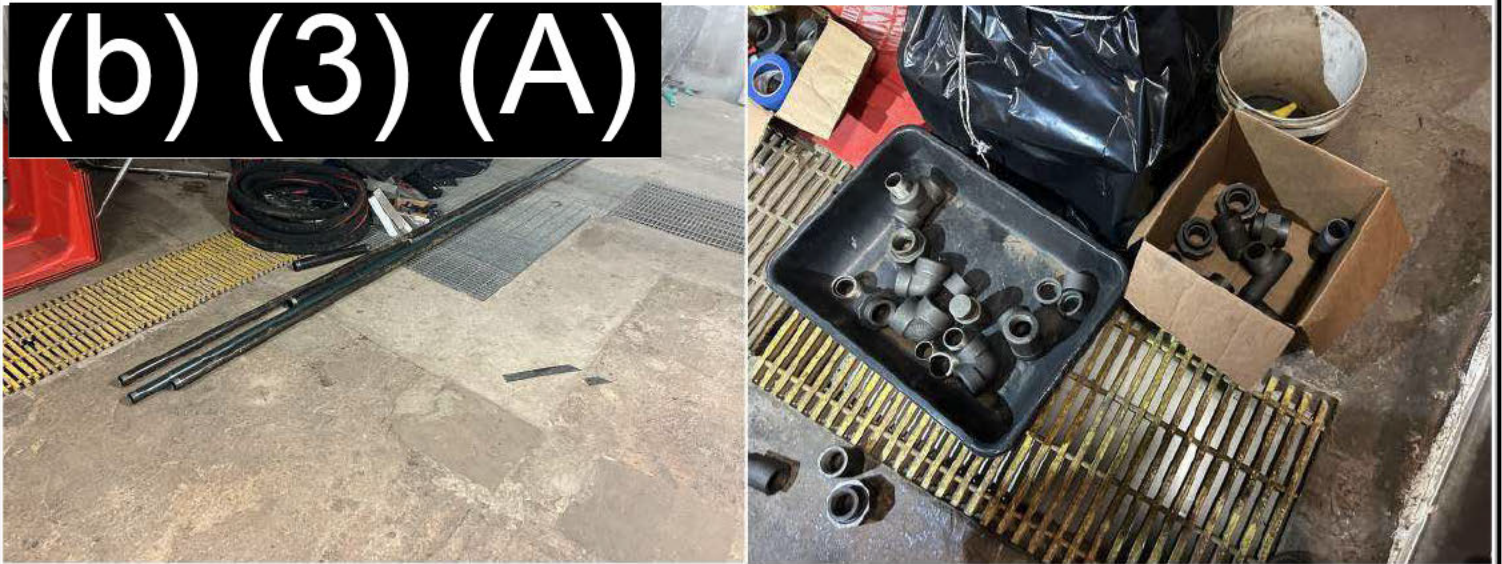
New threaded piping and Class 3000 fittings used for replacing existing FOR piping at Zone 7.

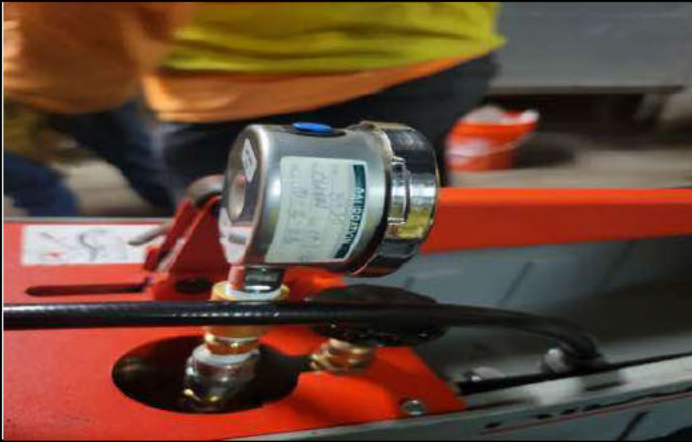
Photo 1

Calibrated 0-300 pressure gauge.

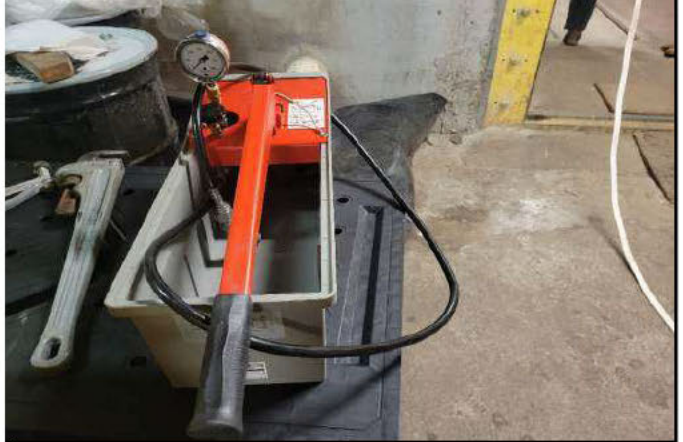
Photo 2

Hydrostatic pressure testing pump.

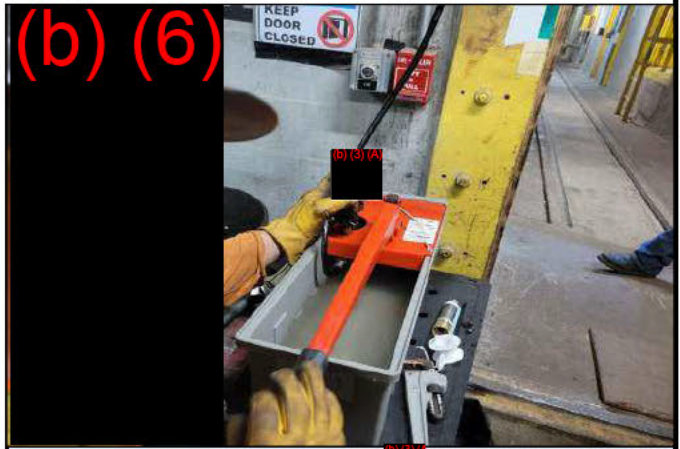
Photo 6

Pumping the hydrostatic pump to get out (b) (3) (E) PSIG testing pressure.
