Subject: Notice of Violation and Order
Docket No. 2025-CW-EO-44
Hawaii Water Pollution Rules and Regulations
Agricultural Road in Hanapepe
Hanapepe, Island of Kauai, Hawaii
File No. HIU010809

STATE OF HAWAII
DEPARTMENT OF HEALTH
NOTICE OF VIOLATION AND ORDER

Site Name: Hanapepe Unpermitted Grading
NGPC File No.: HIU010809

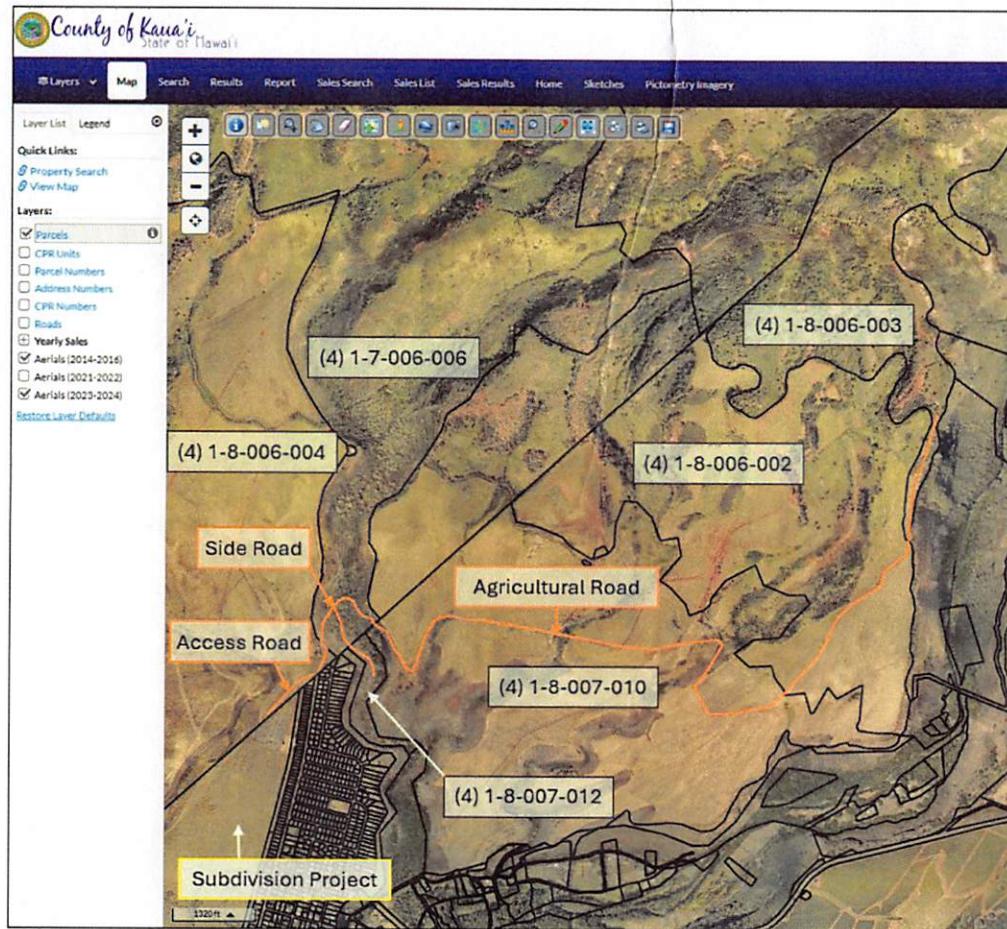
2. The inspection started at the northernmost point of Moi Road where there is an access to the Agricultural Road (Figure 1, Photograph 1). The Inspection Team entered the Agricultural Road (Photograph 2) and drove directly to the property leased by T. Brun (Brun Property). At the Brun Property, the Inspection Team observed work done on a short portion of the Agricultural Road and where the Bruns would like to lay down the soil from the DHHL project. The Inspection Team then continued back down the Agricultural Road to observe the grading work as well as a side road that extends southeast off the Agricultural Road. The inspection concluded with a visit to a short segment of the Agricultural Road south of the initial access at Moi Road; the segment meets with the DHHL Subdivision Project.

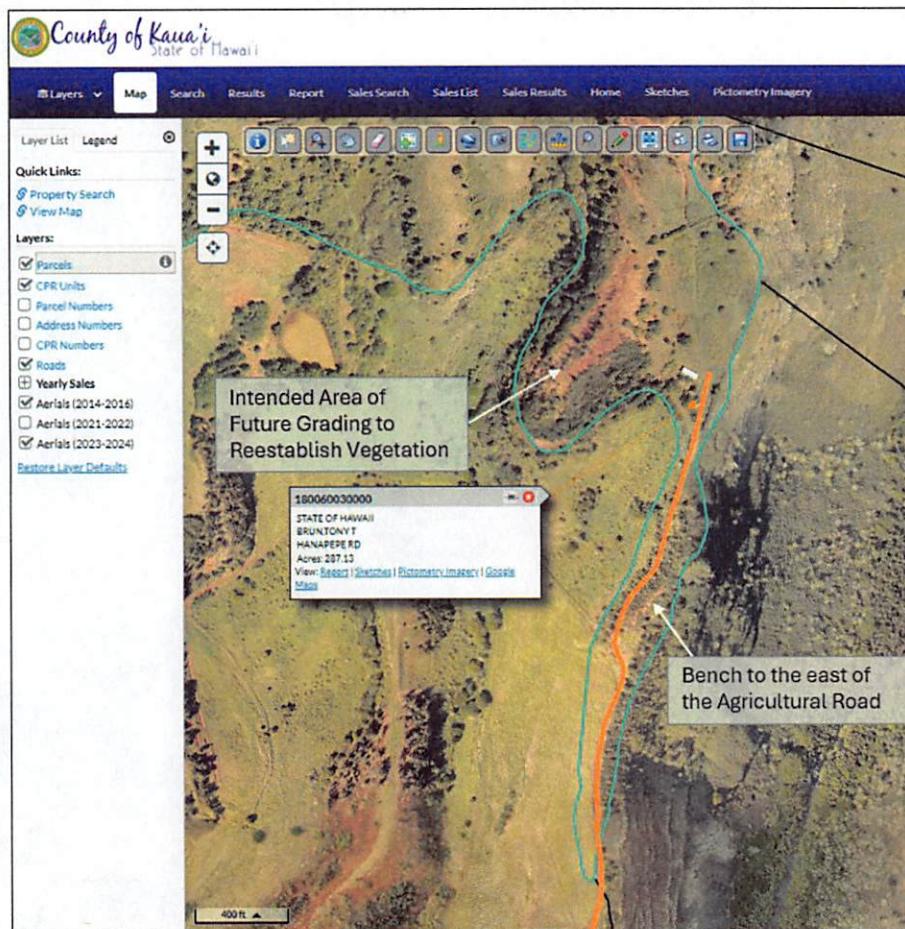
Figure 2. Aerial view of TMK (4) 1-8-006:003, owned by the State of Hawaii and leased by Tony T. Brun. Orange line depicts the Agricultural Road. Aerial image with tax map key boundary lines obtained from the County of Kauai Real Property Website, <https://www.qpublic.net/hi/kauai/>.

4. Within the Brun Property, we came to a gate that M. Contrades-Brun opened for us (Photograph 3). Just after entering the gate, I observed a bench adjacent and to the east of the Agricultural Road (Figure 2, Photographs 3-6).

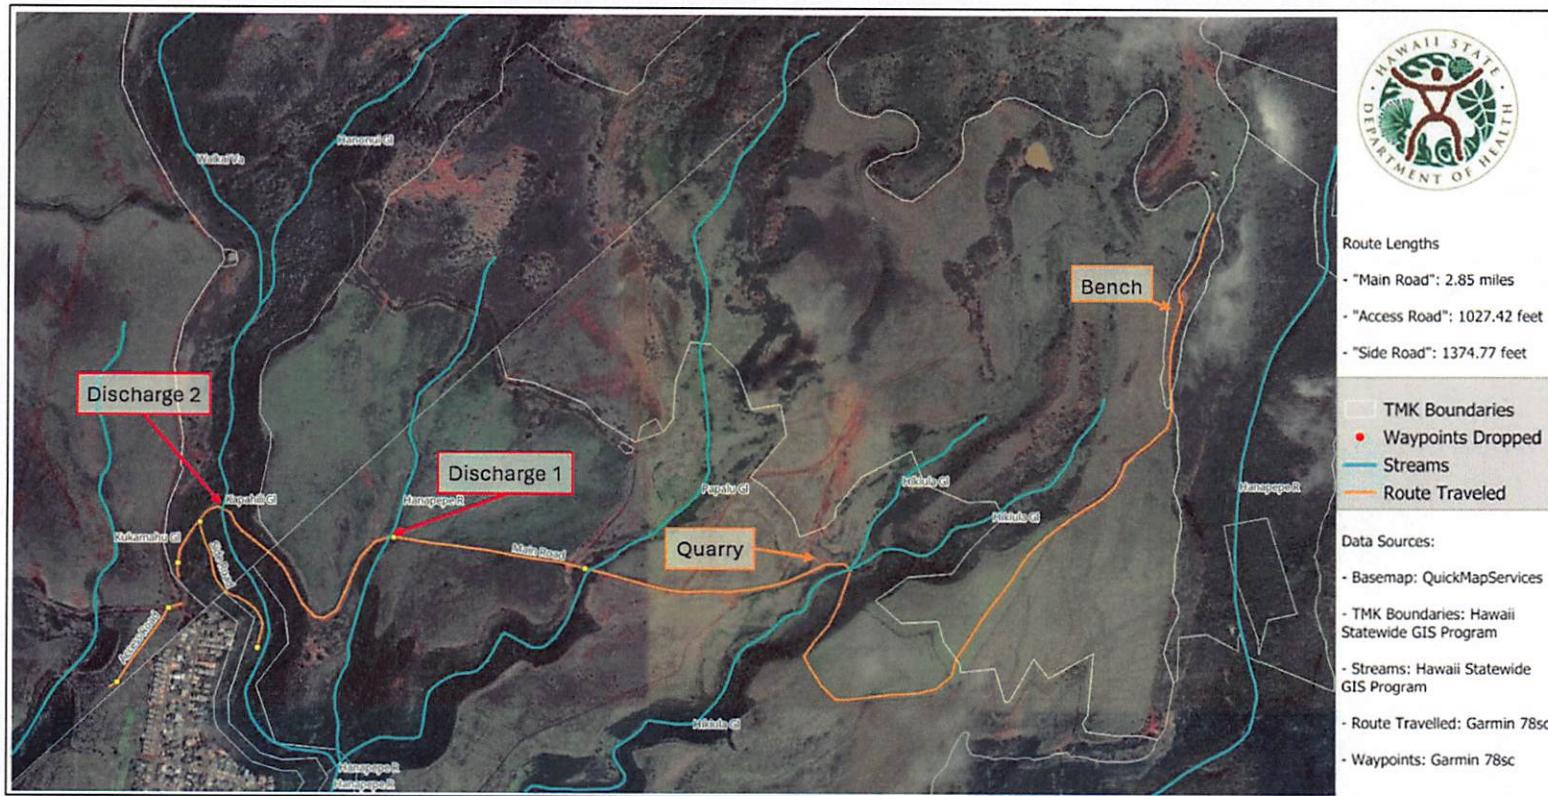
Figure 3. Aerial view of the Agricultural Road (orange lines) and other notable features observed by the Inspection Team on August 25, 2025 inspection.

- TMK boundary lines - white lines
- State waters and labels – blue lines
- Discharge 1 – Discharge of dirt, vegetation, and rocks to the Hanapepe River system as described in Item 10
- Discharge 2 – Discharge of dirt, vegetation and rocks to Kapahili Gulch as described in Item 11

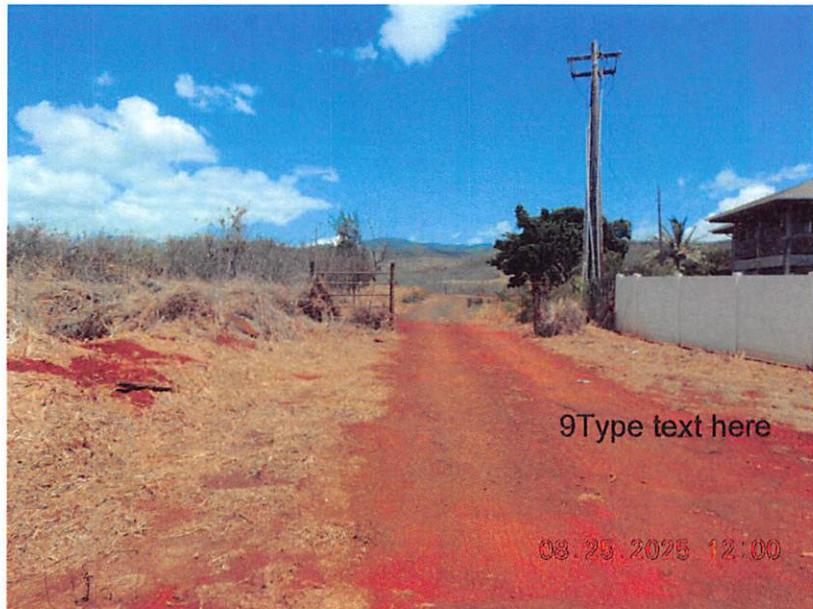
Photograph 1.

Description: View facing north of the access to the Agricultural Road off Moi Road.

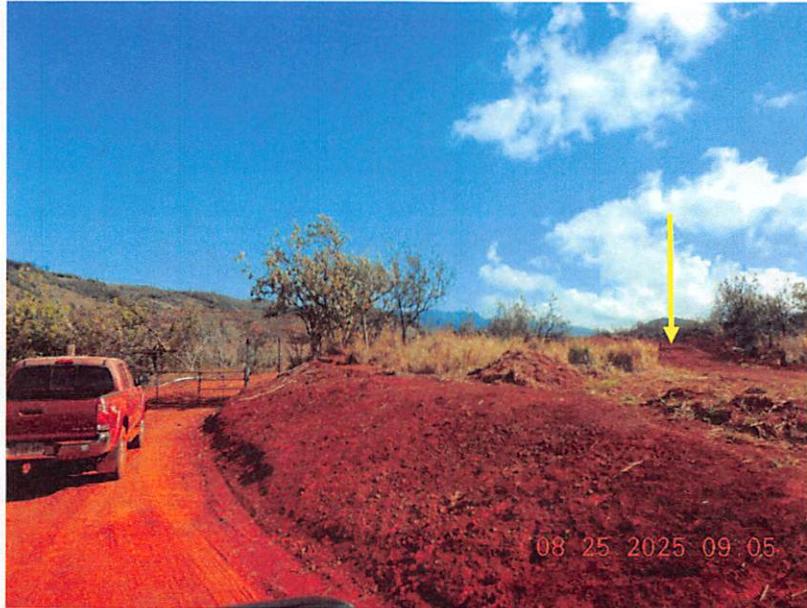
Photograph 3.

Description: View facing north of a gate along the Agricultural Road leading into the Brun Property. A bench (yellow arrow) was present to the east of the Agricultural Road.

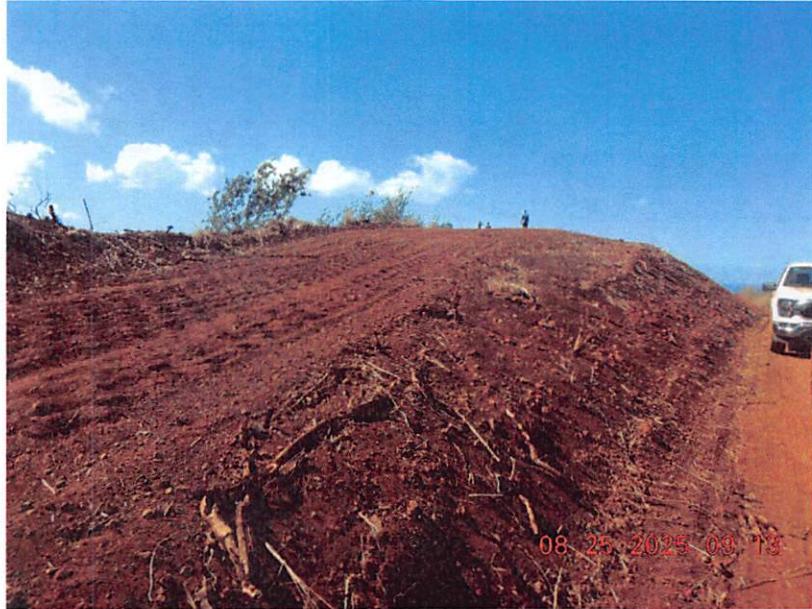
Photograph 5.

- b. I observed fresh tracks from heavy equipment, some of which were heavily compacted (Photograph 7).
 - c. At the east and west sides of the bench, I observed loose soil with dried vegetation mixed in, indicating that vegetated areas had recently been grubbed and graded (Photographs 5, 6, 8 and 9). To the east of the bench, dirt and grubbed vegetation was pushed to the edge of the valley and in some locations, were over two (2) feet high (Photographs 8-9). The west slope of the bench was comprised of loose soil and cut vegetation (Photographs 5-6). It appeared the bench had been widened.

Description: View facing south of the bench to the east of the Agricultural Road inside the Brun Property. Dirt and vegetation were pushed to the edges of the bench.

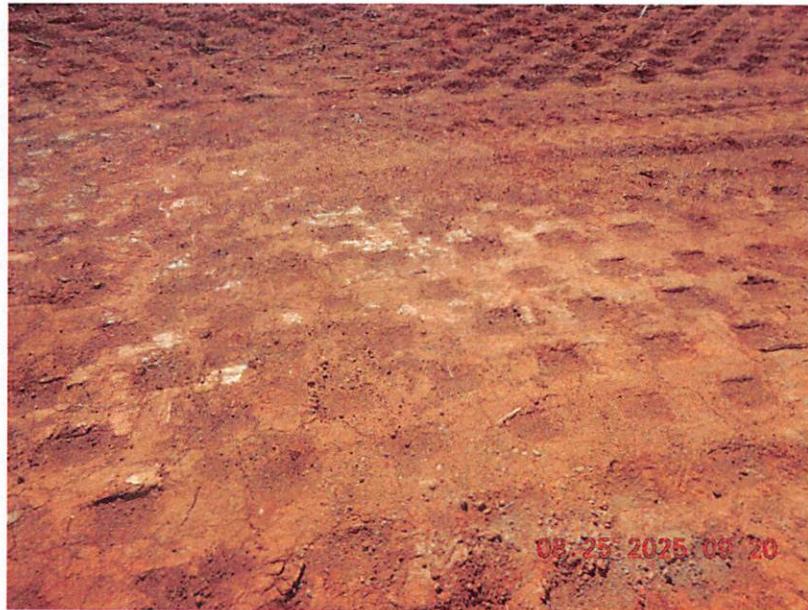
Photograph 7.

Description: View facing east of heavy equipment tracks in the bench. Some tracks were heavily compacted and shiny.

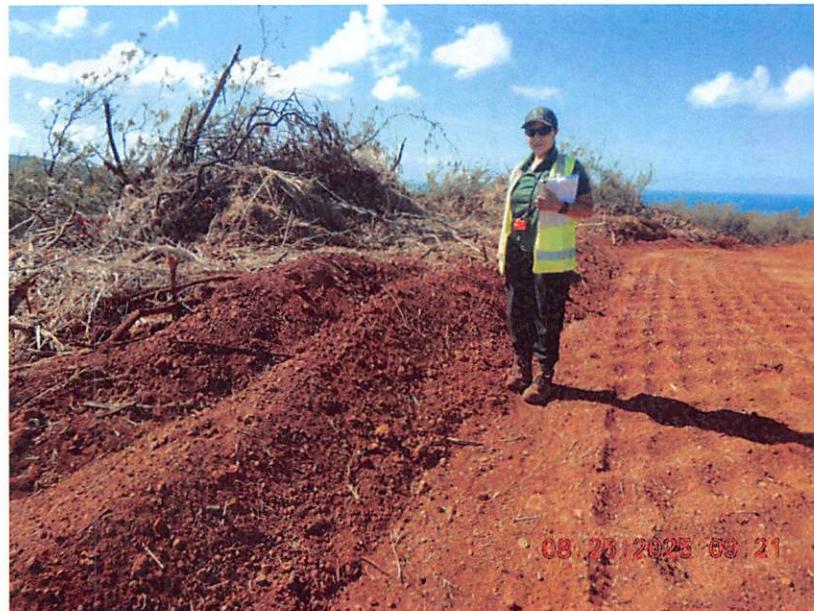
Photograph 9.

- d. Since the road and the recently graded bench are not stabilized, there is a high potential that they will be eroded during the next rain event and discharge soil-laden storm water to Hanapepe River to the east and Hikiula Gulch to the west (Figure 3). I observed erosion rills at the southern end of the bench (Photograph 10). It appears that the sediment-laden runoff will enter a tributary to the Hanapepe River system (Figure 3). I did not observe any Best Management Practices (BMPs) installed at the Agricultural Road or the bench to prevent erosion or capture sediment-laden storm water.

Description: View facing south of dirt and vegetation pushed to the east edge of the bench. The piled dirt and vegetation are at the edge of a valley leading down to Hanapepe River.

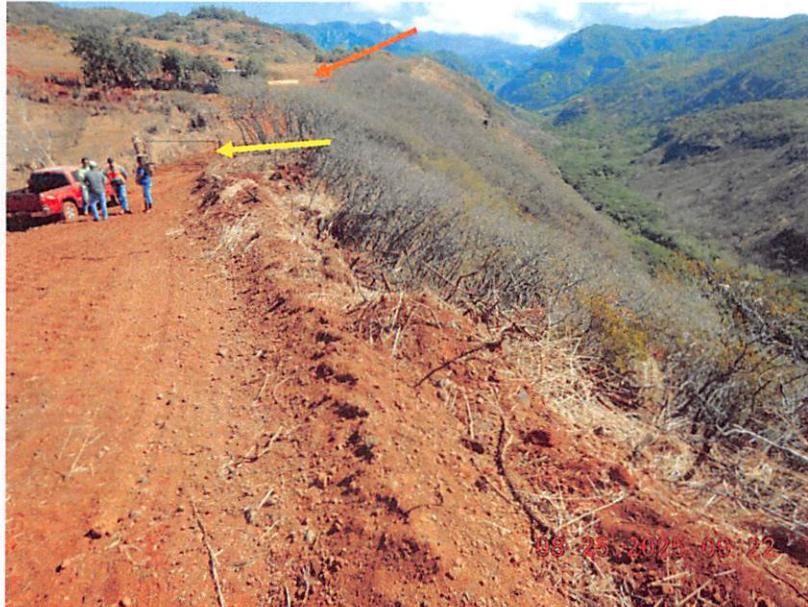
Photograph 11.

Description: View facing north of a gate (yellow arrow) just beyond the bench, where the Agricultural Road leads to an open area with a stable (orange arrow) on the Brun Property.

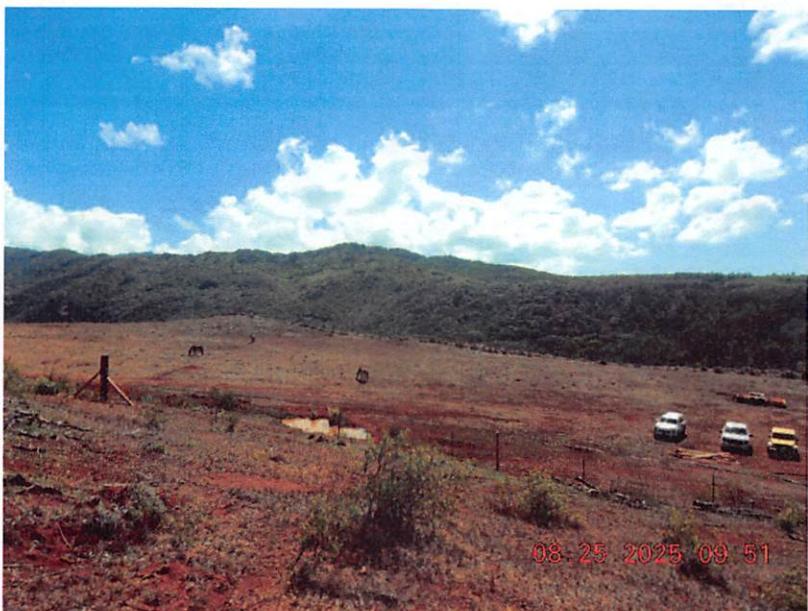
Photograph 12.

Description: View facing east of the open area on the Brun Property. No evidence of grading or grubbing was observed in this location.

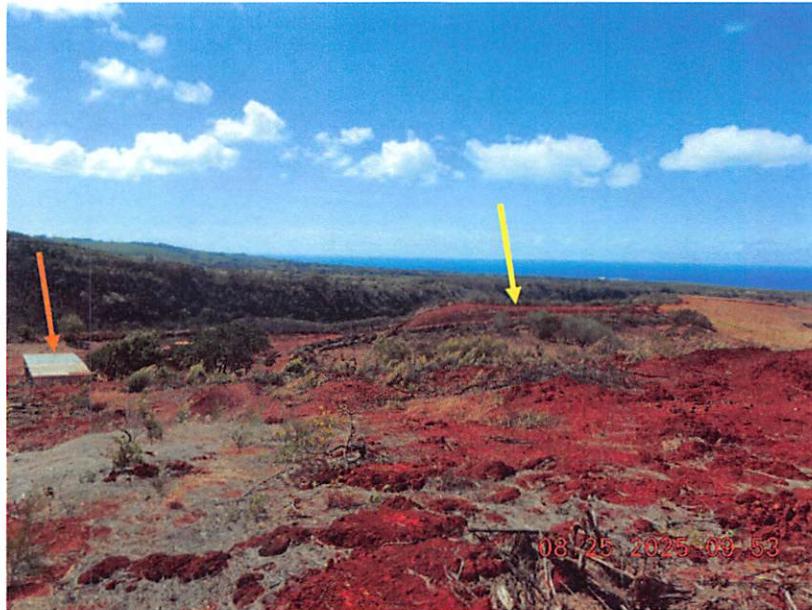
Photograph 13.

5. M. Contrades-Brun opened another gate along the Agricultural Road and north of the bench (Photograph 11). Beyond the gate, I observed an open area with a stable, fencing, and horses (Photograph 12). The ridge above the stable was not stabilized (Photograph 13). M. Contrades-Brun stated that the soil on the ridge doesn't support the growth of vegetation, and they plan to place the material brought in by HDCC and regrow ground cover. I did not observe evidence of recent earthwork in the area beyond the gate and on the ridge above the stable. Further, M. Contrades-Brun and R. Coelho both stated that work had not occurred in this area.

Description: View facing east of the unstabilized ridge on the Brun Property above the stable (orange arrow) and the bench (yellow arrow). No evidence of grading or grubbing was observed on the ridge.

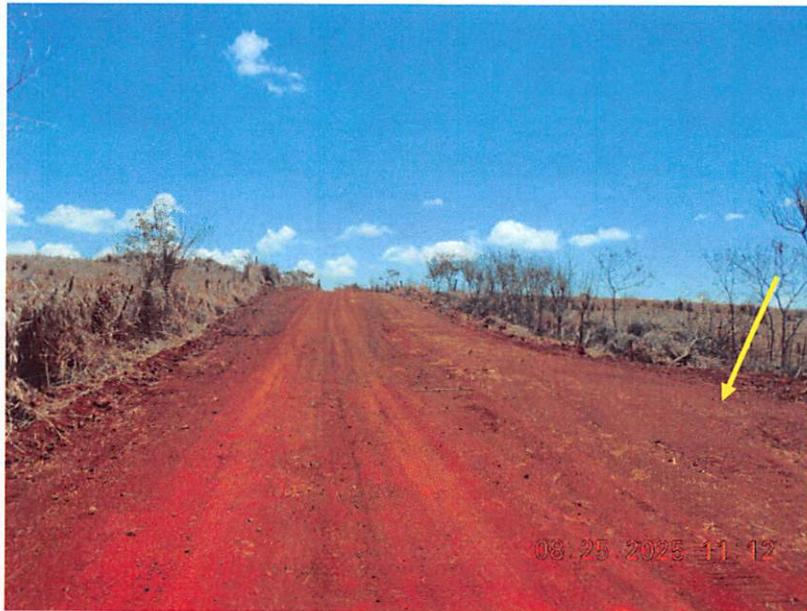
Photograph 15.

- a. In multiple locations along the Agricultural Road, I observed dirt and grubbed vegetation pushed to the sides of the road and small trees that had been pushed over (Photographs 15-18). It appeared that vegetation growing along the existing Agricultural Road was pushed over or grubbed when the road was worked on and widened.

- b. In several locations, I observed areas of fresh red dirt on the side of the Agricultural Road that appeared to be turnouts or shoulders that would allow for trucks to pass as R. Coelho had previously explained (Photograph 14-15, 19-21).

Description: View facing northeast of the Agricultural Road where dirt and vegetation were pushed to the sides. The appeared to be a turnout area on the side of the road (yellow arrow).

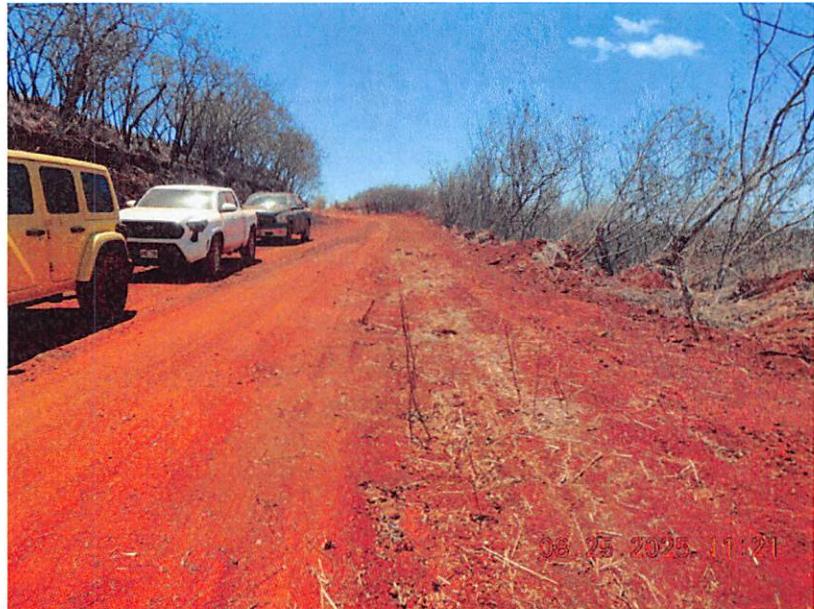
Photograph 17.

Description: View facing south of the Agricultural Road where dirt and vegetation were pushed to the side of the road and trees were pushed over.

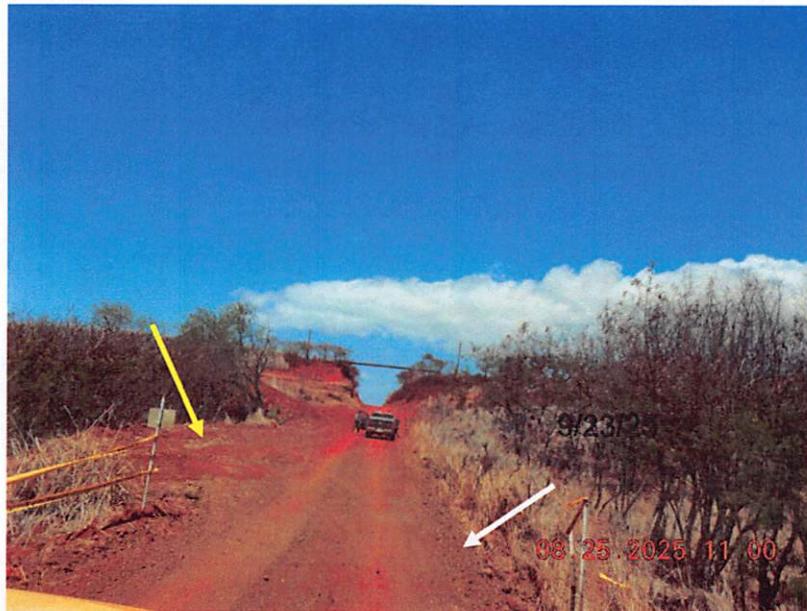
Photograph 19.

- b. Material in front of the scraped quarry wall was gray in color with rock chunks varying in size, and was distinctly different in appearance from the red, powdery soils in the area (Photographs 23-25). In some locations along the Agricultural Road, I observed gray colored dirt and rock that may have originated from the quarry area (Photographs 19, 21, and 27).

Description: View facing west of the Agricultural Road where there was a turnout area (yellow arrow). Gray rock and soil were present on a part of the road (white arrow).

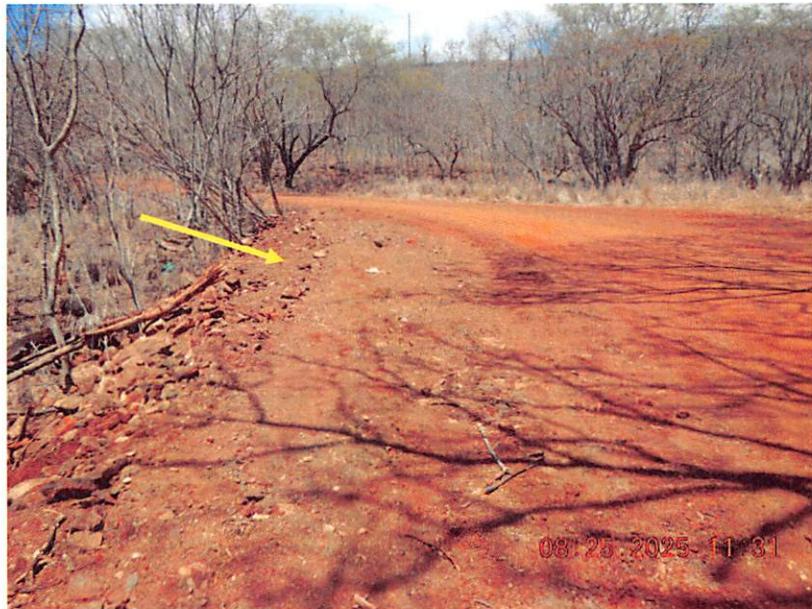
Photograph 21.

Description: View facing southwest of an area along the Agricultural Road with dirt and rock (yellow arrow) that was a slightly different color than the road. The area appeared to be widened to provide a turnout.

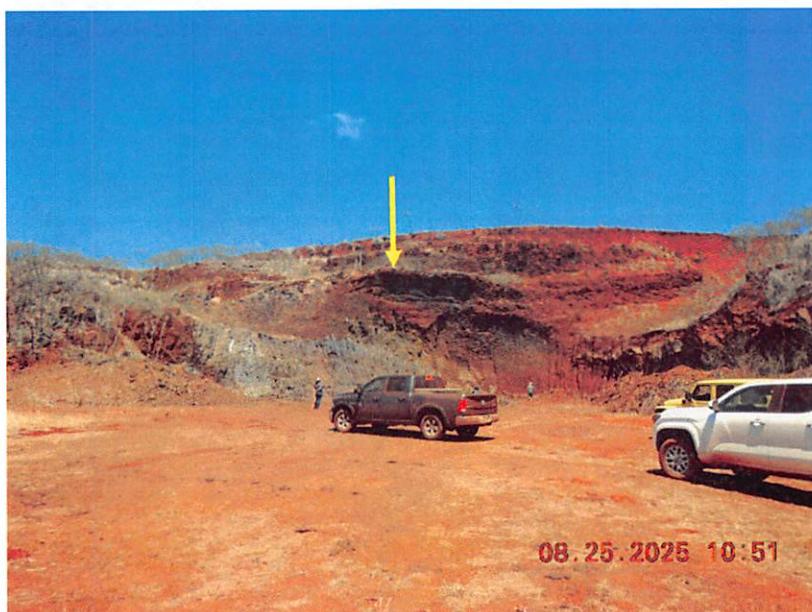
Photograph 22.

9. I observed a quarried area along the Agricultural Road (Figure 3, Photographs 22-26).
 - a. I observed a large, quarried area that was dug and scraped out, as well as stockpiles of dirt, rock, and grubbed vegetation (Photographs 25-26). The quarried area appeared to be over 40 feet at its tallest point (Photographs 22-24). It appeared that a large volume of material was taken from the quarry area. R. Coelho stated that the material removed from the quarry area was used on the Agricultural Road.

Description: View facing north of a quarried area along the Agricultural Road. The highest point that was dug out (yellow arrow) appeared to be over 40 feet high.

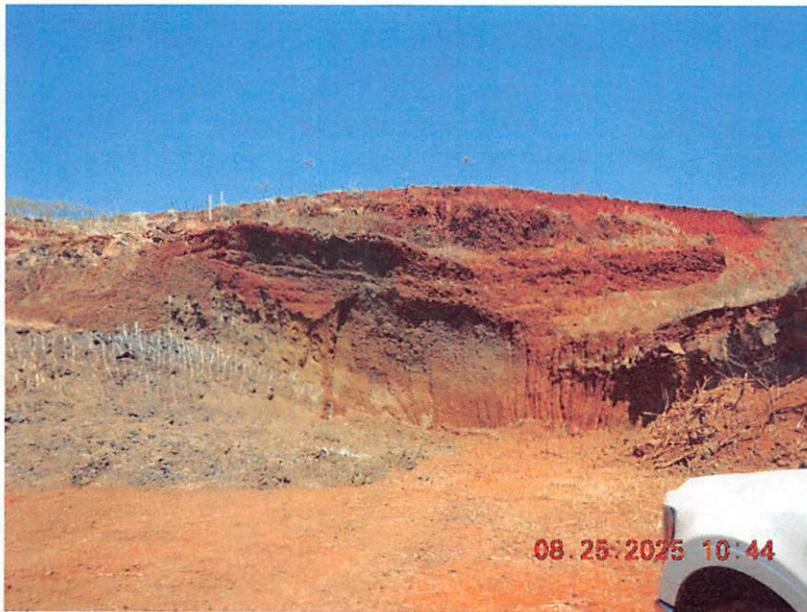
Photograph 23.

Description: Another view facing north of the quarried area along the Agricultural Road. No BMPs were implemented on the slopes or stockpiles to prevent erosion or capture sediment.

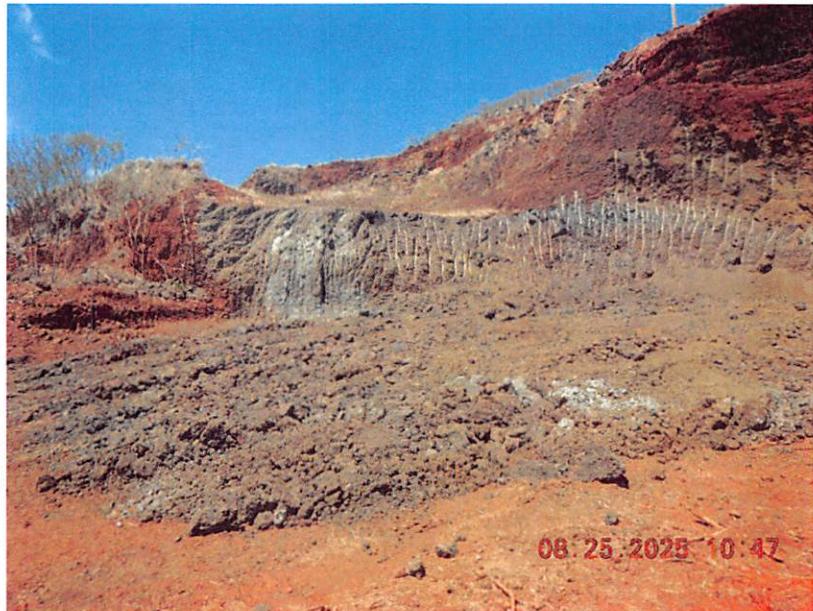
Photograph 25.

Description: View facing northwest of the quarried area along the Agricultural Road. Gray colored soil and rock were stockpiled at the foot of the quarried area.

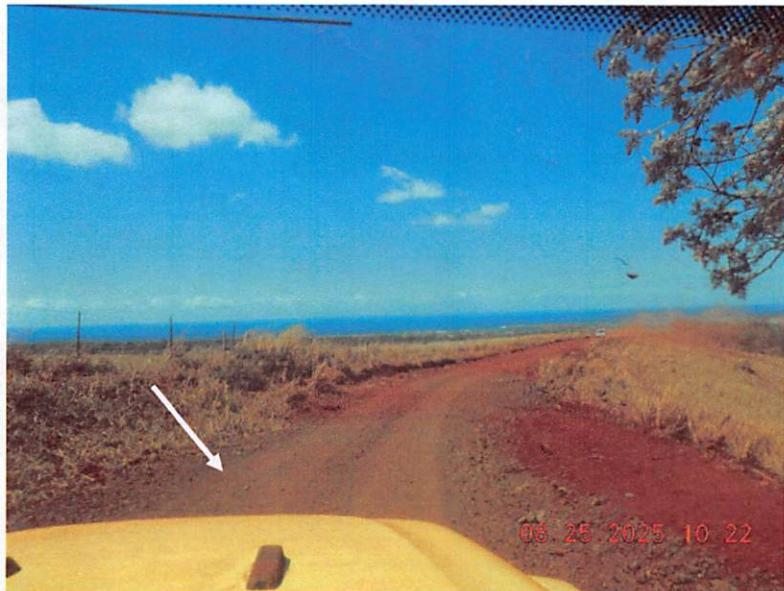
Photograph 27.

Description: View of gray colored soil and rock (white arrow) on the Agricultural Road near the Brun Property. The gray material appeared to originate from the quarried area.

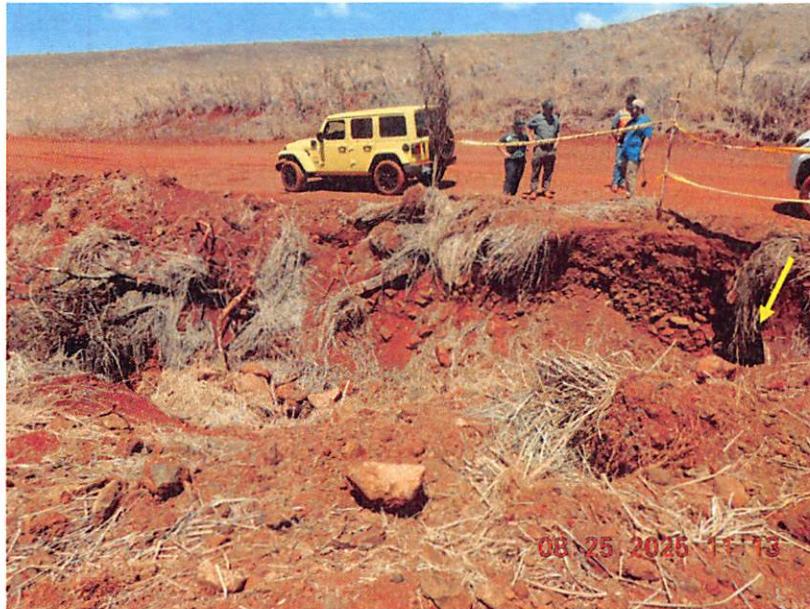
Photograph 29.

10. I observed red dirt, vegetation and rocks pushed into a gully identified as part of the Hanapepe River system (Figure 3, Photographs 28-30). The gully originated from the north (Photograph 31) and continued through a culvert that ran under the Agricultural Road (Photograph 28-29). The Hawaii Statewide GIS Program has a GIS map produced by the Department of Land and Natural Resources (DLNR), Division of Aquatic Resources (DAR), that identifies the gully as a tributary to the Hanapepe River system.

Description: View facing west of the gully identified as a tributary of the Hanapepe Stream. A culvert (yellow arrow) was installed under the Agricultural Road. Dirt, rocks and vegetation were pushed into the gully.

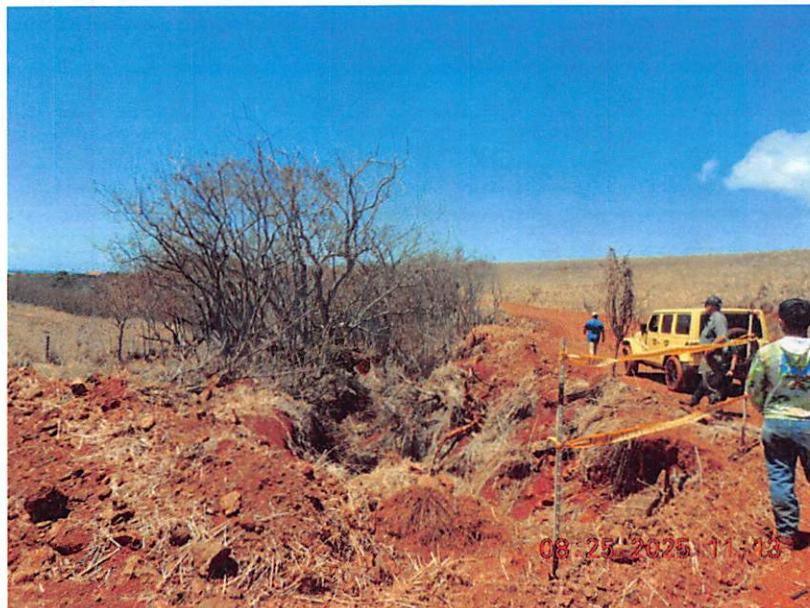
Photograph 30.

Description: View facing southwest of the gully that is a tributary to Hanapepe Stream, downstream of the Agricultural Road. Dirt, rocks, and vegetation were pushed into the gully.

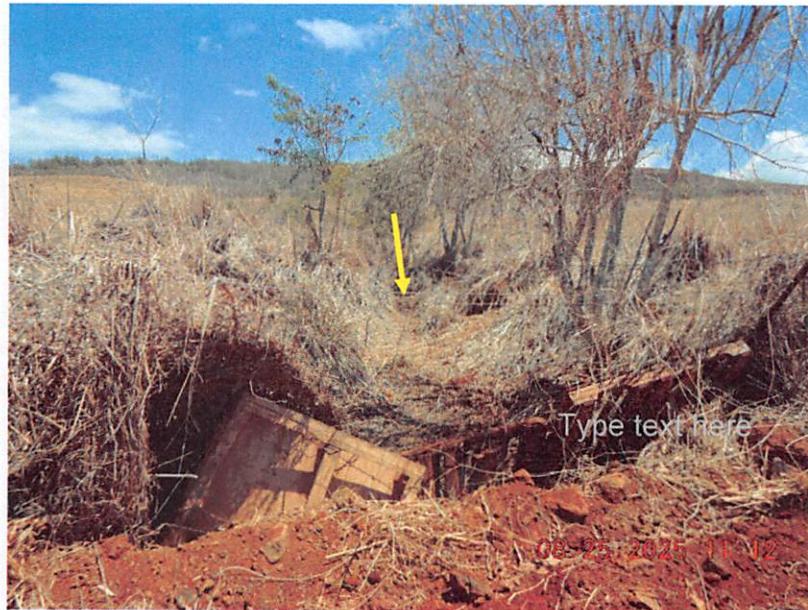
Photograph 31.

Description: View facing north of the gully that is a tributary to the Hanapepe River system (yellow arrow). This portion of the gully is upstream of the Agricultural Road.

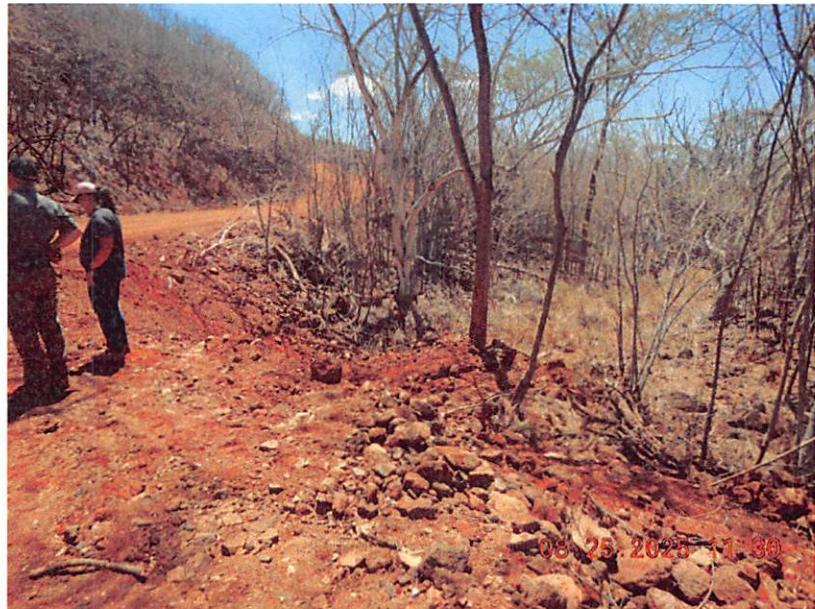
Photograph 33.

11. I observed red dirt, vegetation and rocks pushed into Kapahili Gulch (Photographs 32-37). The red dirt was loose and fluffy, and appeared to be a recent discharge. Further indicating a discharge into Kapahili Gulch, the dirt and rocks were red and contrasted against the lighter brown dirt and rocks at the gulch floor and in an upstream portion of the gulch.

Description: View facing east of red dirt and rocks pushed into Kapahili Gulch from the Agricultural Road.

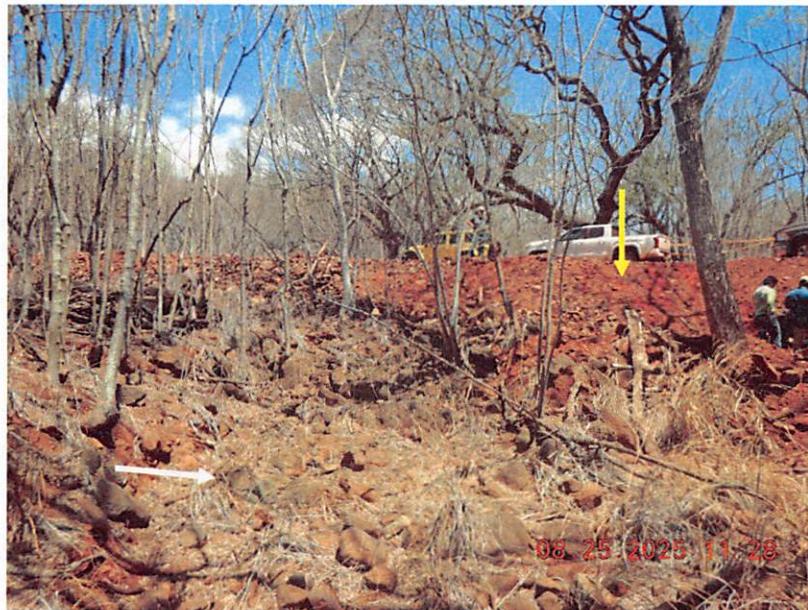
Photograph 35.

Description: Another view facing north of the red dirt, rocks, and vegetation (yellow arrow) pushed into Kapahili Gulch from the Agricultural Road. The material was red in color, contrasting with the brown rocks and vegetation (white arrow) in the gulch.

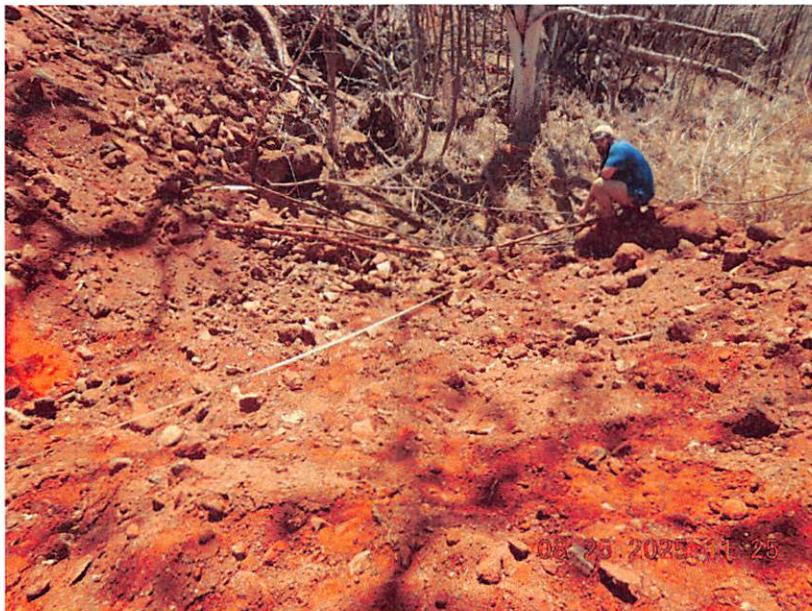
Photograph 37.

Description: View of the Inspection Team measuring the extent of the red dirt, rocks, and vegetation pushed into Kapahili Gulch. Note the contrast in color between the red dirt and rocks of the discharge and the light brown rocks and yellow-brown vegetation in the gulch.

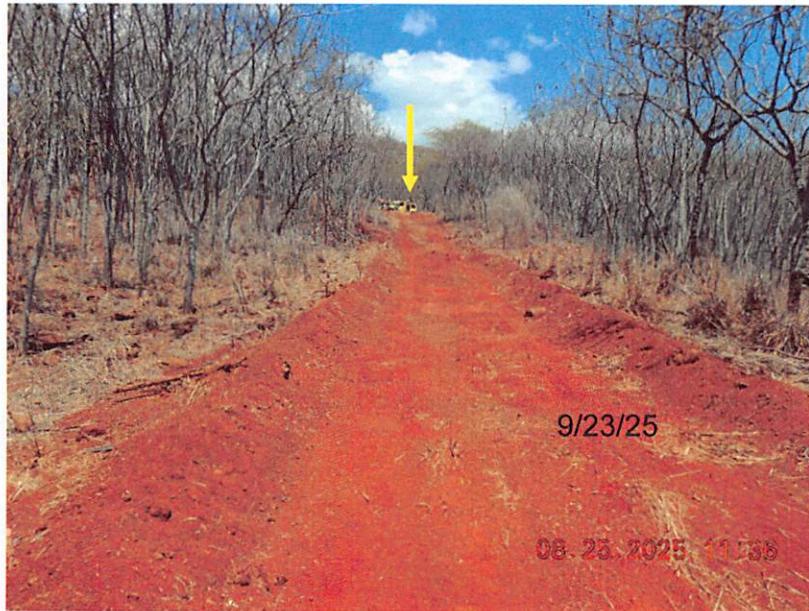
Photograph 39.

- a. The Inspection Team walked the length of the Side Road and R. Grenier took GPS points along the road. Based off the GPS points, the Side Road is approximately 1,375 feet in length. The Inspection Team measured the width of the Side Road at approximately eleven (11) feet and eight (8) inches wide. After the inspection, I calculated the area of the Side Road to be approximately 0.34 acres.
- b. I observed dirt, dried vegetation and tree branches pushed along the edges of the Side Road, indicating it had recently been disturbed and grubbed (Photographs 39-41).

Description: View facing north of the Side Road. Dirt is pushed to the sides of the road and vegetative debris was on the road. The Agricultural Road (yellow arrow) can be seen at the end of the Side Road.

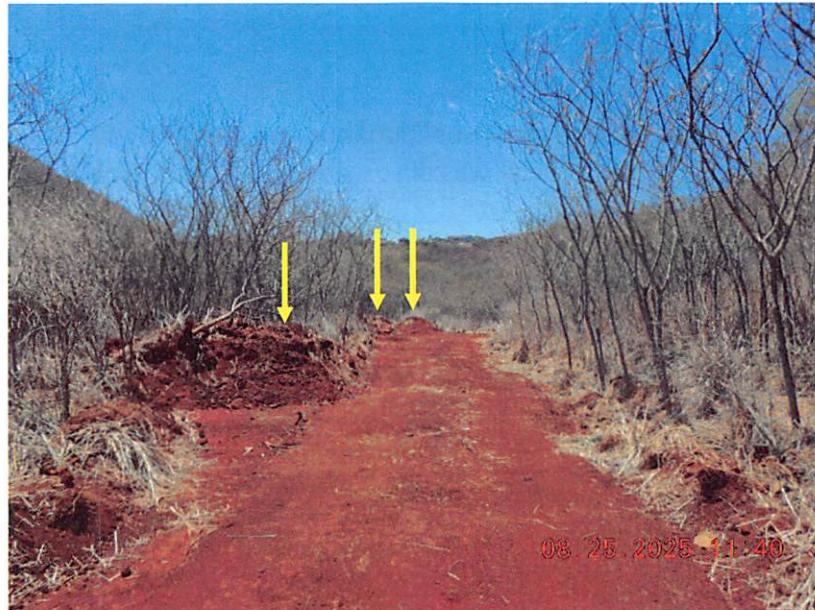
Photograph 41.

- c. The Side Road terminated at a dead end (Photograph 41). Near the terminus of the Side Road, I observed a few small stockpiles of dirt on the side of the road. I observed grubbed grass and trees on the sides of the road.
- d. I did not observe any BMPs along the Side Road or installed around stockpiles to prevent erosion and control sediment. However, the Side Road is generally flat, which helps to lower the potential for polluted storm water discharges.

Description: View facing south of the end of the Side Road. A few stockpiles of dirt (yellow arrows) were on the side of the road along with grubbed grass and trees.
