STATE OF HAWAII  
DEPARTMENT OF HEALTH  
P. O. BOX 3378  
HONOLULU, HI 96801-3378

**Subject: Notice of Violation and Order**  
**Docket No. 2021-CW-EO-47**  
**Hawaii Water Pollution Rules and Regulations**  
**Paradise Beverages, Inc.**  
**94-1450 Moaniani Street, Waipahu, Island of Oahu**  
**TMK: (1) 9-4-128:002**

**Complaint Investigation Report**  
**Figure Log**  
 Site Name: Paradise Beverage  
 Permit No.: HIU010639

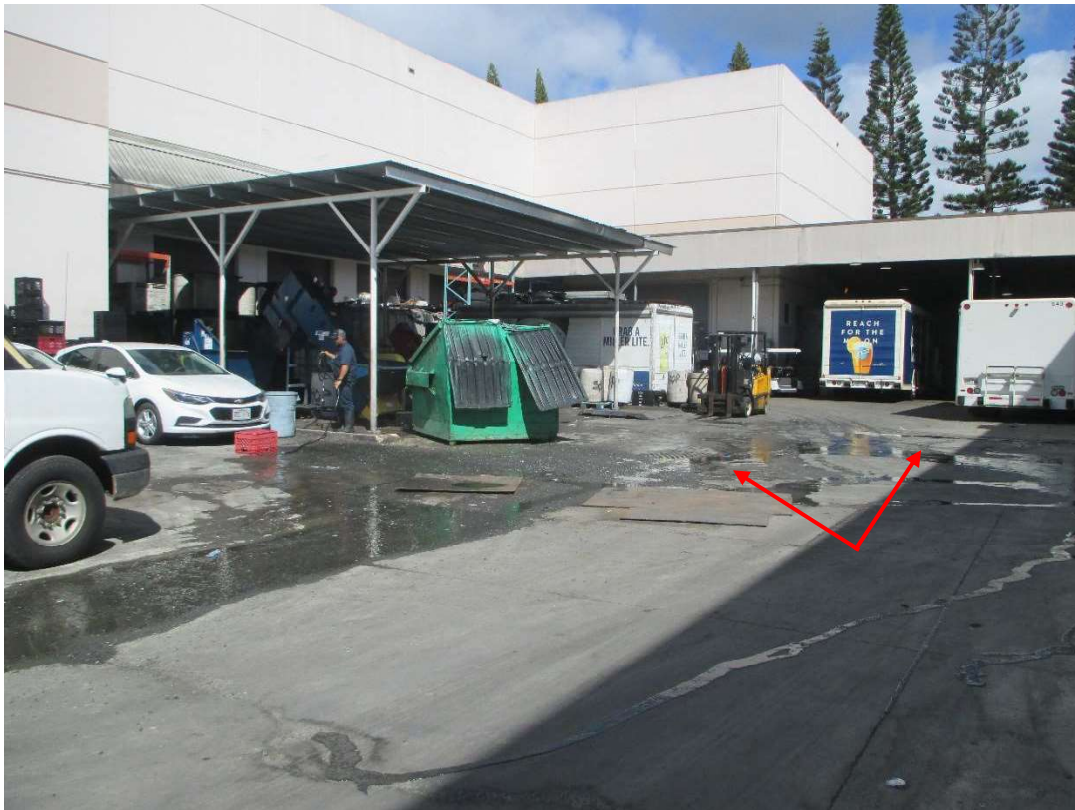
**Photograph 1:**

- ii. The Inspection Team observed significant erosion of the concrete pad in the receiving area (refer to Photographs 1, 3, and 6). Liquids flowing from the crushing area flow towards a drain inlet in the receiving area of the Facility. The current trench drain system, located at the edge of the crushing area, does not have the proper grade and accumulates the liquid on the opposite side of the sump's inlet. This causes liquid waste to overflow into the Facility's receiving area. (refer to Photograph 12). There was significant concrete erosion in areas where flow was observed.

Note the Facility's employees discharge the beverage container on the concrete pad at the crushing area before compacting the cans for disposal. Also, a water hose is used to help drain the product through the storm water drains.

Note red arrows pointing to two (2) of four (4) drain inlets at the Facility's receiving area.

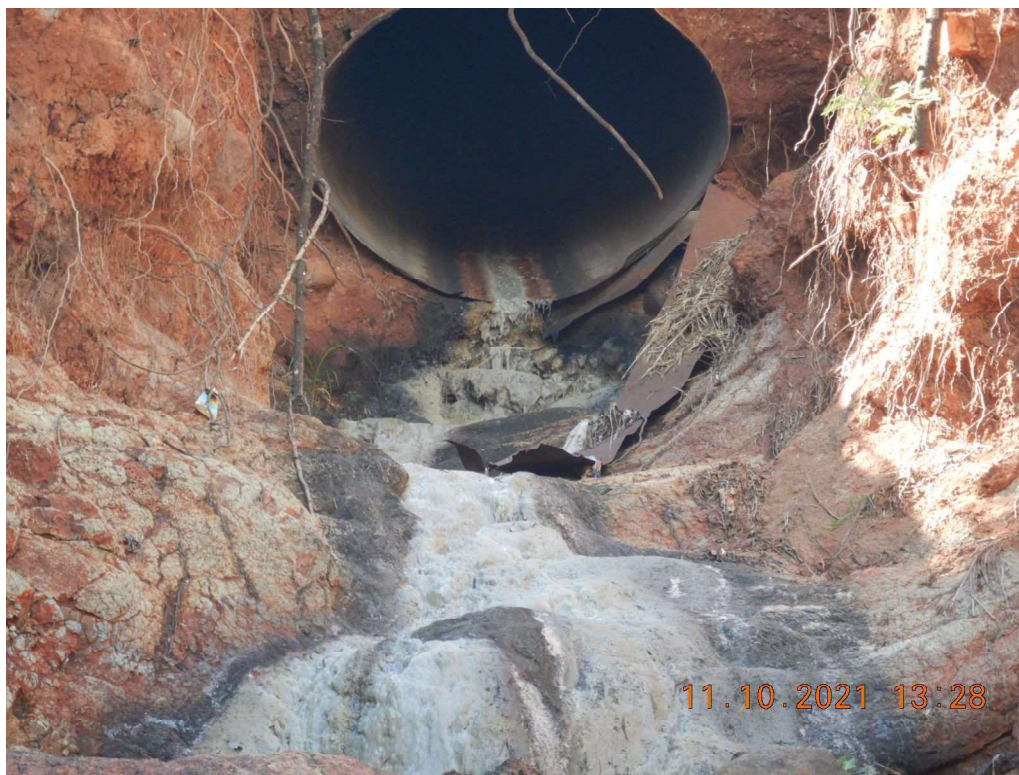
**Photograph 2:**

On November 10, 2021, the DOH-CWB conducted reconnaissance of the Outfall and documented evidence of discharges consistent with those previously observed by representatives of HDOT and the complainants. Further, the DOH-CWB observed what appeared to be the presence of domestic wastewater at the Outfall (refer to Photograph 2).

Description: View, facing west, of the Outfall.

Note the discharge appears to be residual toilet paper. This white residue could indicate the presence of domestic wastewater (sewage). It is essential to verify if there is a cross-connection between the storm water and wastewater drain systems.

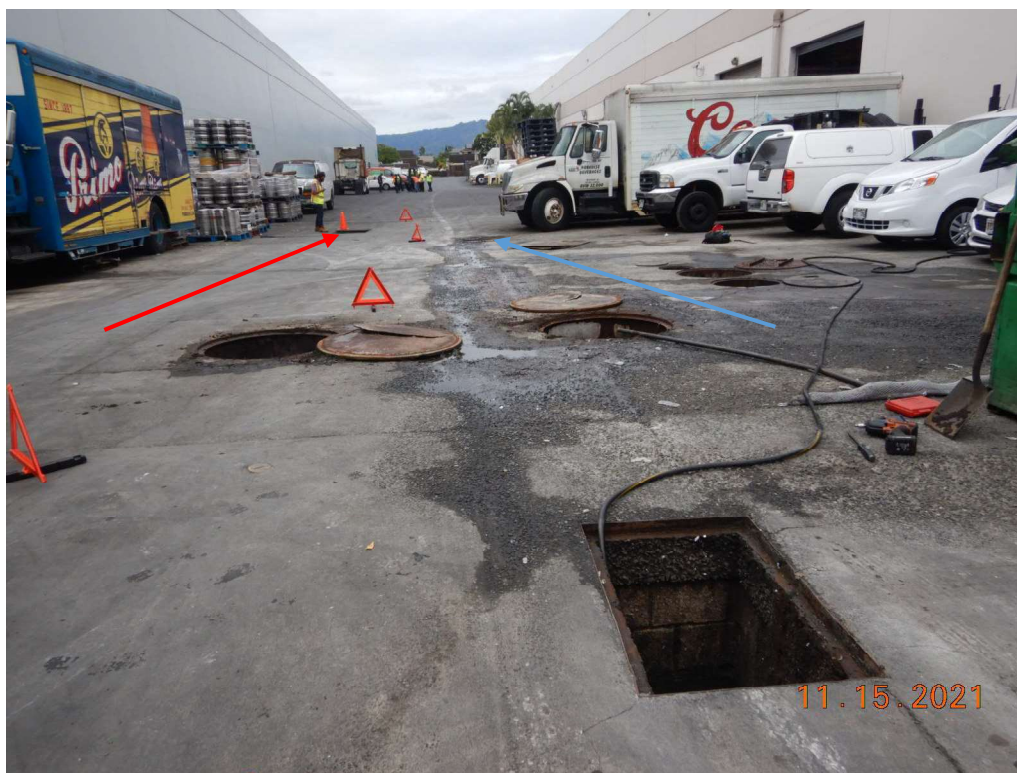
**Photograph 3:**

Description: View, facing west, of the receiving area of the Facility. Concrete aggregate on the surface shows the primary path of the liquid from where it got discharged to a storm drain inlet.

Note blue arrow pointing to the first storm drain inlet that was dye tested. Red arrow points to the junction box.

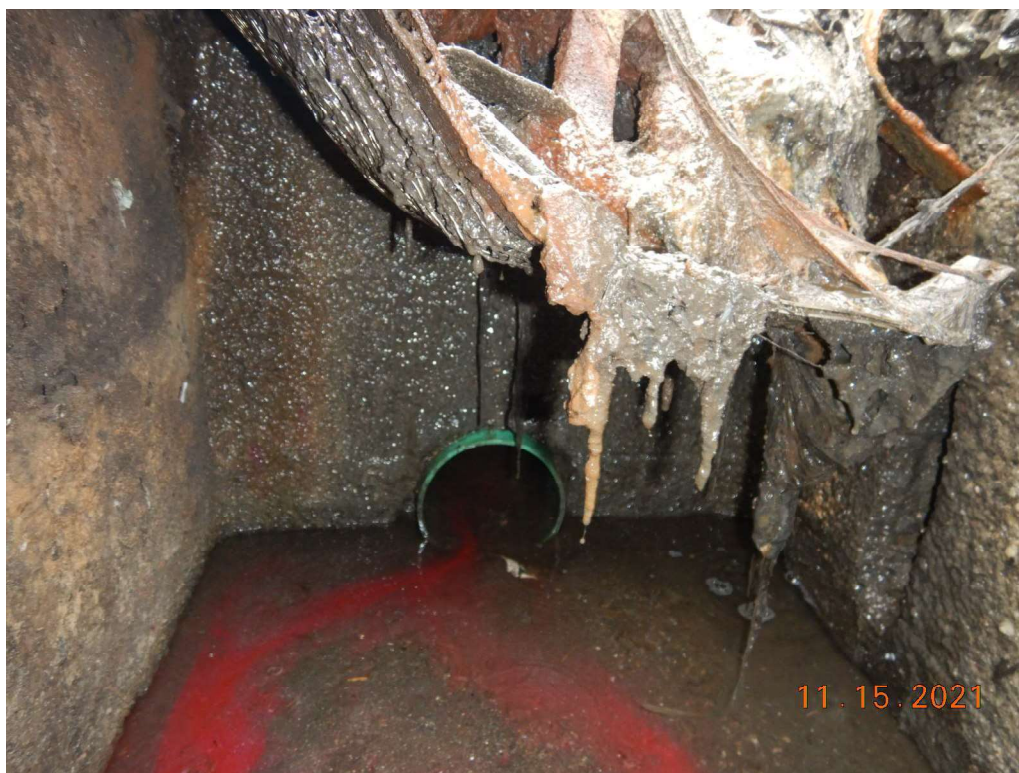
**Photograph 4:**

Description: View, facing east, of the first storm drain inlet that was dye tested.

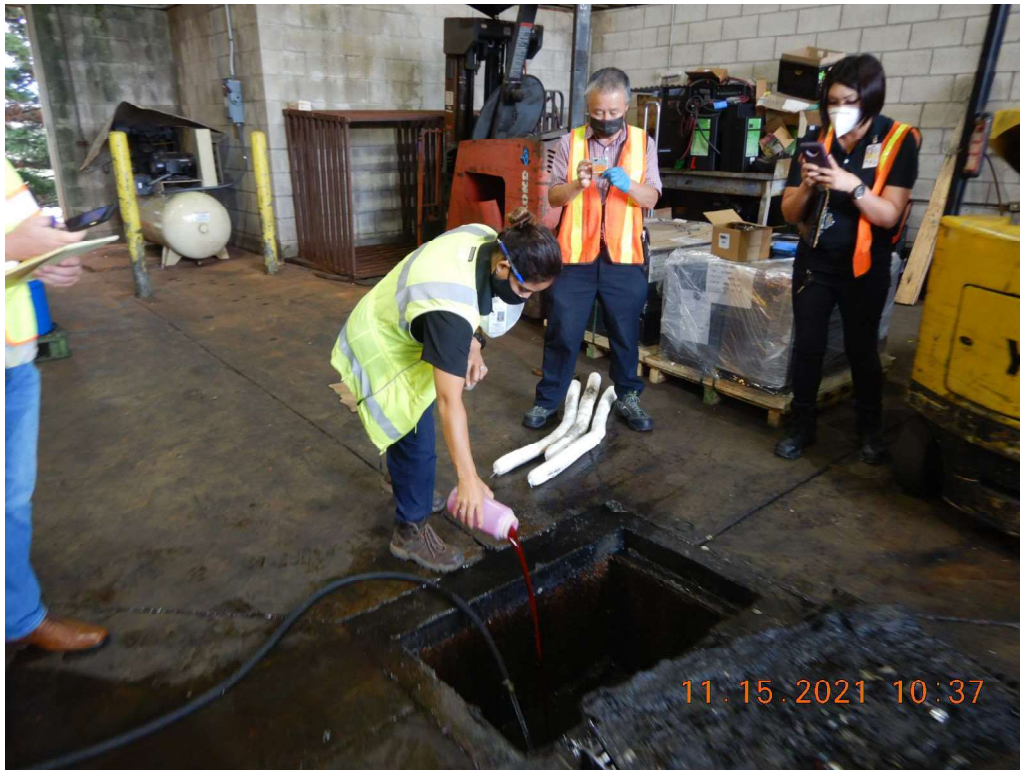
**Photograph 5:**

- a. At 10:45 am, B. Teixeira poured fuchsia dye into the drain inlet in the maintenance bay (refer to Photograph 5).
  - b. At 10:52 am, the Inspection Team observed the fuchsia dye entering the junction box.

Description: View, facing southeast, of second drain inlet that was dye tested located in the maintenance bay.

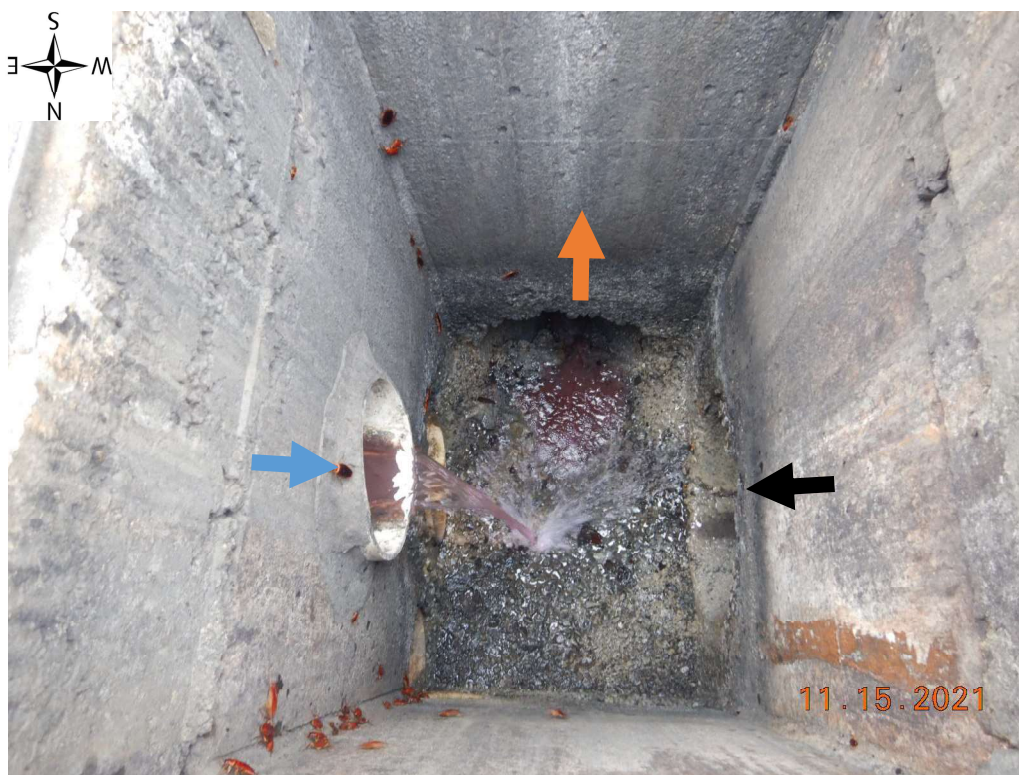
**Photograph 6:**

Description: View, facing south, of the junction box. The junction box's effluent is made of the comingling of the five (5) pipes' flows. The final flow will discharge through the Outfall. Note the black arrow represents the flow coming from the drain inlet located on the west section of the Facility's receiving area. The blue arrow represents the collection pipe that discharges the effluents from the three (3) drain inlets on the east side of the receiving area and the drain inlet of the maintenance bay. And, the orange arrow represents the discharge effluent from the junction box itself.

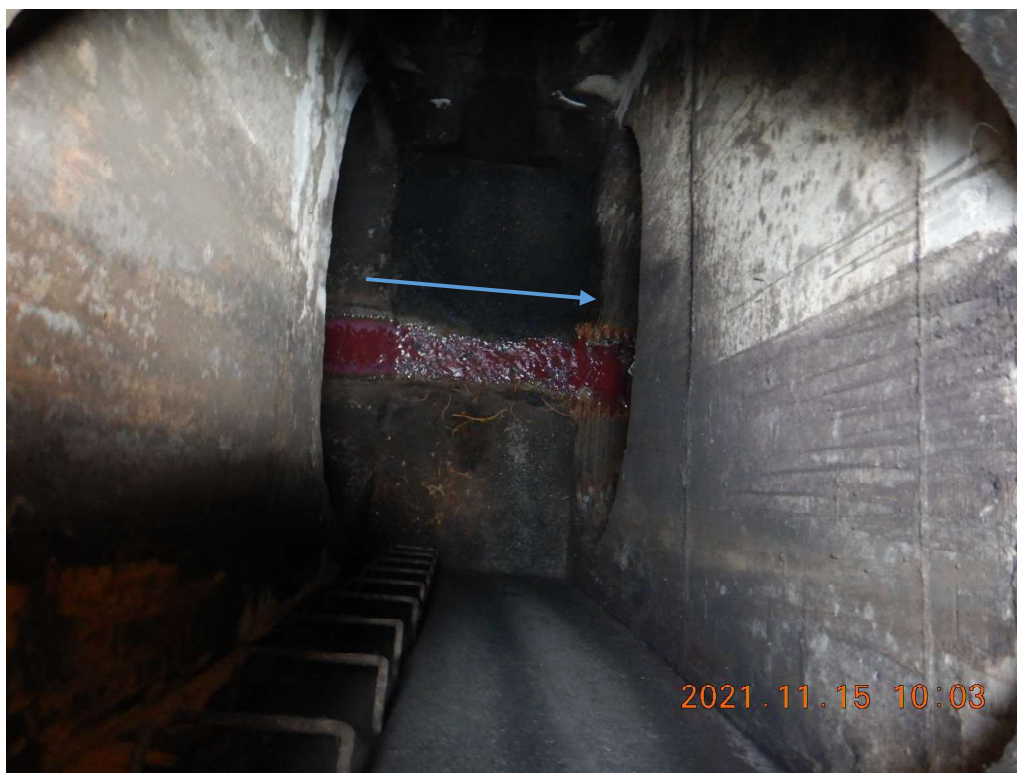
**Photograph 7:**

- b. At 10:03 am, Marian Dean observed the fuchsia dye flowing through the CCH's 84-inch reinforced concrete pipe, which leads to the Outfall on the other side of the H-2 (refer to Photograph 7).

Description: View of the interior of the 84-inch reinforced concrete pipe inlet PID 203145.  
Note blue arrow points towards the direction of the flow.

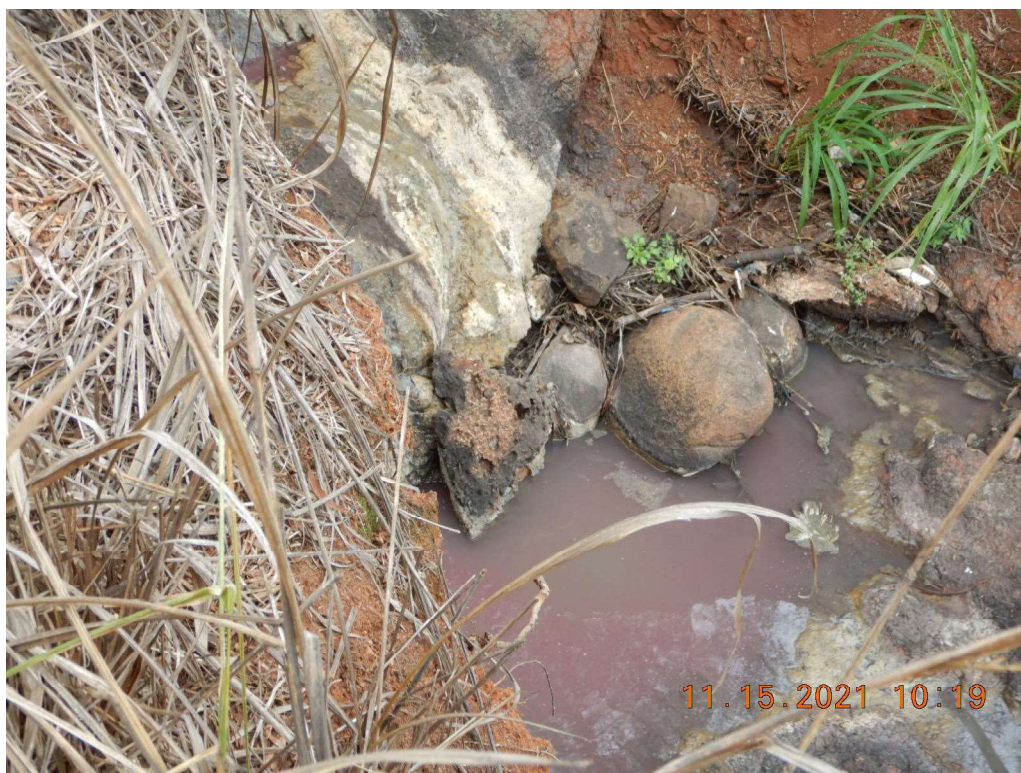
**Photograph 8:**

Description: View, facing north, of the fuchsia dye discharged to Waiawa Stream from the Outfall.

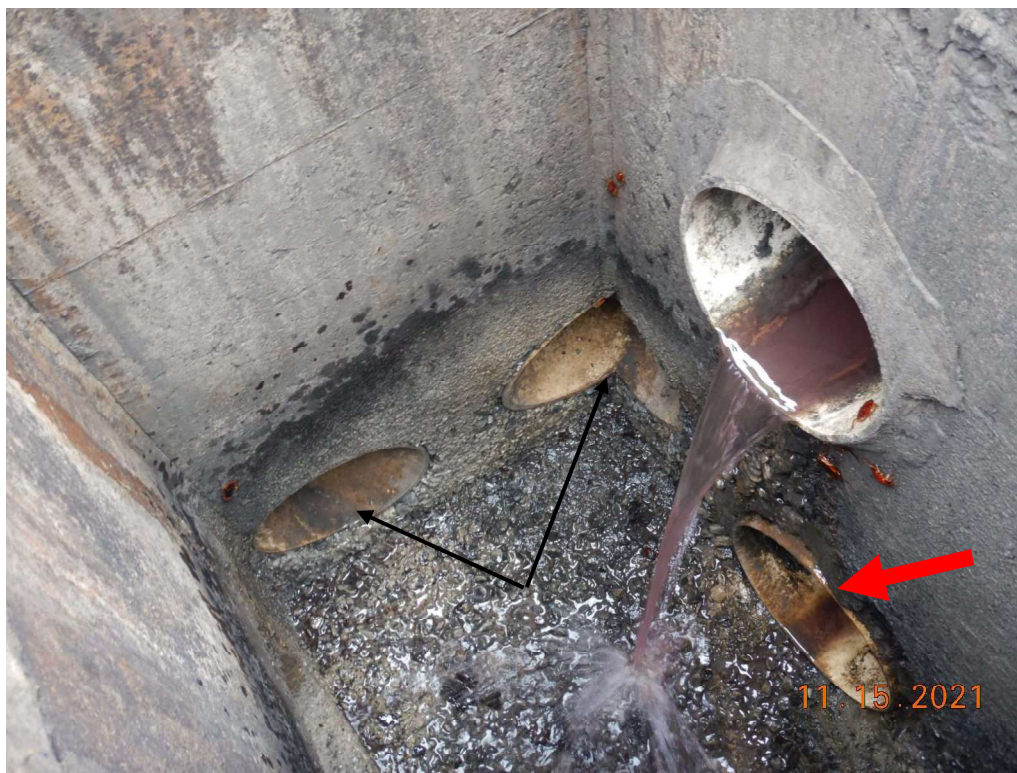
**Photograph 9:**

- iii. The inspection team observed that the first concrete layer of the bottom of the junction box was eroded, causing the aggregate to be exposed (refer to Photograph 9). This observation is consistent with low pH liquids such as carbonated beverages flowing over concrete, such as in the junction box.

7. The Inspection Team observed that the main building has two (2) laterals connected directly to the junction box. The origin of the laterals was unknown (refer to Photograph 9 black arrows) at the time of inspection.
  - a. The Inspection Team was not able to trace any bottom pipes of the junction box (refer to Photograph 6, black arrow, and 9). We observed possible sewage or grease deposits in the bottom pipes. These observations and the previous findings of the November 10, 2021 inspection made us believe that those pipes could potentially be cross-connected to a wastewater system.

Description: View, facing northeast, of the junction box.

Note the black arrows point to a pair of pipes that appears to be in line with the main building. The black and red arrows point to lines that we could not trace during the investigation.

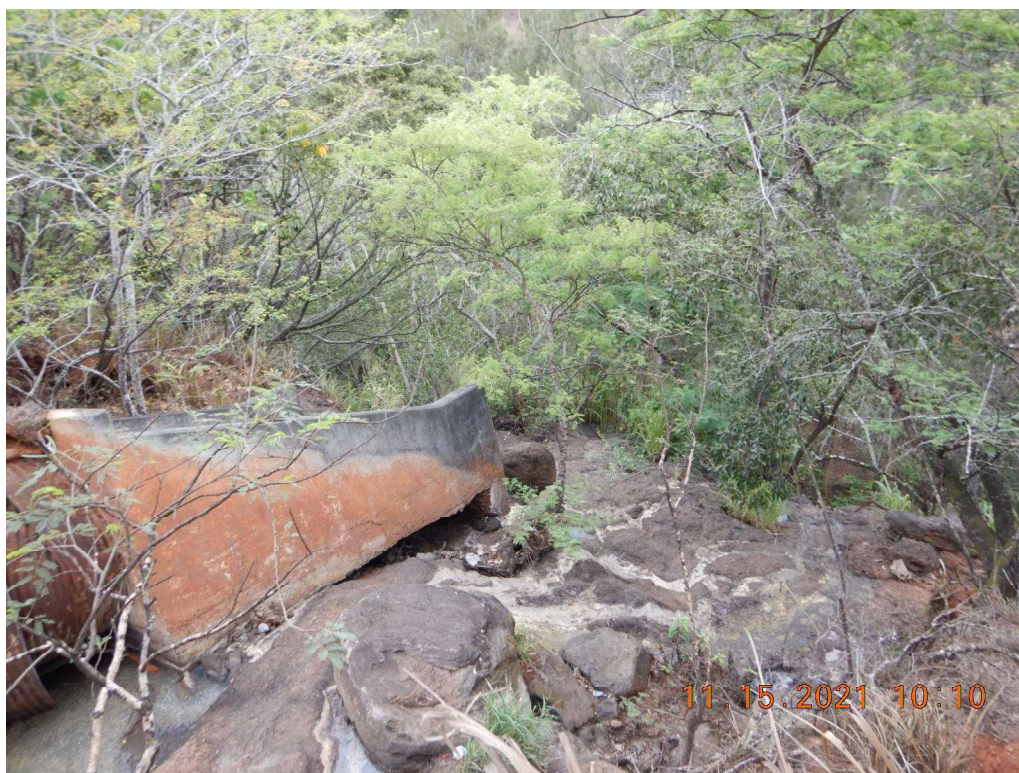
**Photograph 10:**

- c. At 10:30 am, M. Kurano observed the same fuchsia dye being discharged from the Outfall to Waiawa Stream (refer to Photograph 10).
3. To determine whether the storm drain inlet in the Facility's maintenance bay connects to the Outfall, dye was introduced into the drain inlet located in the maintenance bay. Visual observations were then made at the storm water junction box. The dye test was conducted as follows:

Description: View, facing east, of the connection from the Outfall to the Waiawa Stream.

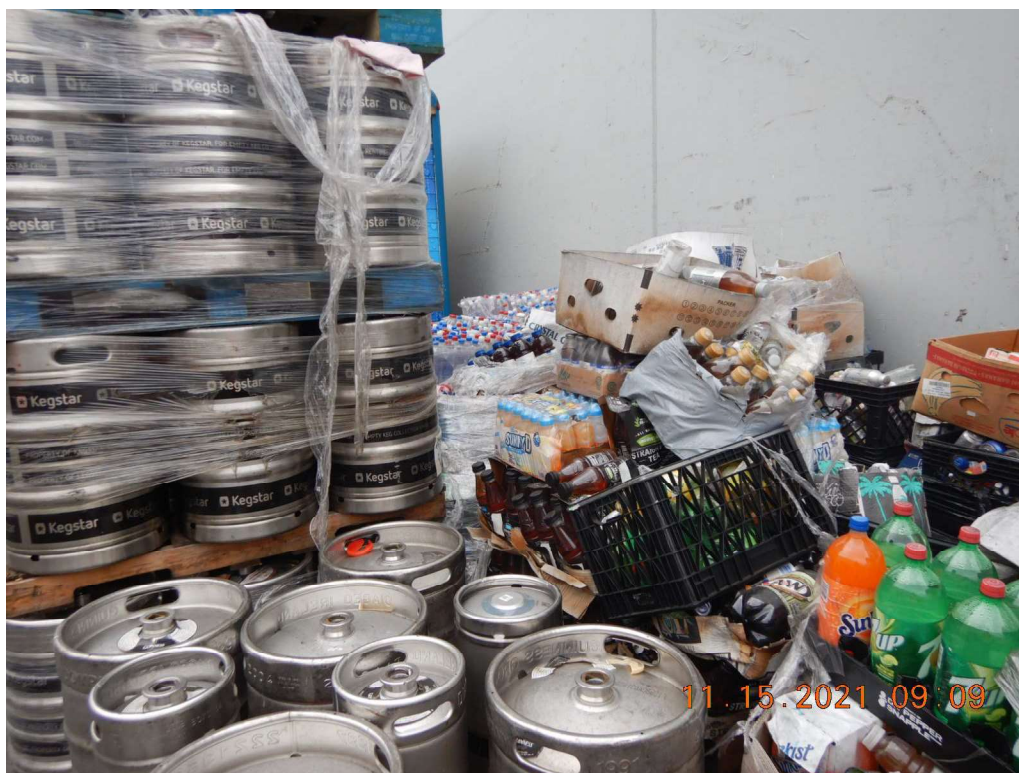
**Photograph 11:**

Description: Close-up view of broken alcoholic and carbonated beverages stored in the Facility's receiving area.

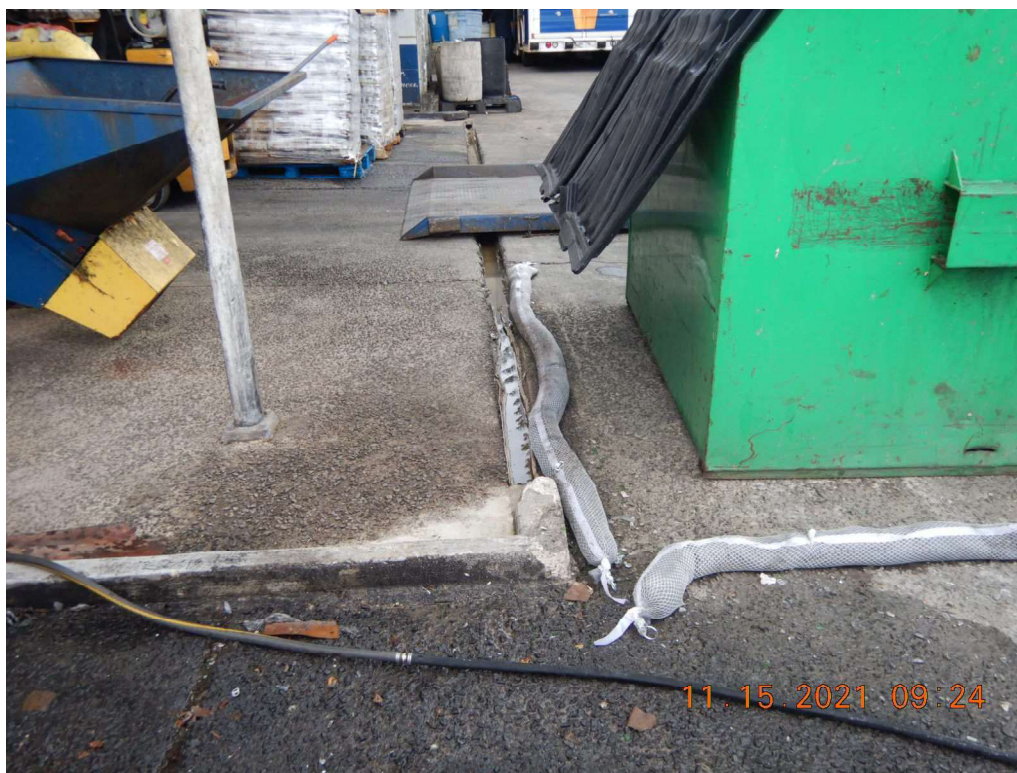
**Photograph 12:**

Description: Close-up view of the crushing area trench drain system.

Note the pool of liquid on the other side of the sump's inlet. The concrete degradation shows the main direction of the liquid after overflowing the western section of the opened trench drain system.

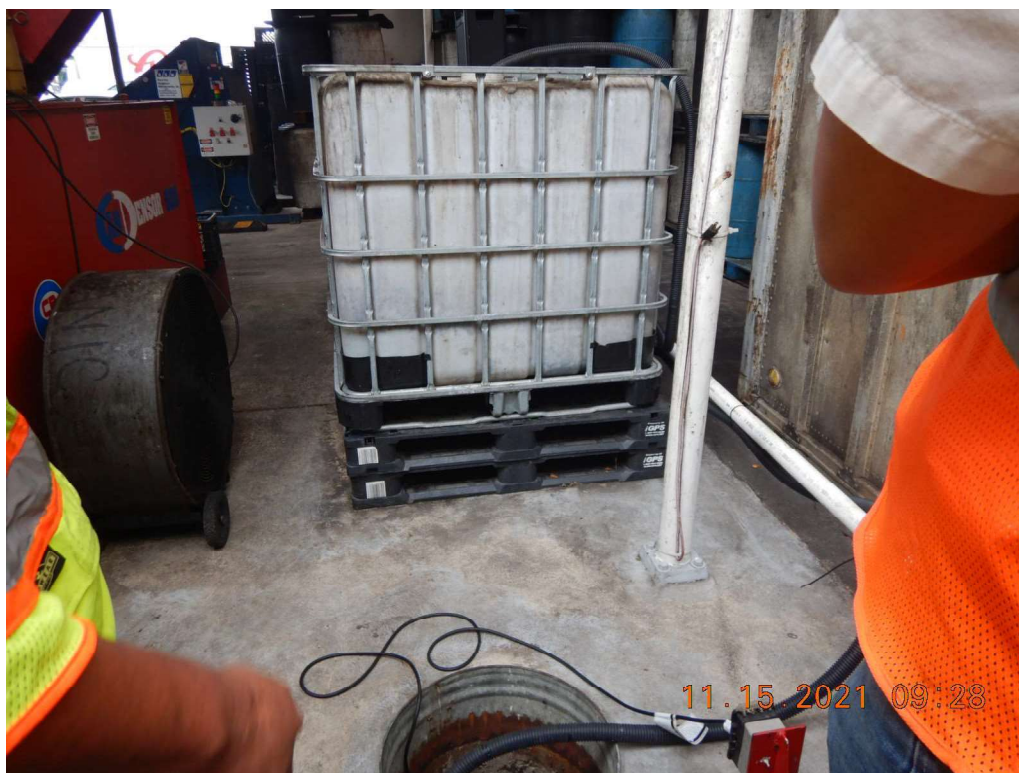
**Photograph 13:**

Description: Close-up view of the sump pump and tote at the back of the crushing area.

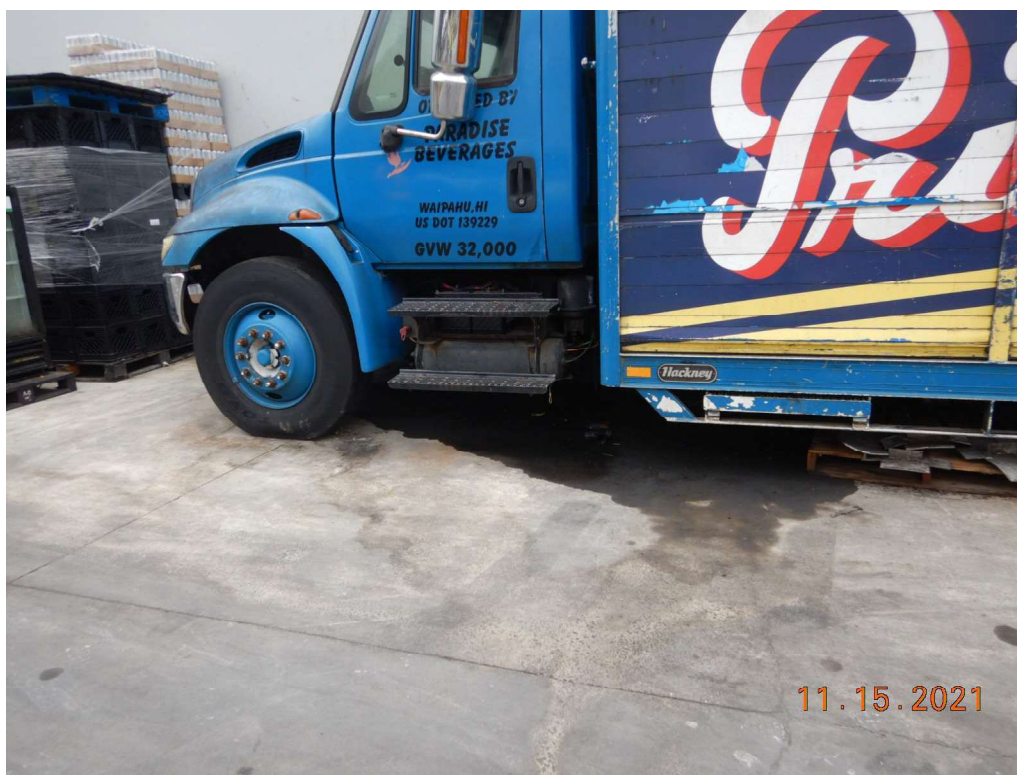
**Photograph 14:**

5. The Inspection Team observed leaking oil (refer to Photograph 14) and a stain that indicated leaking oil flowed into the storm water inlet at the Facility. The Inspection Team did not observe Best Management Practices (BMPs) in the receiving area that prevent the discharge of the leaking oil.

Description: View, facing south, of one of the Facility's trucks leaking oil onto the concrete without any BMP in place.

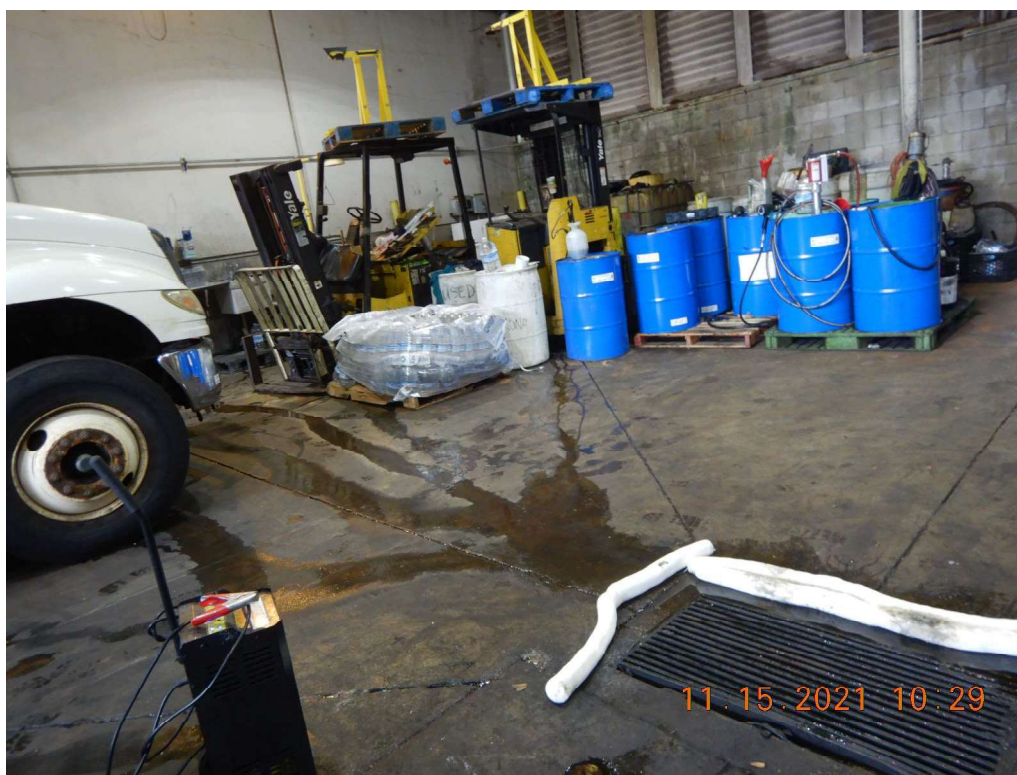
**Photograph 15:**

vehicle maintenance area discharge to the drain inlet in the maintenance bay (refer to Photograph 15). There were multiple potential sources of used oil and related wastes stored in the maintenance area. Further, the Inspection Team observed multiple stains on the floor of the maintenance area that indicated discharges from the maintenance area into the drain inlet.

Description: View, facing northeast, of the maintenance bay of the Facility where employees store equipment, damaged product, and various materials needed to maintain their equipment.

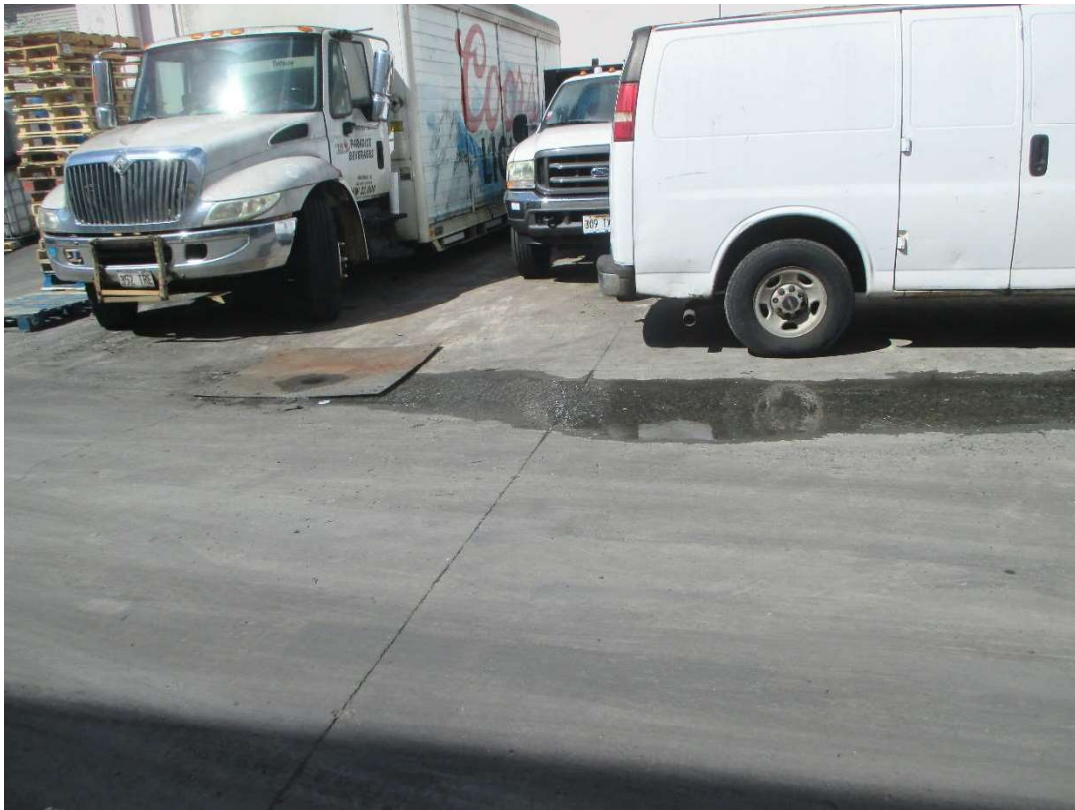
Dry weather flow with alcohol odor entering private inlet which initially discharges to a City and County of Honolulu (CCH) 84-inch reinforced concrete pipe (RCP).

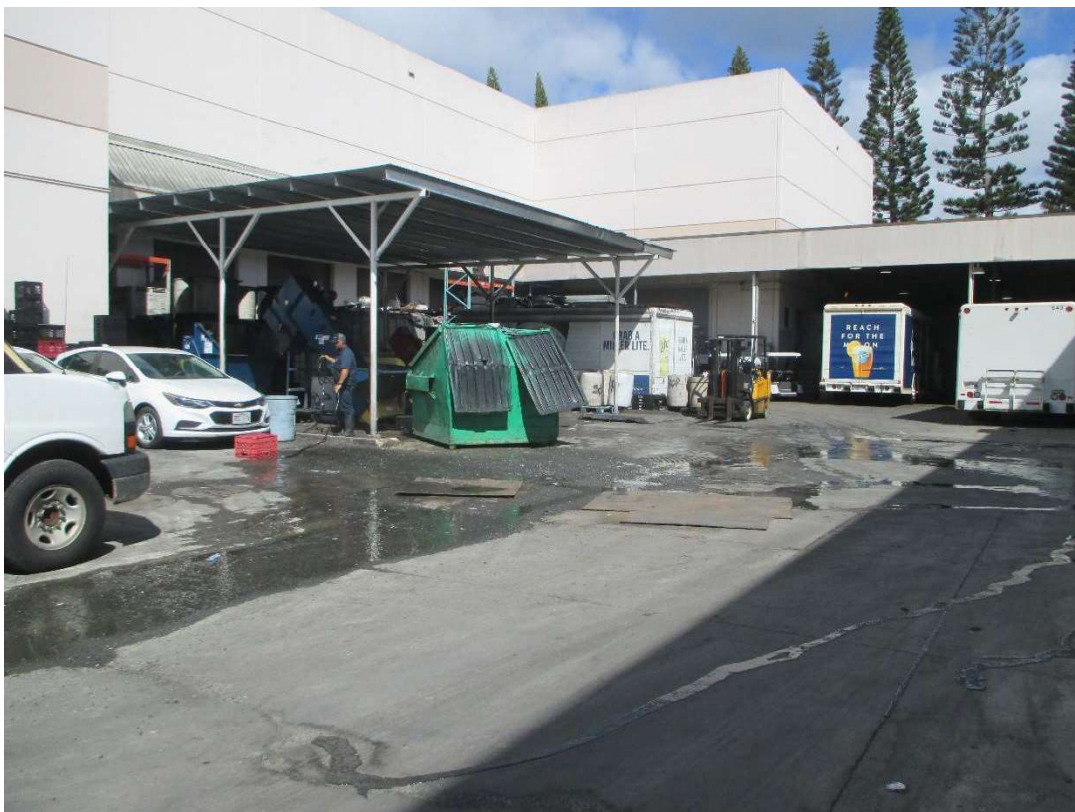
Reclamation area where pallets of alcoholic seltzer water were sprayed down.

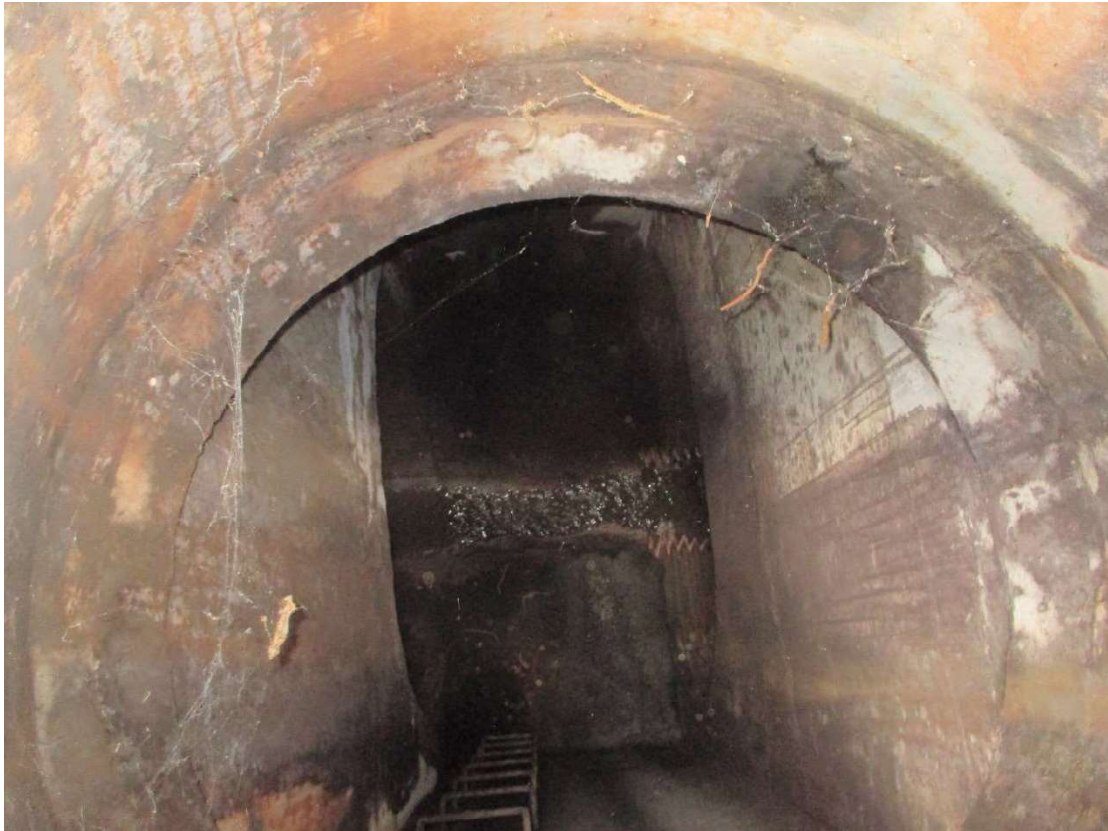
CCH 84-inch RCP (to the left) with dry weather flow with alcohol odor discharging to a State Highways Division 84-inch corrugated metal pipe (CMP) (to the right).

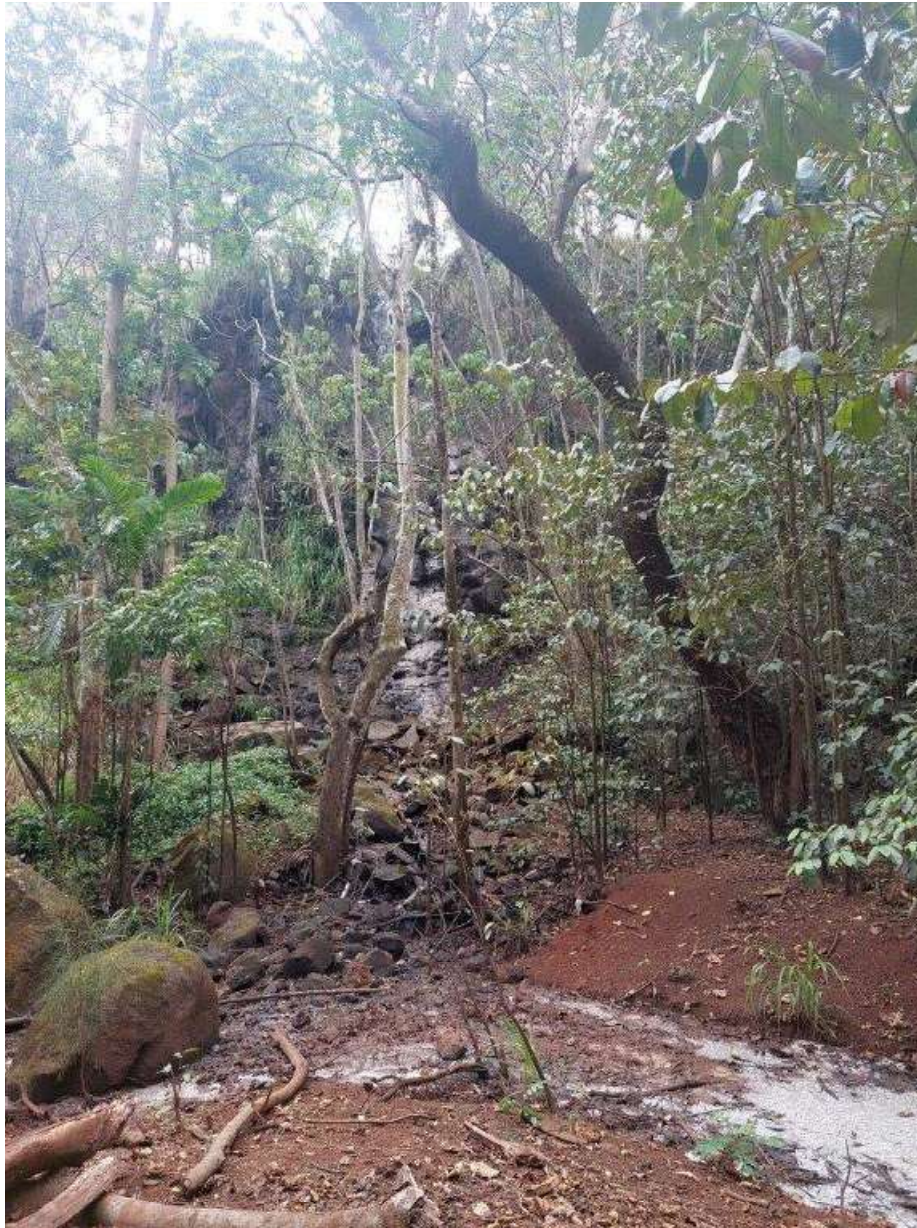
**Image 1:** The image above shows liquid waste initially flowing from the Outfall. It was taken by an anonymous complainant on October 27, 2021, and sent to Mr. Cox on October 28, 2021.

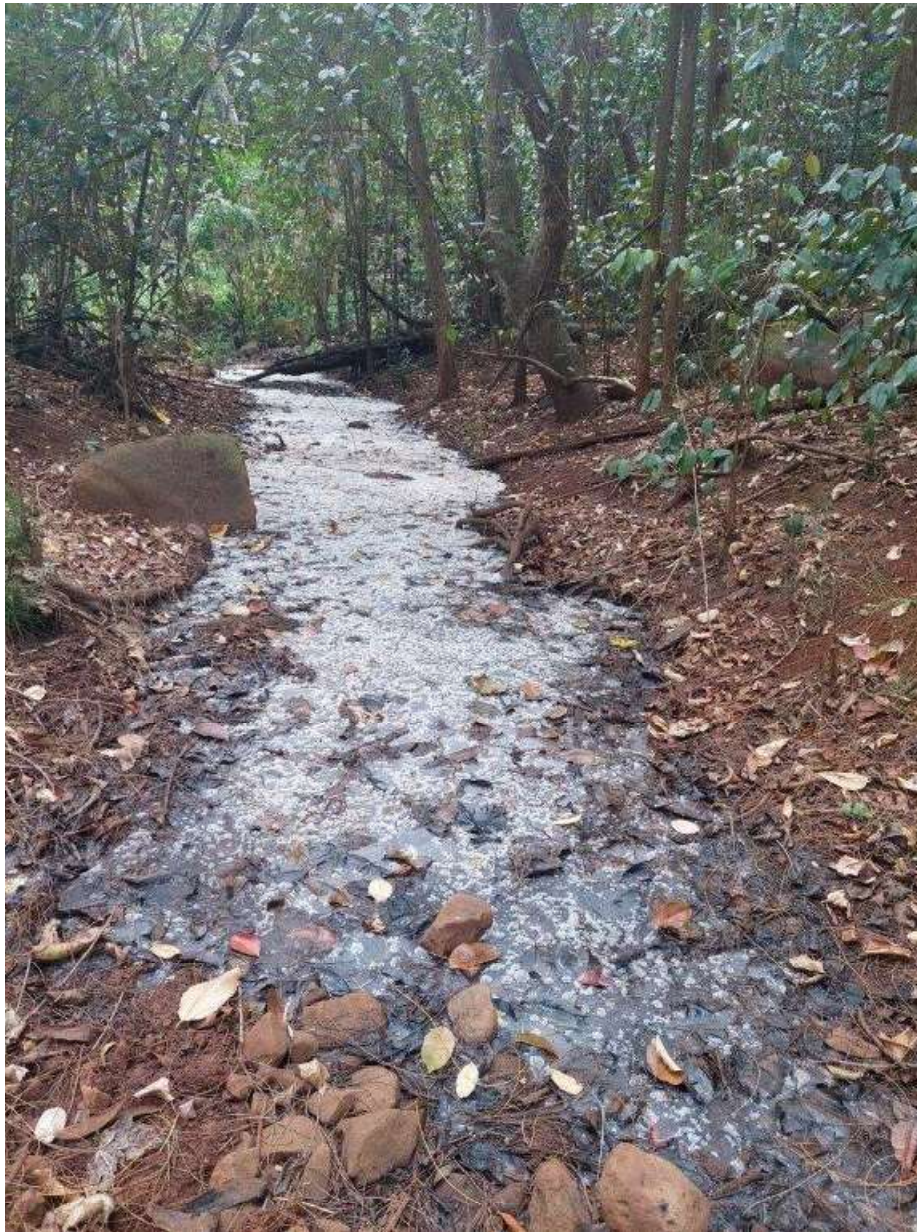
**Image 2:** The image above shows liquid waste flowing downstream from Image 1 towards Waiawa Stream. It was taken by an anonymous complainant on October 27, 2021, and sent to Mr. Cox on October 28, 2021.

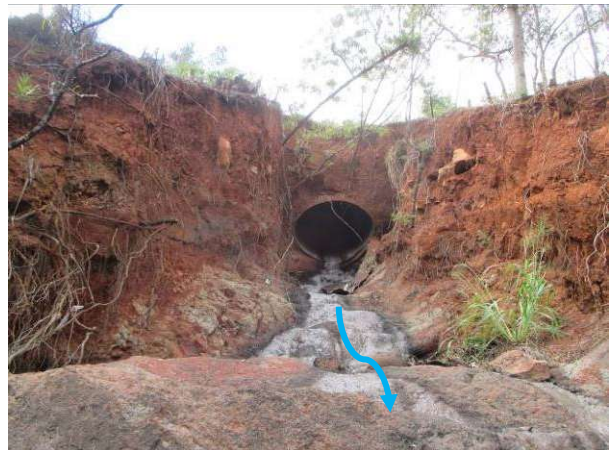
TMK: 9-4-128:002: State Highways Division outfall (PID 300732) along H-2 with observed dry weather flow with an alcohol odor. Staining and mold cover the rocks surrounding the outfall. (IMG\_004)

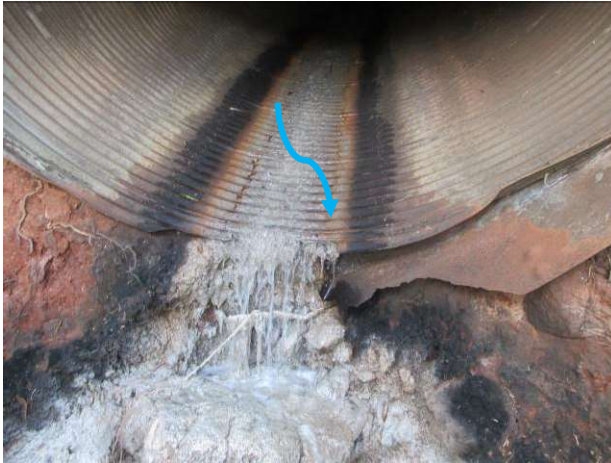
TMK: 9-4-128:002: Closer view of the State Highways Division outfall (PID 300732) with observed dry weather flow with an alcohol odor. Staining and mold observed within the outfall and covering the rocks surrounding the outfall. (IMG\_005)

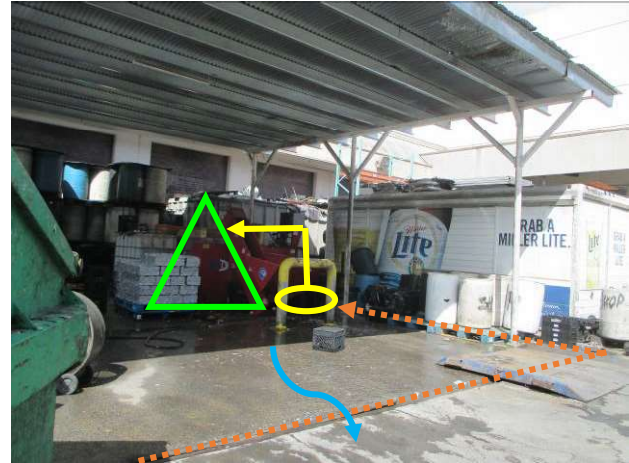
TMK: 9-4-128:002: Covered reclamation area located on the southeastern portion of the property. A private trench drain (orange dashed line) captures wash water from the reclamation area and discharges to a private sump (yellow circle). Wash water is then pumped to intermediate bulk containers (green triangle) for disposal. (IMG\_006)

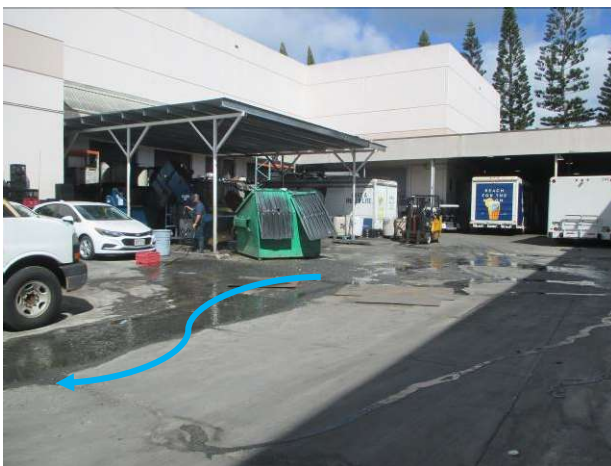
TMK: 9-4-128:002: A dry weather flow with an alcohol odor was observed flowing on the paved lot. The flow originates from the reclamation area where pallets of alcoholic seltzer water were sprayed down. (IMG\_007)

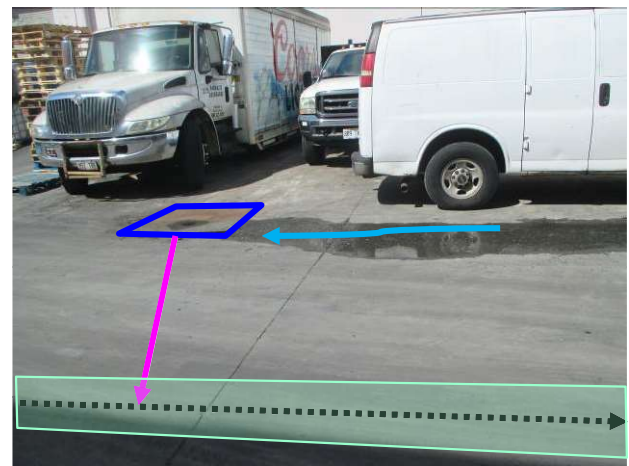
TMK: 9-4-128:002: The dry weather flow entered a private inlet on the property that discharges to a City and County of Honolulu (CCH) 84-inch reinforced concrete pipe (RCP) within a CCH storm water drainage easement that extends along the southern perimeter of the property. (IMG\_008)

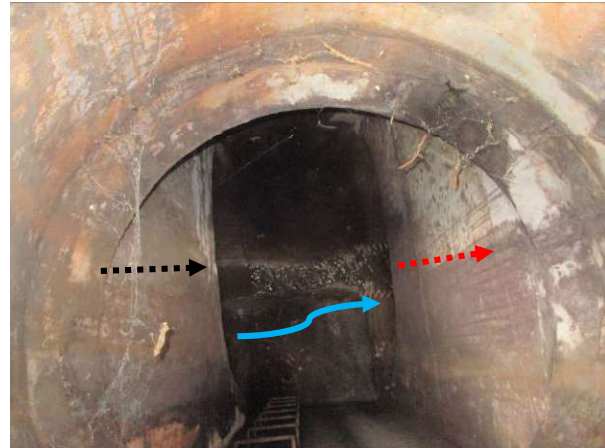
TMK: 9-4-128:002: View within the State Highways Division SDMH (PID 203145) of the dry weather flow with an alcohol odor discharging from a CCH 84-inch RCP (to the left) to a State Highways Division 84-inch CMP culvert (PID 700670) (to the right). (IMG\_010)
