**SUBJECT: RED HILL TANK COMPLEX  
SOIL VAPOR SAMPLING RESULTS FOR SEPTEMBER 2018  
DOH FACILITY ID NO. 9-102271  
DOH RELEASE ID NO. 990051, 010011, 020028, AND 140010**

Subj: NAVSUP FLC PEARL HARBOR CAUSATIVE RESEARCH REPORT IRT RED HILL  
SOIL VAPOR MONITORING REPORT FOR SEPTEMBER 2018

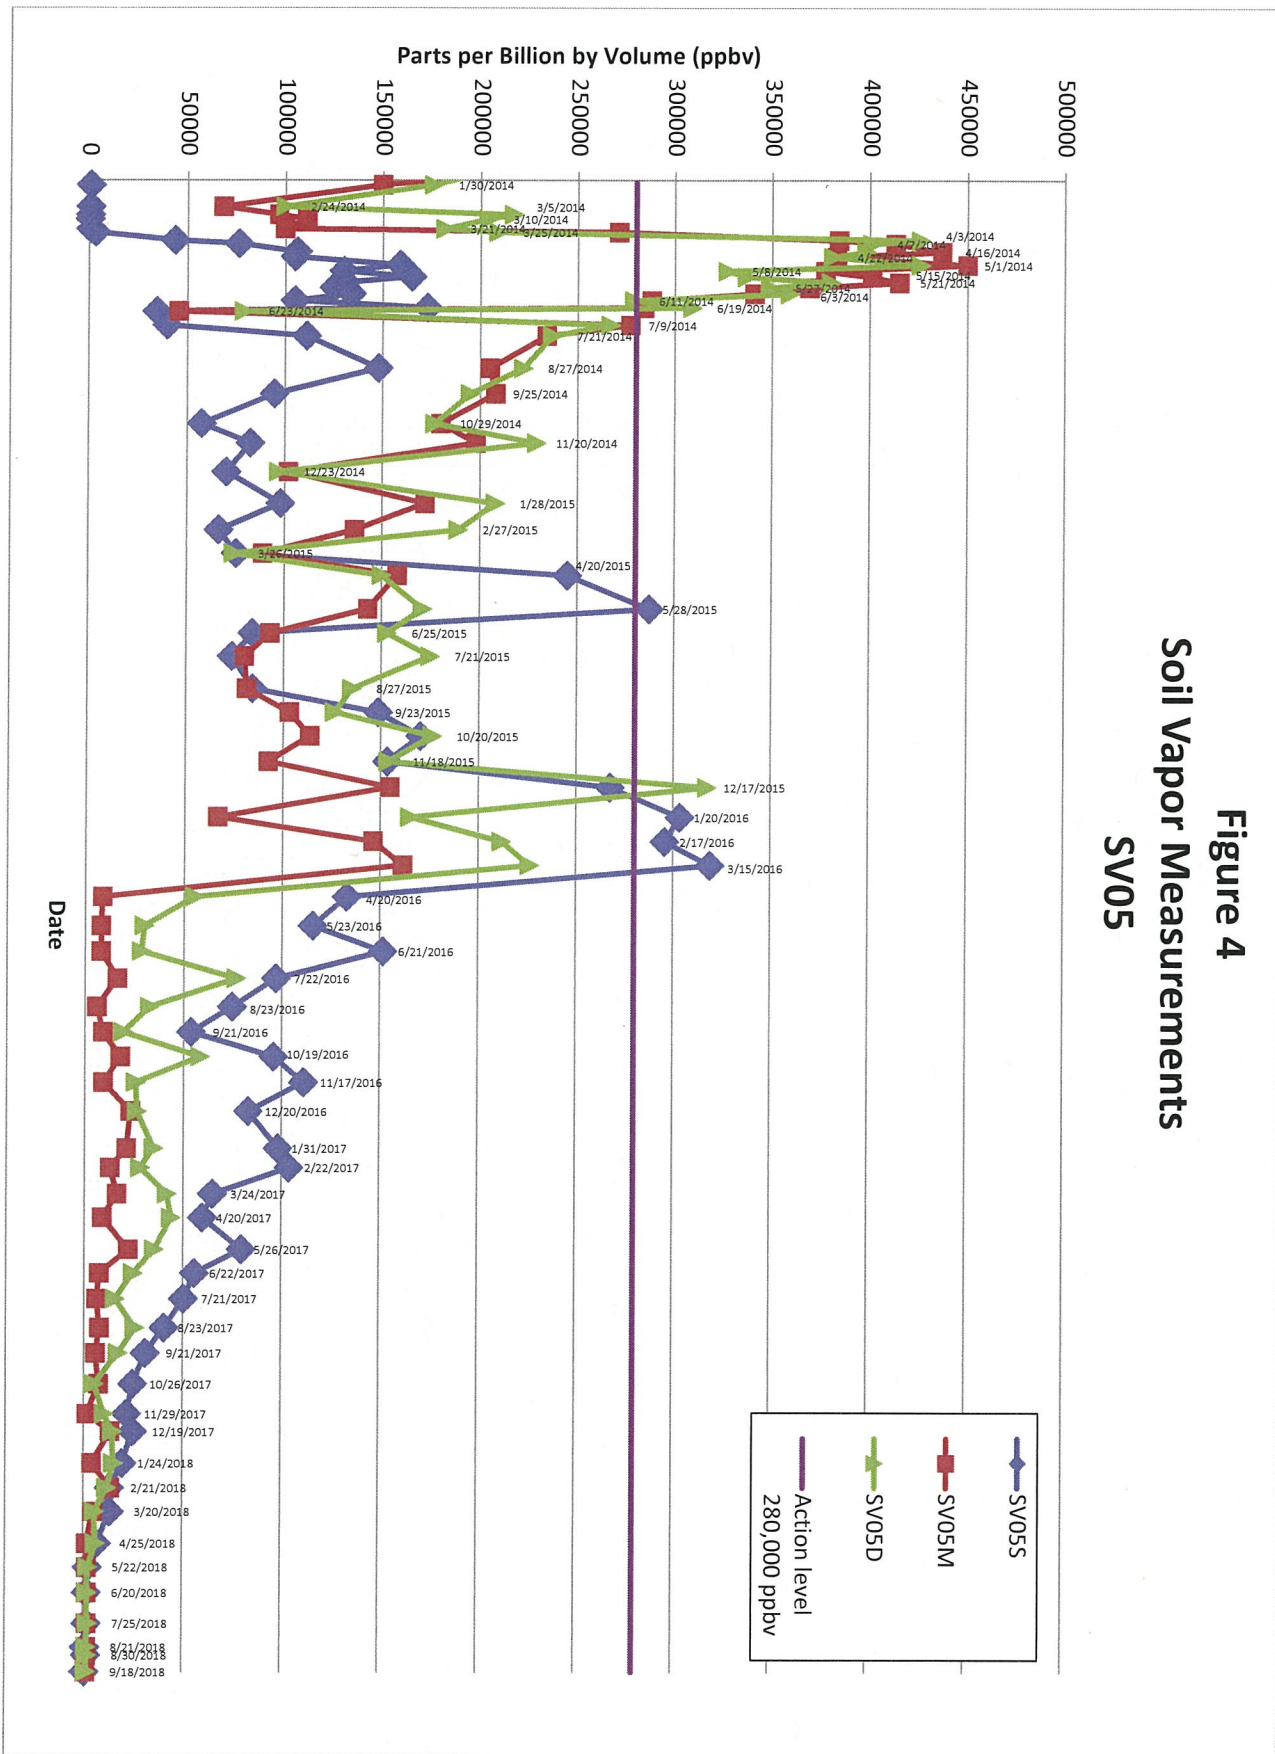
**Figure 4**  
**Soil Vapor Measurements**  
**SV05**

At Tank 5, the concentrations of VOCs detected in the front, middle, and outer edge soil vapor monitoring probes were 670 ppbv, 1,103 ppbv, and 1,211 ppbv, respectively. Tank 5 was emptied in January 2014 and has not contained fuel since that time. VOC concentrations in all down-gradient soil vapor monitors were below 630 ppbv.
