20 March 2015

Subject: Summary of the Second Phase II Liner Investigation  
Kekaha Sanitary Landfill, Kekaha, Hawai'i

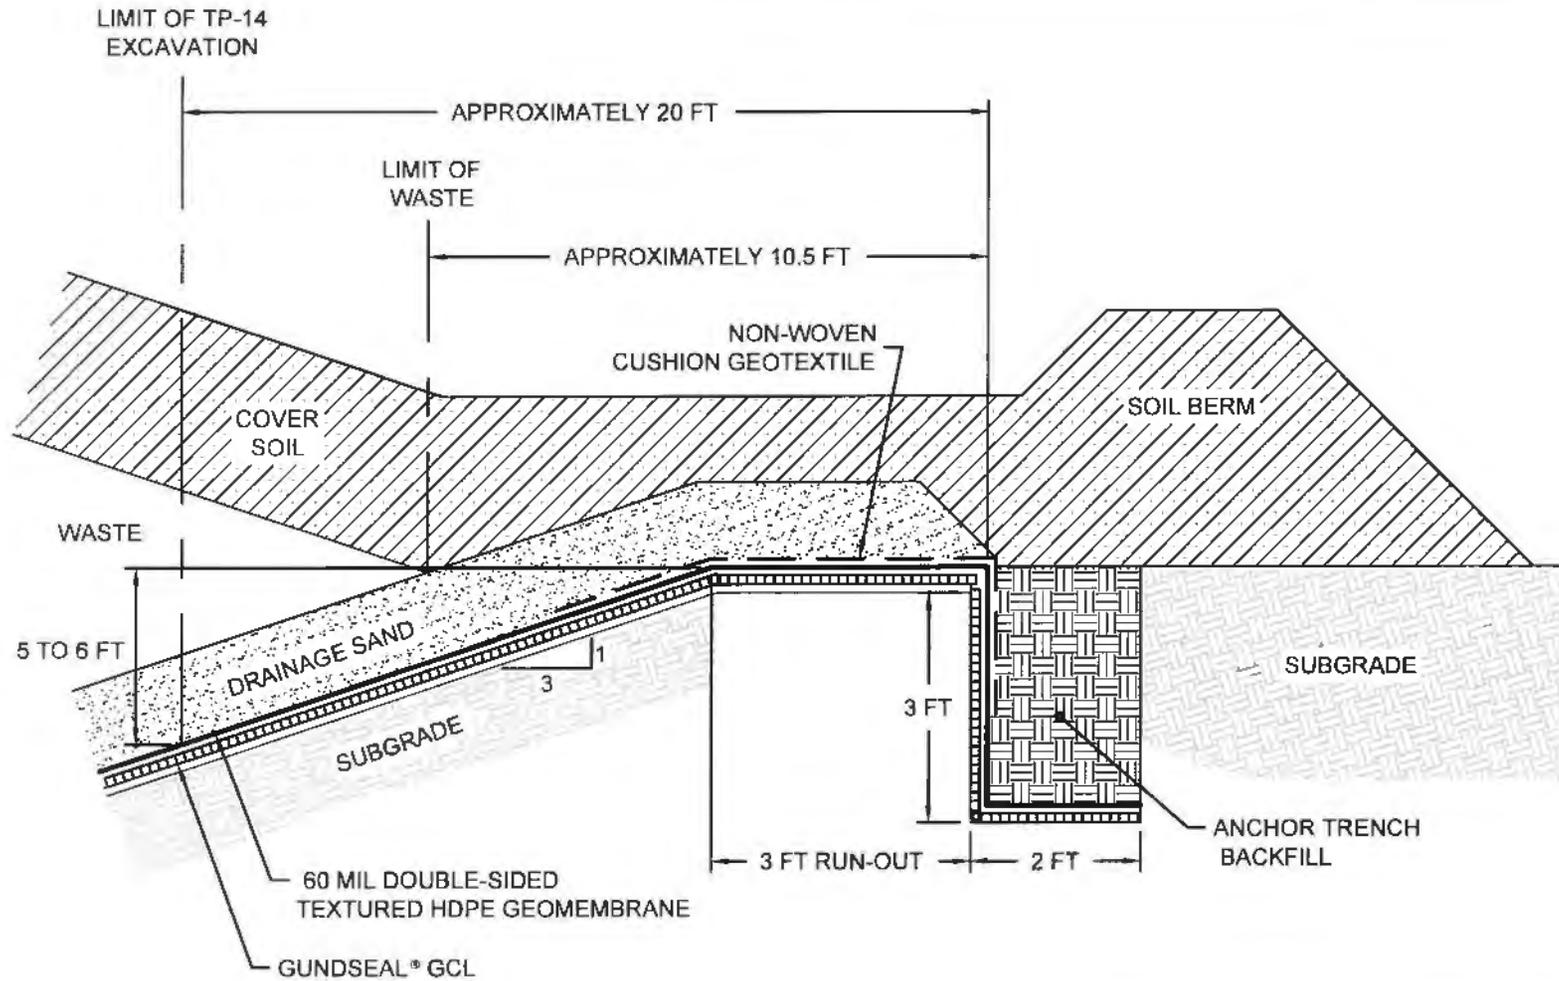
CONFIGURATION OF THE PERIMETER OF  
PHASE II AT TEST PIT #14  
KEKAHA SANITARY LANDFILL  
KEKAHA, COUNTY OF KAUA'I, HAWAII

Figure 1 shows the typical configuration of the geosynthetics and anchor trench at the perimeter of Phase II.

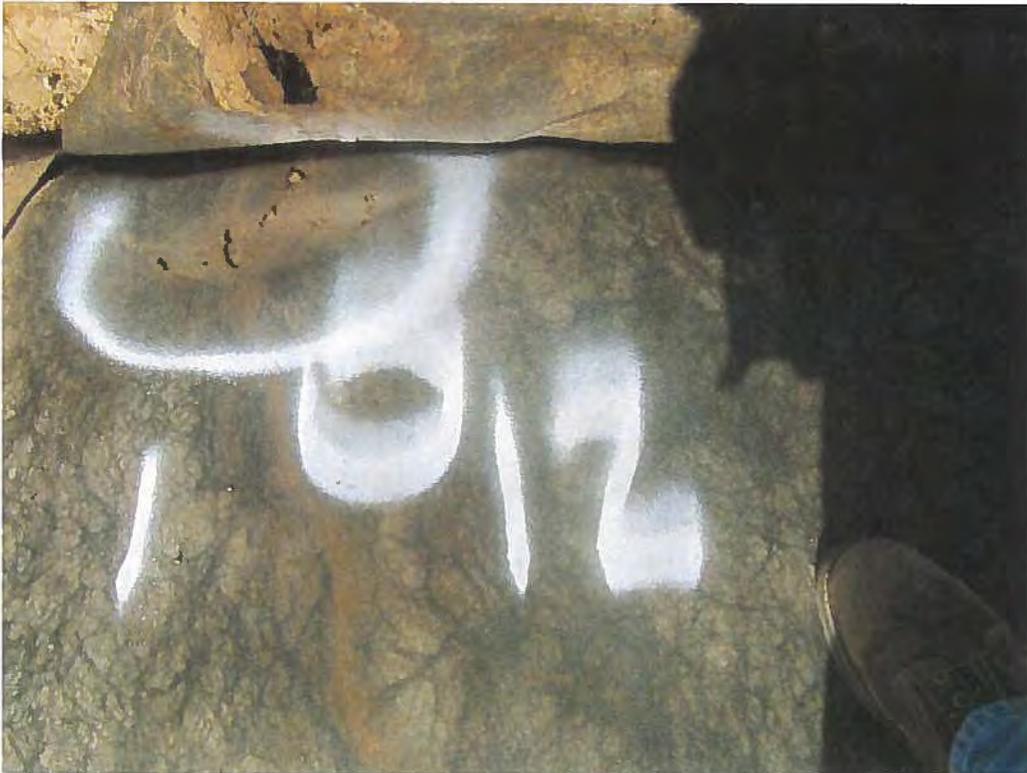
Pre-existing damage to the geosynthetic containment system was observed in test pit TP-14. Similar to the previous damage seen in 2012 and 2014, the observed damage was a series of irregularly-shaped, rounded holes through the cushion geotextile, and/or through the underlying 60-mil HDPE geomembrane. In some of these holes, the bentonite layer of the GCL was partially missing. After exposing the surface of the GCL, a series of trails, or tunnels, was found within the bentonite layer. In one location, unlike in the previous investigation, an approximate 2.5-in. by 1.25-in. irregular hole was observed to penetrate through the 20-mil HDPE backer geomembrane of the GCL. Up to this point, all other observed damage to the GCL had been isolated to the bentonite layer. Photos of the damage are provided in Attachment B. While past termite activity was evident, no termites were found in TP-14.

Photo 4. Holes in both the 16 oz/sy non-woven cushion geotextile and 60-mil HDPE geomembrane

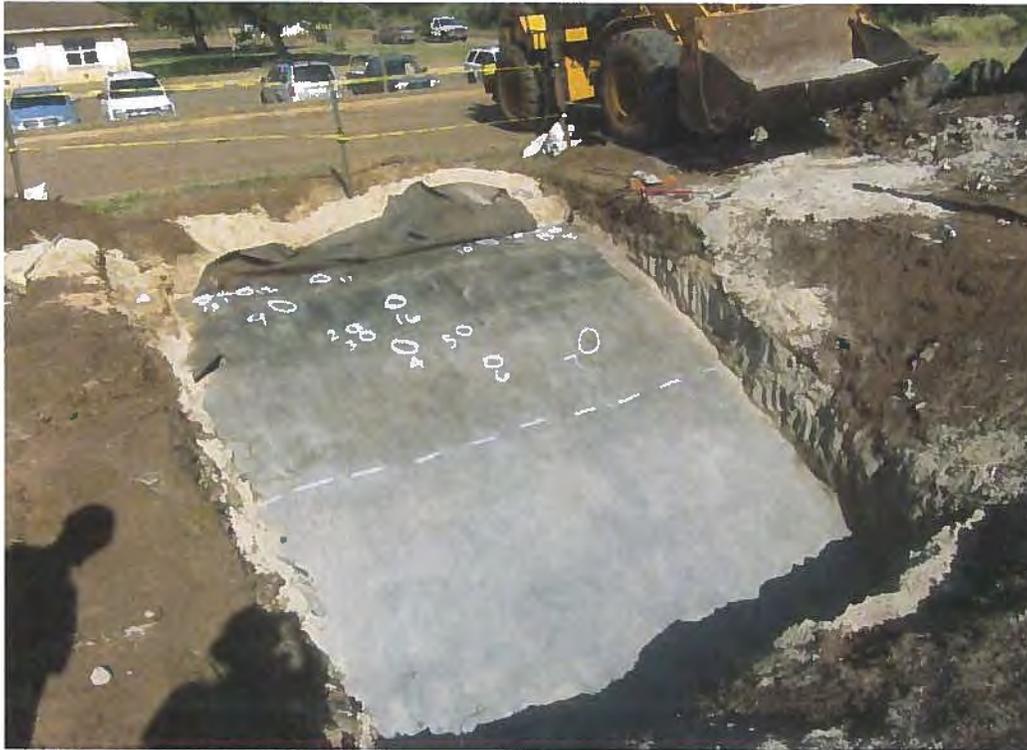
Also similar to the June 2014 investigation, the geotextile and geomembrane holes were most abundant at edge of the liner and the damage was less on the 3H:1V sideslope. All observed penetrations were confined to within 10 ft of the perimeter anchor trench. Likewise, the tunnels observed in the GCL were mostly at the rim of the landfill and diminished on the 3H:1V sideslope. A few trails were observed to extend down the slope approximately 14 ft from the anchor trench and then terminated. The limit of waste at TP-14 was measured at approximately 10.5 ft from the anchor trench. Therefore, below the waste, the only observed damage was a limited number of termite trails within the bentonite layer of the GCL and both the underlying 20-mil backer geomembrane and overlying 60-mil primary geomembrane were intact.

Photo 5. Holes in the existing 60-mil HDPE geomembrane were confined to the anchor trench, flat run-out, and upper portion of the 3H:1V sidelope (dashed white lines marks approximately 10.5 ft from anchor trench)

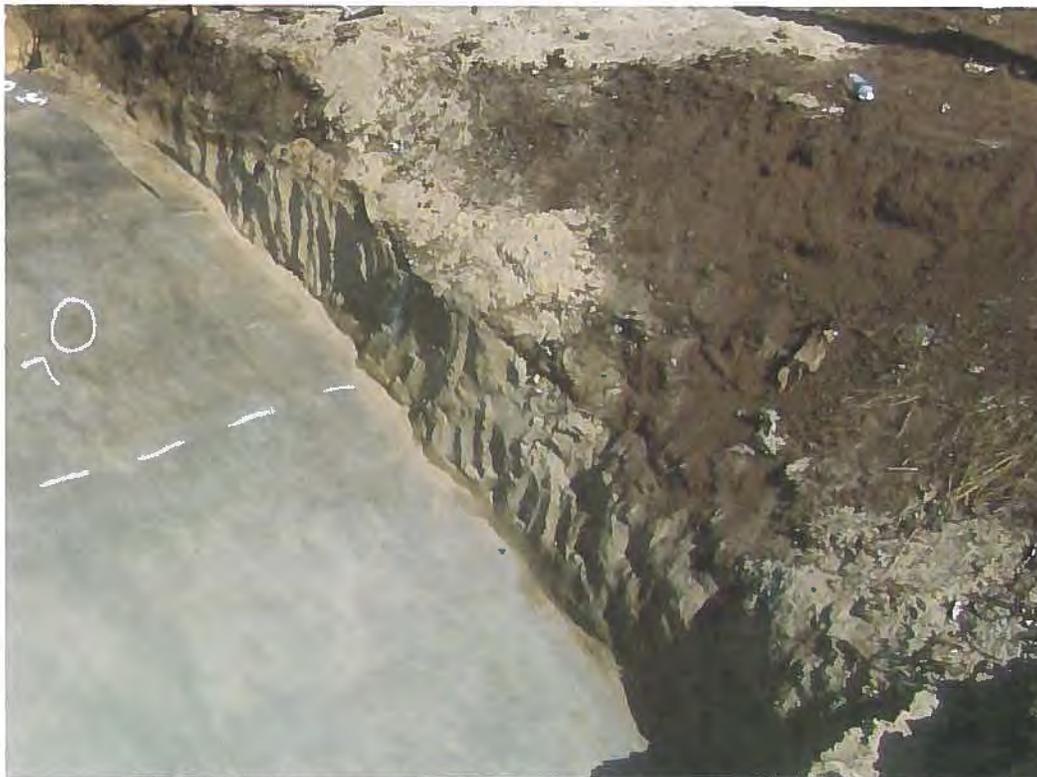
With the observed damage mostly beyond the limit of waste and the primary geomembrane observed to be intact below the waste footprint, Geosyntec considers the potential for a leachate release from these damaged areas to be low. Likely, this termite damage has existed for many years and Geosyntec is not aware of any evidence of a previous release. Therefore, the need to restore the containment system is not urgent. The restoration described above will require heavy equipment, a specialized liner installer, earthwork and liner CQA, and coordination with landfill operations. Therefore, Geosyntec recommends that the restoration work be performed in conjunction with a future landfill construction project, such as Cell 2 or Final Cover construction which would already include these components.

Photo 6. Limit of waste shown beyond area of damage (to right of white line)

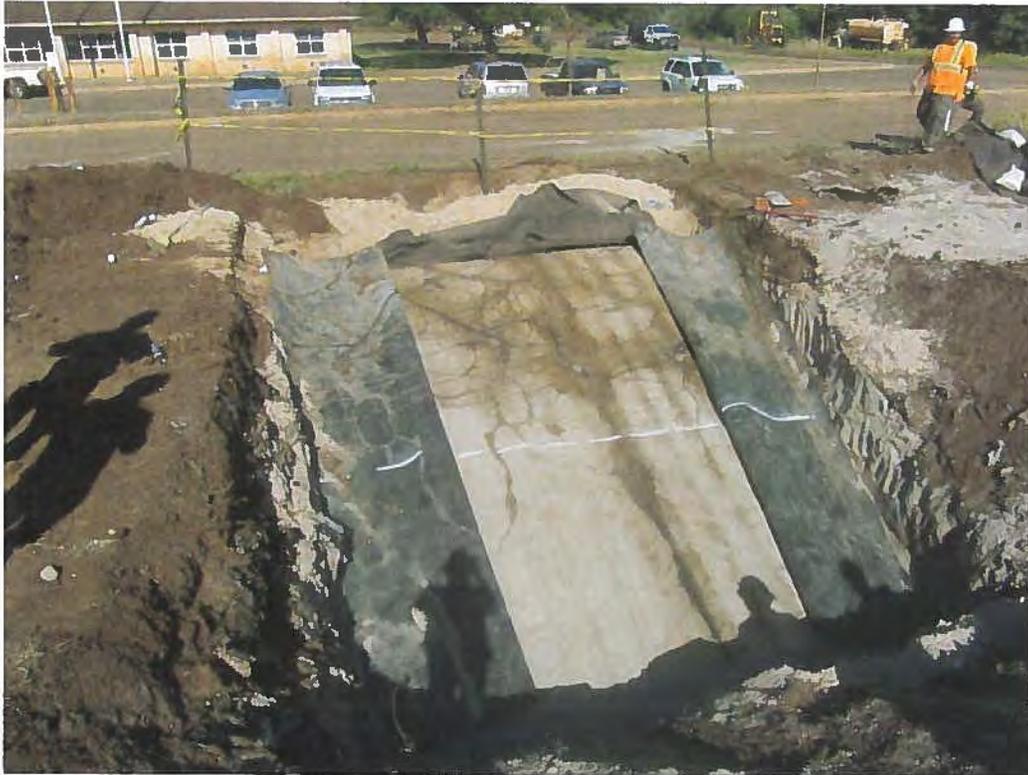
Photo 7. Trails/tunnels in the bentonite layer of the Gundseal GCL

Where termite trails/tunnels were observed (and above the welded patch described above), a layer of AGRU-manufactured GeoClay NN66 GCL was placed over the existing Gundseal GCL. The purpose of adding this extra GCL was to provide a full layer of bentonite where the original bentonite layer was damaged.

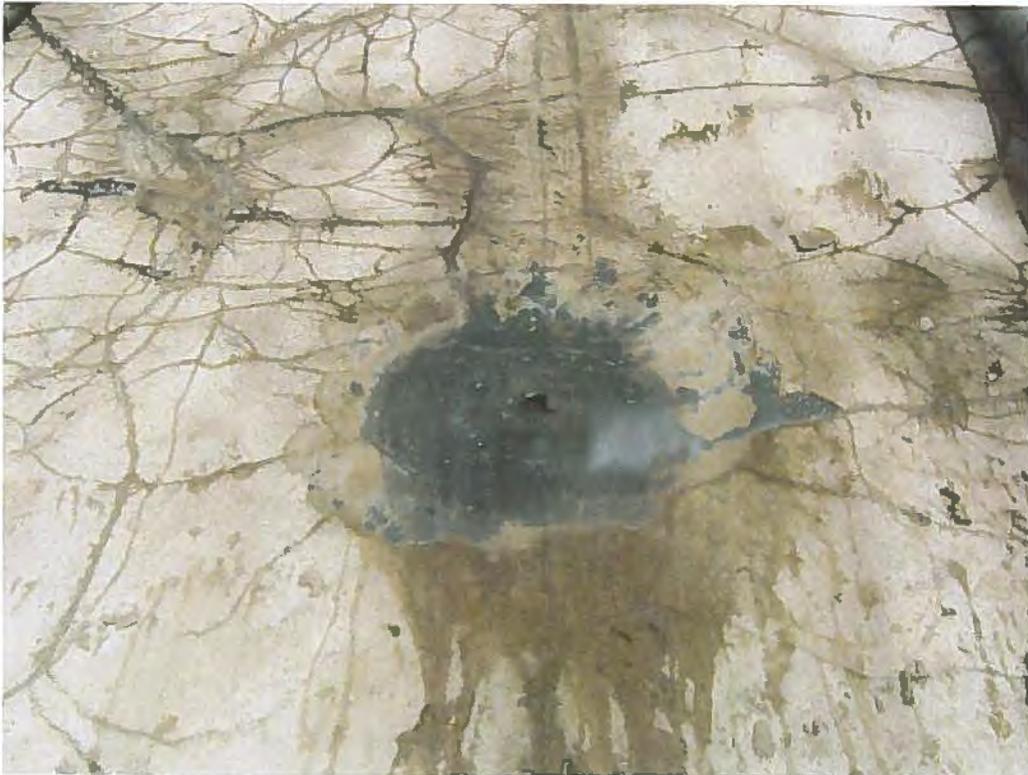
Photo 8. One hole observed in the 20-mil HDPE backer geomembrane of the Gundseal GCL

In test pit TP-14 where one hole was observed in the 20-mil HDPE backer geomembrane, a geomembrane patch was constructed over the penetration. A 1-ft by 1-ft area around the penetration was first cleared of bentonite and cleaned. A 1-ft by 1-ft patch of GSE-manufactured 60-mil DST HDPE geomembrane was then extrusion welded to the 20-mil HDPE backer geomembrane. Prior to welding, ILT constructed an extrusion-weld trial seam using the site-specific materials to verify the welding method did not damage the 20-mil geomembrane and provided a bond between the geomembranes. Coupons were cut from the trial seam and tested for peel and shear using the calibrated field tensiometer. Once the patch was constructed, ILT perform vacuum box testing of weld to verify the integrity of the weld. Trial seam and vacuum box test results are provided in Attachment D.

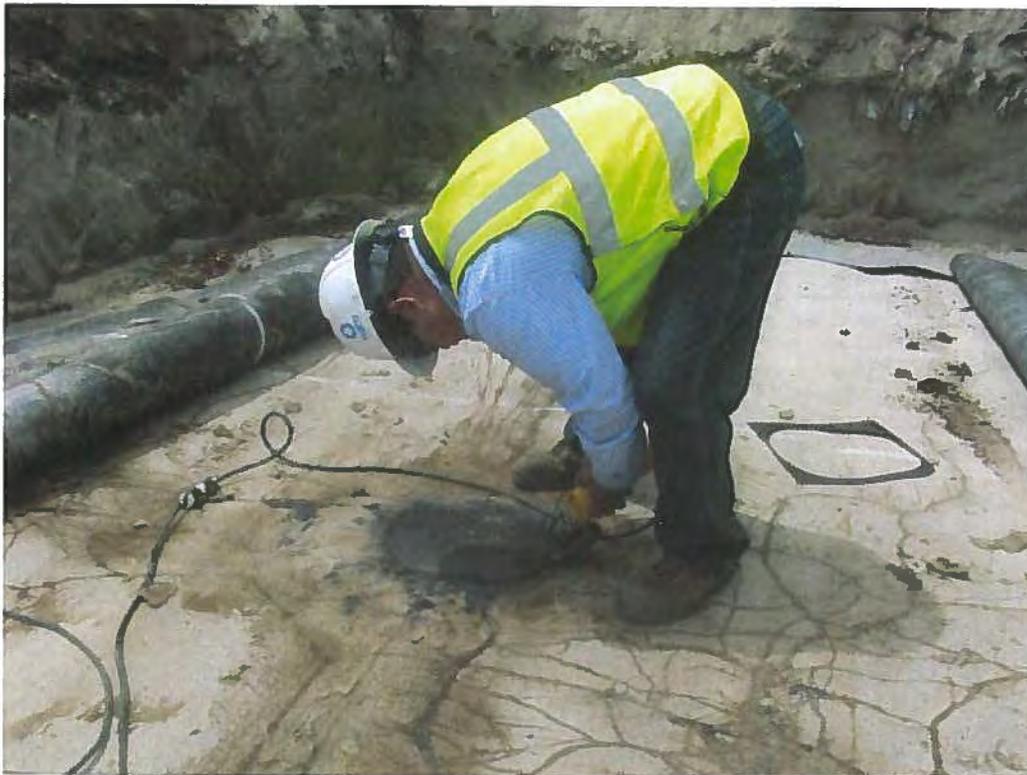
Photo 11. Abrading 20-mil backer geomembrane surface before extrusion welding a repair patch

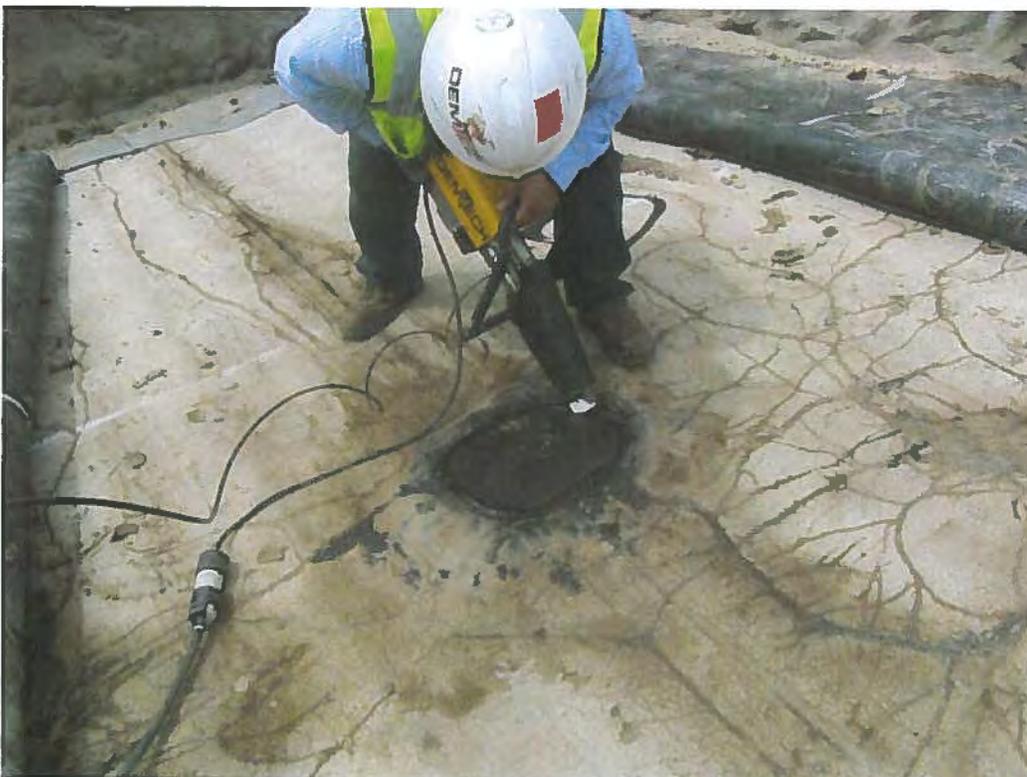
Photo 12. Extrusion welding the 60-mil HDPE geomembrane patch to the 20-mil HDPE backer geomembrane

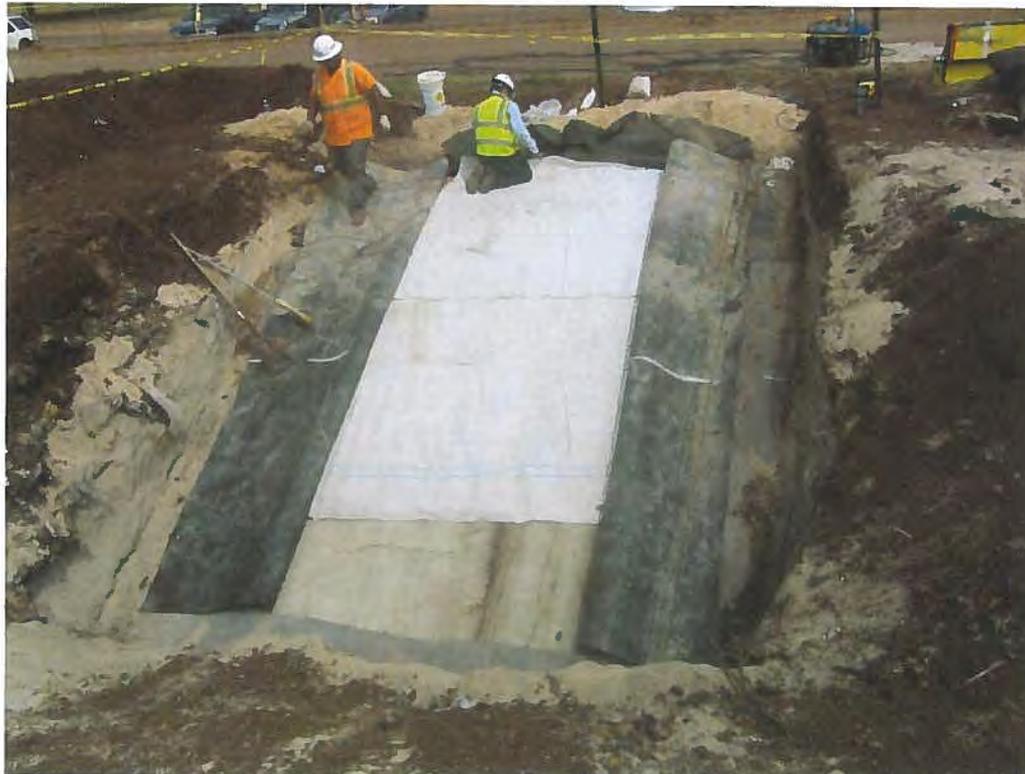
Photo 14. Placing AGRU-manufactured GCL over existing Gundseal GCL

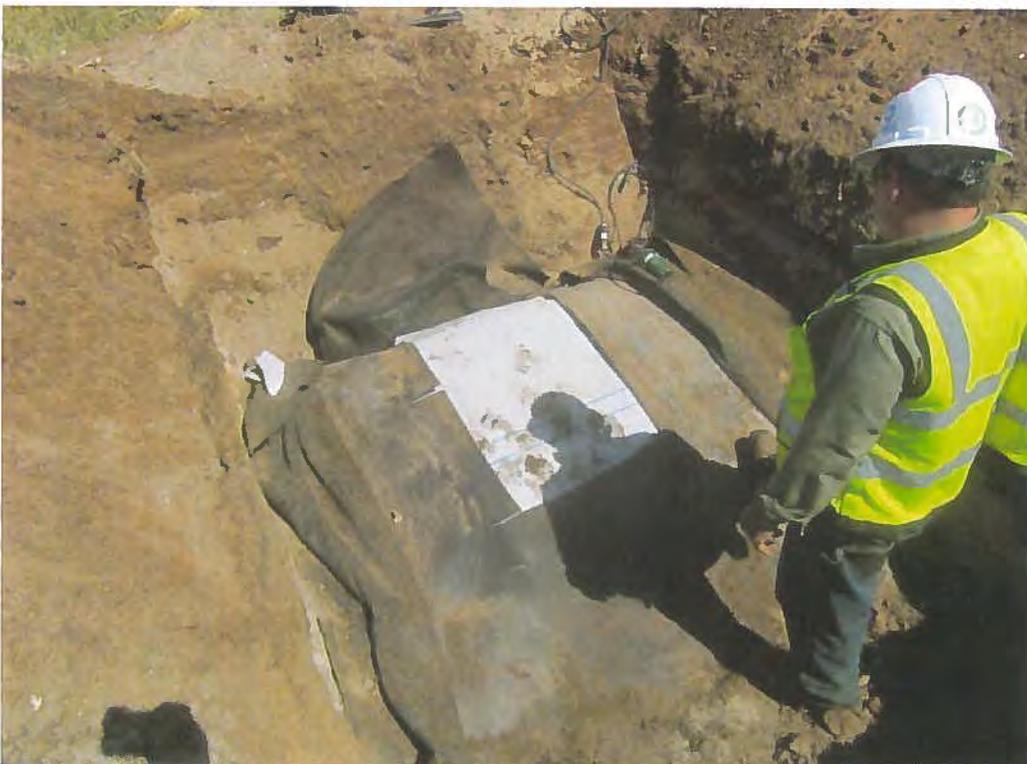
Photo 18. Test pits TP-1 through TP-5 from the June 2014 investigation were all similarly restored; AGRU-manufactured GCL placed over existing Gundseal GCL (above)

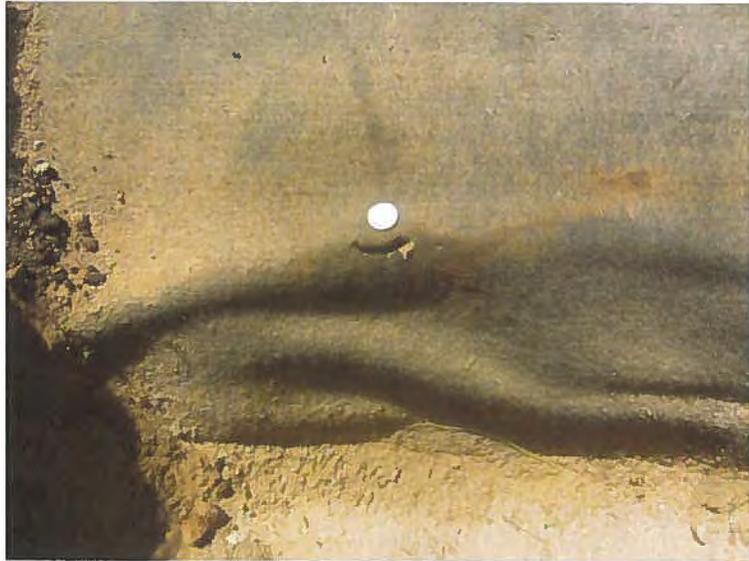
<p>During excavation a small hole adjacent to the anchor trench was observed in the cushion geotextile consistent with damaged observed during previous 2014 investigation. No other damage was observed as the containment system is still intact and will remain until the entire excavation area has been exposed and cleaned in accordance with the work plan.</p>

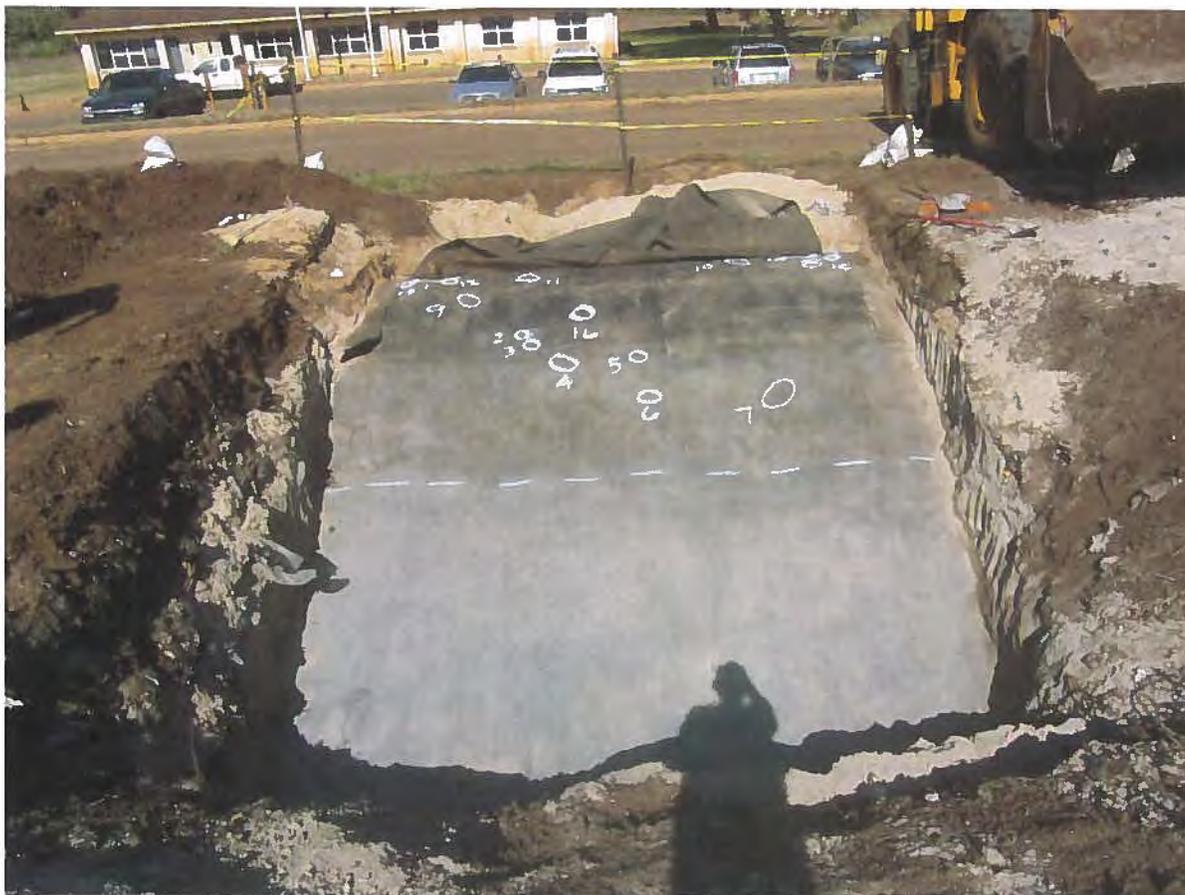
16 penetrations through the exposed 60 mil HDPE geomembrane, ranging from approximately 1/16<sup>th</sup> of an inch to several inches in size, were observed and identified (see numbered white markings shown in the above photo). The observed damage to the 60 mil HDPE geomembrane was limited to within approximately 9 ft from the perimeter anchor trench, down into the 3H:1V side-slope of the containment system. No damage was observed in the geomembrane in the 9-ft to 20-ft stretch from the anchor trench. Based on visual observations during excavation, no waste was observed within 10.5 ft of the perimeter anchor trench. However, beyond 10.5 ft from the anchor trench, waste was encountered and removed for this investigation. The white painted dotted line seen in the above photo is the approximate start of waste based on visual observations of the excavated materials.

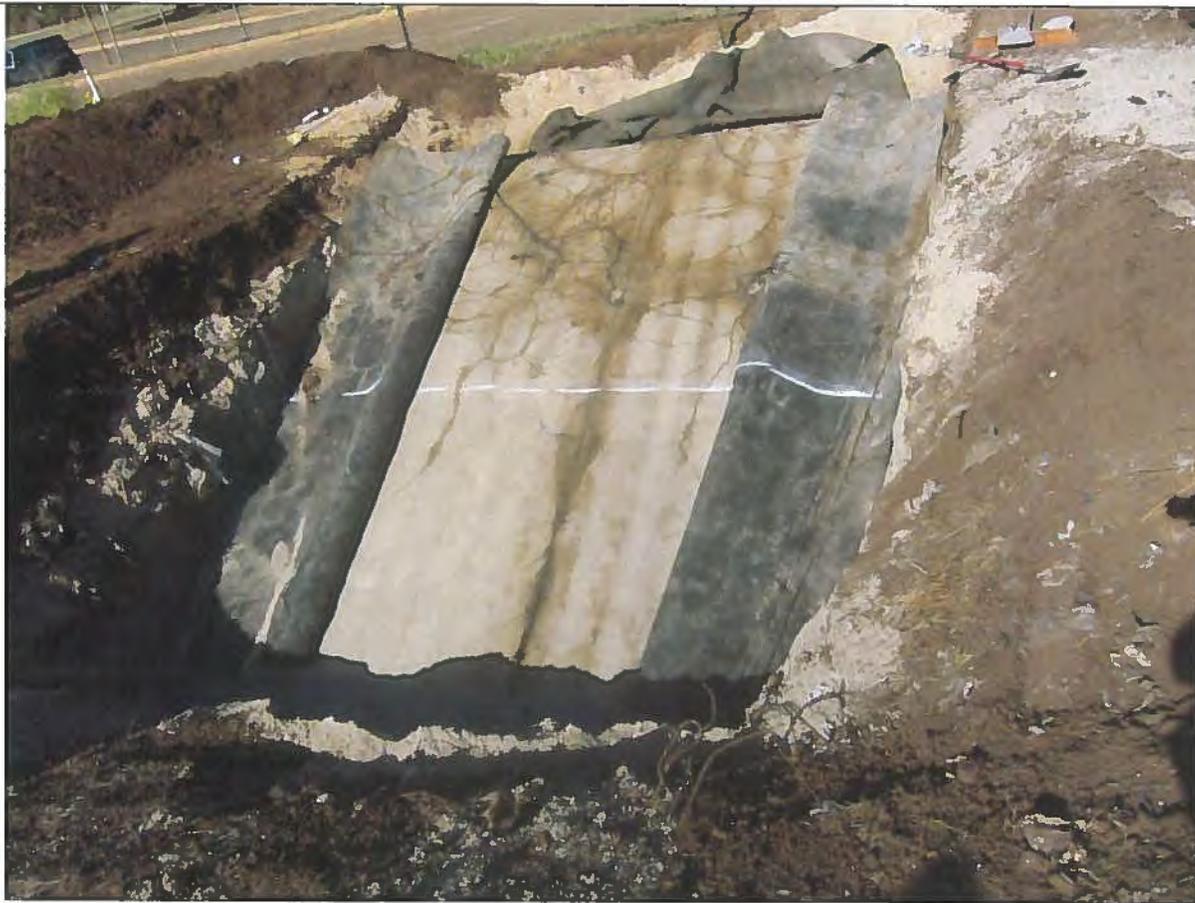
I carefully examine the underlying Gundseal GCL and no active or dead termites were observed, however, termite trails are readily apparent, as shown in the above photo. The white painted line in the photo above represents the limits of observed waste approximately 10.5 ft from the perimeter termination anchor trench, extending into the landfill. Based on the observed trails, it appears that the termite activity was primarily limited to within 10-ft of the anchor trench, with exception of two trails which extended further downslope to a distance of 14 ft from the anchor trench.

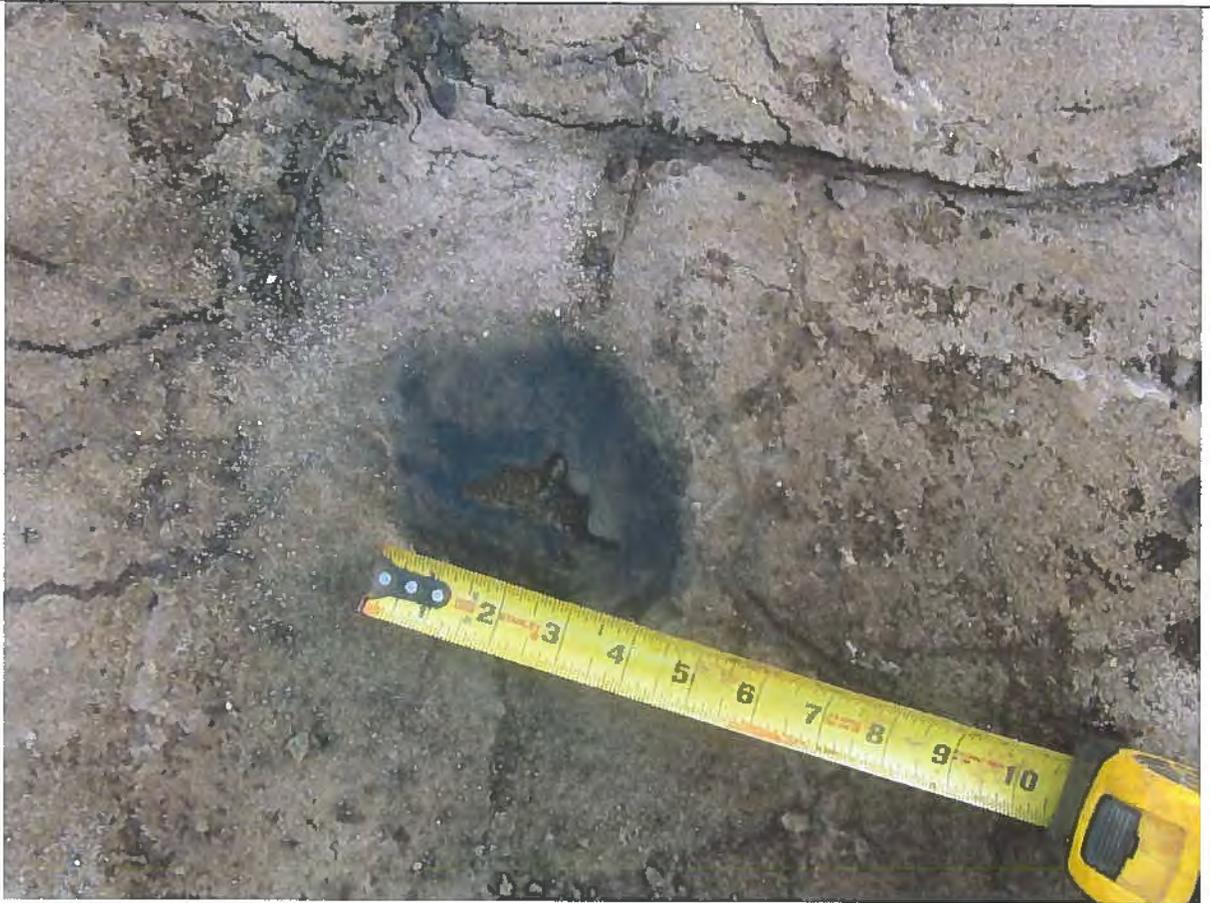
In addition to the termite trails within the GCL, one area of the GCL Gundseal 20-mil HDPE backer was observed to be penetrated. The penetration was approximately 2 ½ inches long and 1 ¼ inches wide and was 8.5 ft from the anchor trench.
