SUBJECT: RED HILL TANK COMPLEX  
SOIL VAPOR SAMPLING RESULTS FOR MAY 2019  
DOH FACILITY ID NO. 9-102271  
DOH RELEASE ID NO. 990051, 010011, 020028, AND 140010

Subj: NAVSUP FLC PEARL HARBOR CAUSATIVE RESEARCH REPORT IRT RED HILL  
SOIL VAPOR MONITORING REPORT FOR MAY 2019

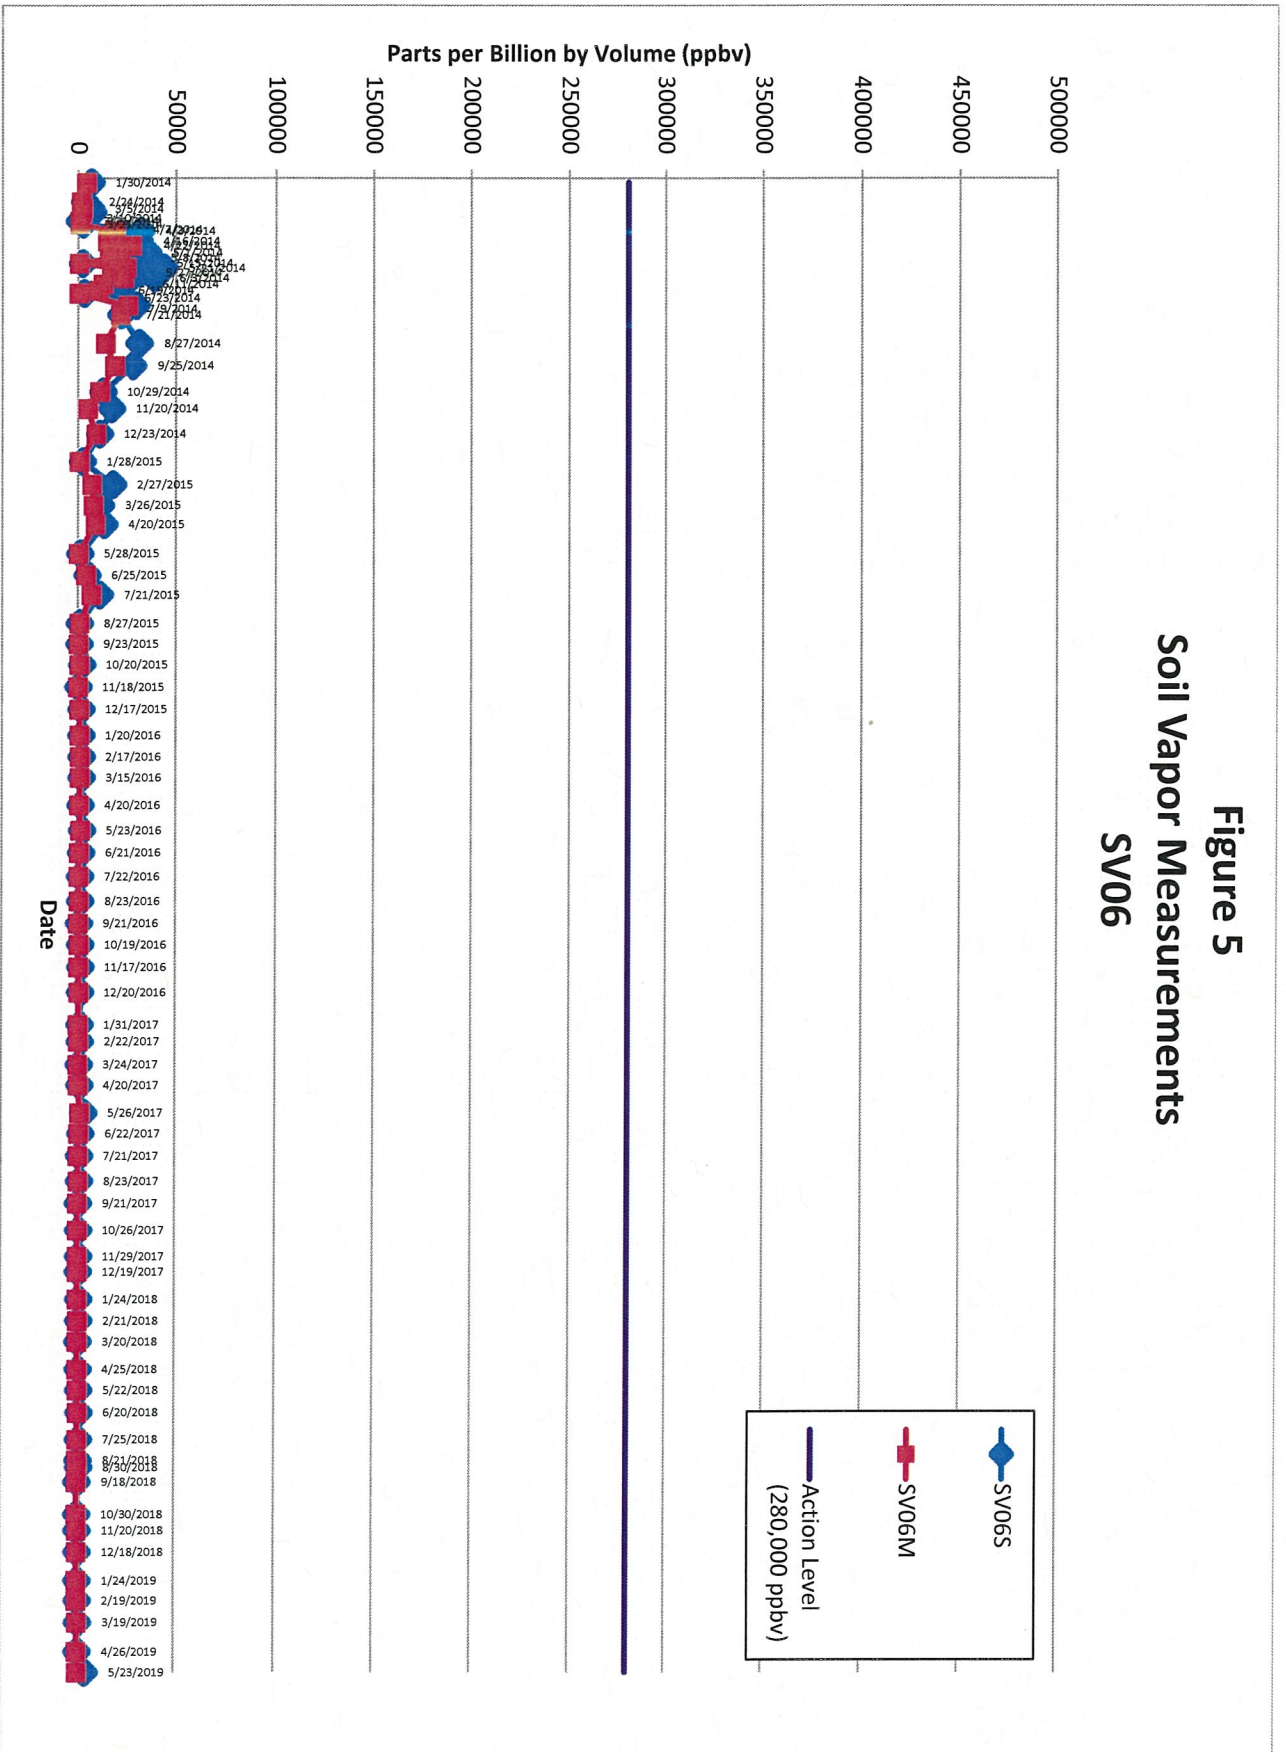
**Figure 5**  
**Soil Vapor Measurements**  
**SV06**

At Tank 5, the concentrations of VOCs detected in the front, middle, and outer edge soil vapor monitoring probes were 586 ppbv, 4,513 ppbv, and 7,026 ppbv, respectively. Tank 5 was emptied in January 2014 and has not contained fuel since that time. VOC concentrations in all down-gradient soil vapor monitors were below 430 ppbv.
