DEPARTMENT OF THE NAVY

**SUBJECT: RED HILL TANK COMPLEX
SOIL VAPOR SAMPLING RESULTS FOR JUNE 2019
DOH FACILITY ID NO. 9-102271
DOH RELEASE ID NO. 990051, 010011, 020028, AND 140010**

Subj: NAVSUP FLC PEARL HARBOR CAUSATIVE RESEARCH REPORT IRT RED HILL
SOIL VAPOR MONITORING REPORT FOR JUNE 2019

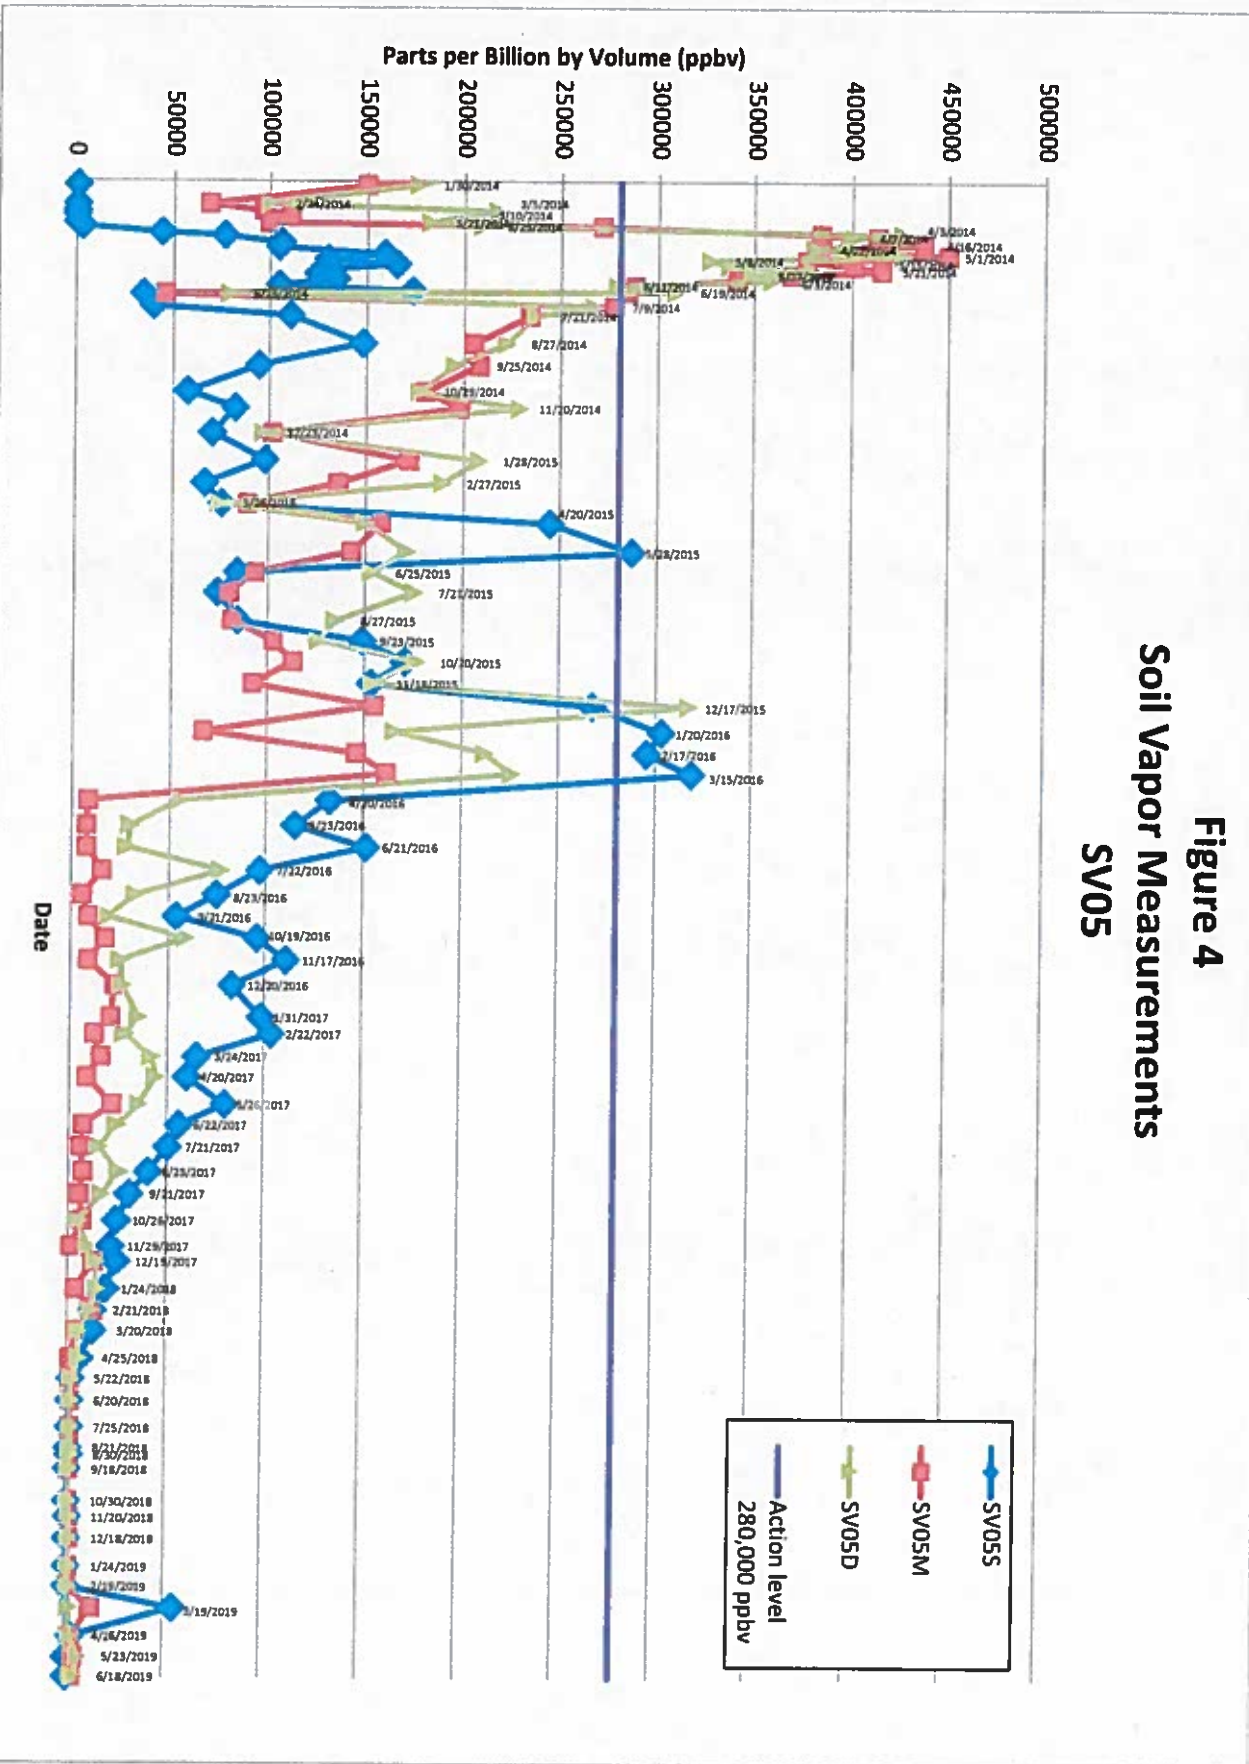
Figure 4
Soil Vapor Measurements
SV05

At Tank 5, the concentrations of VOCs detected in the front, middle, and outer edge soil vapor monitoring probes were 646 ppbv, 3,586 ppbv, and 4,895 ppbv, respectively. Tank 5 was emptied in January 2014 and has not contained fuel since that time. VOC concentrations in all down-gradient soil vapor monitors were below 290 ppbv.

- Strong increase trends at tanks 5 and 6
- Slight increase trends at tanks 7 and 20
