SUBJECT: RED HILL TANK COMPLEX
SOIL VAPOR SAMPLING RESULTS FOR JULY 2019
DOH FACILITY ID NO. 9-102271
DOH RELEASE ID NO. 990051, 010011, 020028, AND 140010

Subj: NAVSUP FLC PEARL HARBOR CAUSATIVE RESEARCH REPORT IRT RED HILL
SOIL VAPOR MONITORING REPORT FOR JULY 2019

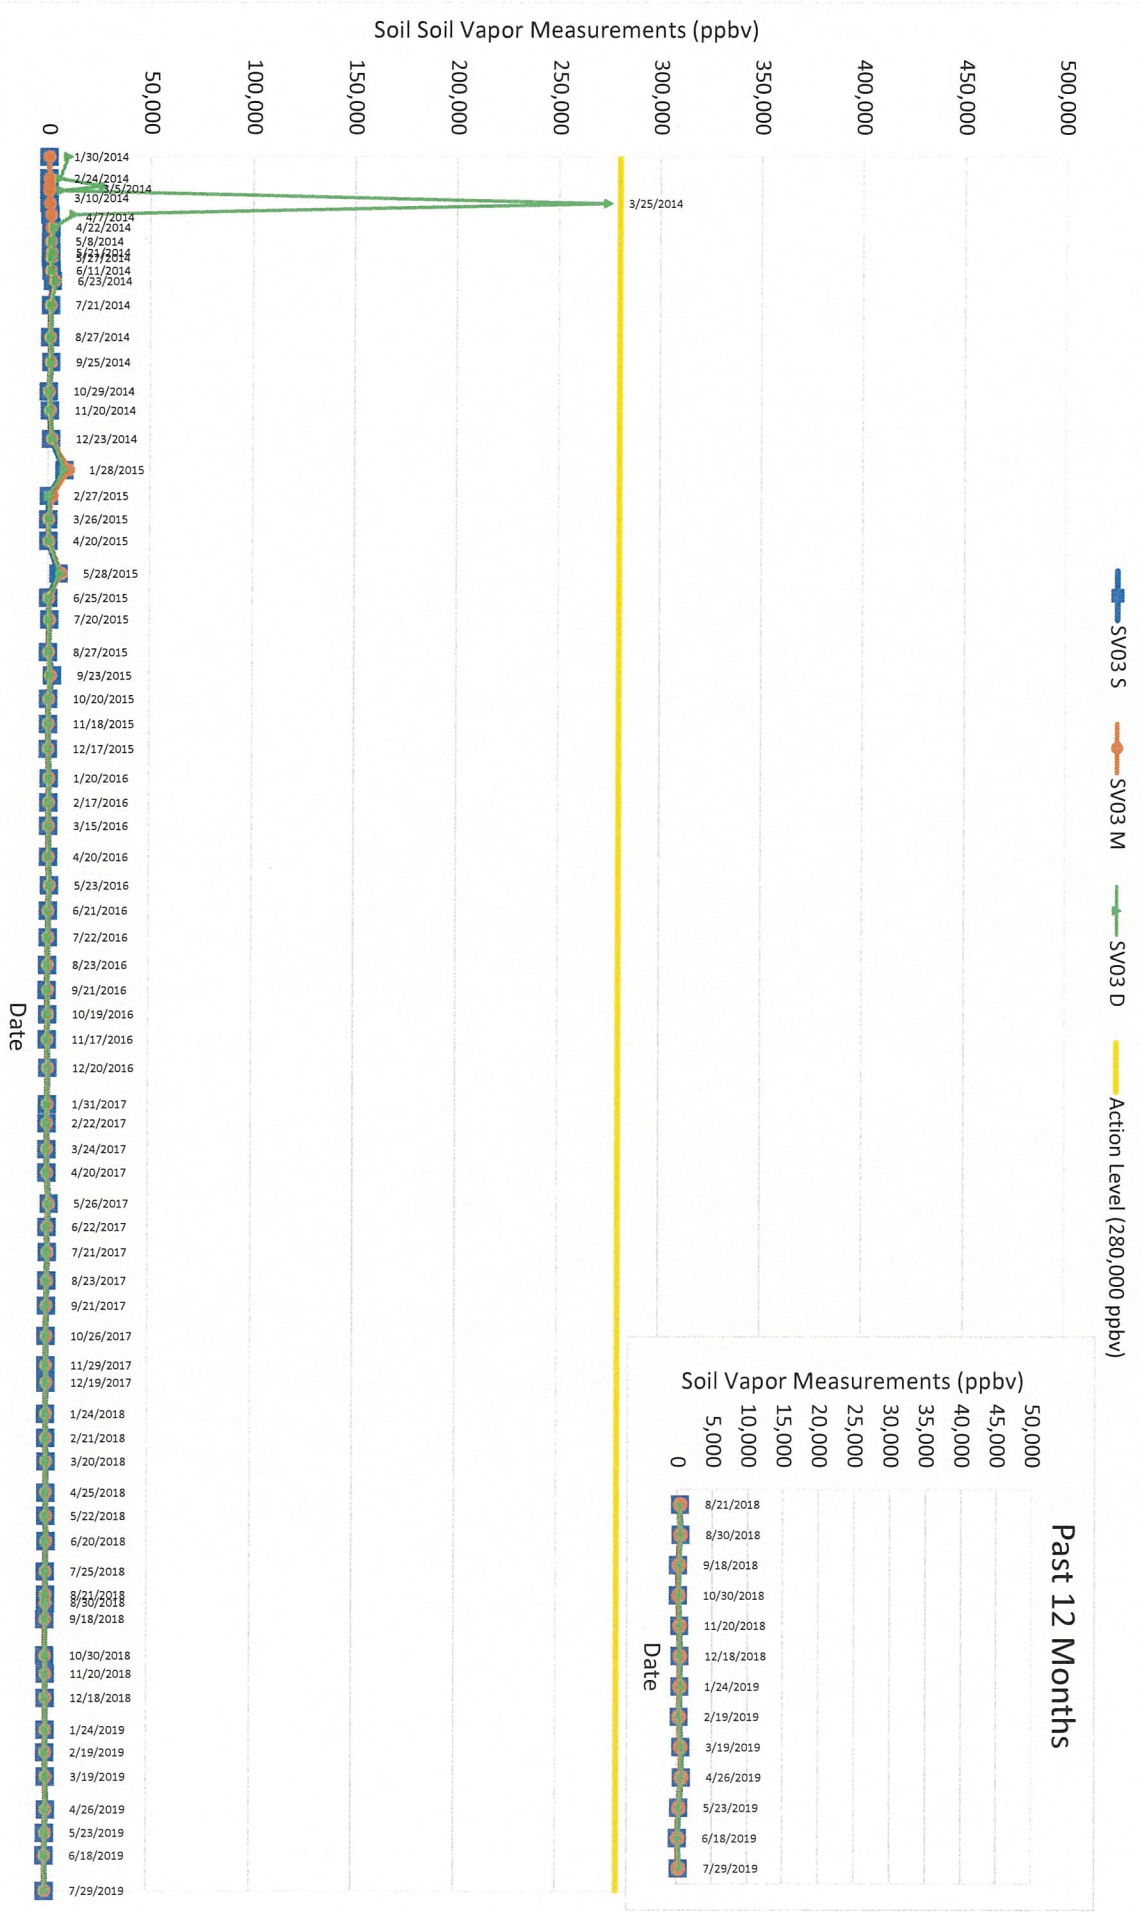
Figure 2
Soil Vapor Measurements - SV03 (F-24)

- Strong increase trends at tanks 5 and 6
- Slight increase trends at tanks 3

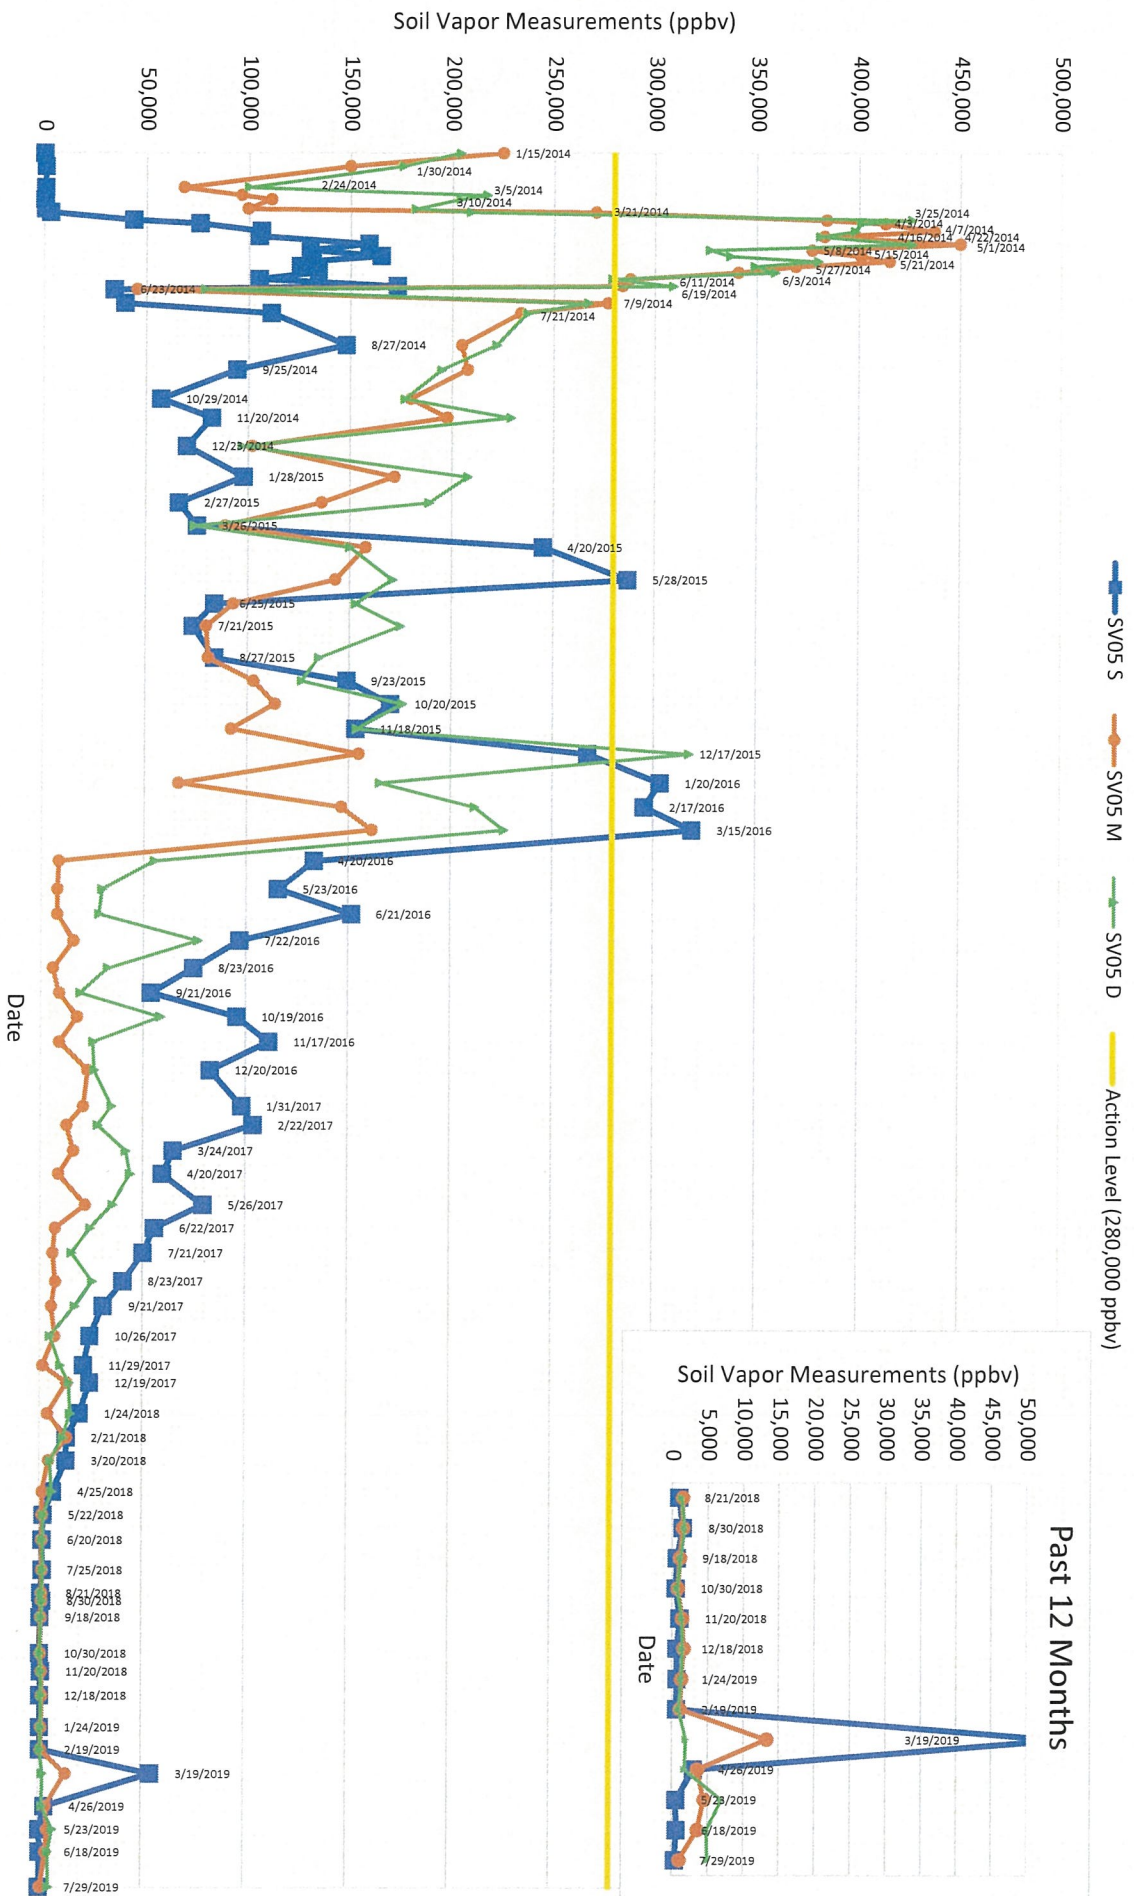
Figure 4
Soil Vapor Measurements - SV05 (F-24)

At Tank 5, the concentrations of VOCs detected in the front, middle, and outer edge soil vapor monitoring probes were 439 ppbv, 1,034 ppbv, and 4,978ppbv, respectively. Tank 5 was emptied in January 2014 and has not contained fuel since that time. VOC concentrations in all down-gradient soil vapor monitors were below 772 ppbv.
