**SUBJECT: RED HILL TANK COMPLEX**  
**SOIL VAPOR SAMPLING RESULTS FOR NOVEMBER 2019**  
**DOH FACILITY ID NO. 9-102271**  
**DOH RELEASE ID NO. 990051, 010011, 020028, AND 140010**

Subj: NAVSUP FLC PEARL HARBOR CAUSATIVE RESEARCH REPORT IRT RED HILL  
SOIL VAPOR MONITORING REPORT FOR NOVEMBER 2019

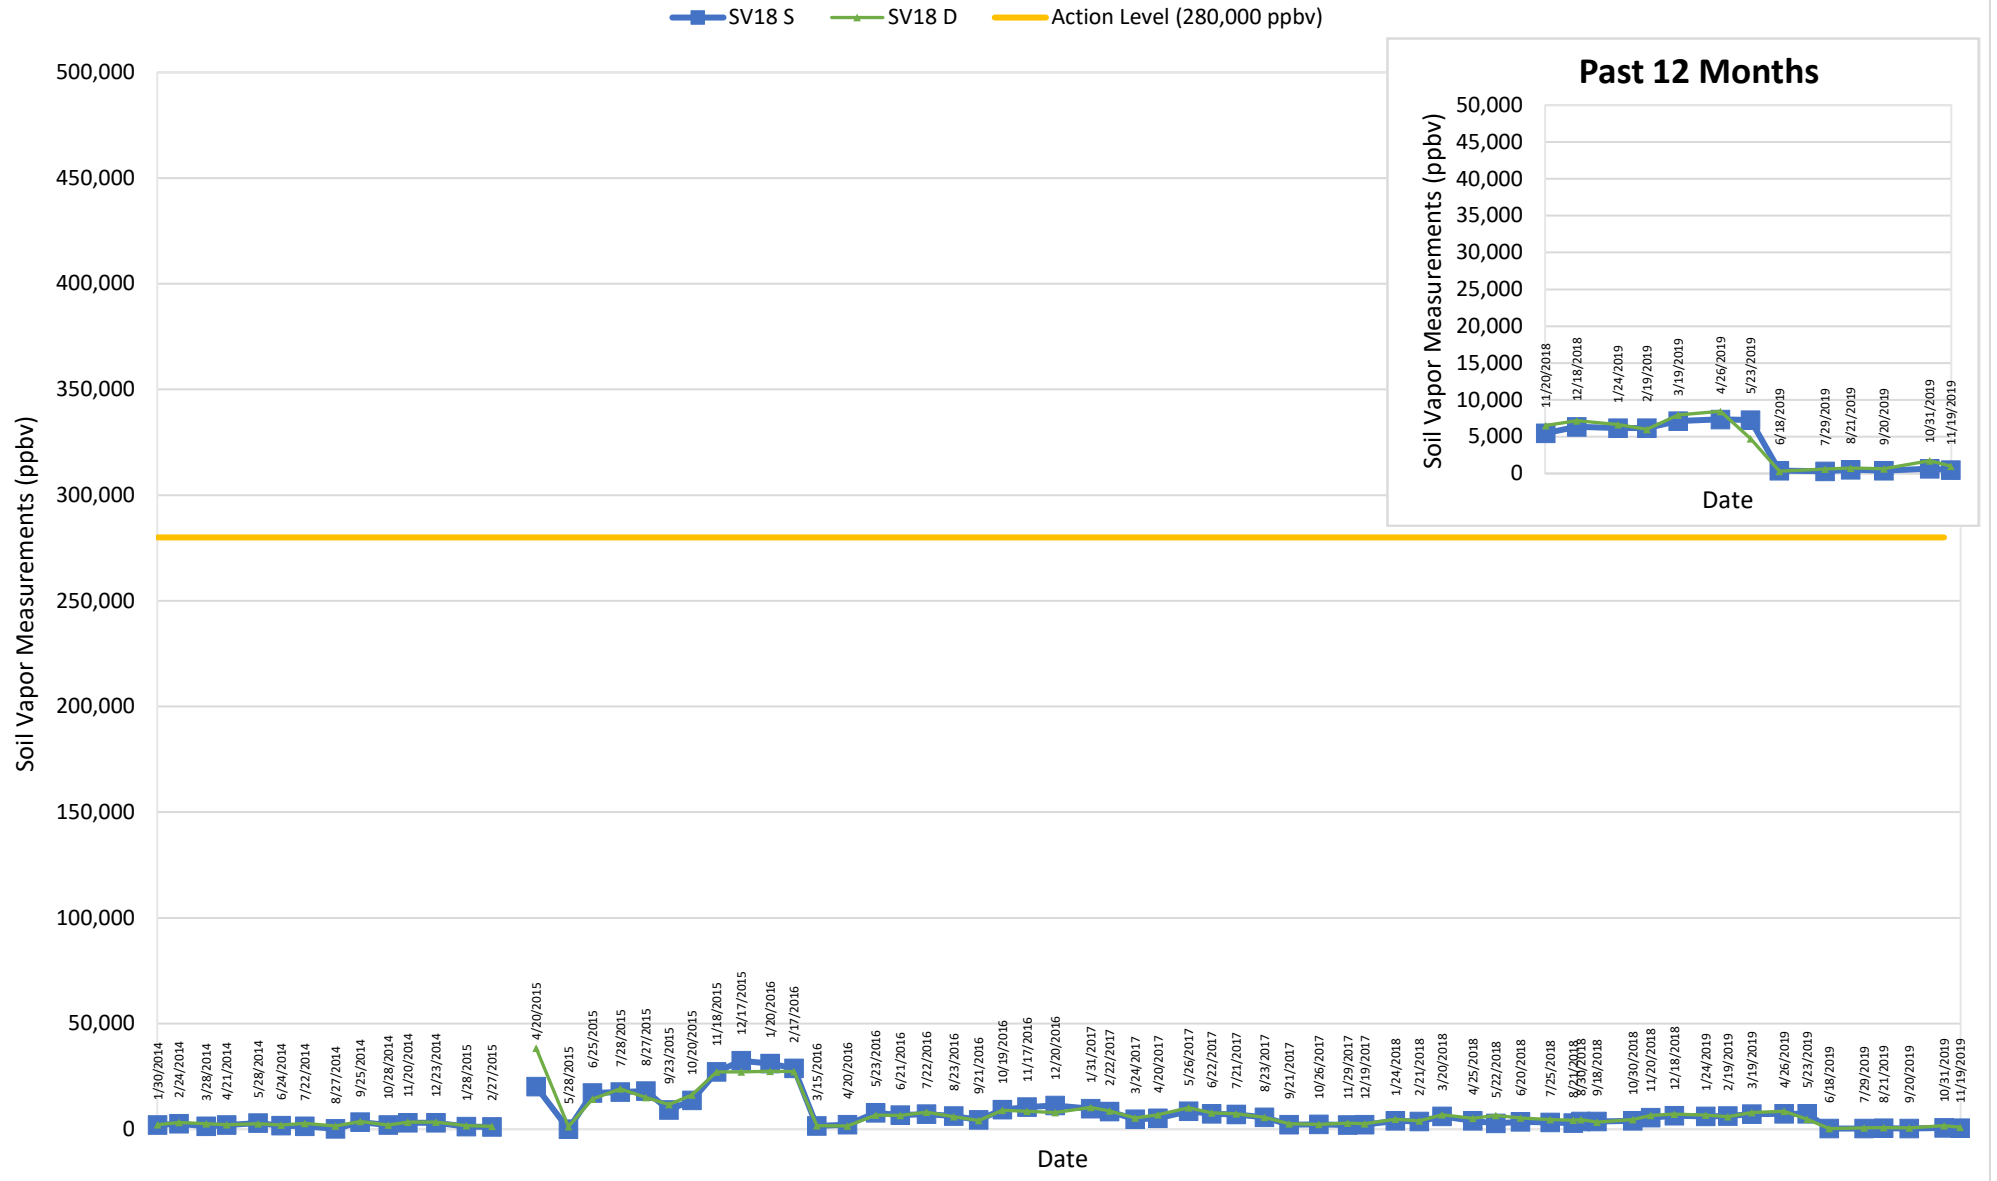
**Figure 17**  
**Soil Vapor Measurements - SV18 (JP-5)**

- Moderate increase at tank 18.
- Slight increase trends at tanks 4, 6, 7, 11-18, and 20.
