SUBJECT: 42nd ANNUAL PERFORMANCE MONITORING REPORT, REMEDIAL ACTION
AREA 1, HOTEL PIER SITE, NAVSUP FLEET LOGISTICS CENTER,
PEARL HARBOR NAVAL COMPLEX, HAWAII

**Annual Performance
Monitoring Report
Product Recovery System
Remedial Action Area 1 (RAA-1)**

(Hotel Pier Site)

**NAVSUP FLEET LOGISTICS CENTER
JOINT BASE PEARL HARBOR-HICKAM, OAHU,
HAWAII**

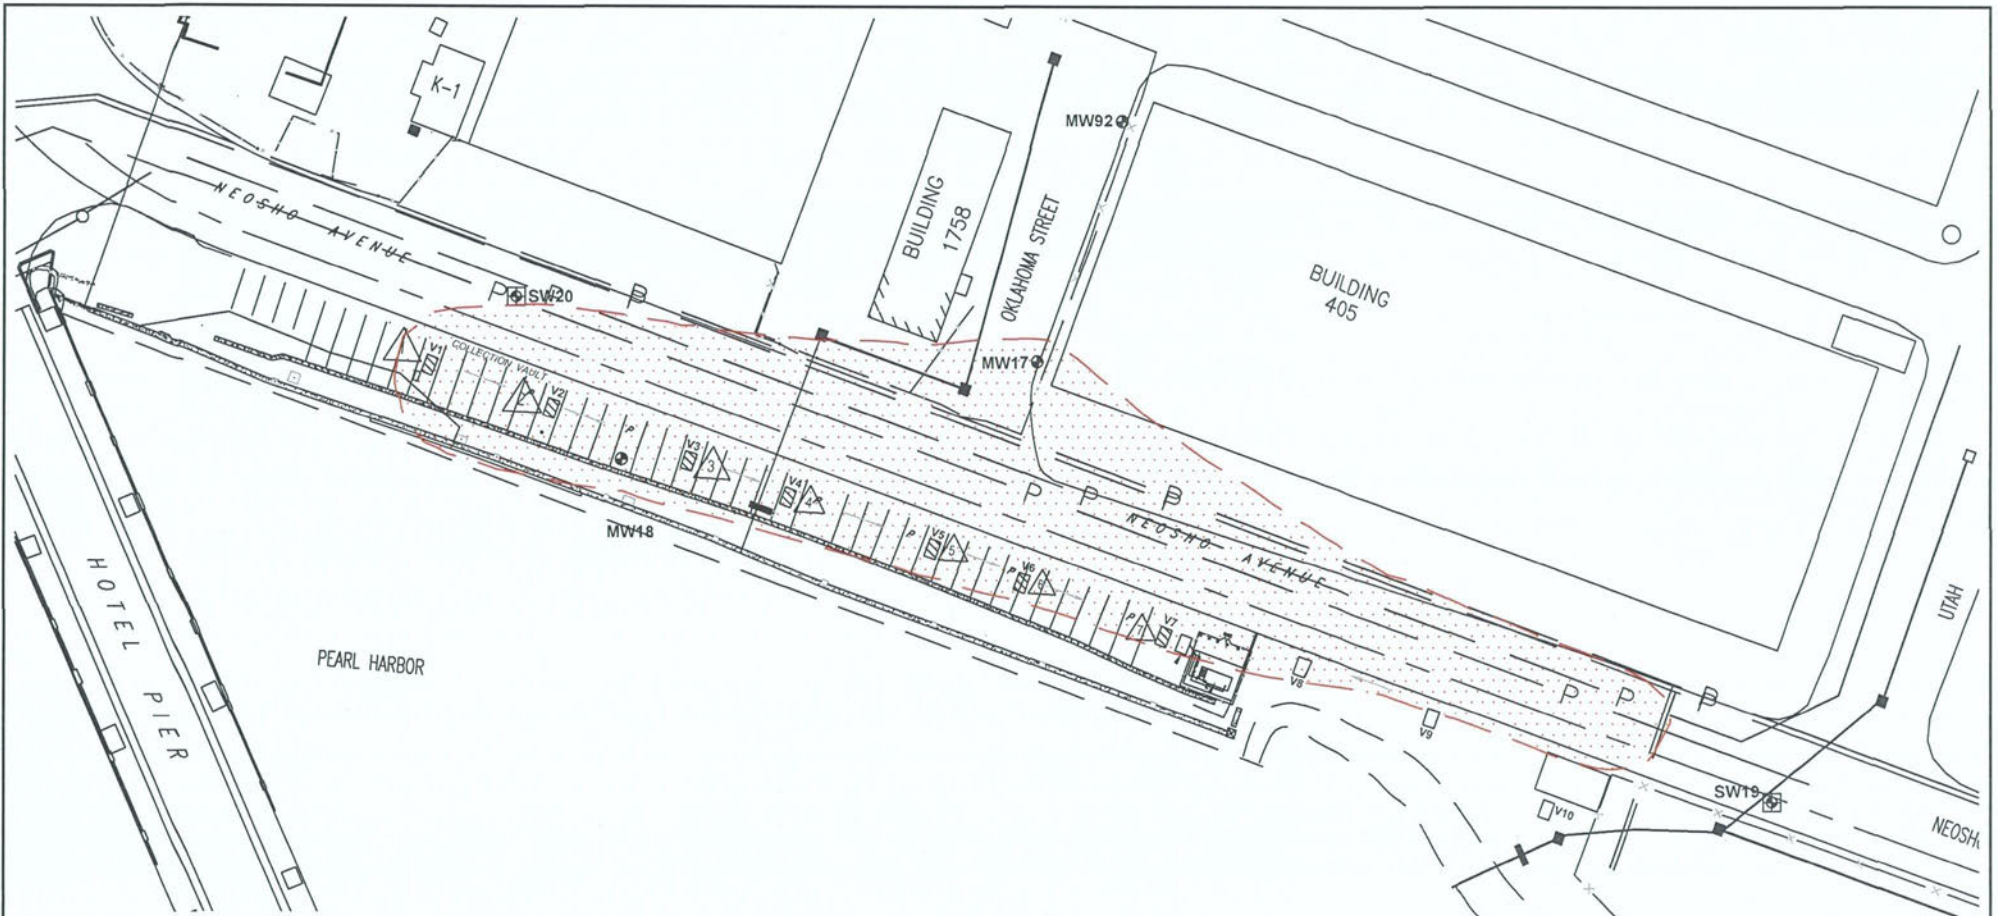
DATE: OCT 2015	PROJECT TITLE: ANNUAL PERFORMANCE MONITORING HOTEL PIER PRODUCT RECOVERY SYSTEM JBPHH, OAHU, HAWAII
	FIGURE TITLE: LIMIT OF FREE-PHASE PRODUCT PLUME - JANUARY 2001	FIGURE NO.: 2

Product thickness data collected on 1, 2 and 4 September 2015 is presented in Table 1 and the performance monitoring field sheet is included in Appendix B. Table 2 summarizes the product thicknesses at monitoring locations bound by the conditional *no further action* provided by HDOH. Figure 2 depicts the extent of the free-phase product plume delineated in January 2001, prior to the construction of the fuel oil extraction system (IT 2002). The estimated extent of the free-phase product plume remaining at RAA-1 in September 2015 (42nd event) is provided in Figure 3.

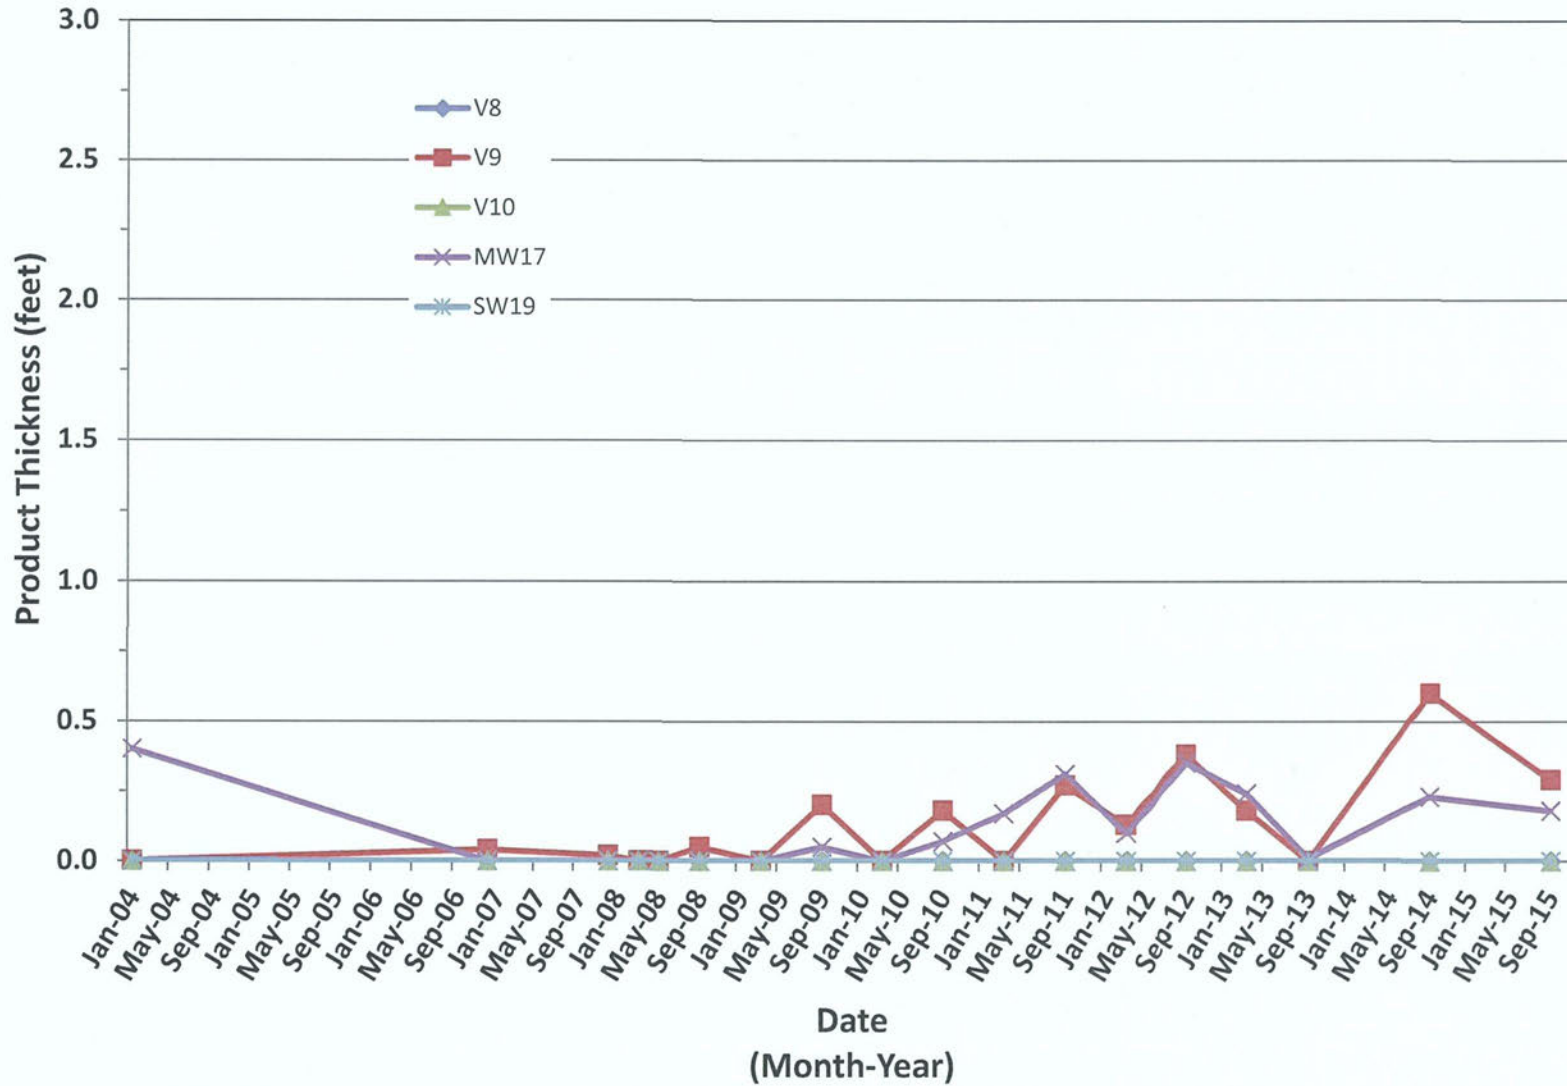
Figure 4
Historical Product Thickness
Hotel Pier RAA-1

Annual performance monitoring of five locations at RAA-1 (vault [V] 8, V9, V10, monitoring well [MW] 17, and microwell [SW] 19) was conducted during this event. The locations were monitored for product thickness during the lowest tide of the day. No product was observed, or has been observed at three locations (i.e. V8, V10 and SW19) over the past four consecutive monitoring events. The product thickness at location V9 was observed to have decreased from 0.60 feet to 0.29 feet since the last monitoring event. Additionally, the product thickness at MW17 was observed to have decreased from 0.23 feet to 0.18 feet since the last monitoring event. There has been no change of product thickness greater than 1 foot in any of the monitoring locations over the past four consecutive events. The largest degree of product thickness fluctuation observed since the monitoring program started in 2004 was observed during the previous (41st) monitoring event when product thickness in V9 increased from no measureable product (NMP) to 0.60 feet.
