Red Hill – Monitoring Well Fuel Product Gauging Photos

AECOM

01/12/2026 – 01/16/2026

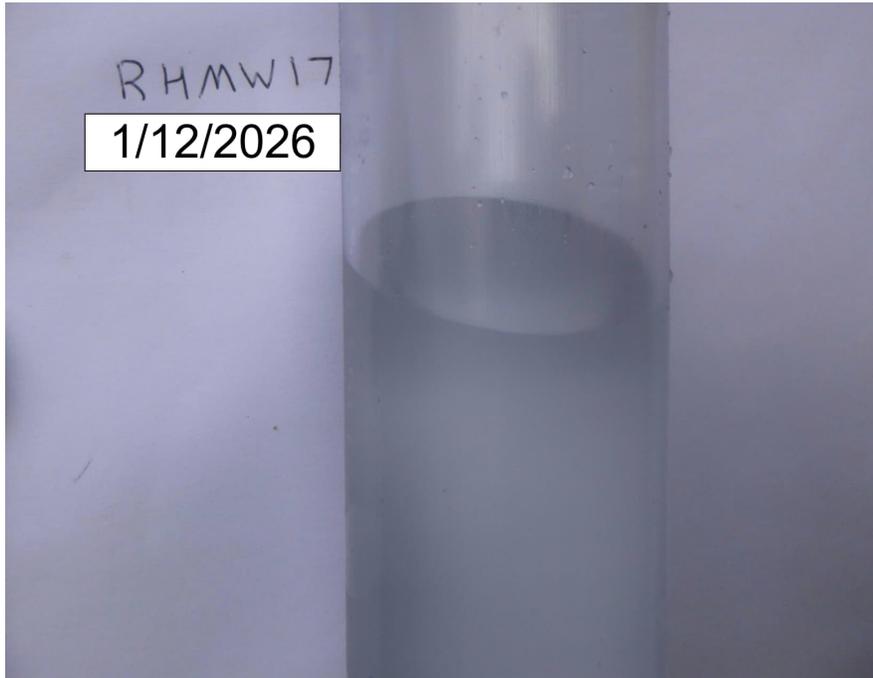
[P1050957.JPG] – RHMW17 – 01/12/2026 – 1132  
No fuel product observed. Water observed is clear in the bailer sample.

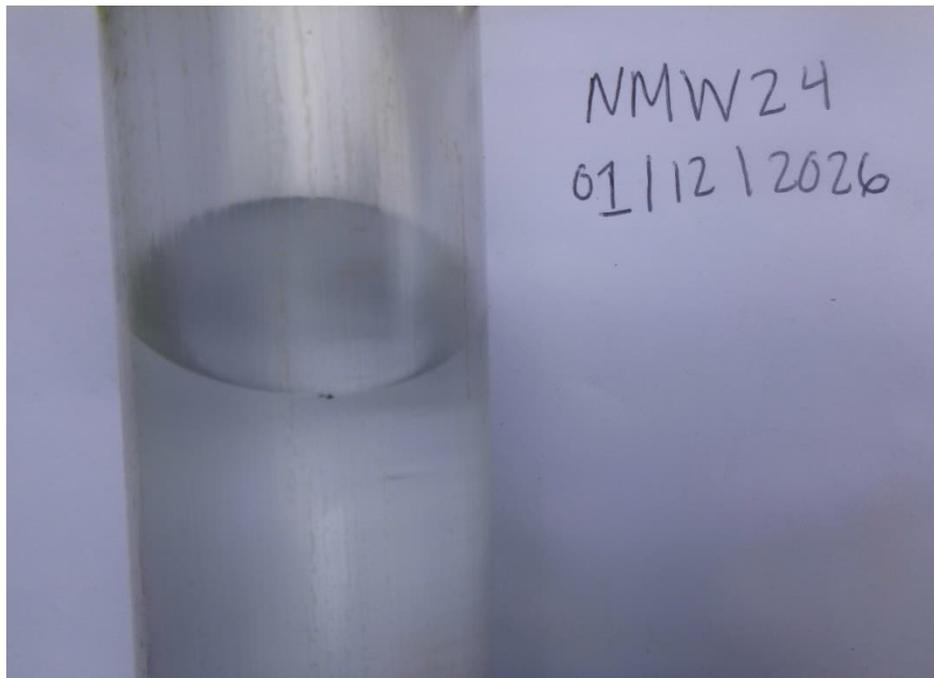
[P1030299.JPG] – NMW24 – 01/12/2026 – 0946  
No fuel product observed. Water observed is clear in the bailer sample.

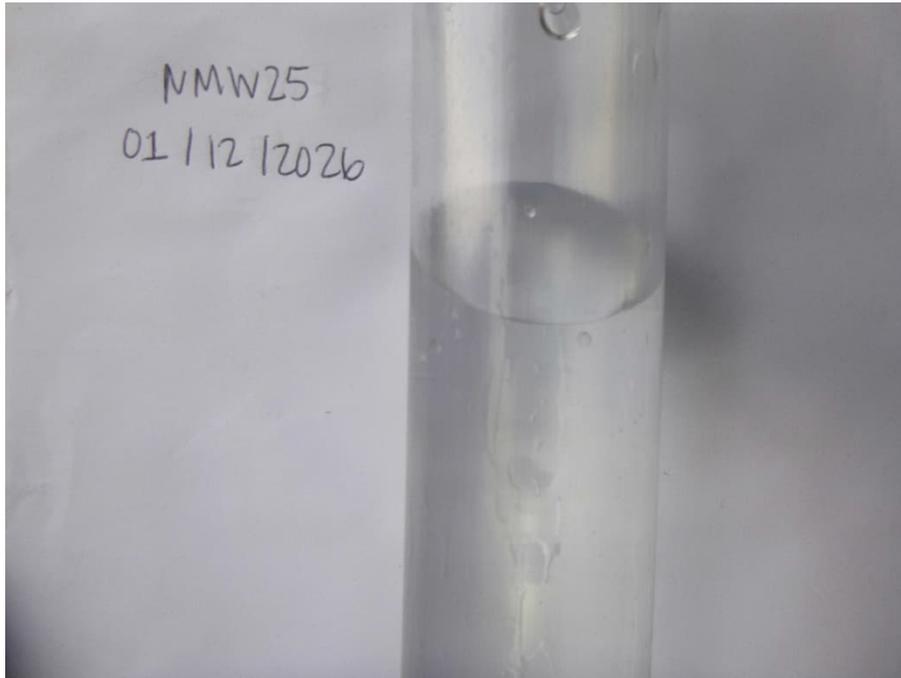
[P1030298.JPG] – NMW25 – 01/12/2026 – 0819  
No fuel product observed. Water observed is clear in the bailer sample.

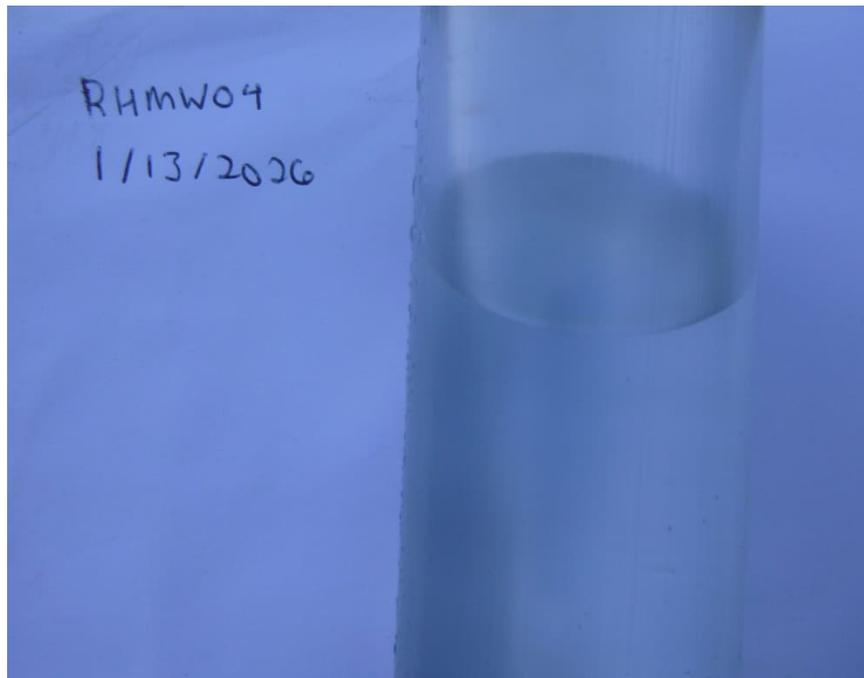
[P1050960.JPG] – RHMW04 – 01/13/2026 – 0838  
No fuel product observed. Water observed is clear in the bailer sample.

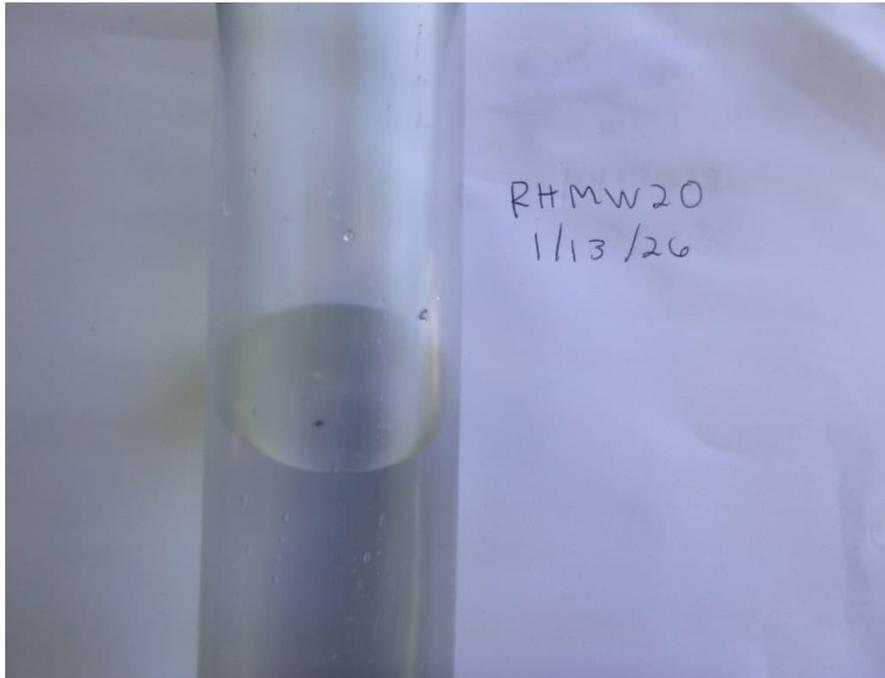
[P1030302.JPG] – RHMW20 – 01/13/2026 – 1105  
No fuel product observed. Water observed is clear in the bailer sample.

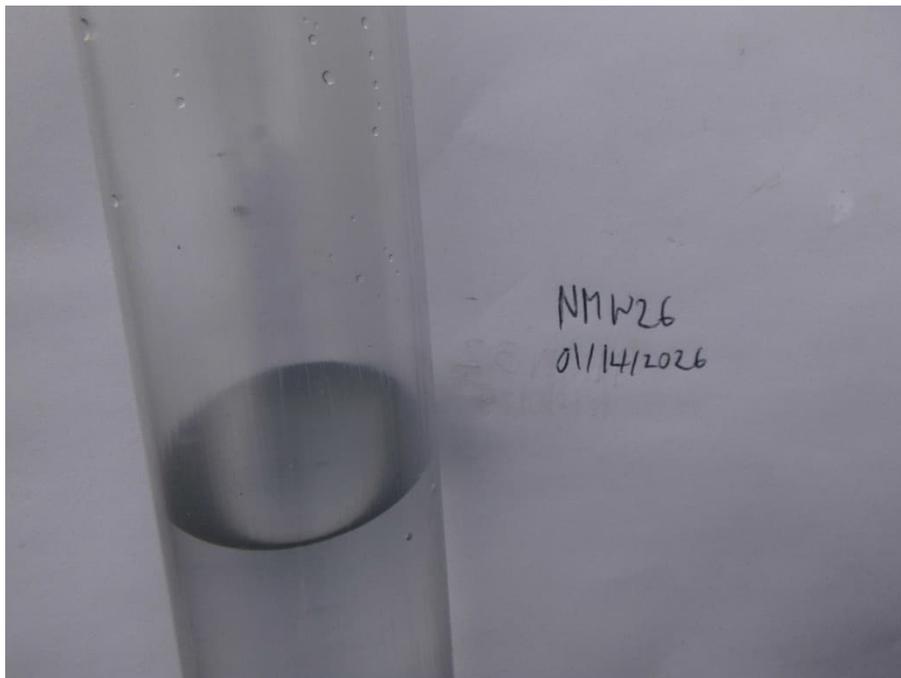
[P1050962.JPG] – NMW26 – 01/14/2026 – 0844  
No fuel product observed. Water observed is clear in the bailer sample.

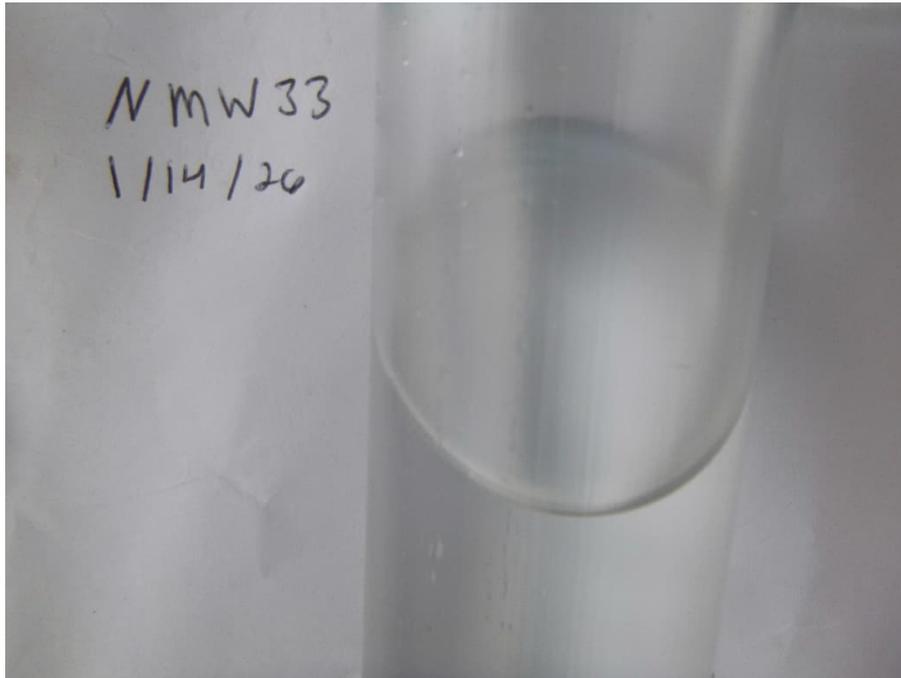
[P1030303.JPG] – NMW33 – 01/14/2026 – 0858

No fuel product observed. Water observed is clear in the bailer sample.

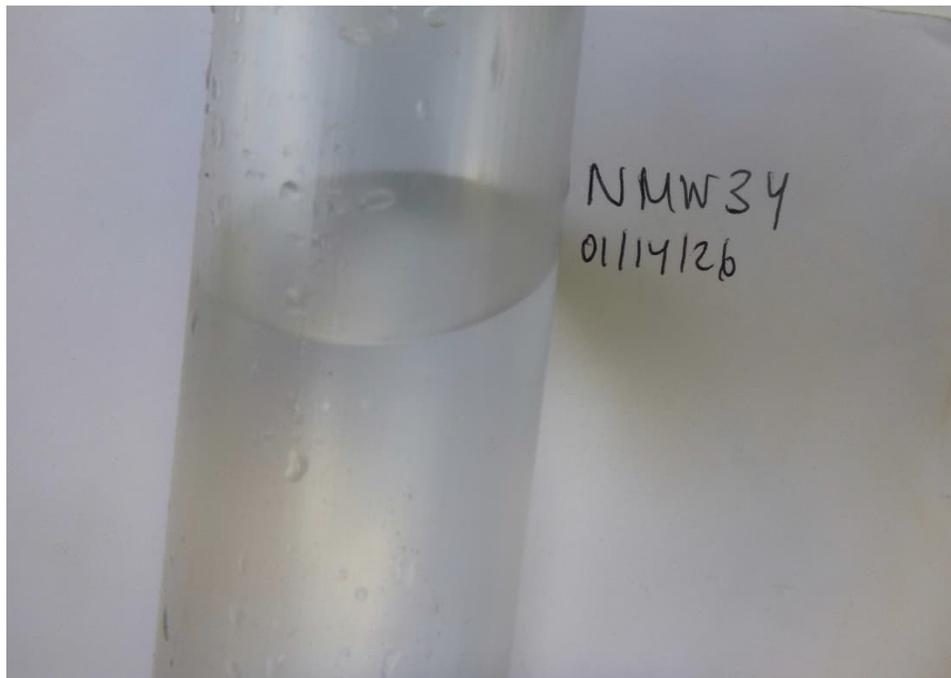
[P1030305.JPG] – NMW34 – 01/14/2026 – 1106

No fuel product observed. Water observed is clear in the bailer sample.

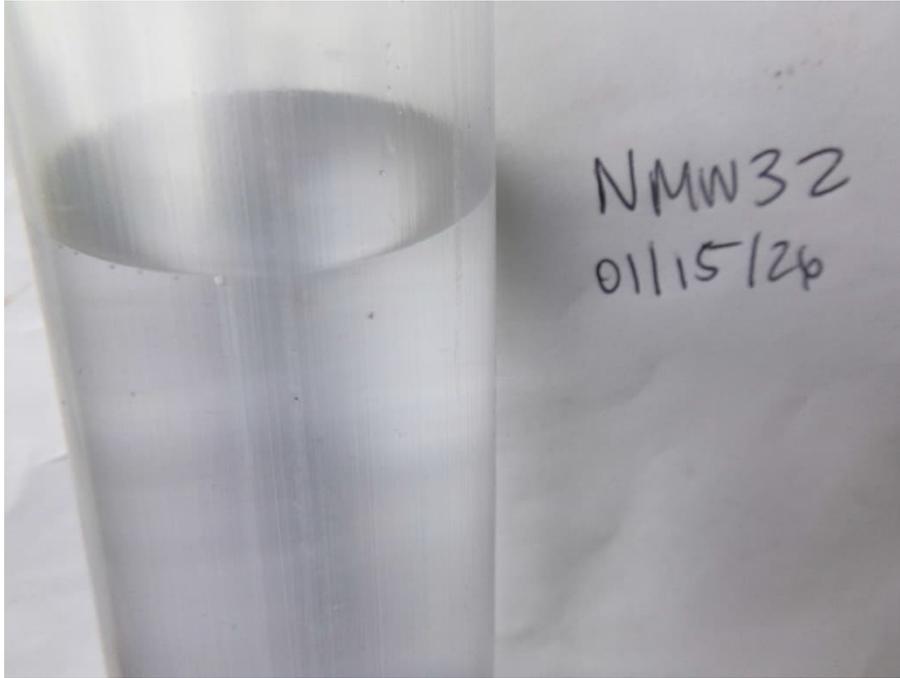
[P1030306.JPG] – NMW32 – 01/15/2026 – 0841  
No fuel product observed. Water observed is clear in the bailer sample.

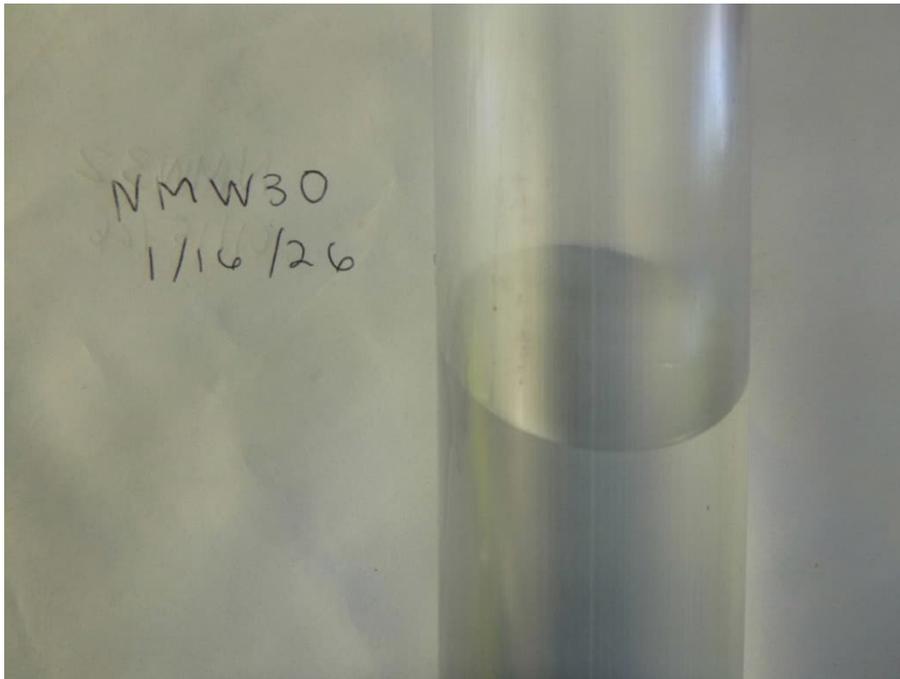
[P1030307.JPG] – NMW30 – 01/16/2026 – 0833  
No fuel product observed. Water observed is clear in the bailer sample.
