**Red Hill – Monitoring Well Fuel Production Gaugin Photos**

**AECOM**

**06/22/2026 – 06/26/2026**

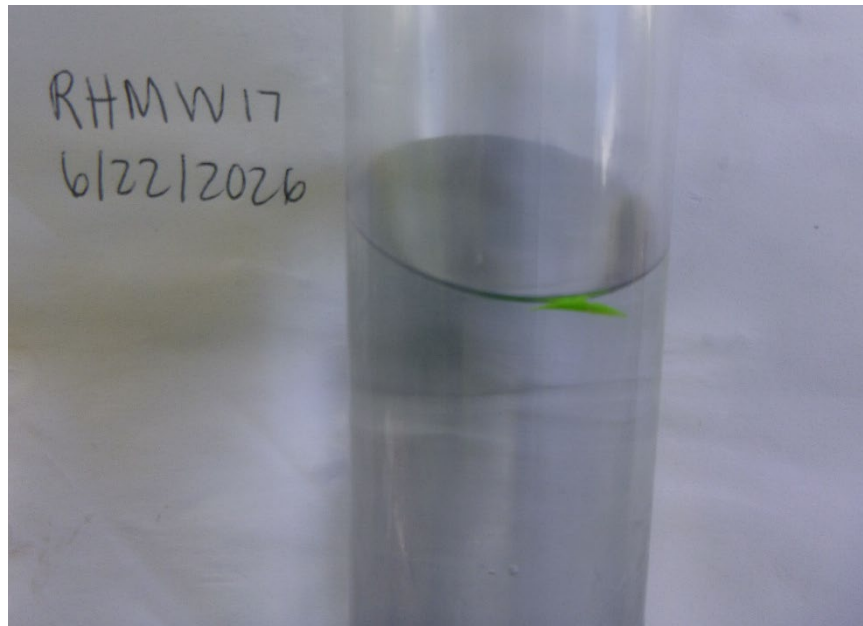
[P1060358.JPG] RHMW17 – 06/22/2026 – 1046

No fuel product observed. Water observed is clear in the bailer sample. Floating green debris at surface dislodged from bailer check ball seat.

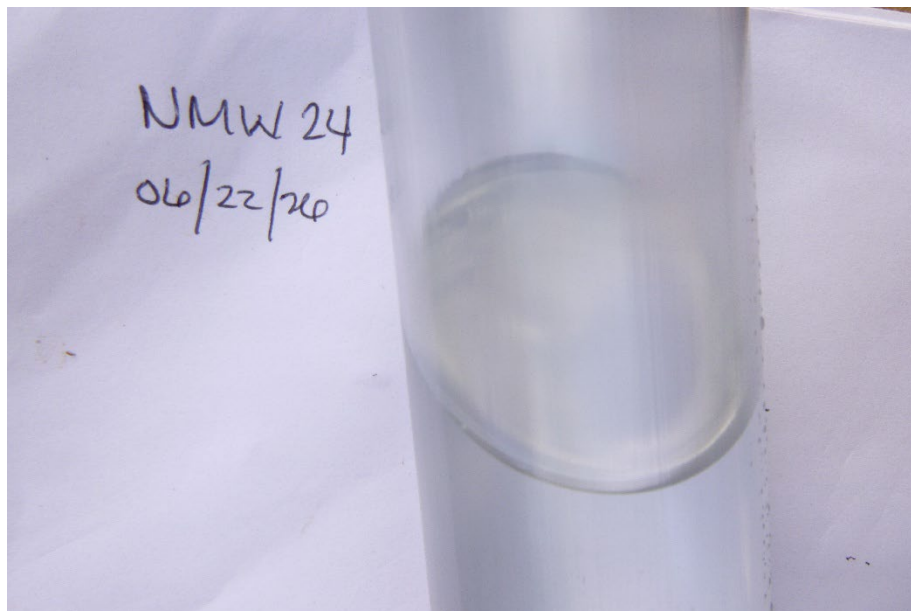
[P1030639.JPG] NMW24 – 06/22/2026 – 0747

No fuel product observed. Water observed is clear in the bailer sample.

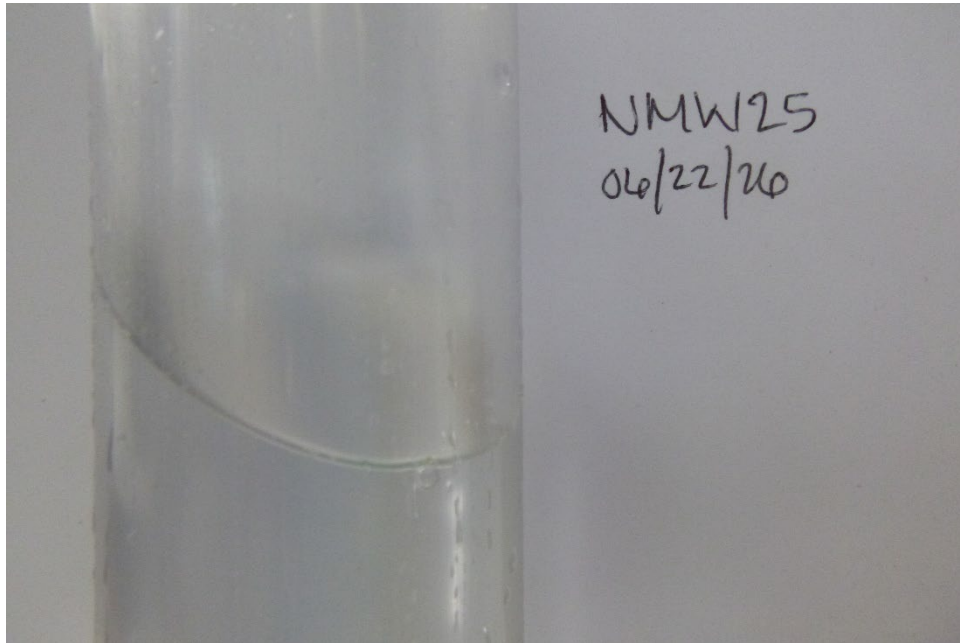
[P1030640.JPG] NMW25 – 06/22/2026 – 0859

No fuel product observed. Water observed is clear in the bailer sample.

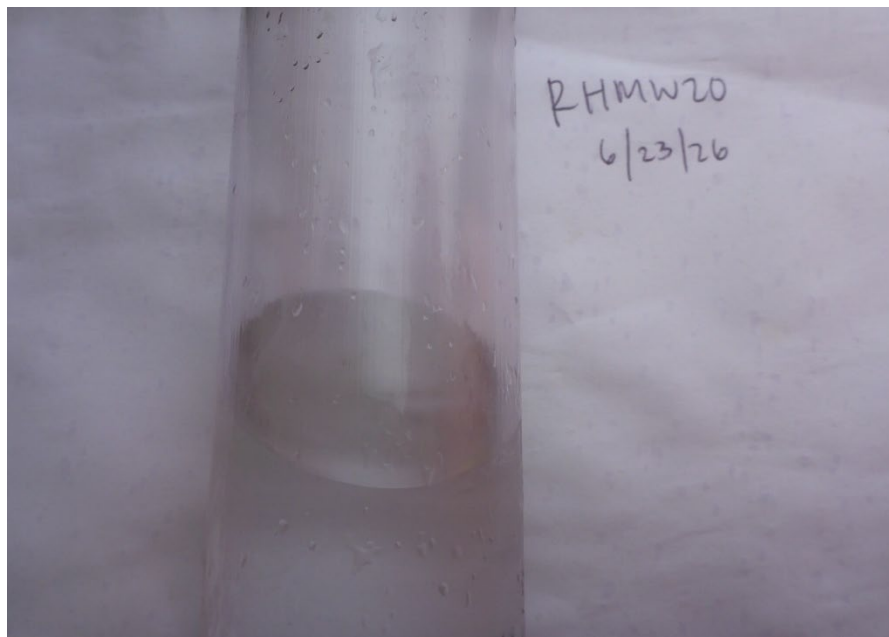
[P1240268.JPG] RHMW20 – 06/23/2026 – 1039

No fuel product observed. Water observed is clear in the bailer sample. Orange color on the bailer due to reflective PPE clothing.

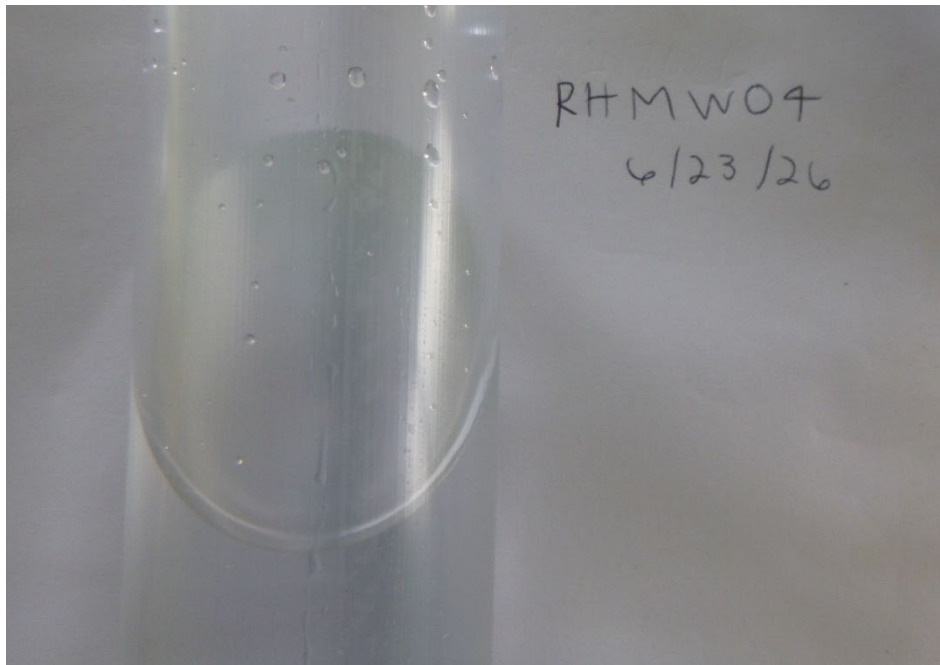
[P1060359.JPG] RHMW04 – 06/23/2026 – 0830

No fuel product observed. Water observed is clear in the bailer sample.

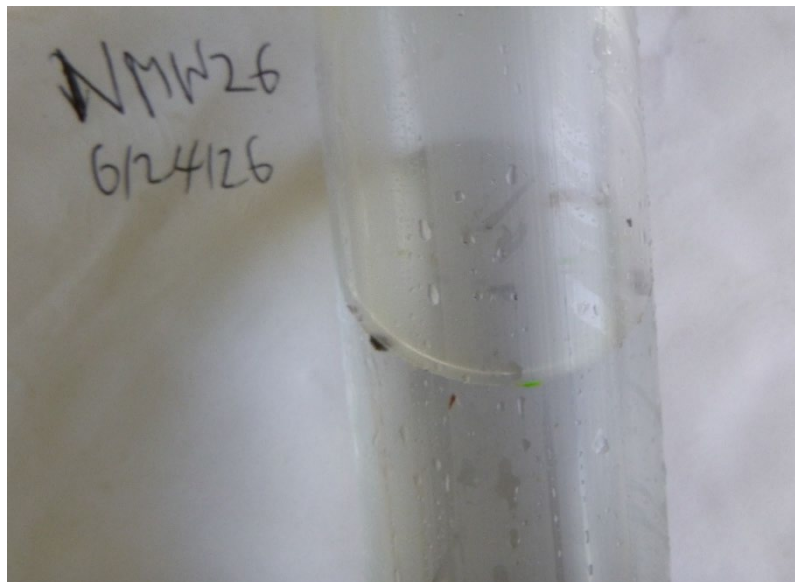
[P1030643.JPG] NMW26 – 06/24/2026 – 1012

No fuel product observed. Water observed is clear in the bailer sample. Small debris noted at surface.

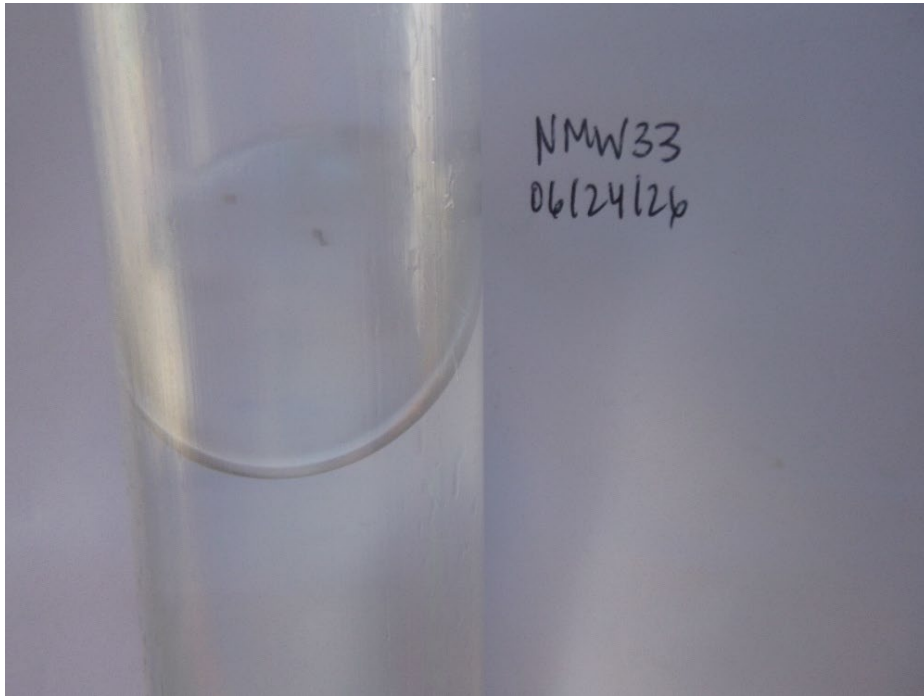
[P1060362.JPG] NMW33 – 06/24/2026 – 0804

No fuel product observed. Water observed is clear in the bailer sample.

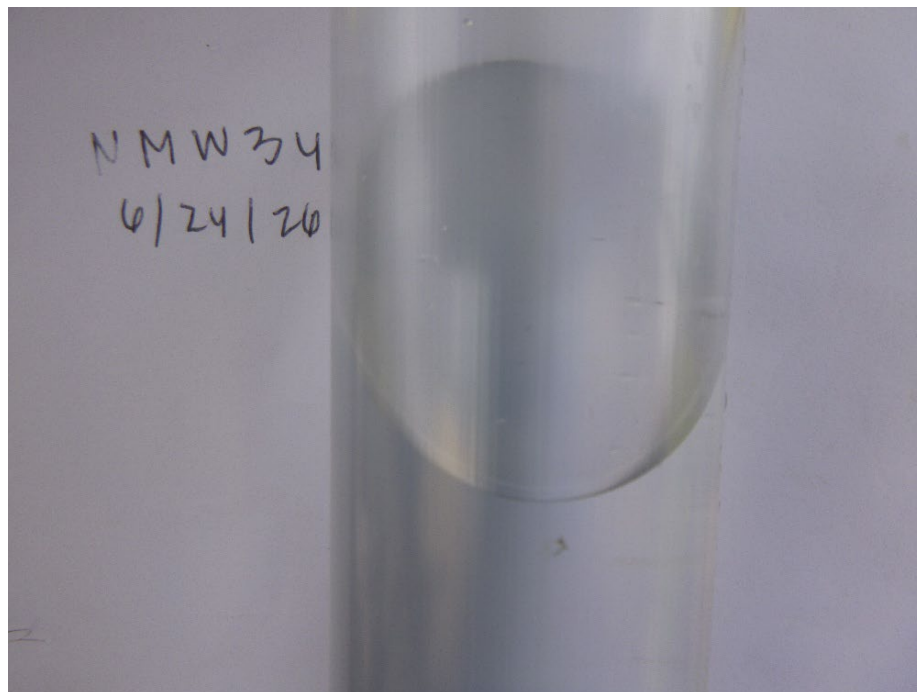
[P1060363.JPG] NMW34 – 06/24/2026 – 0956

No fuel product observed. Water observed is clear in the bailer sample.

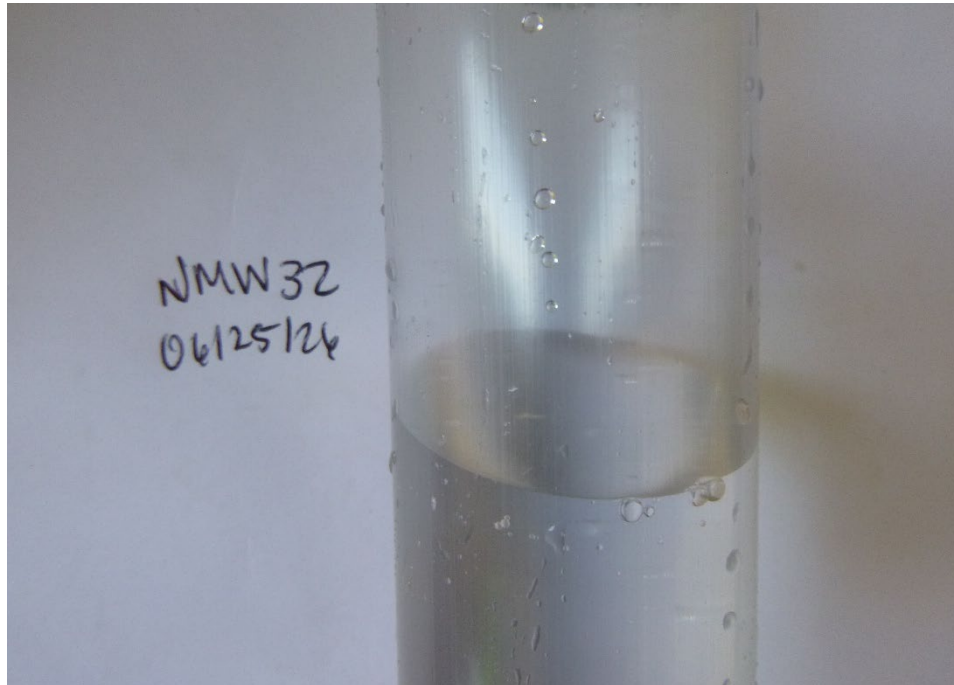
[P1030645.JPG] NMW32 – 06/25/2026 – 0751

No fuel product observed. Water observed is clear in the bailer sample. Orange/yellow color near the water surface due to reflective PPE clothing.

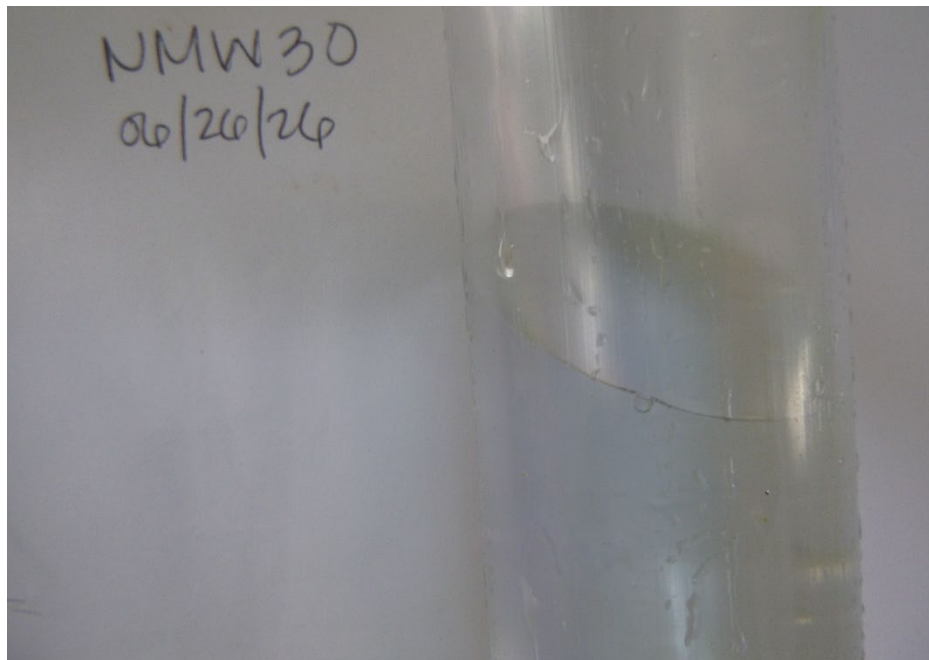
[P1060364.JPG] NMW30 – 06/26/2026 – 0752

No fuel product observed. Water observed is clear in the bailer sample.
