KAIAKA BAY
WATERSHED-BASED PLAN

APPENDIX A:
GEOMORPHIC ASSESSMENT OF
POAMOHO STREAM

Geomorphic Assessment of Poamoho Stream

**Kaiaka Bay Watershed-Based Plan
Oahu, Hawaii**

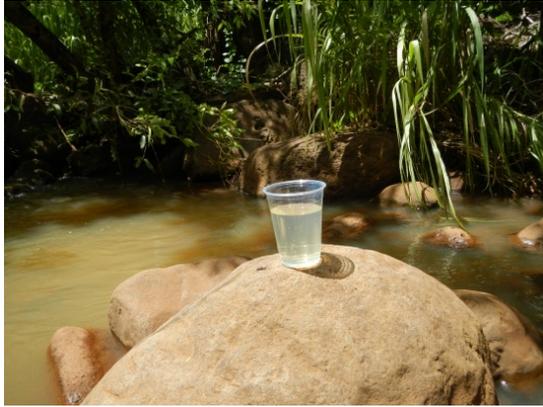
Day 1 – Lower Reach

Throughout the Day 1 field investigation the water color and clarity was found to be relatively consistent. The flow appears to be turbid, likely due to remnant suspended material from the earlier high flows.

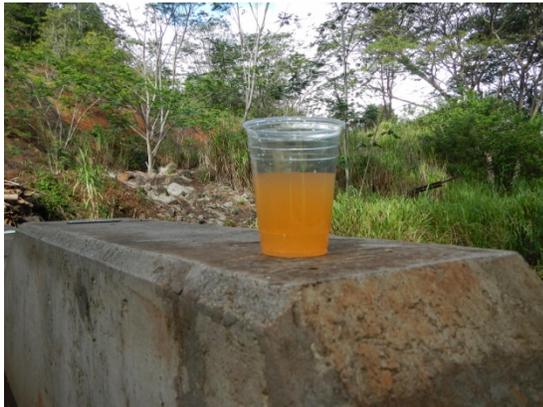
Day 2 – Near Dole Plantation

This sample is taken at the Striker Brigade crossing approximately 2,000-ft downstream of Kamehameha Highway crossing. The orange color suggests high suspended clay content. A visual inspection of the stream from the Kamehameha Highway bridge also found the flow to be orange.

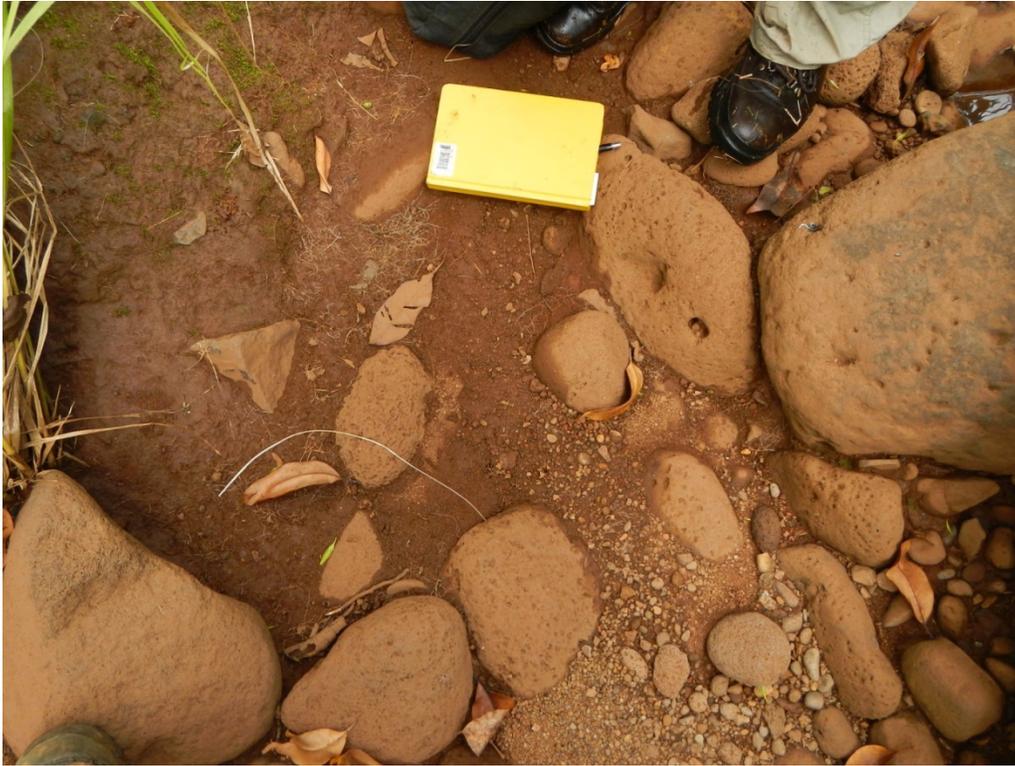
In portions of the stream channel protected from high flow velocities the accumulated sediment is much finer. The finer material in Photo 3-2 is covering the coarse material which means it was deposited on the falling limb of the flow hydrograph. Photo 3-3 illustrates the consistency of the bed material from Poamoho Stream in the reach near the Tanada Reservoir.

Photo 3-2 Fine Material Deposited in Protected Areas

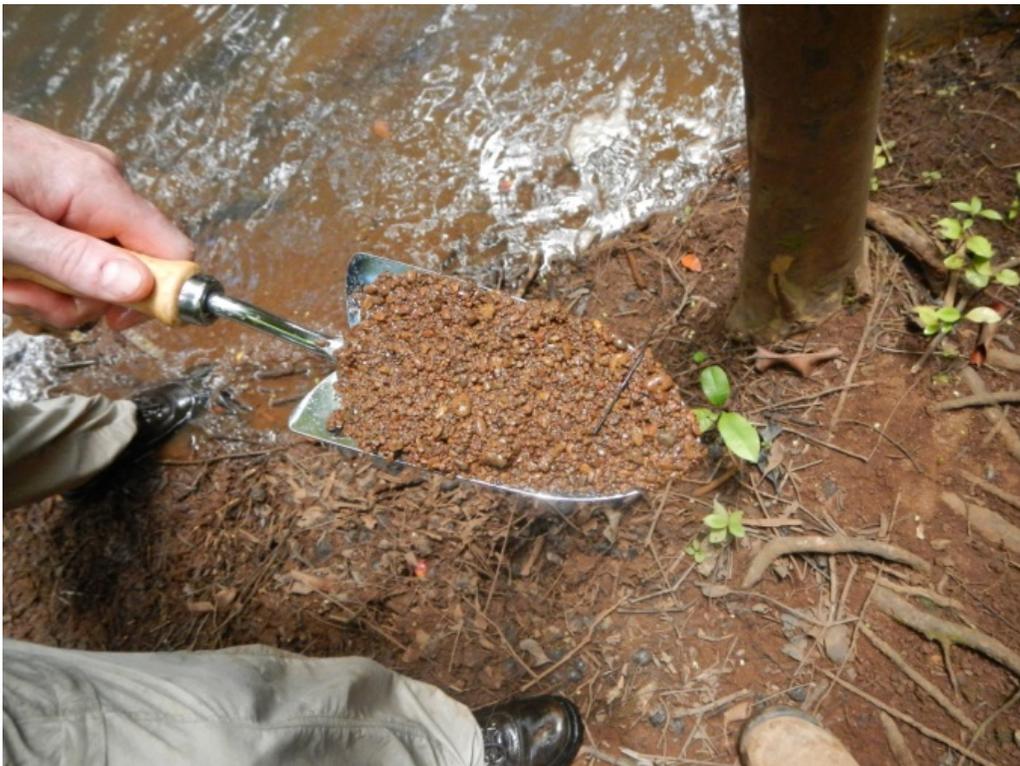
Photo 3-3 Granular Stream Bed Material in the Upper Poamoho Stream

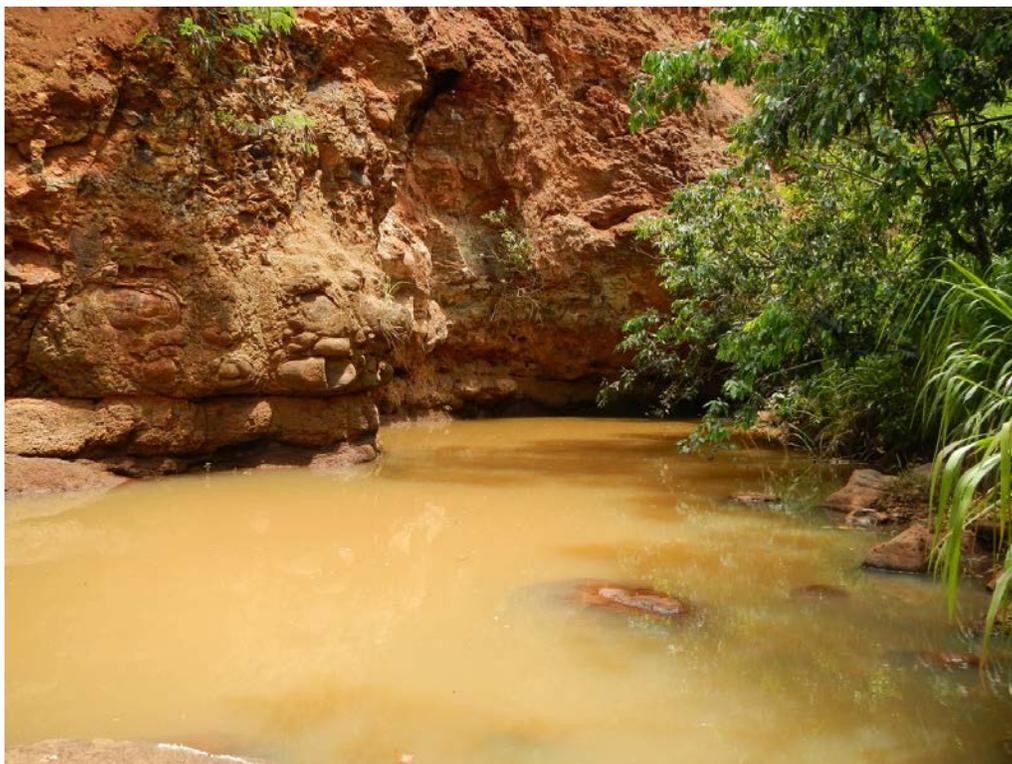
Throughout the field investigation multiple sites were found that provided local source material to the stream. These locations were all associated with near vertical slopes. As the desktop land slope revealed (Figure 2-8), the study area streams are confined in canyons with canyon walls of varying slopes. Photo 3-4 is a typical pool at the base of a vertical face.

Photo 3-4 Under-cutting of a Vertical Face on Poamoho Stream

Rock material from the exposed face in Photo 3-4 created the pool. The size of the material that fell into the stream at this location is too large to be transported by stream energy. As the pool creates a near zero velocity environment, suspended and transported loads will settle in the pool creating an aggradation area that has the potential to become higher than the adjacent floodplain. During future high flow events the increased stream bed elevation may cause a channel avulsion, creating a new stream alignment. The stream at the base of this vertical slope is typical of those found in the lower reach of Poamoho Stream.

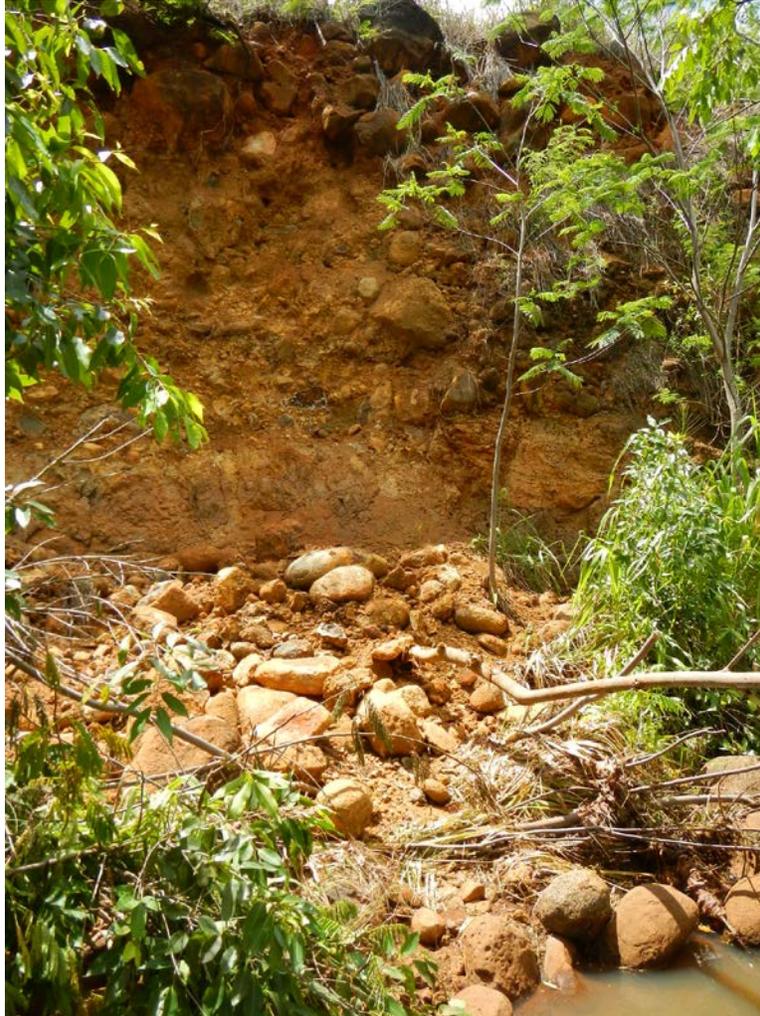
Smaller material released by slope failures also was observed to be entering the channel. The site shown in Photo 3-5 is an example of the recent small debris slide on banks of the stream. Future high flow events will transport this material through the lower reach of Poamoho Stream and discharge into the Kaiaka Bay.

Photo 3-5 Recent Slope Failure Adjacent to Poamoho Stream

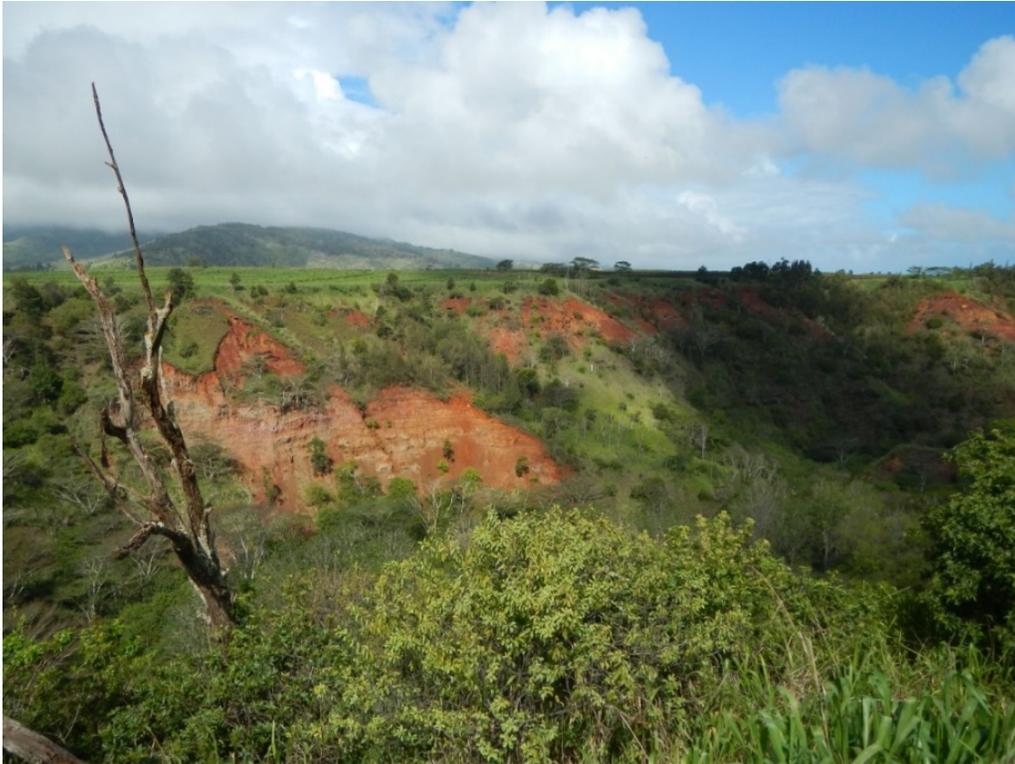
The Poamoho Stream canyon walls have multiple areas of recent slope movement. In many cases the volume of the material fills a portion of the valley floor with a portion entering the stream. The finer material is transported downstream while the larger material remains in place. The material that does not enter the stream comes to rest at a stable slope, as shown in Figure 2-8, and becomes vegetated with invasive grasses. The exposed surfaces in Photo 3-6 are from recent slides and grasses can be seen vegetating the debris slopes.

Photo 3-6 Evidence of Slope Failure on the Poamoho Canyon

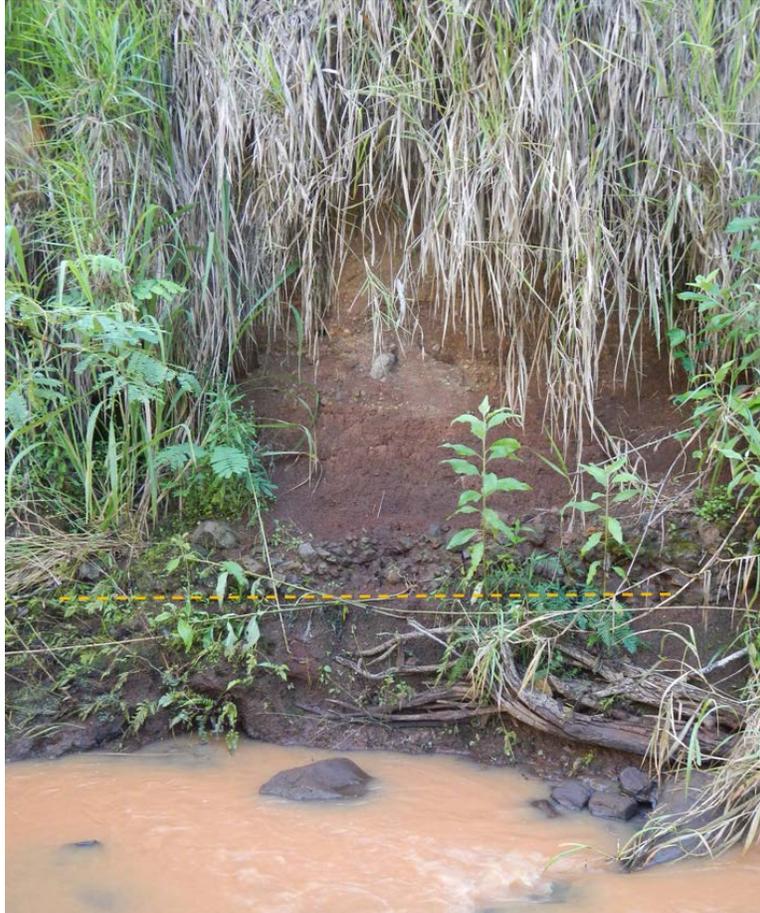
Exposed streambanks provide the opportunity to see historic fluvial geomorphic characteristics. The dotted line in Photo 3-7 illustrates a layer of gravel approximately 3-feet above the water surface. The gravel material is streambed deposits and marks a historic streambed elevation. As the Lane's Diagram (Figure 1-2) suggests, for the stream to drop the channel invert, there must have been changes related to some aspect of flow and/or sediment volume and size.

Photo 3-7 Evidence of Previous Streambed Elevation

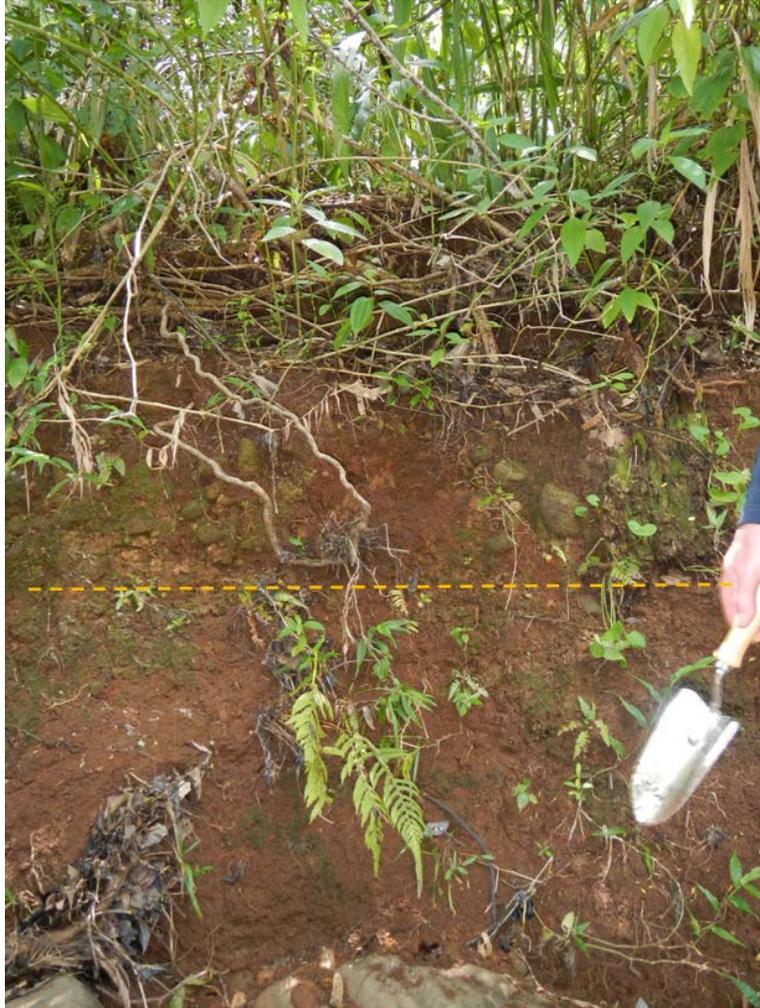
Similarly in the upper watershed, the exposed Poamoho stream bank reveals a layer of rocks that represents a historic deposition of stream bed materials. The rock layer in Photo 3-8 is likely a remnant of historic bed channel invert.

Photo 3-8 Upper Poamoho Watershed Historic Streambed

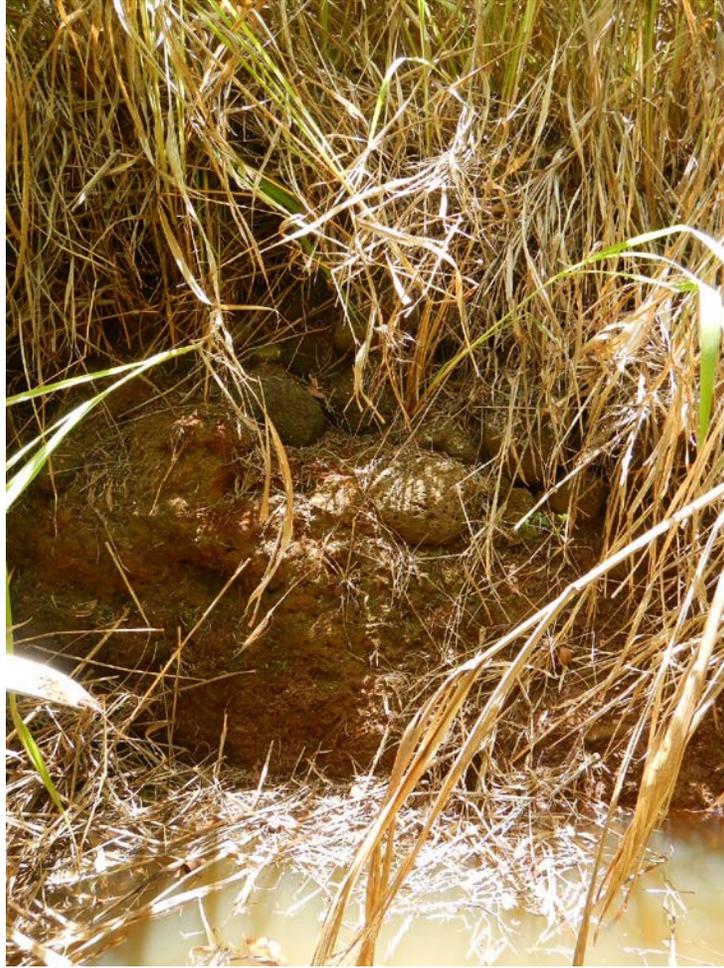
In Photo 3-9, the deposition of the larger material is indicative that the stream alignment has migrated across the partially confined canyon floor and that the bed elevation has lowered. The historic channel was located in the floodplain where fine sediment was deposited during high flow events. When the current channel alignment with lower elevations crossed the historic channel alignment, it exposed the historic remnant channel.

Photo 3-9 Evidence of Earlier Poamoho Streambed Elevations

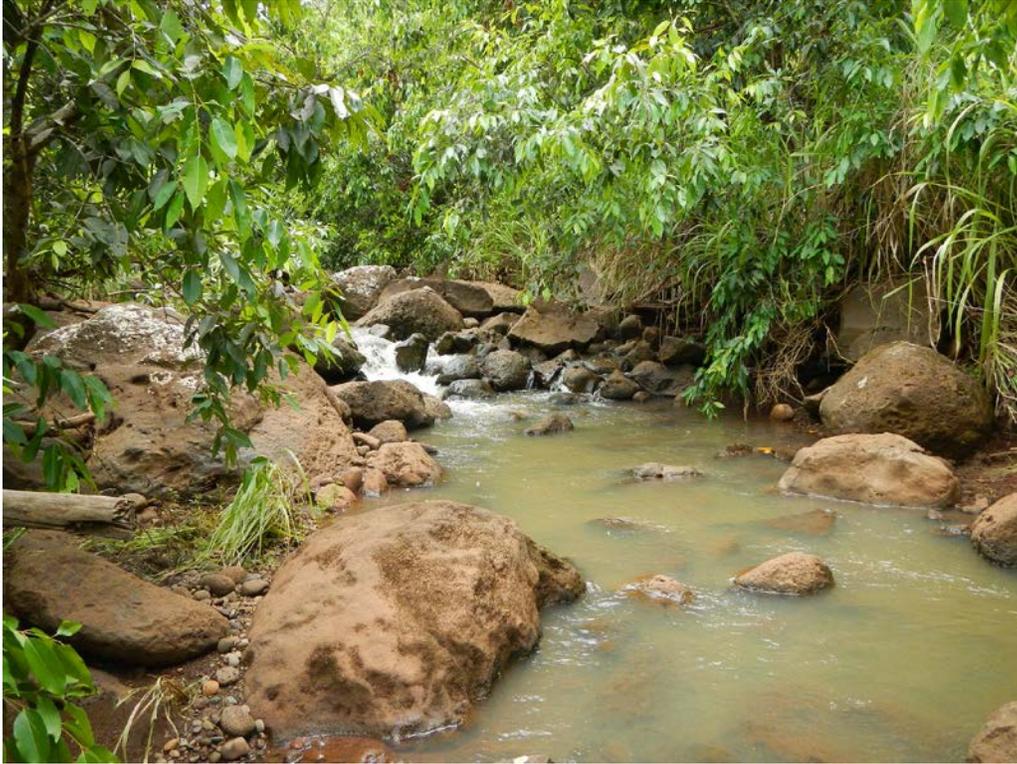
The upper reach of Poamoho Stream is classified as a Cascade channel. For this classification the channel is described as confined by valley walls and in direct contact with hillslopes. The channel slope provides for efficient transport of sand and gravel sized materials supplied from adjacent hillslopes. Boulders found in the stream channel are deposited from adjacent hillslopes with typical stream energy too low to transport. Photo 3-11 shows the Poamoho Stream within the confined portion of the watershed.

Photo 3-10 Step-Pool Channel Classification on Poamoho Stream

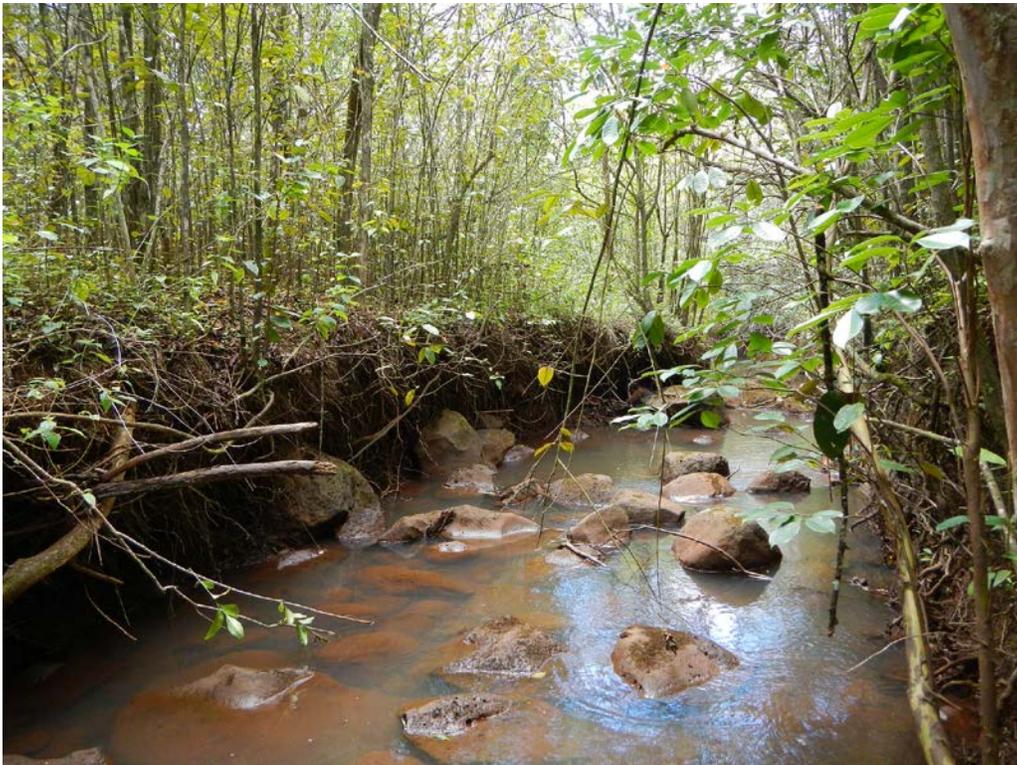
The boulders shown in the photo have been deposited from the adjacent slopes and have come to rest on the far side of the stream. The stream energy is configured to transport large volumes of sediment resulting from landslides. When there is not a source of sediment the stream energy is directed toward the channel bed and banks. The small drainage area in the upper watershed leads to low flows between storm events, limiting the overall sediment transport capacity of the stream.

Photo 3-11 Upper Poamoho Stream Channel

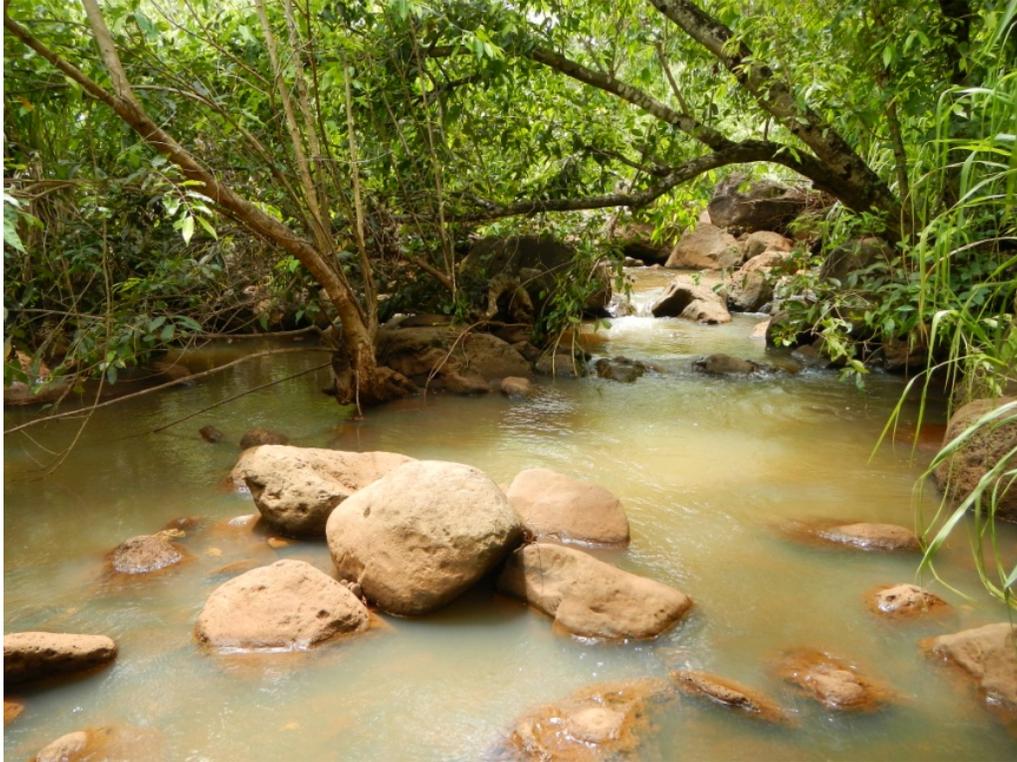
In the partially confined channel lower reach, geomorphic features suggesting the natural dynamic of Poamoho Stream were identified. Photo 3-12 shows a section of the stream with multiple channels. In many locations in the lower reach, gravel bars had become stabilized with vegetation creating multiple channels. Multiple channels mean flow conditions can provide additional, temporary storage of transported sediment.

Photo 3-12 Split Flow Conditions and a Vegetated Gravel Bar in Lower Poamoho Stream

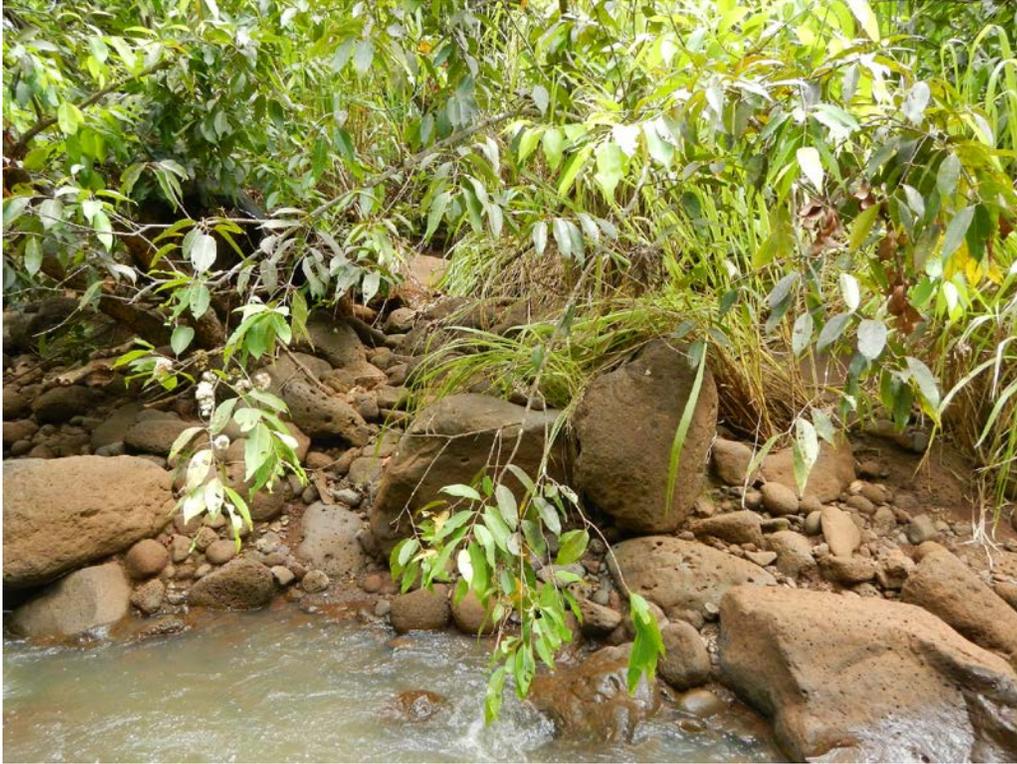
Multiple side channels were found on the canyon floor. The typical side channel was less than 10-feet wide with larger bed material. Photo 3-13 shows the exposed flow path of a side channel entering Poamoho Stream. Because of the dense guinea grass, many of the channels were only identified at the bifurcation or confluence points.

Photo 3-13 Evidence of Side Channels along Lower Poamoho Stream

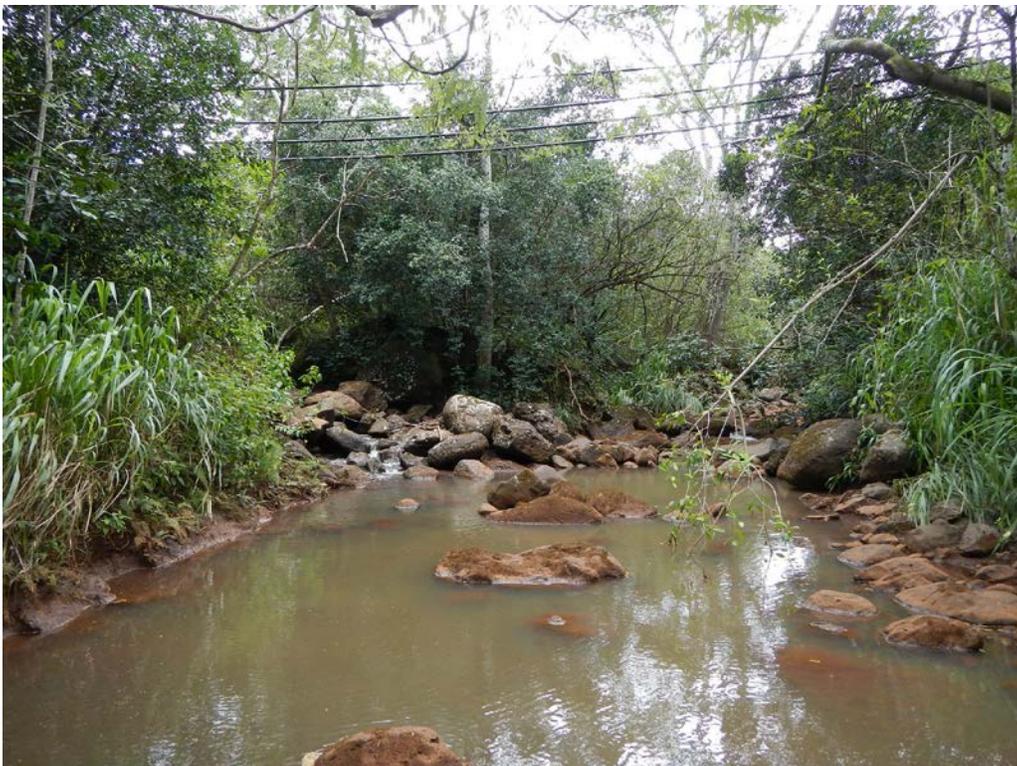
The dynamic geomorphic conditions at stream confluences are shown in Photo 3-14. Upstream of the confluence the stream channel contains large boulders. After the confluence the stream bed has fewer boulders and the stream banks are composed of finer material.

Photo 3-14 A Confluence on the Poamoho Stream

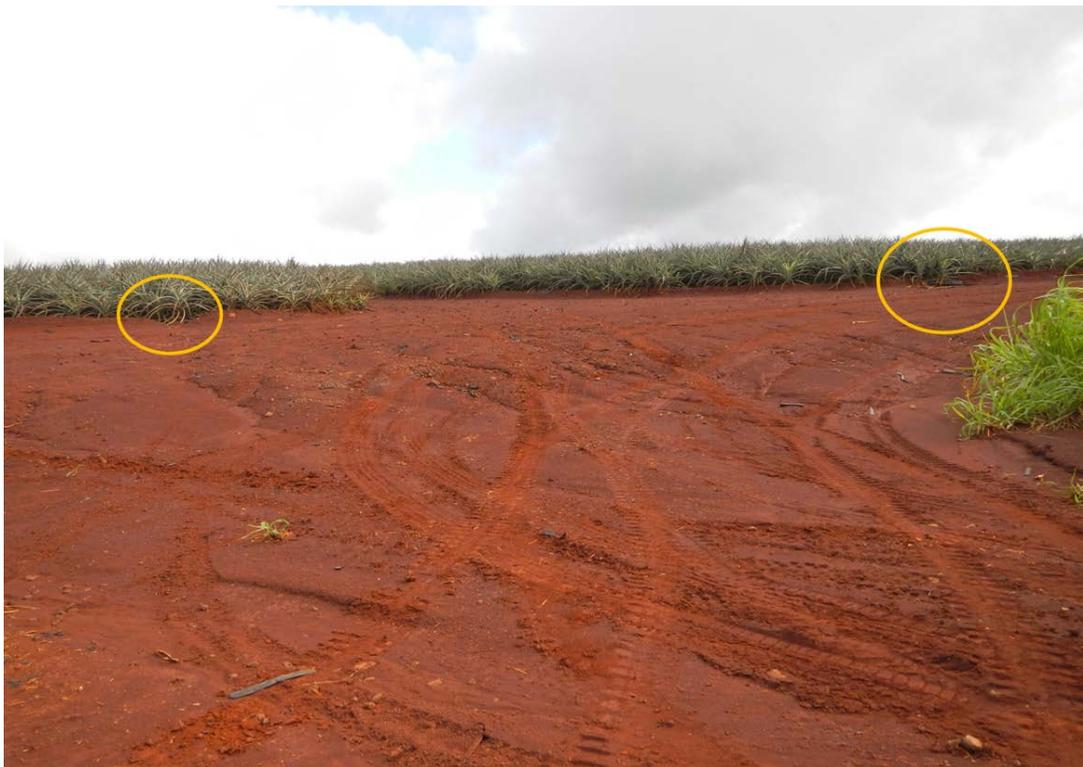
On August 23rd, the week prior to the site visit, the Dole Pineapple field received over 2.6-inches of precipitation over a 6-hour period. Photo 3-15 shows accumulated sediment that washed off one of the pineapple fields as well as surface erosion channel developing in the hardened driving surface. For this to occur, the intensity of the rainfall likely was greater than the infiltration rate of the soil, allowing for surface runoff. As shown in Table 2-4, the saturated infiltration rate for the Wahiawa silty clay is 1-inch per hour.

Agricultural practices for pineapple include constructing earthen barriers around crops. These are intended to keep sediment from leaving the planted areas. The circled areas in Photo 3-15 highlight barrier breaches that allowed for sediment to leave the row crop areas and potentially reach the stream below.

Photo 3-15 Sediment near the Rim of the Poamoho Stream Canyon

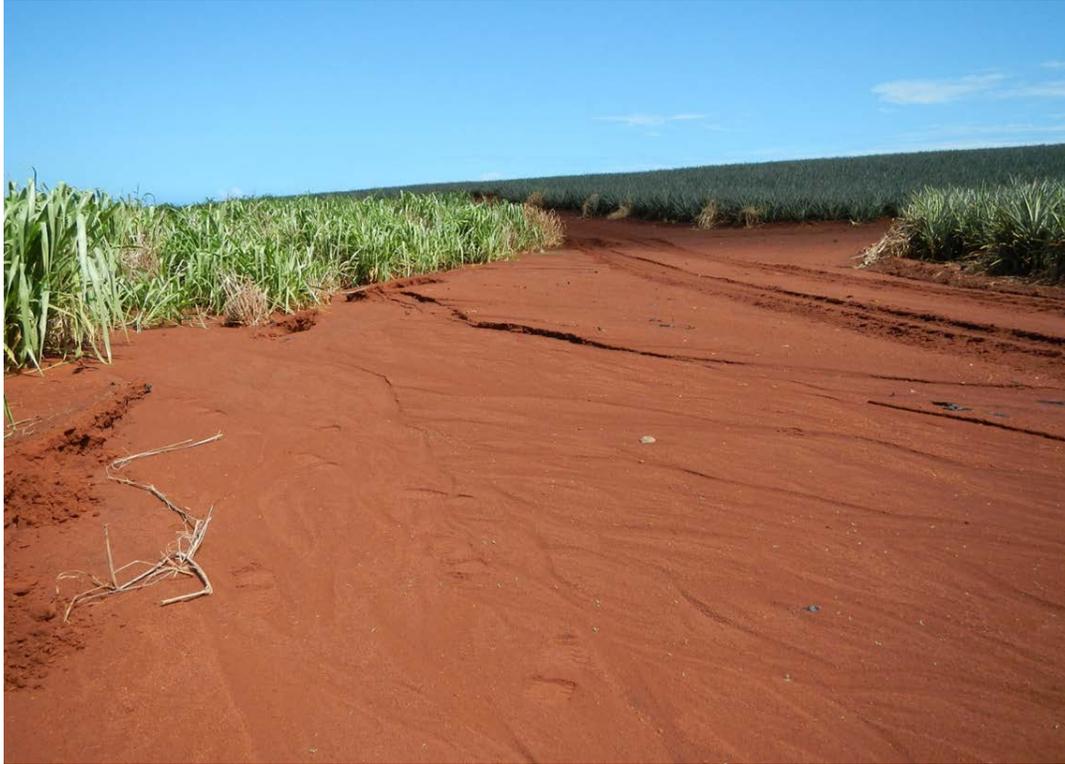
Larger berms were found constructed along the top of the canyon. In most cases it appeared the larger berms succeeded in trapping the sediment prior to flowing over the edge into the canyon. Photo 3-16 shows a location where the larger berms have trapped sediment along the canyon rim.

Photo 3-16 Accumulated Sediment Washed from the Pineapple Fields

Evidence of sediment flowing into the guinea grass bordering the canyon rim indicates material may have reached the walls of the canyon and potentially Poamoho Stream. Limited access due to thick vegetation and steep slope limited the investigation of sediment flows and whether they eventually reached the stream or were trapped on the banks. It is likely that any runoff carrying sediment would infiltrate into the accumulated debris field at the base of the cliffs. As the flow infiltrates the loosely compacted material, the larger sediment is filtered out prior to the flow eventually reaching Poamoho Stream.
