**REPORT TO THE
TWENTY-FIRST LEGISLATURE
STATE OF HAWAII
2002**

**IN COMPLIANCE WITH HAWAII REVISED STATUTES
CHAPTERS 128D AND 128E
ON THE ACTIVITIES OF THE DEPARTMENT OF HEALTH
ENVIRONMENTAL HEALTH ADMINISTRATION
OFFICE OF HAZARD EVALUATION AND EMERGENCY RESPONSE
AND USE OF THE ENVIRONMENTAL RESPONSE REVOLVING FUND**

**PREPARED BY:
DEPARTMENT OF HEALTH
STATE OF HAWAII**

OFFICE OF HAZARD EVALUATION AND EMERGENCY RESPONSE FISCAL YEAR 2001 ACTIVITIES

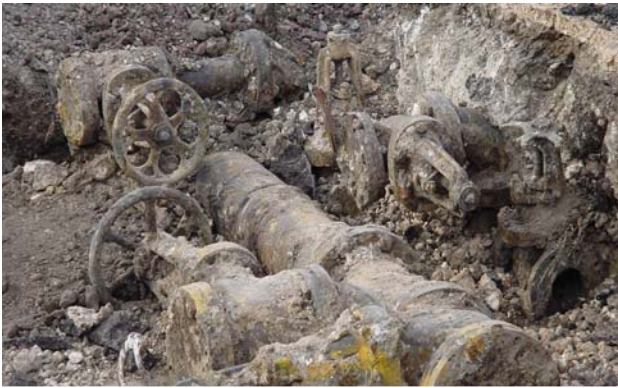
Abandoned Pipeline Valve & Manifold System

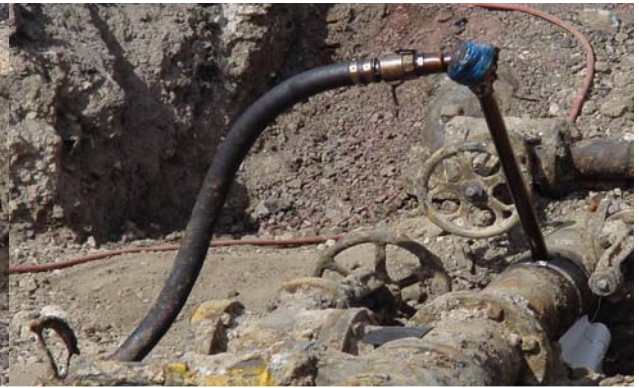
Pipeline Vacuum Truck "Stinger"

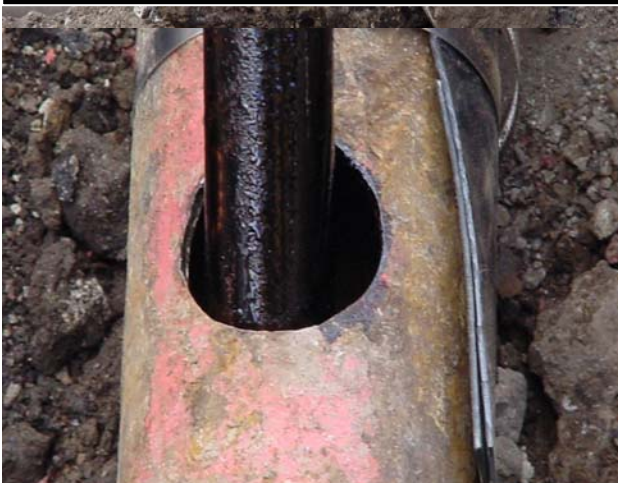
Tapped Pipeline Oil Recovery

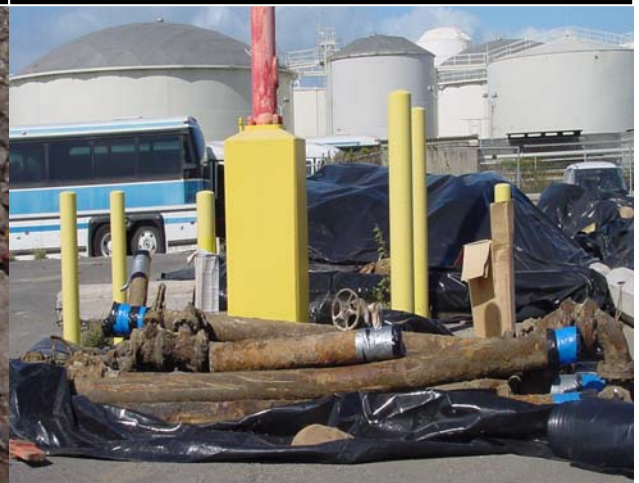
Removed Pipeline Pile

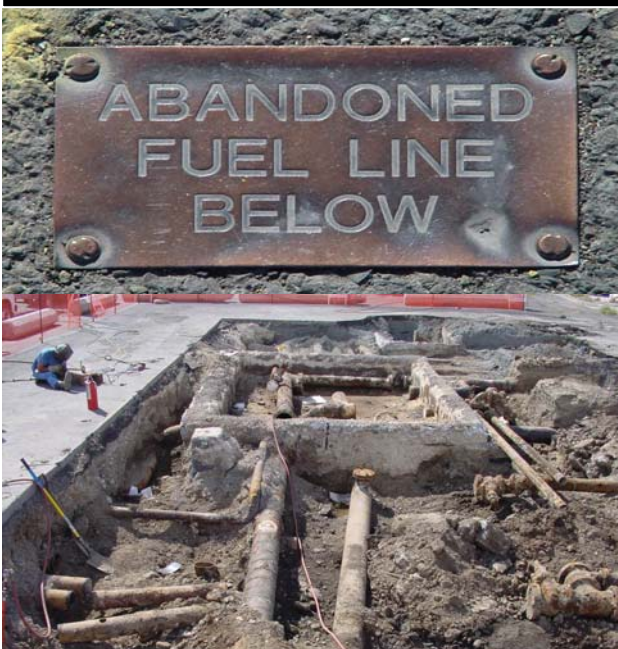
Pier- 26 Abandoned Pipeline Excavation
(Pipeline - Daylighting, Tapping, Product Recovery,
Grouting, and Removal Operation)

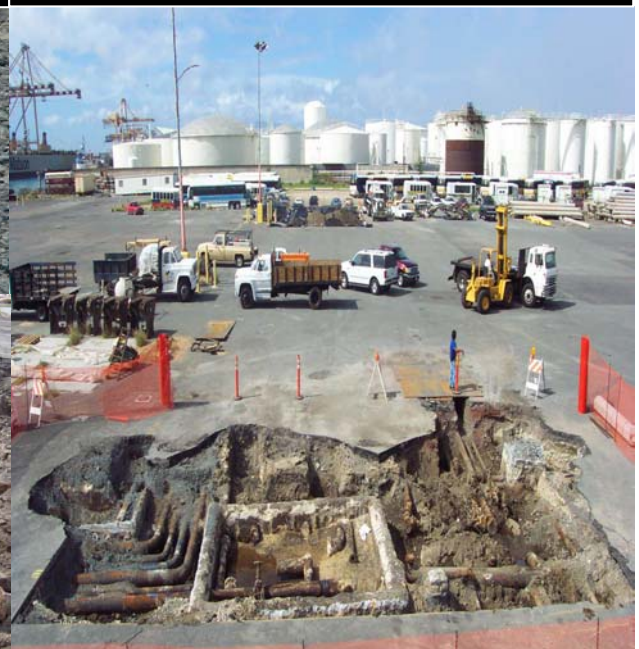
Pipeline Removal Operation

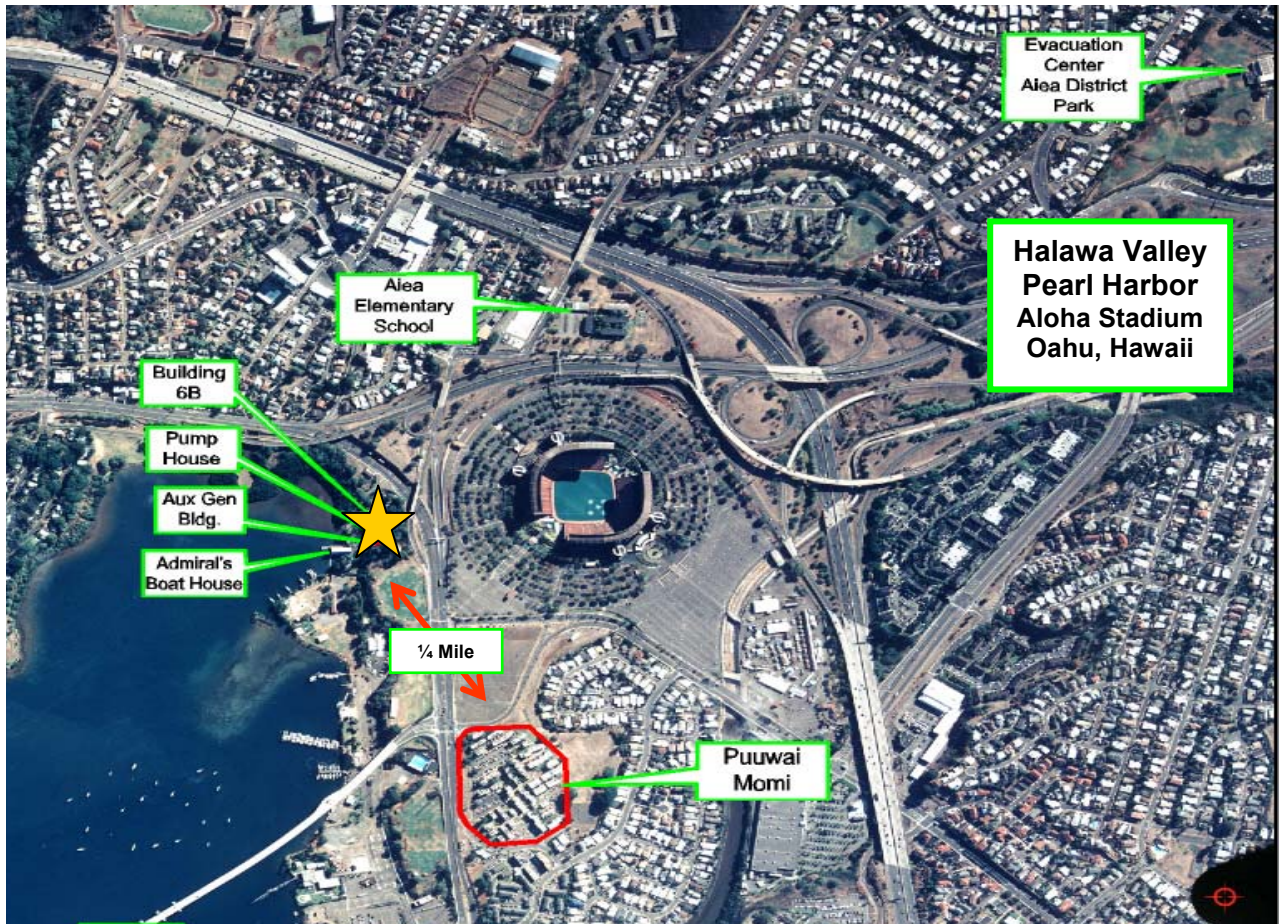
Mercury from electrical metering equipment was transported approximately 1/4 mile to Puuwai Momi Housing over a period of months prior to the Department of Health Environmental Response.

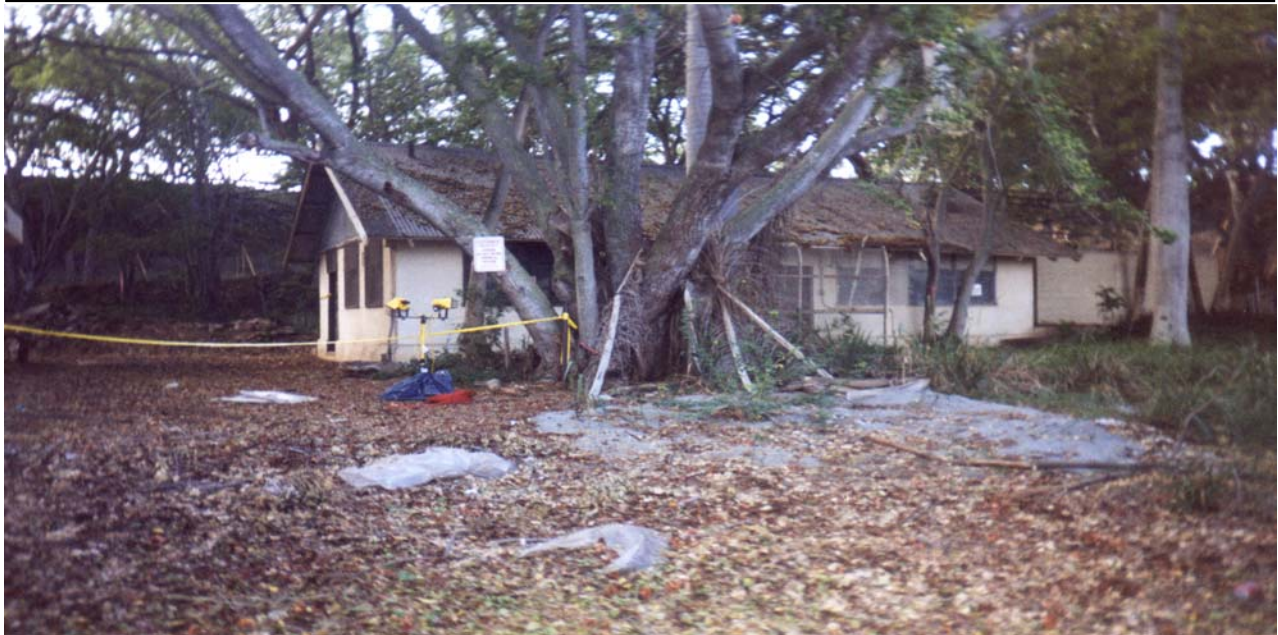
The Mercury Source (old military potable water pumphouse)
Approximately 30lbs. of mercury was recovered during cleanup.

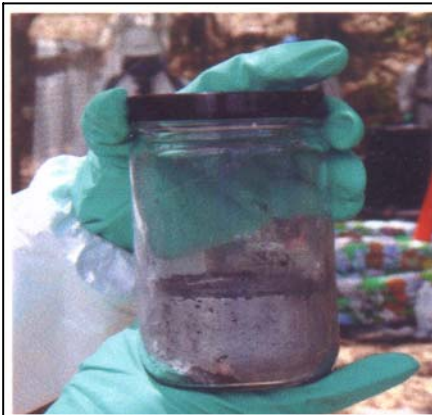
Recovered Mercury
(Pumphouse)

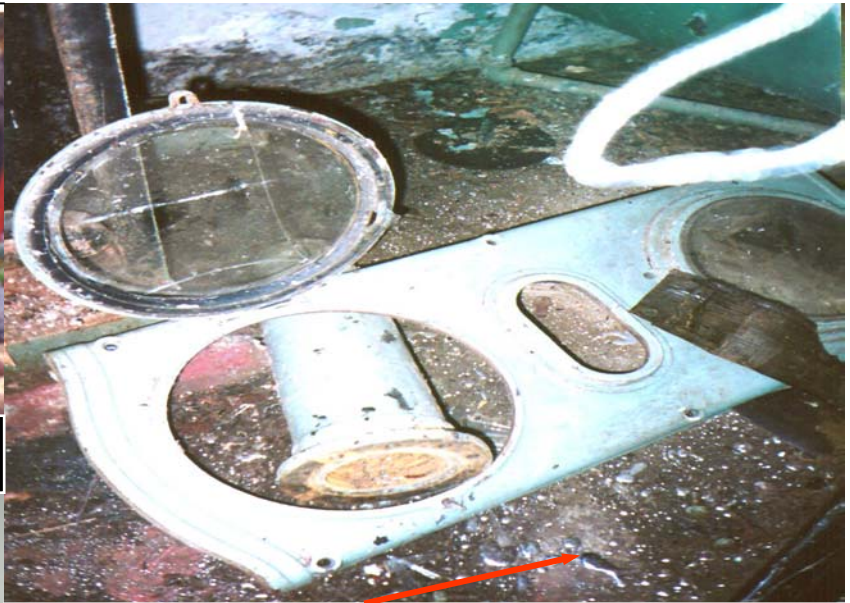
Spilled mercury (puddles on the pumphouse floor)

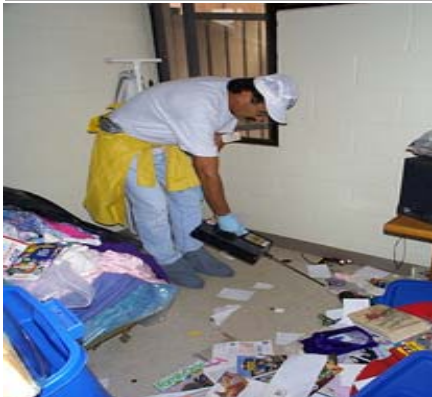
Screening a room for mercury
vapor within the 260 units at
Puuwai Momi Housing Complex

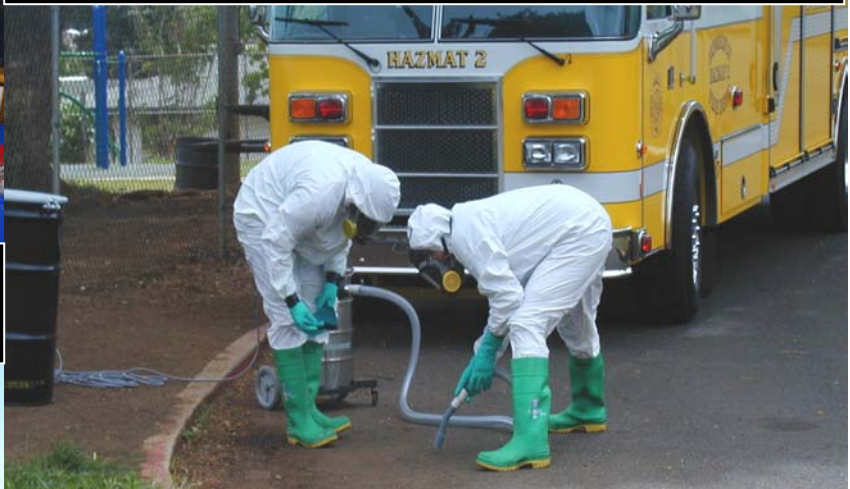
Hazardous Materials Response Team recovering spilled mercury
droplets with a mercury vacuum

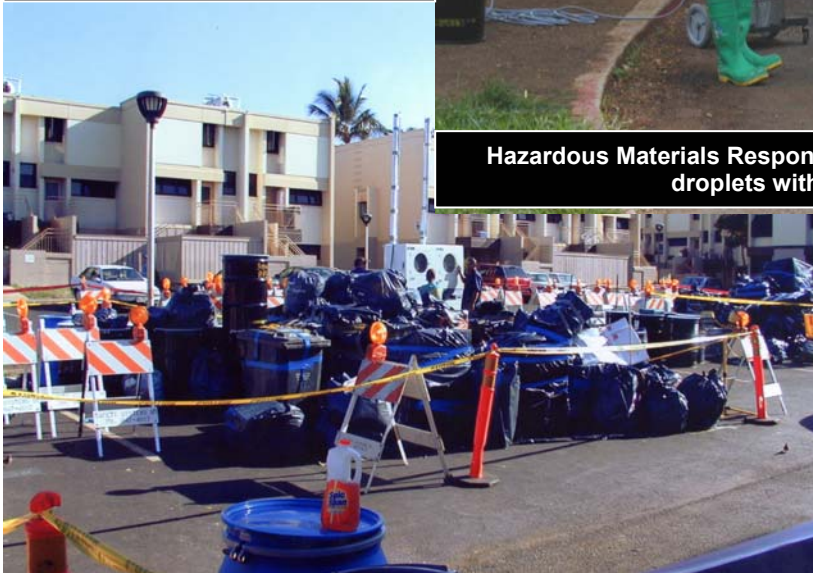
Mercury contaminated items
removed from 71 contaminated housing units
(contaminated items impoundment – cleaning & disposal staging)
