SUBJECT: DESTRUCTIVE ANALYSIS OF 10 STEEL COUPONS REMOVED FROM RED HILL FUEL STORAGE TANK NO. 14, PURSUANT TO SECTION 5.3 OF THE ADMINISTRATIVE ORDER ON CONSENT STATEMENT OF WORK, RED HILL BULK FUEL STORAGE FACILITY, JOINT BASE PEARL HARBOR-HICKAM, OAHU, HAWAII

Destructive Analysis of 10 Steel Coupons Removed from Red Hill Fuel Storage Tank #14

REPORT No. 201801967

December 17, 2018

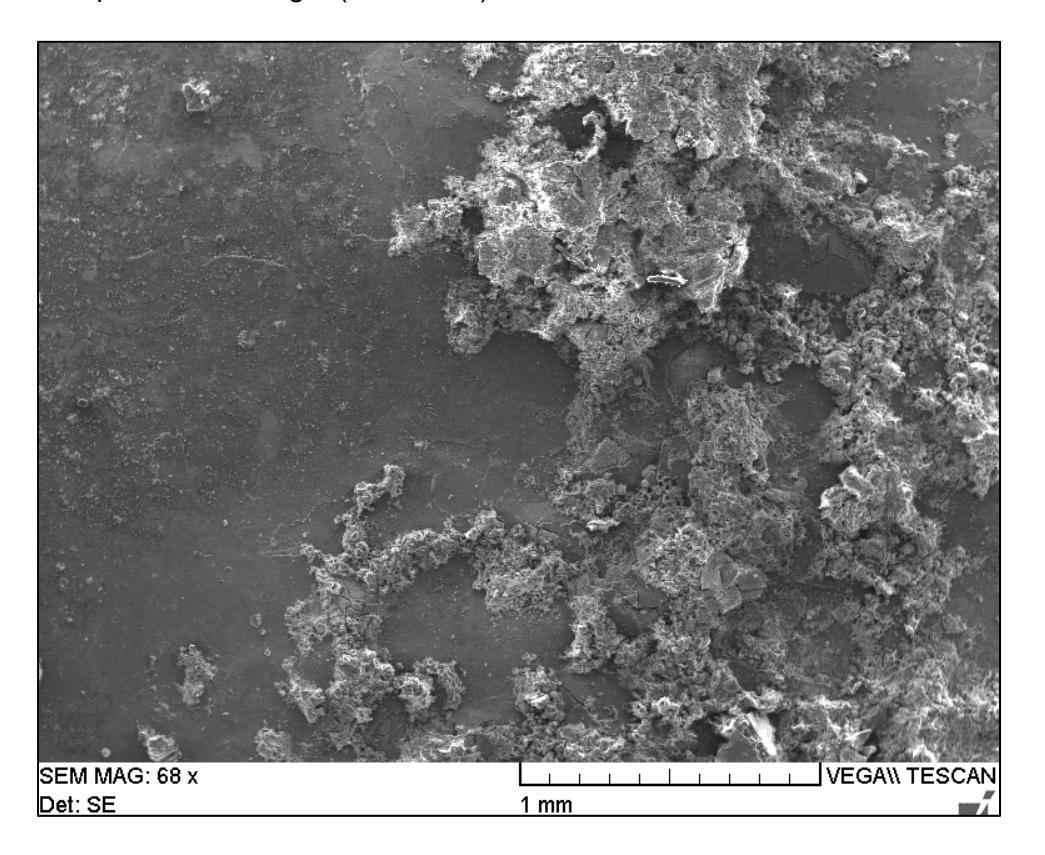
Figure 50. A representative SEM image of the specimen excised from Coupon 5 labeled as 5-1, prior to cleaning. No pits observed. (SEM, 40X)

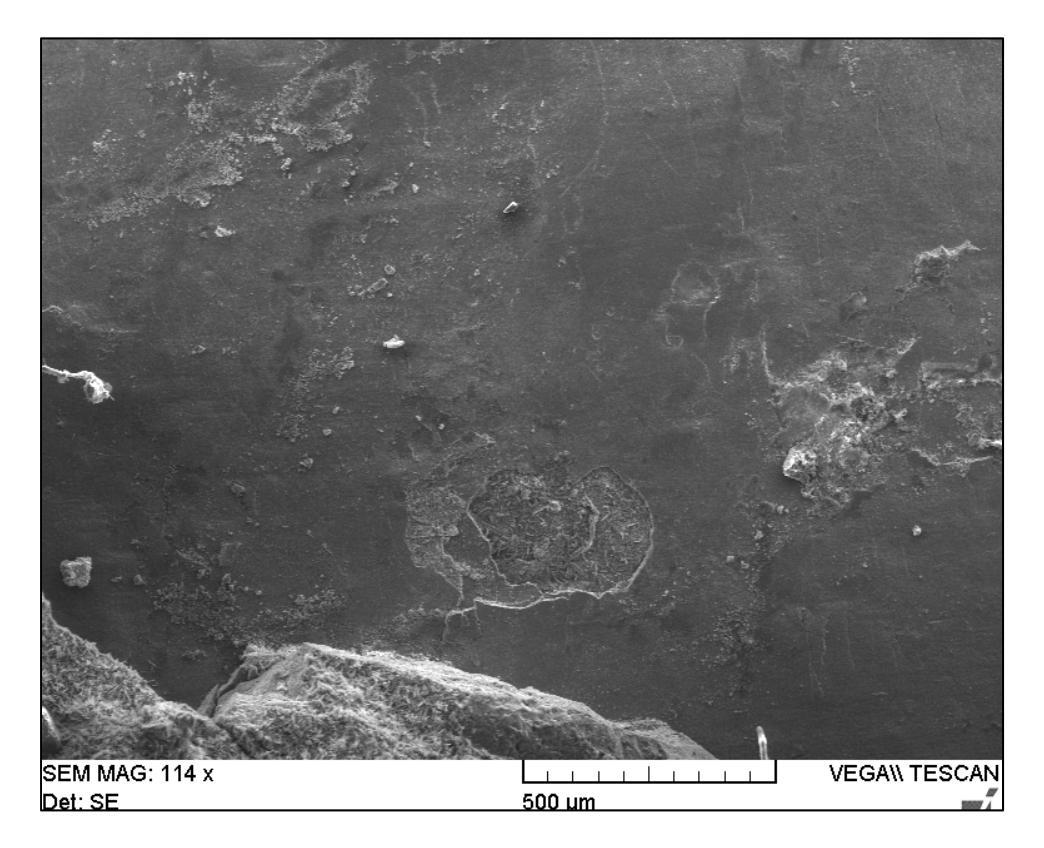
Figure 51. A representative SEM image of a pit on a specimen excised from Coupon 5 labeled as 5-2, prior to cleaning. (SEM, 67X)

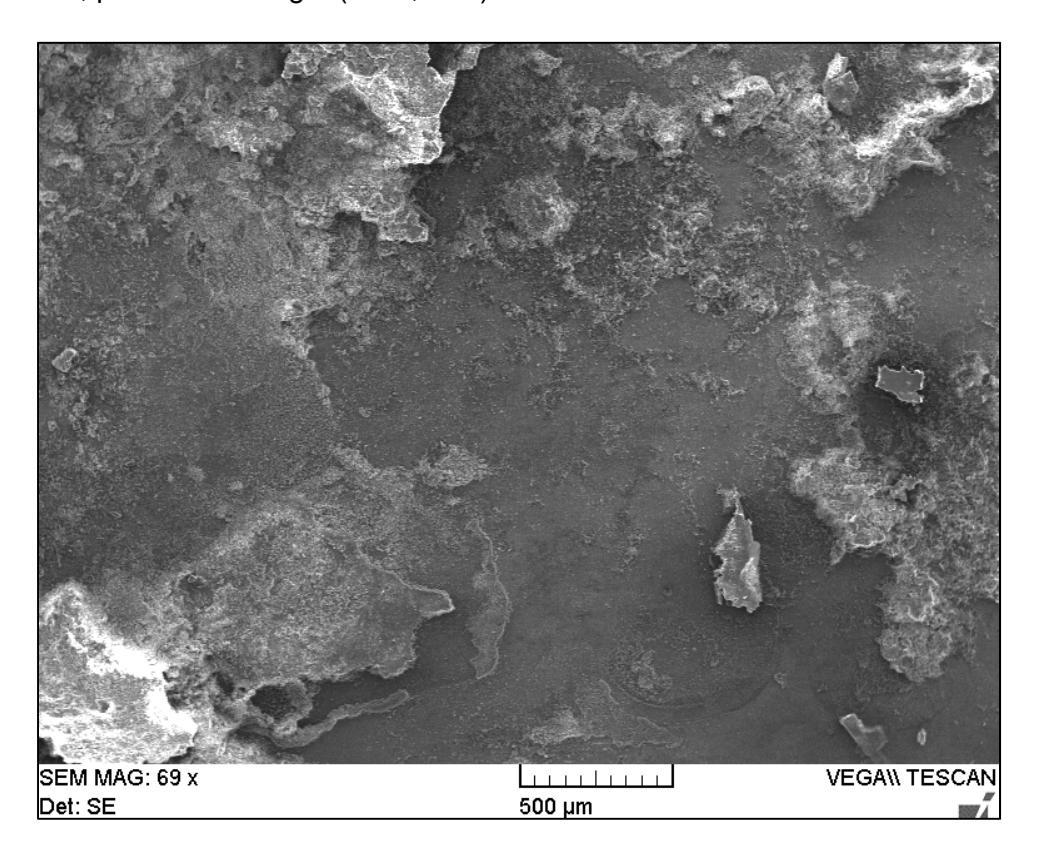
Figure 54. A representative SEM image the surface of a specimen excised from Coupon 6 labeled as 6-2, prior to cleaning. No pit was observed in this location. (SEM, 40X)

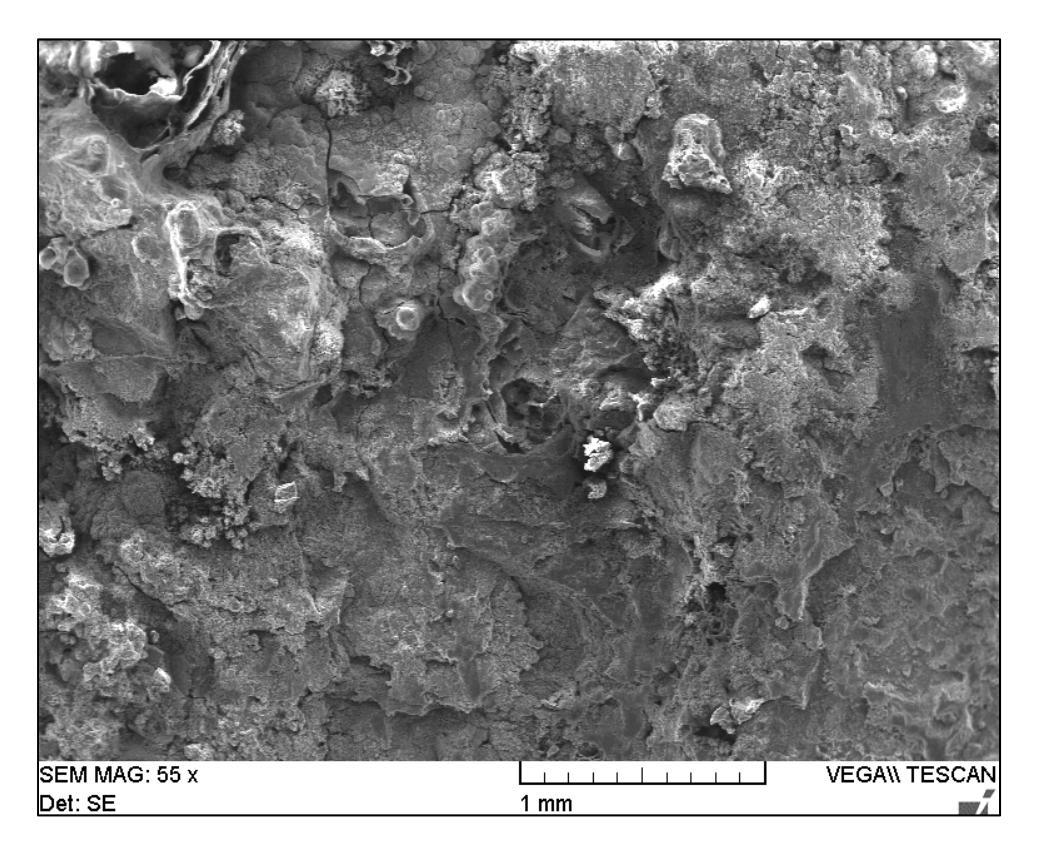
Figure 55. A representative SEM image of a pit on a specimen excised from Coupon 6 labeled as 6-3, prior to cleaning. (SEM, 32X)

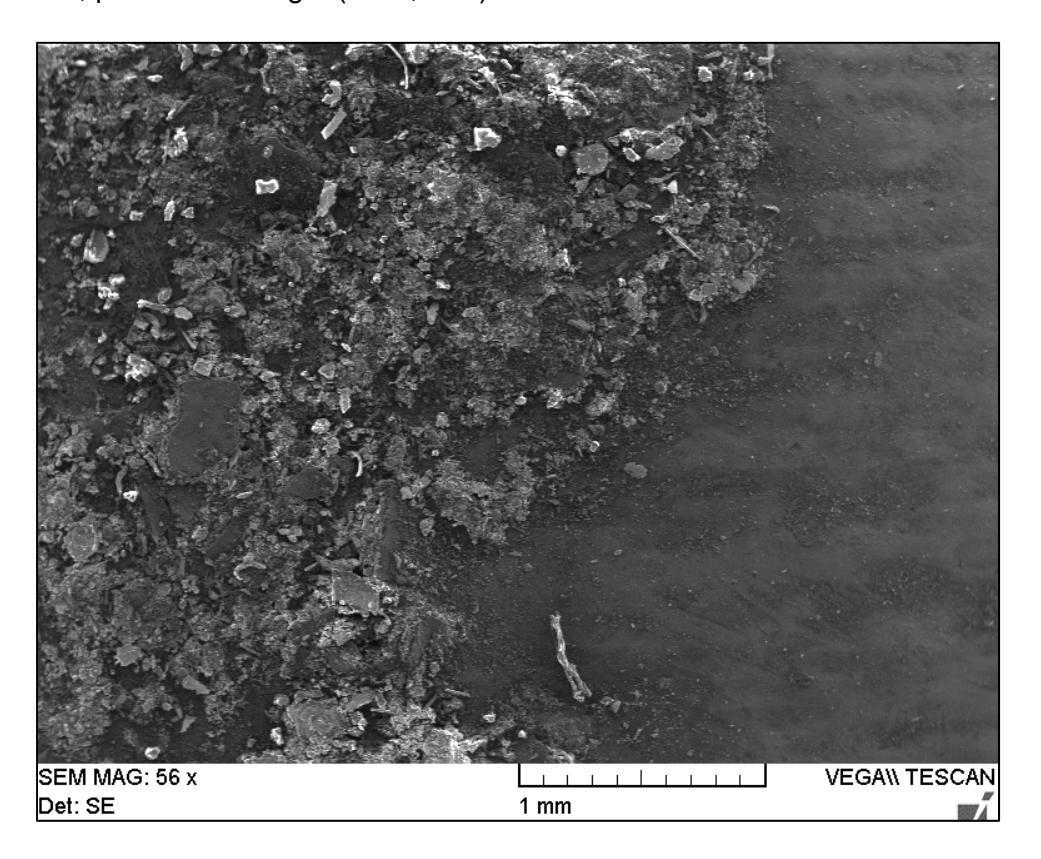
Figure 62. A representative SEM image of the surface of a specimen excised from Coupon 10 labeled as 10-1, prior to cleaning. No pit was observed in this location. (SEM, 33X)

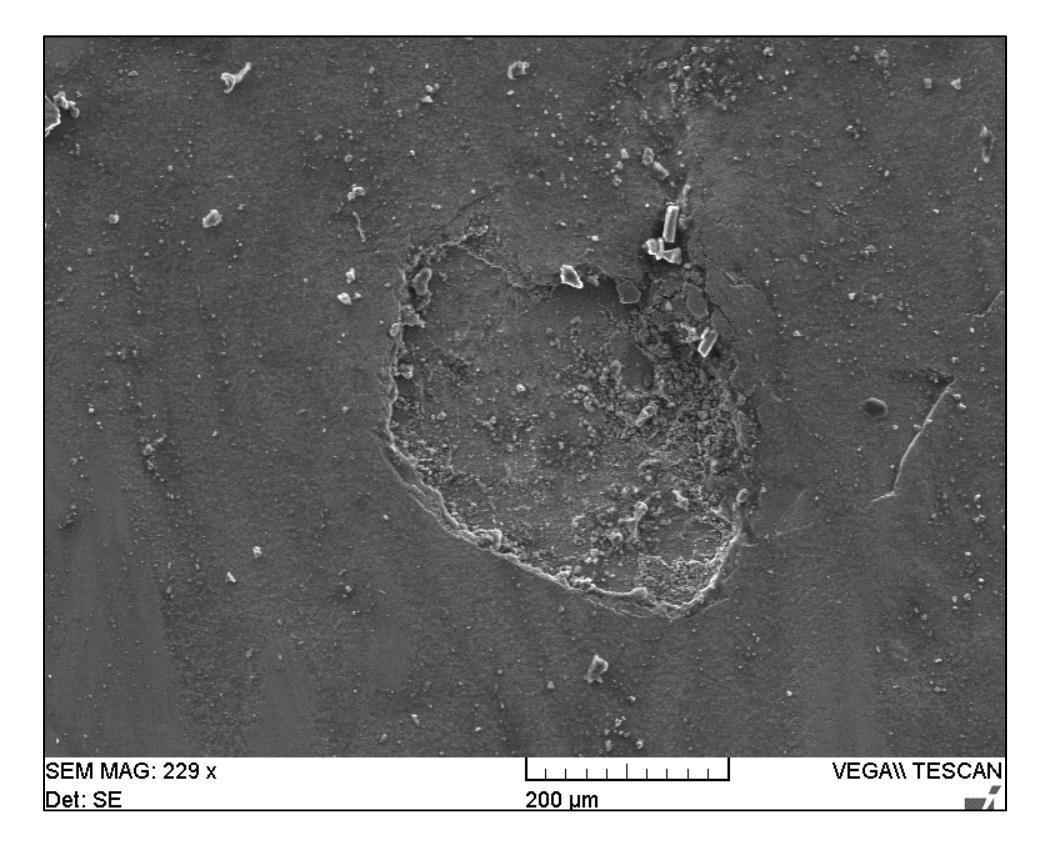
Figure 63. A representative SEM image of a pit on a specimen excised from Coupon 10 labeled as 10-2, prior to cleaning. (SEM, 135X)

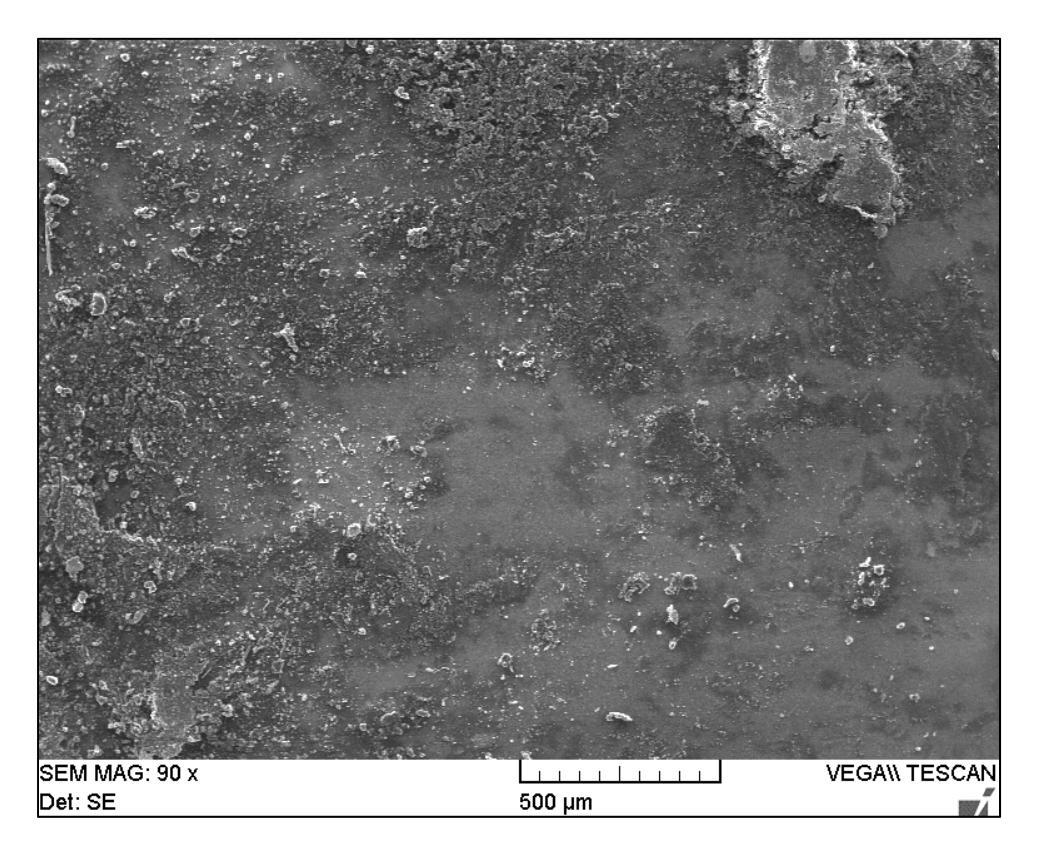
Figure 64. A representative SEM image of the surface on a specimen excised from Coupon 10 labeled as 10-3, prior to cleaning. No pit was observed in this location. (SEM, 53X)

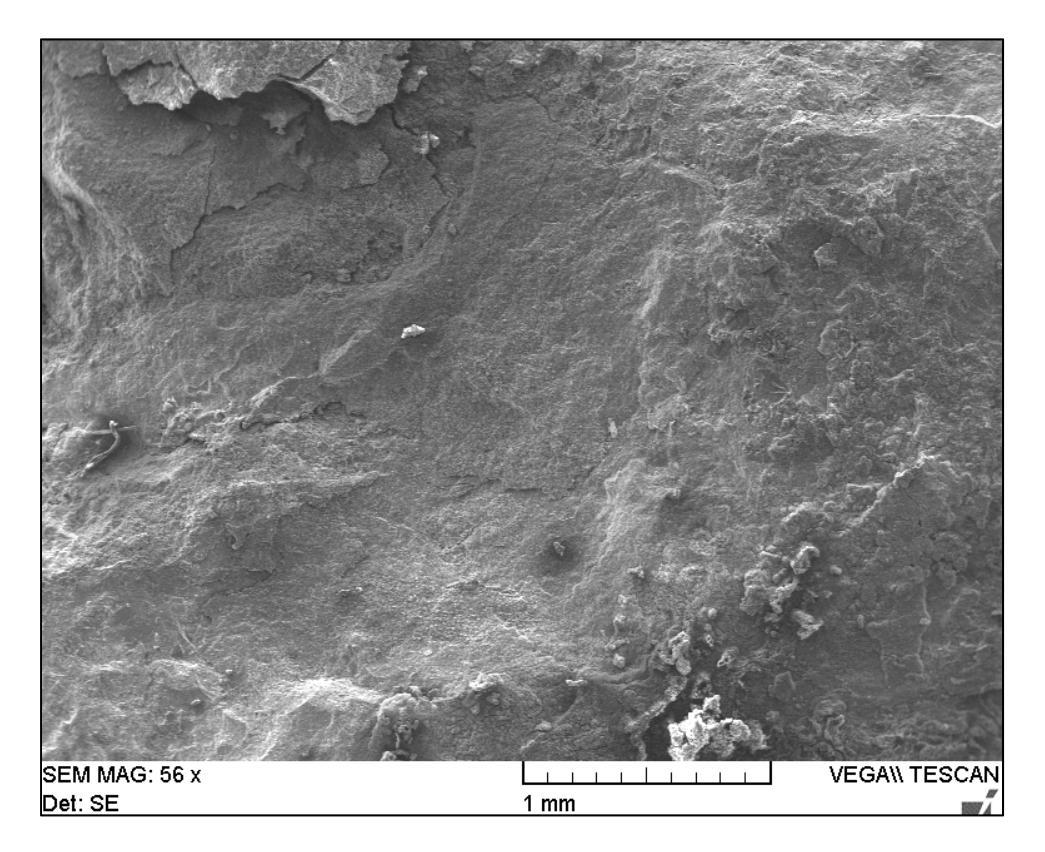
Figure 65. A representative SEM image of a pit on a specimen excised from Coupon A-1 labeled as A1-1, prior to cleaning. (SEM, 33X)

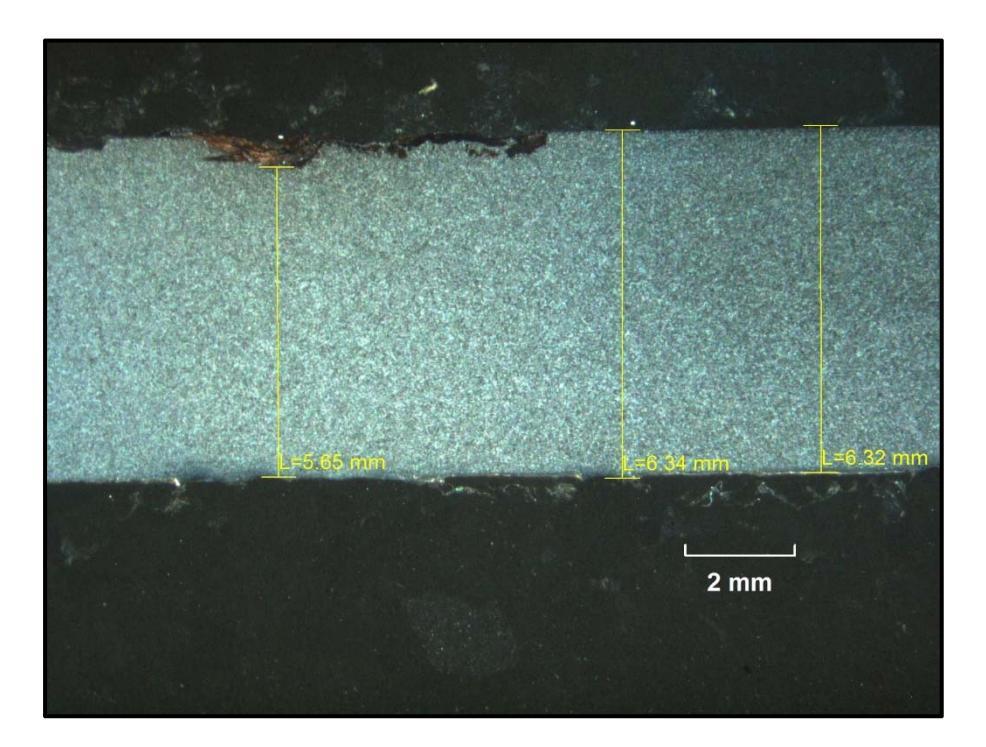
Figure 180. The prepared metallographic cross-section from Sample 1-1 is shown during examination with a stereomicroscope. The thickest location(s) are shown, as well as the thickness remaining underneath the deepest observed pit. (7X)

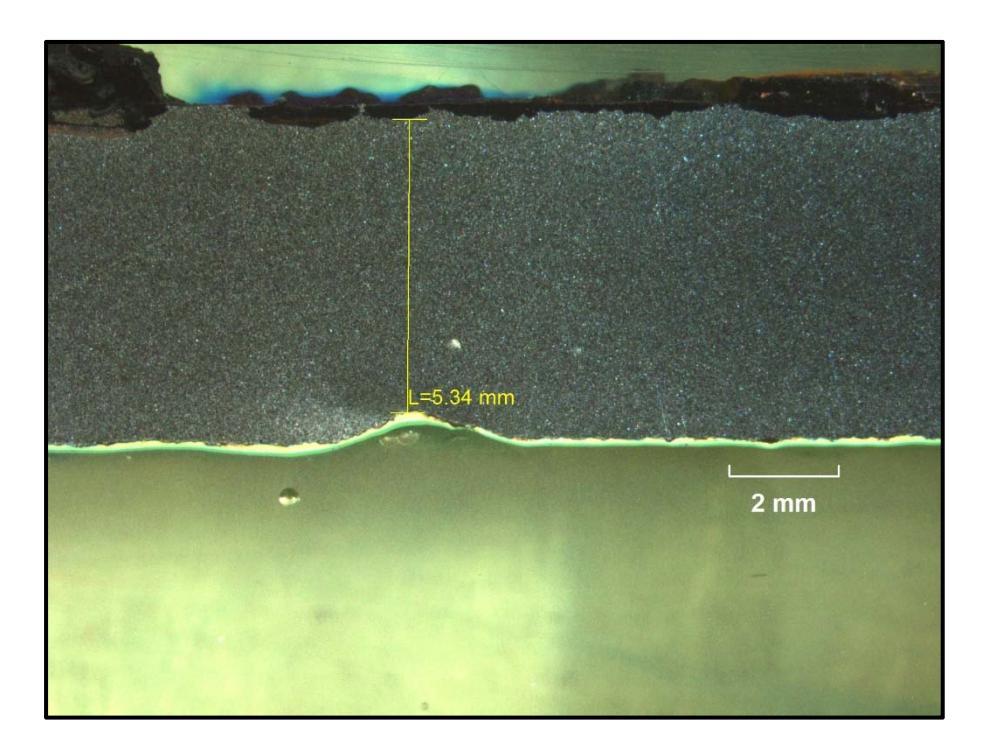
Figure 181. The prepared metallographic cross-section from Sample 1-3 is shown during examination with a stereomicroscope. The thickest remaining wall is shown. Note that the reduction in wall thickness was due to a depression on the painted face of the specimen. (7X)

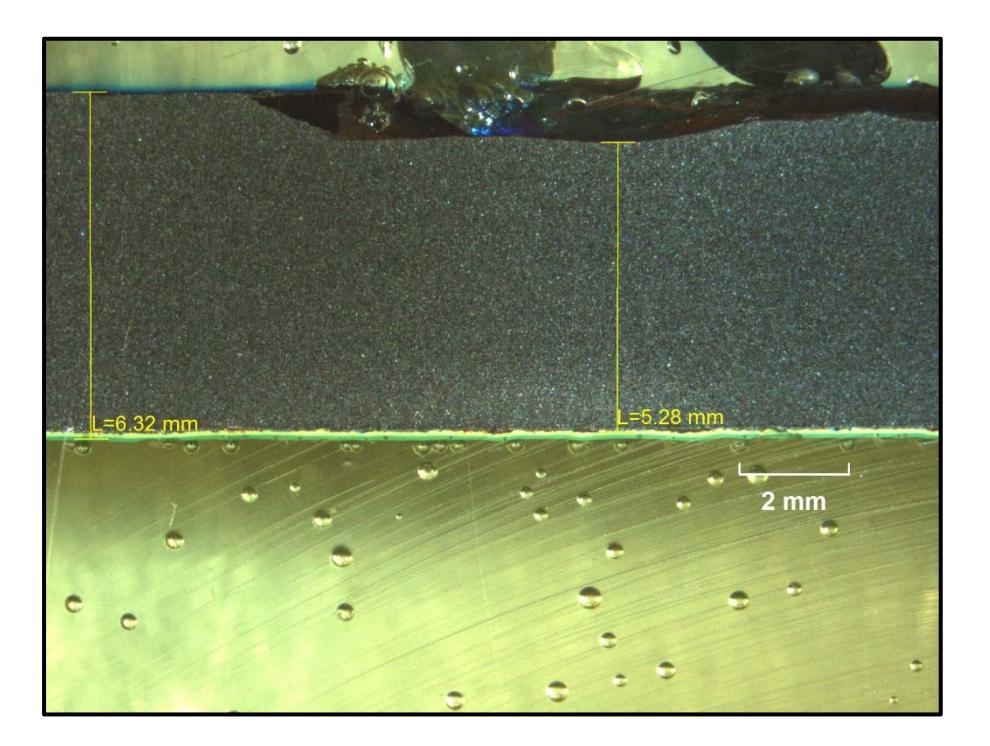
Figure 182. The prepared metallographic cross-section from Sample 1-4 is shown during examination with a stereomicroscope. The thickest location(s) are shown, as well as the thickness remaining underneath the deepest observed pit. (7X)

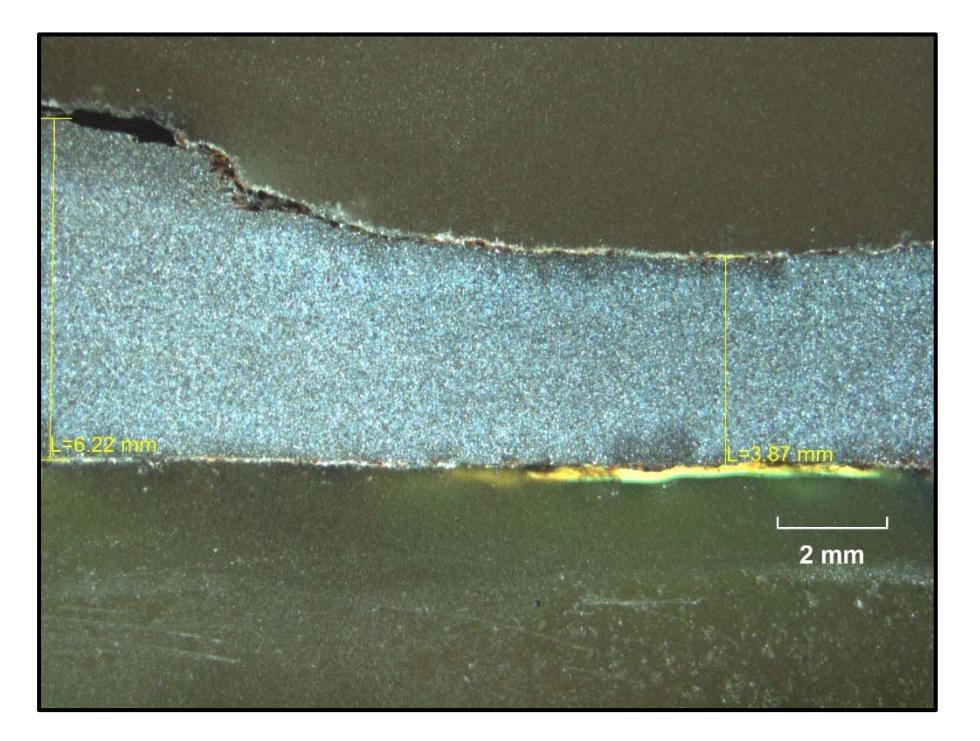
Figure 183. The prepared metallographic cross-section from Sample 2-1 is shown during examination with a stereomicroscope. The thickest location(s) are shown, as well as the thickness remaining underneath the deepest observed pit. (7X)

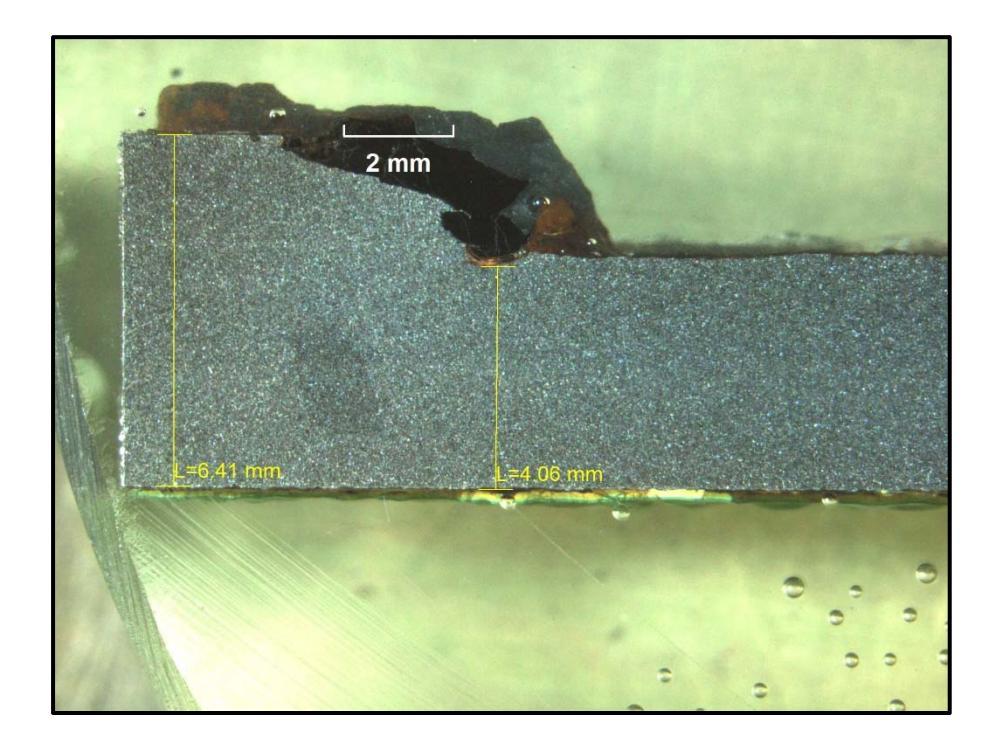
Figure 184. The prepared metallographic cross-section from Sample 2-2 is shown during examination with a stereomicroscope. The thickest location(s) are shown, as well as the thickness remaining underneath the deepest observed pit. (7X)

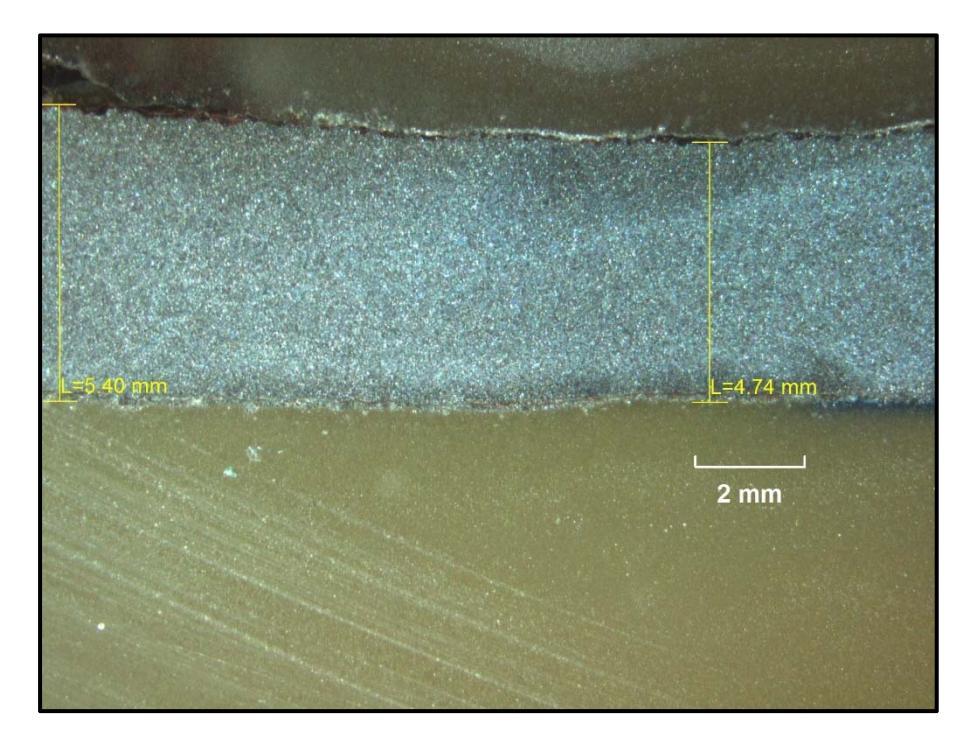
Figure 185. The prepared metallographic cross-section from Sample 2-3 is shown during examination with a stereomicroscope. The thickest location(s) are shown, as well as the thickness remaining underneath the deepest observed pit. (7X)

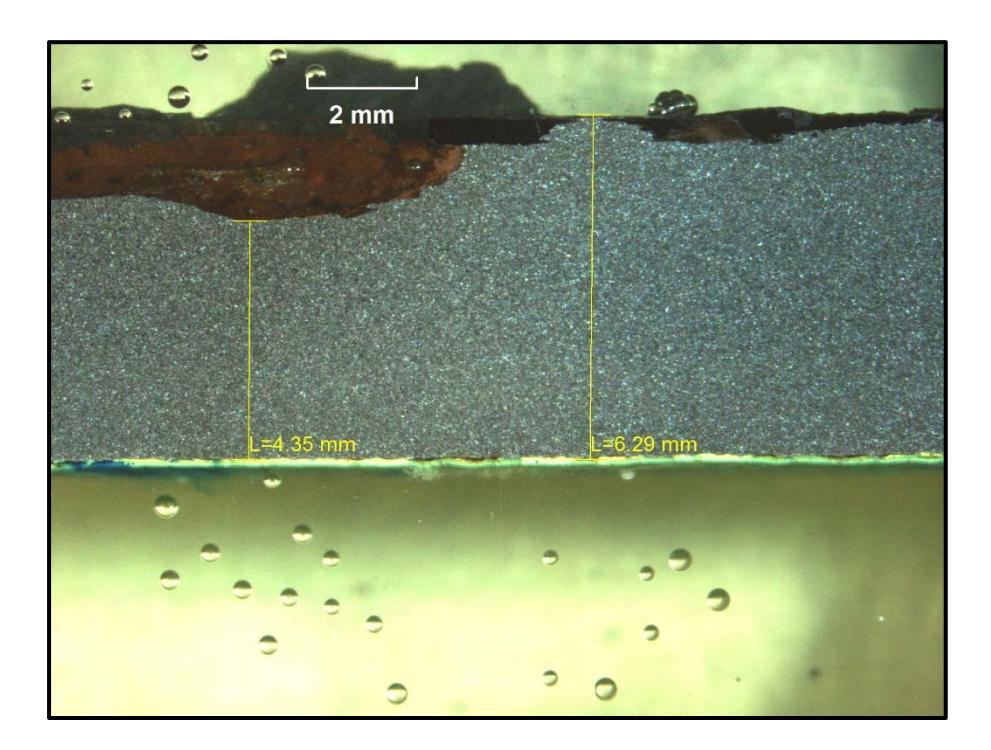
Figure 186. The prepared metallographic cross-section from Sample 3-1 is shown during examination with a stereomicroscope. The thickest location(s) are shown, as well as the thickness remaining underneath the deepest observed pit. (7X)

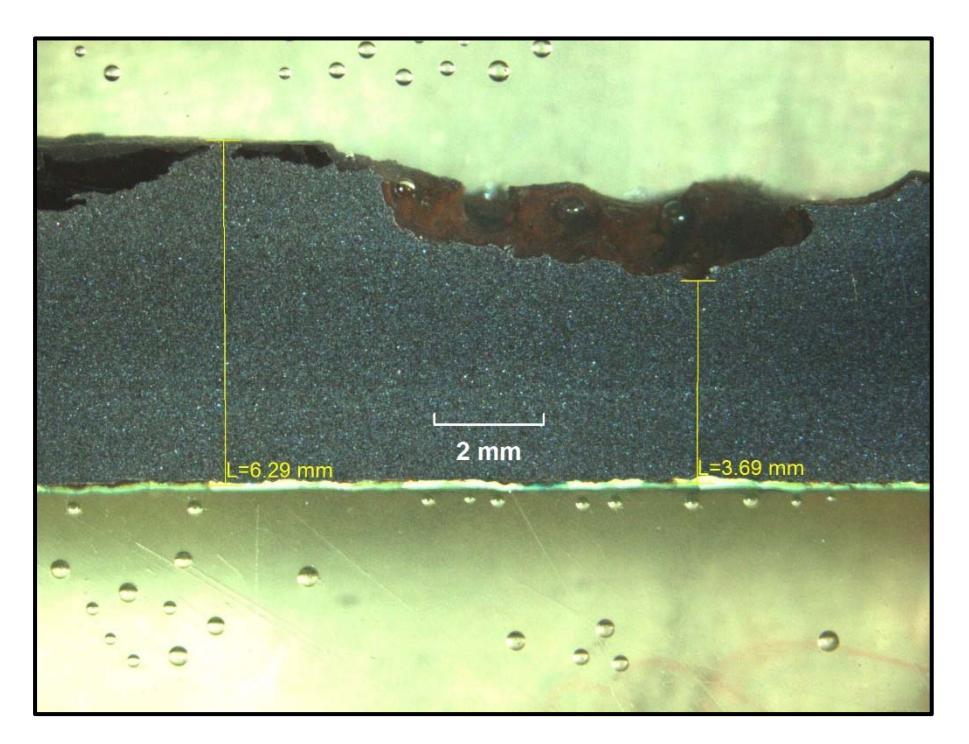
Figure 187. The prepared metallographic cross-section from Sample 3-2 is shown during examination with a stereomicroscope. The thickest location(s) are shown, as well as the thickness remaining underneath the deepest observed pit. (7X)

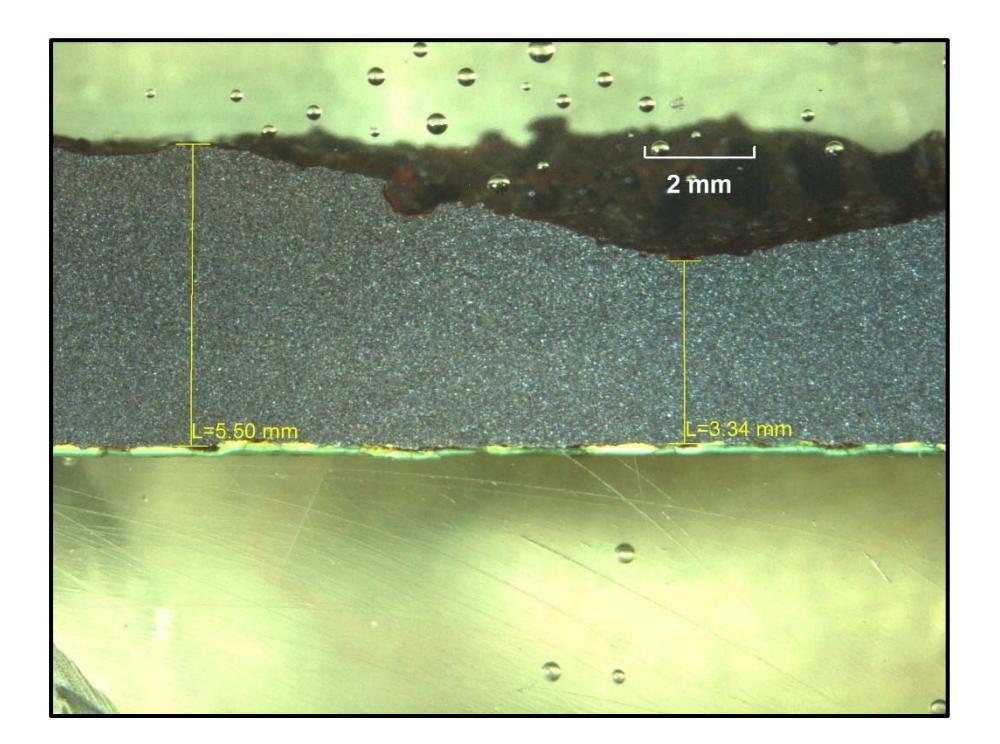
Figure 188. The prepared metallographic cross-section from Sample 3-3 is shown during examination with a stereomicroscope. The thickest location(s) are shown, as well as the thickness remaining underneath the deepest observed pit. (7X)

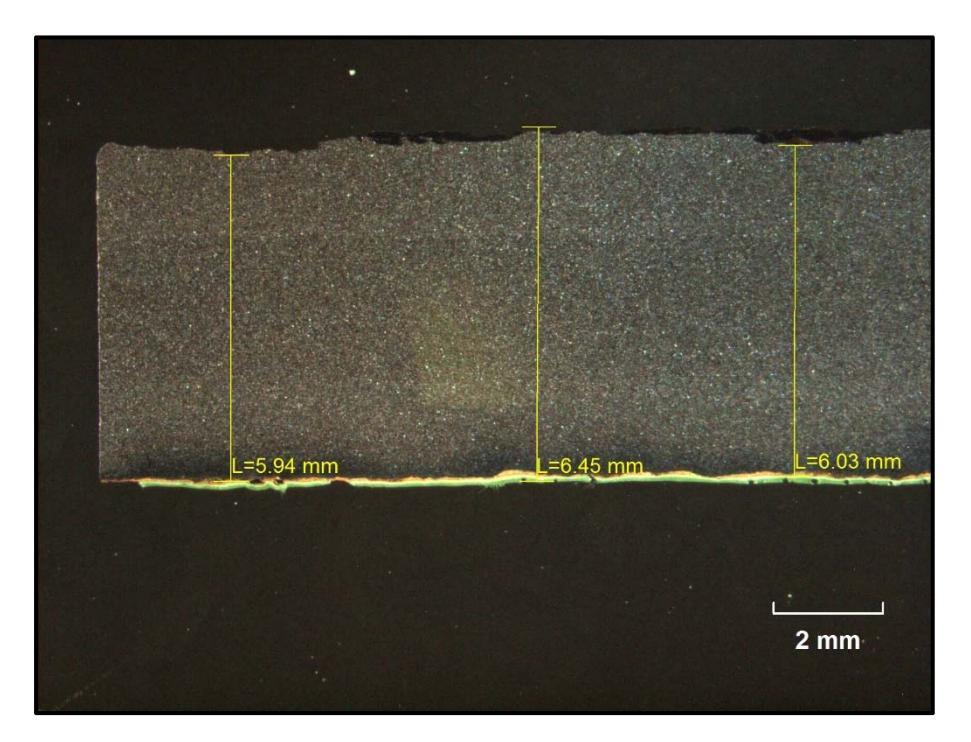
Figure 189. The prepared metallographic cross-section from Sample 3-4 is shown during examination with a stereomicroscope. The thickest location(s) are shown, as well as the thickness remaining underneath the deepest observed pit. (7X)

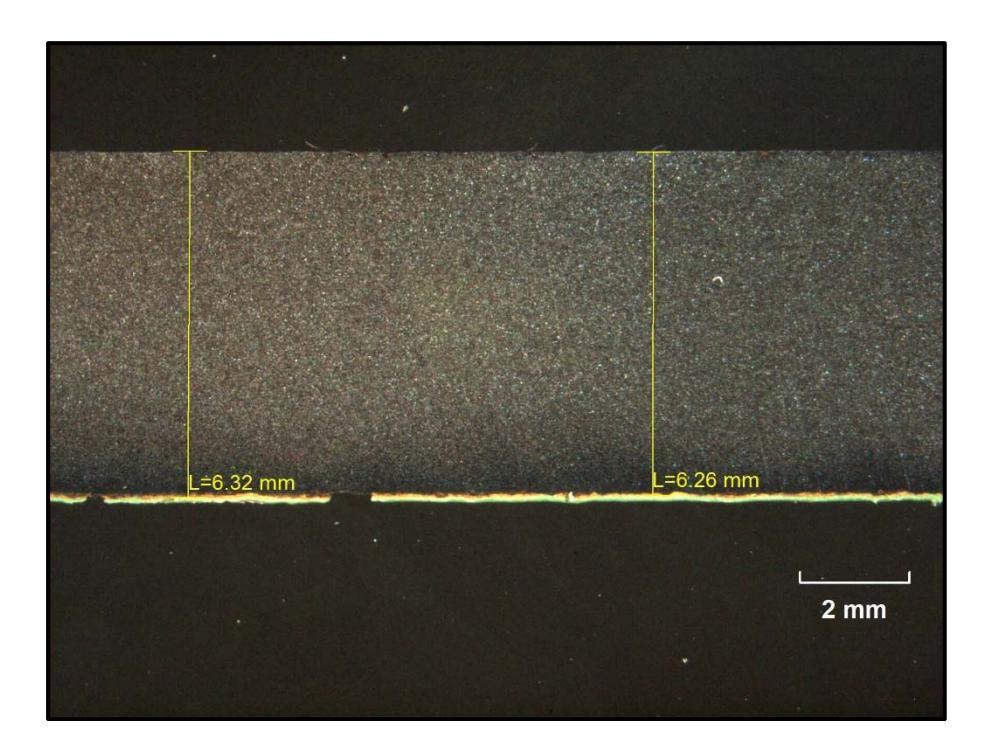
Figure 190. The prepared metallographic cross-section from Sample 5-1 is shown during examination with a stereomicroscope. No significant corrosion was observed. (7X)

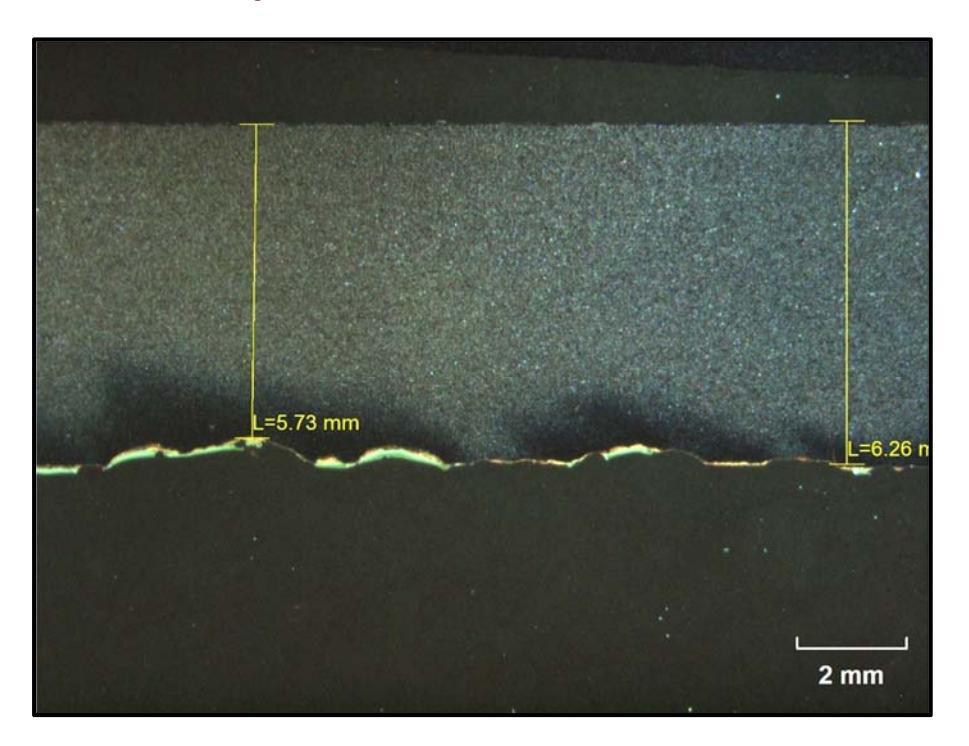
③ Suspected NDT inspection indication was a depression on the painted face of Sample 5-4. No pits observed.

Figure 191. The prepared metallographic cross-section from Sample 5-4 is shown during examination with a stereomicroscope. The thickest remaining wall is shown. Note that the reduction in wall thickness was due to a depression on the painted face of the specimen. (7X)

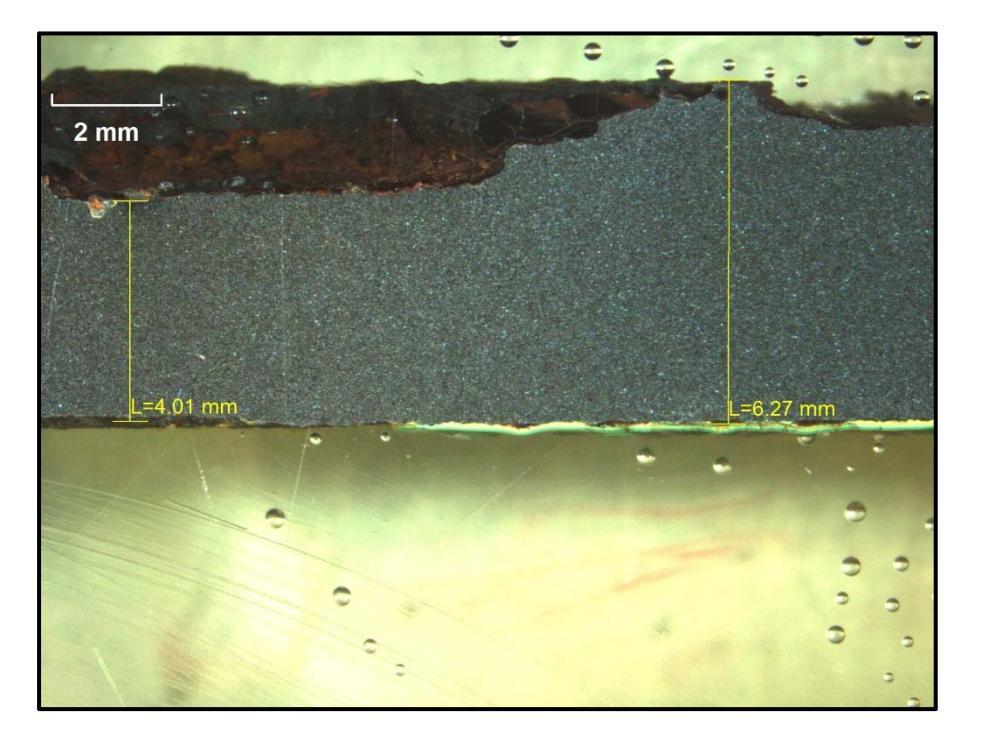
Figure 193. The prepared metallographic cross-section from Sample 6-1 is shown during examination with a stereomicroscope. The thickest location(s) are shown, as well as the thickness remaining underneath the deepest observed pit. (7X)

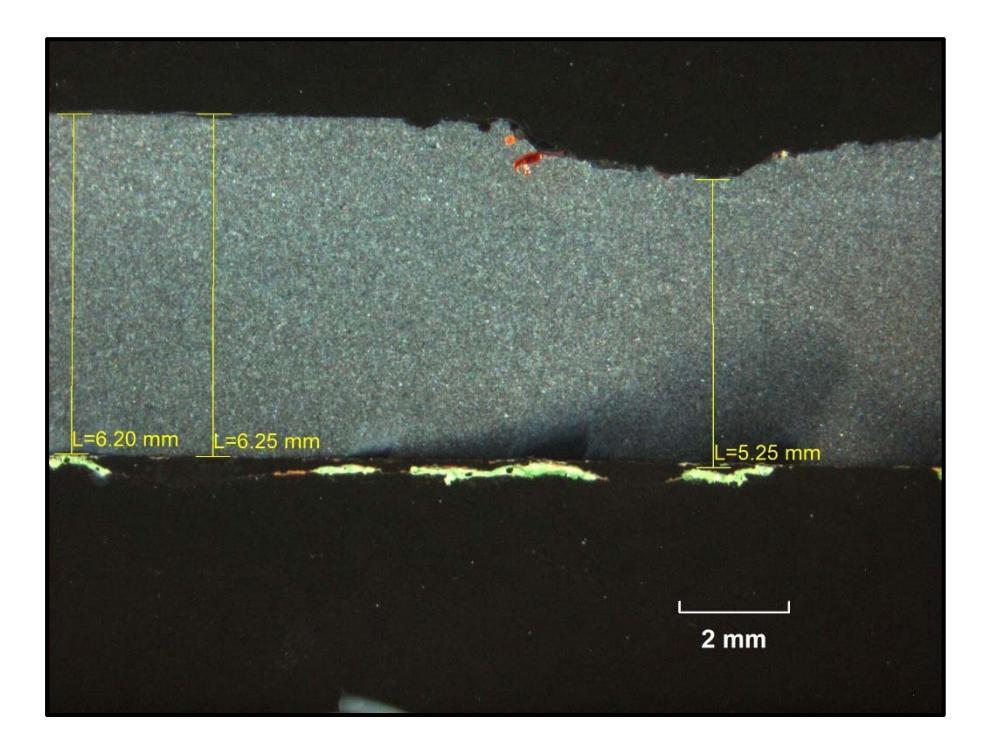
Figure 194. The prepared metallographic cross-section from Sample 6-2 is shown during examination with a stereomicroscope. The thickest location(s) are shown, as well as the thickness remaining underneath the deepest observed pit. (7X)

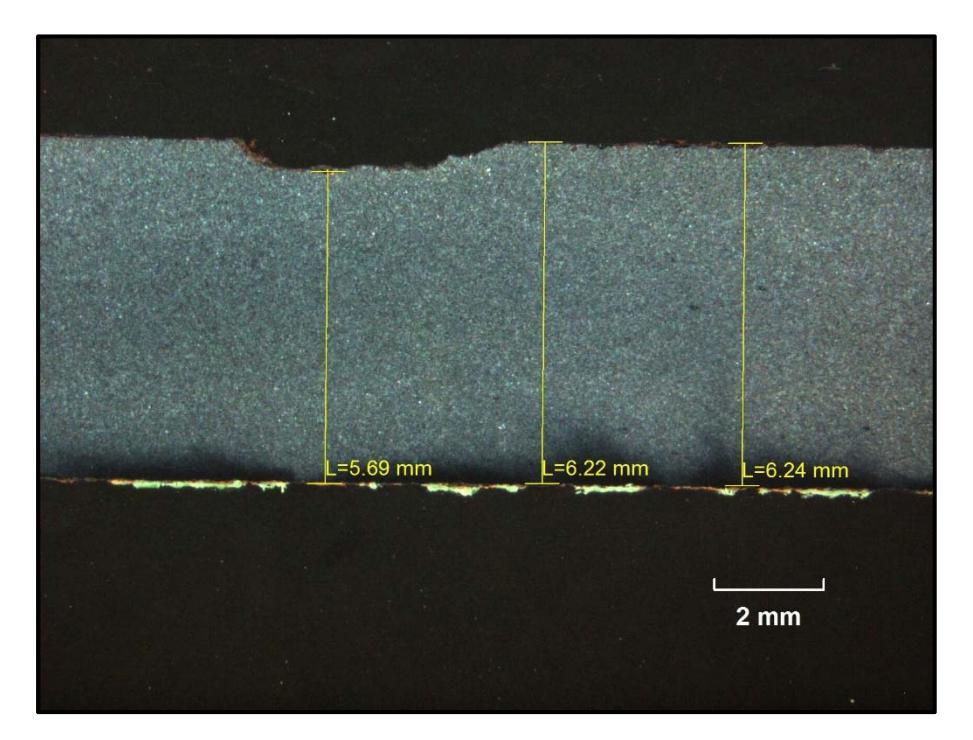
Figure 195. The prepared metallographic cross-section from Sample 6-3 is shown during examination with a stereomicroscope. The thickest location(s) are shown, as well as the thickness remaining underneath the deepest observed pit. (7X)

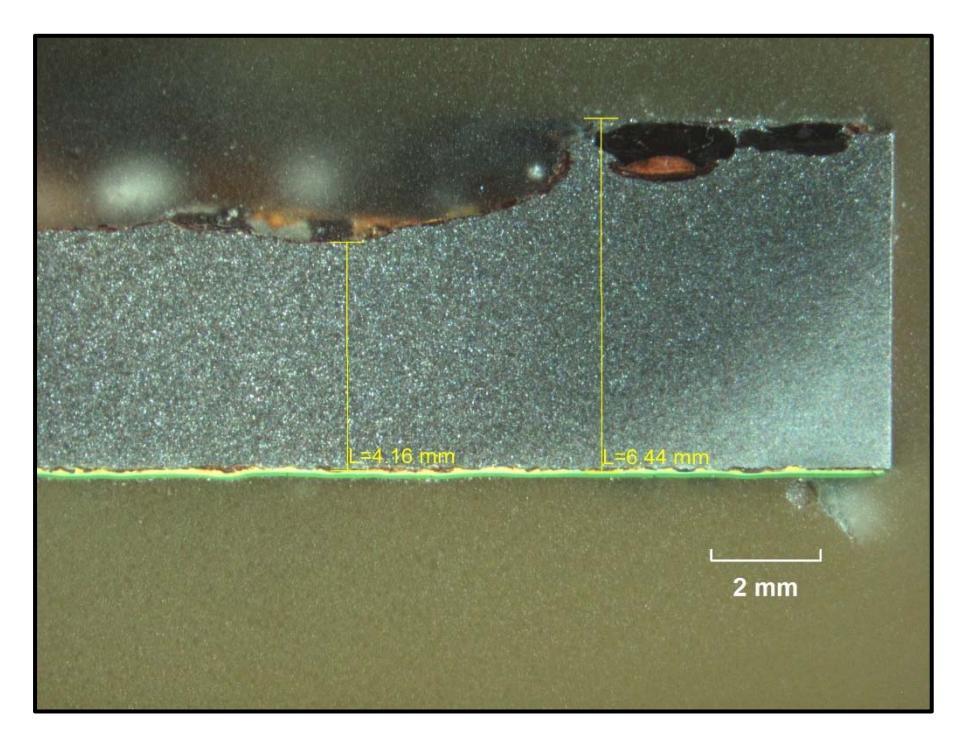
Figure 196. The prepared metallographic cross-section from Sample 7-1 is shown during examination with a stereomicroscope. The thickest location(s) are shown, as well as the thickness remaining underneath the deepest observed pit. (7X)

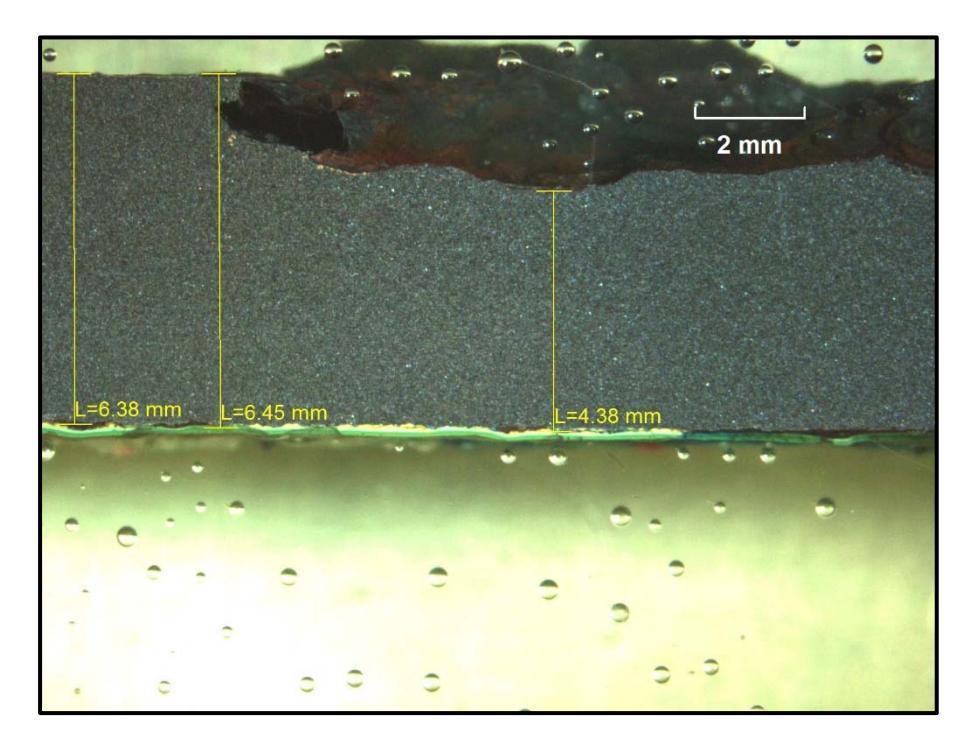
Figure 197. The prepared metallographic cross-section from Sample 7-3 is shown during examination with a stereomicroscope. The thickest location(s) are shown, as well as the thickness remaining underneath the deepest observed pit. (7X)

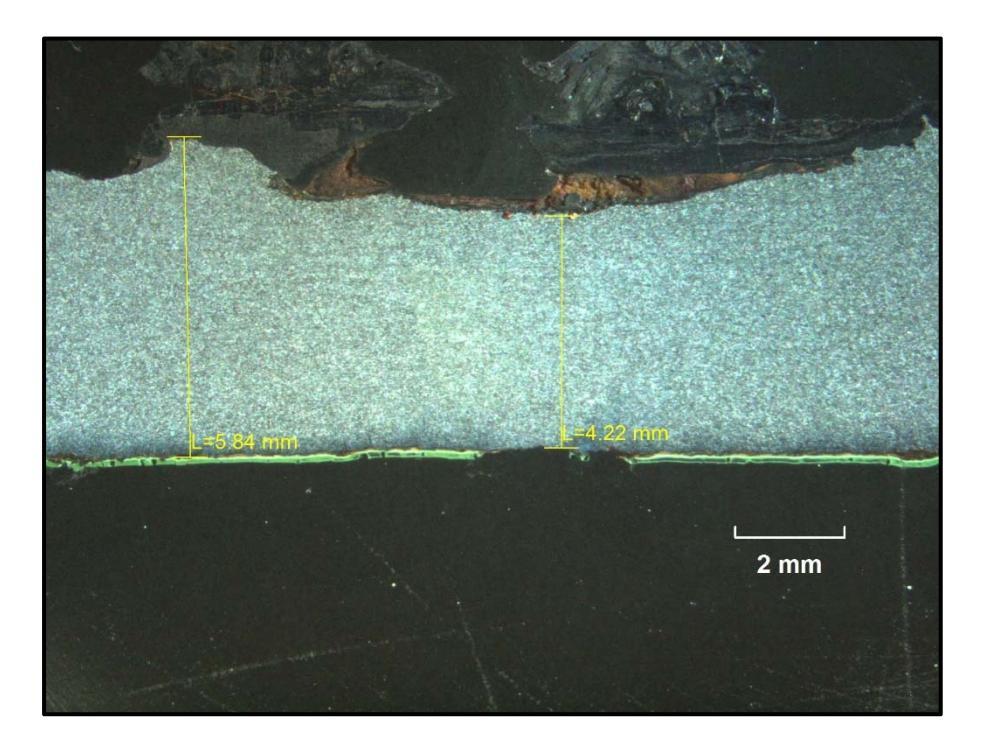
Figure 198. The prepared metallographic cross-section from Sample 7-4 is shown during examination with a stereomicroscope. The thickest location(s) are shown, as well as the thickness remaining underneath the deepest observed pit. (7X)

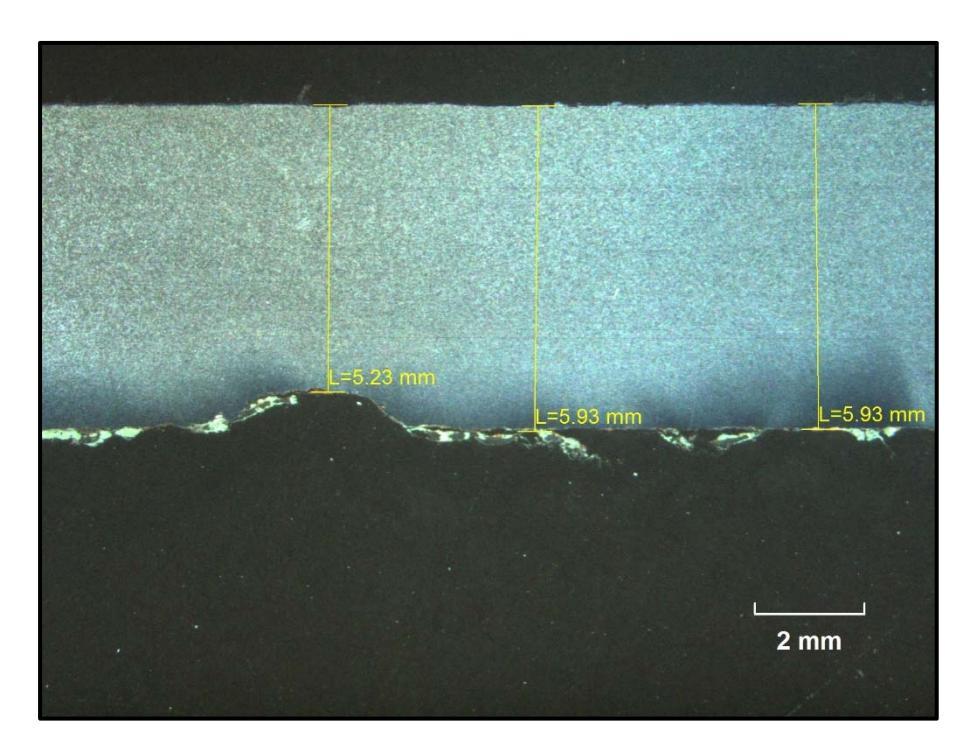
④ This is the weld-repaired plate section. Sample 8-3 exhibited a depression or pit on the painted surface.

Figure 199. The prepared metallographic cross-section from Sample 8-3 is shown during examination with a stereomicroscope. The thickest remaining wall is shown. Note that the reduction in wall thickness was due to a depression on the painted face of the specimen. (7X)
