SUBJECT: DESTRUCTIVE ANALYSIS OF 10 STEEL COUPONS REMOVED FROM RED HILL FUEL STORAGE TANK NO. 14, PURSUANT TO SECTION 5.3 OF THE ADMINISTRATIVE ORDER ON CONSENT STATEMENT OF WORK, RED HILL BULK FUEL STORAGE FACILITY, JOINT BASE PEARL HARBOR-HICKAM, OAHU, HAWAII

Destructive Analysis of 10 Steel Coupons Removed from Red Hill Fuel Storage Tank #14

REPORT No. 201801967

December 17, 2018

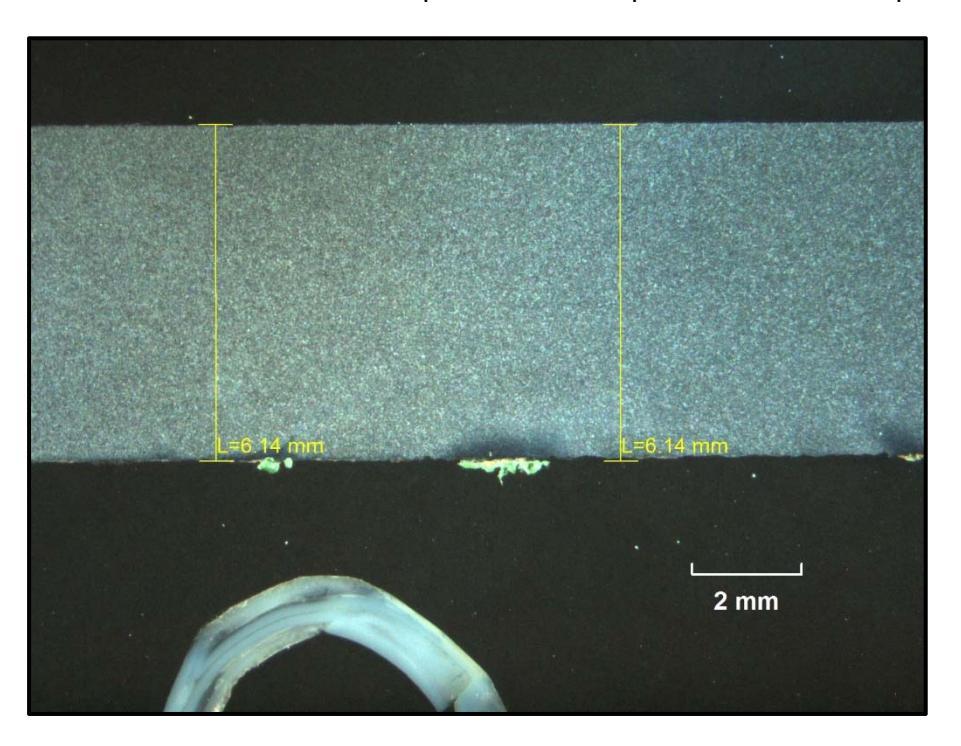
Figure 200. The prepared metallographic cross-section from Sample 10-1 is shown during examination with a stereomicroscope. The thickest location(s) are shown. No pitting was observed. (7X)

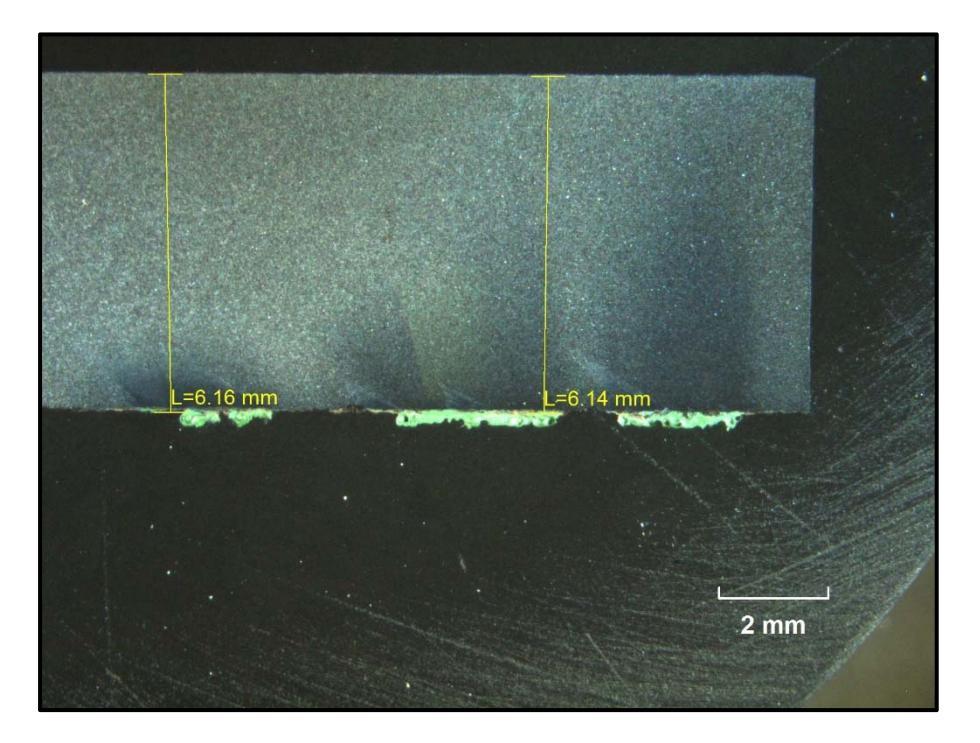
Figure 201. The prepared metallographic cross-section from Sample 10-2 is shown during examination with a stereomicroscope. The thickest location(s) are shown. No pitting was observed. (7X)

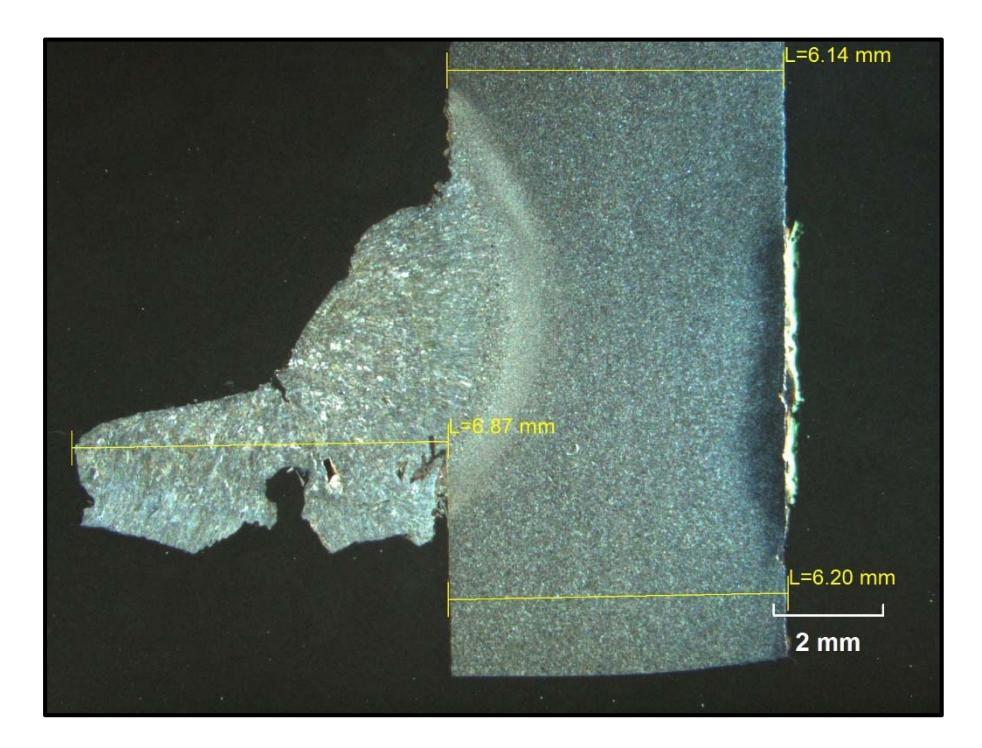
© No pits observed. Suspected NDT inspection indication was a weld nugget on the interior surface of the coupon (thick area) on Sample 10-4.

Figure 202. The prepared metallographic cross-section from Sample 10-4 is shown during examination with a stereomicroscope. Image is rotated 90° from other images. The anomaly detected during NDE was likely the weld nugget on the interior surface of the coupon (left). No pitting or significant wall loss was observed. (7X)

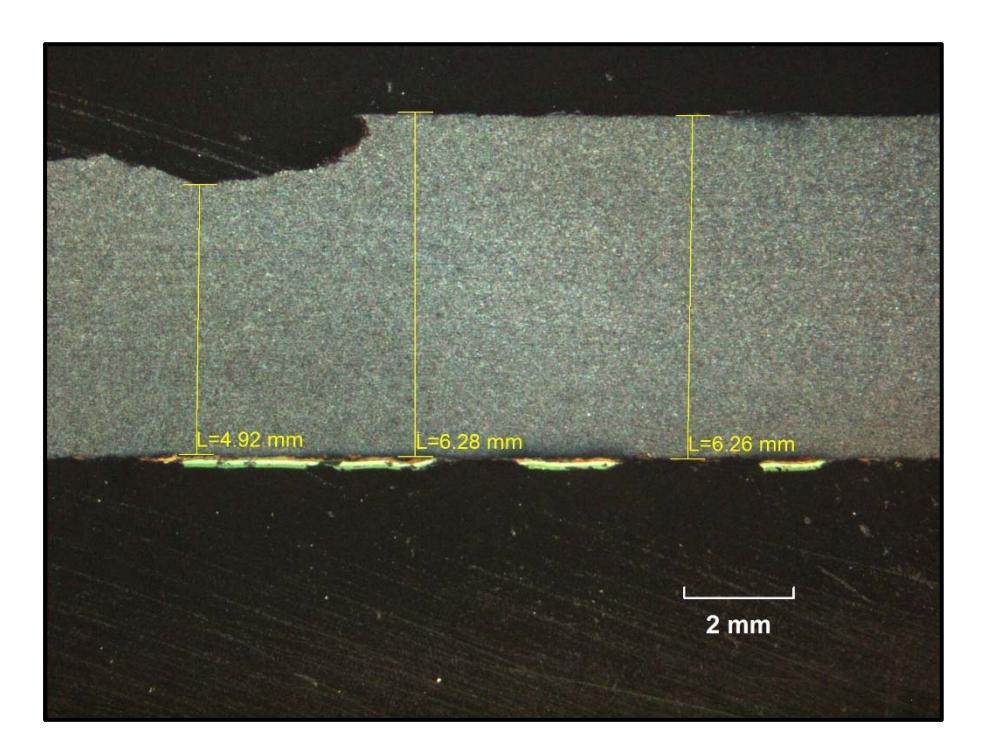
Figure 203. The prepared metallographic cross-section from Sample A1-1 is shown during examination with a stereomicroscope. The thickest location(s) are shown, as well as the thickness remaining underneath the deepest observed pit. (7X)

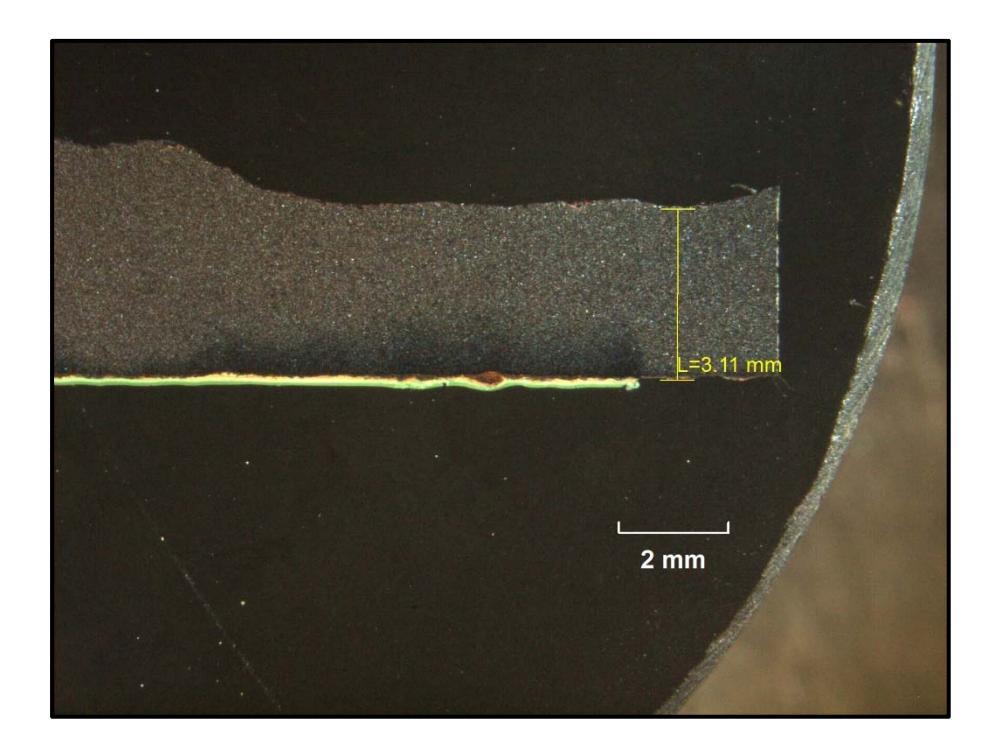
Figure 204. The prepared metallographic cross-section from Sample A1-4 is shown during examination with a stereomicroscope. The thickness remaining underneath the deepest observed pit is shown. (7X)

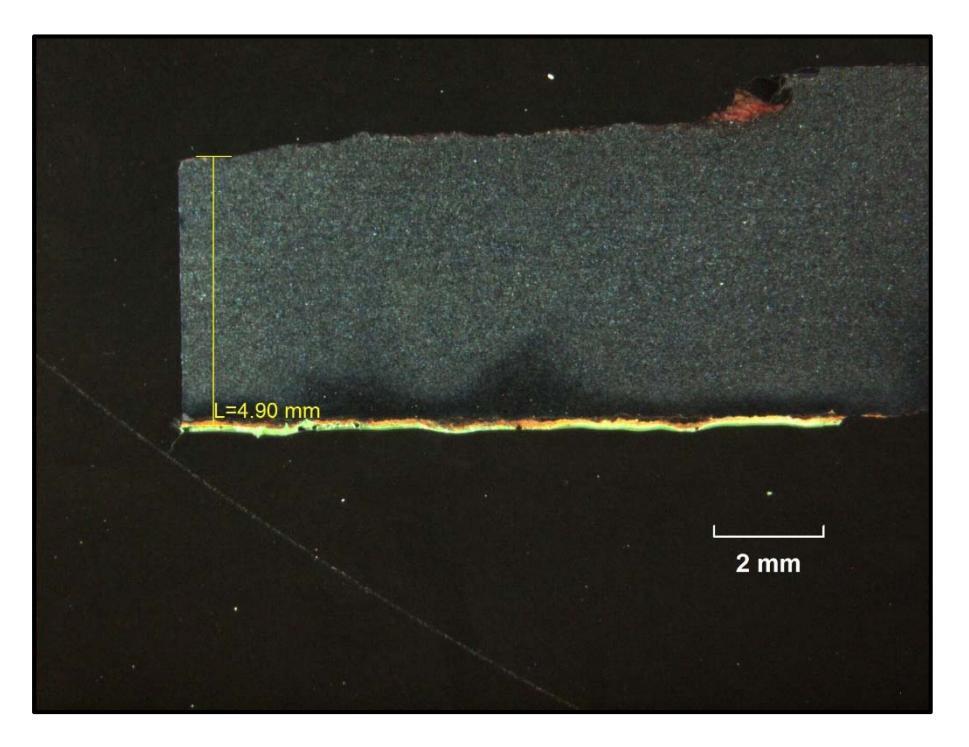
Figure 205. The prepared metallographic cross-section from Sample A1-5 is shown during examination with a stereomicroscope. The thickness remaining underneath the deepest observed pit is shown. (7X)

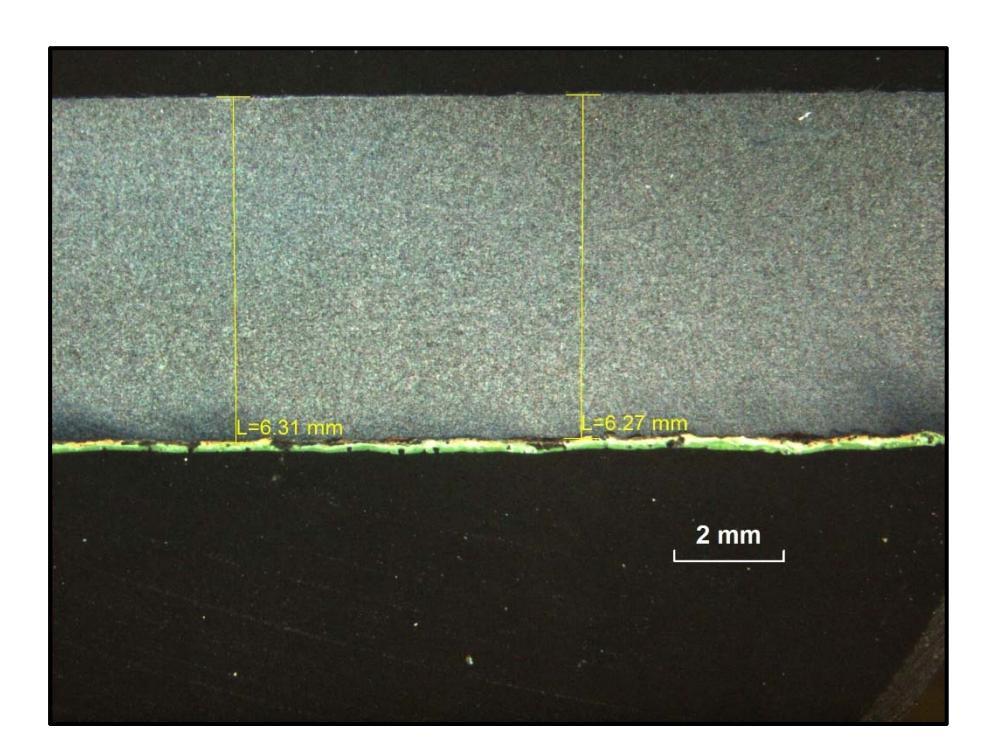
Figure 206. The prepared metallographic cross-section from Sample A2-3 is shown during examination with a stereomicroscope. No pitting was observed. (7X)

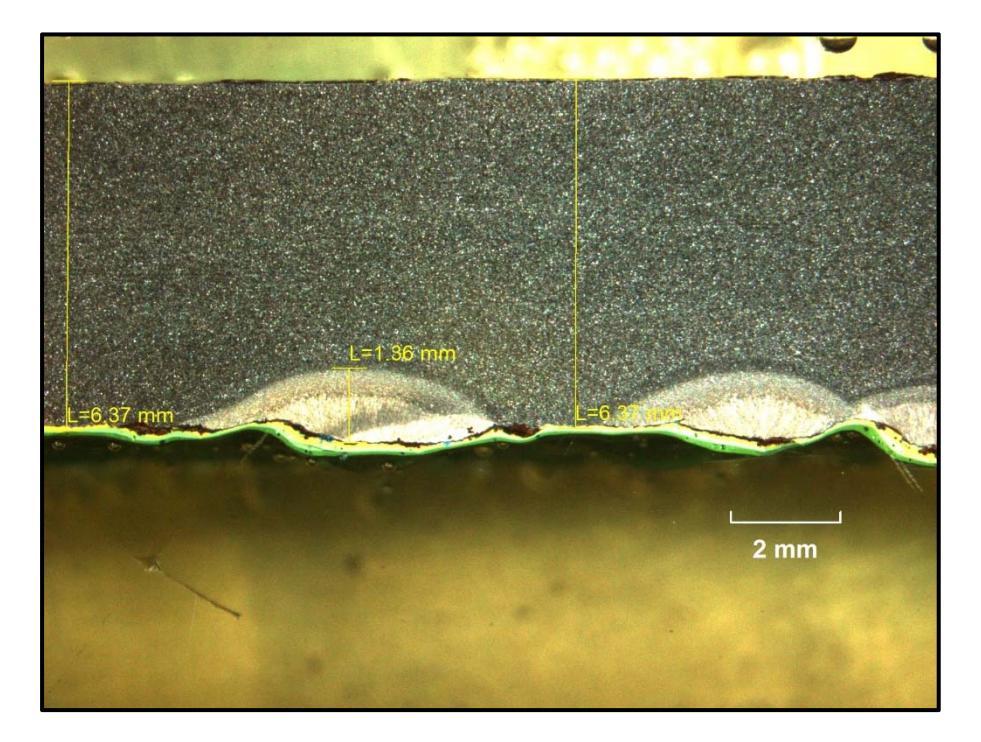
© No pits observed. Suspected NDT inspection indications are areas of melting on the painted face, underneath the paint on Sample A2-4.

Figure 207. The prepared metallographic cross-section from Sample A2-4 is shown during examination with a stereomicroscope. The NDE indication was most likely locations of melting/re-solidification underneath the painted surface. No pitting was observed. (7X)

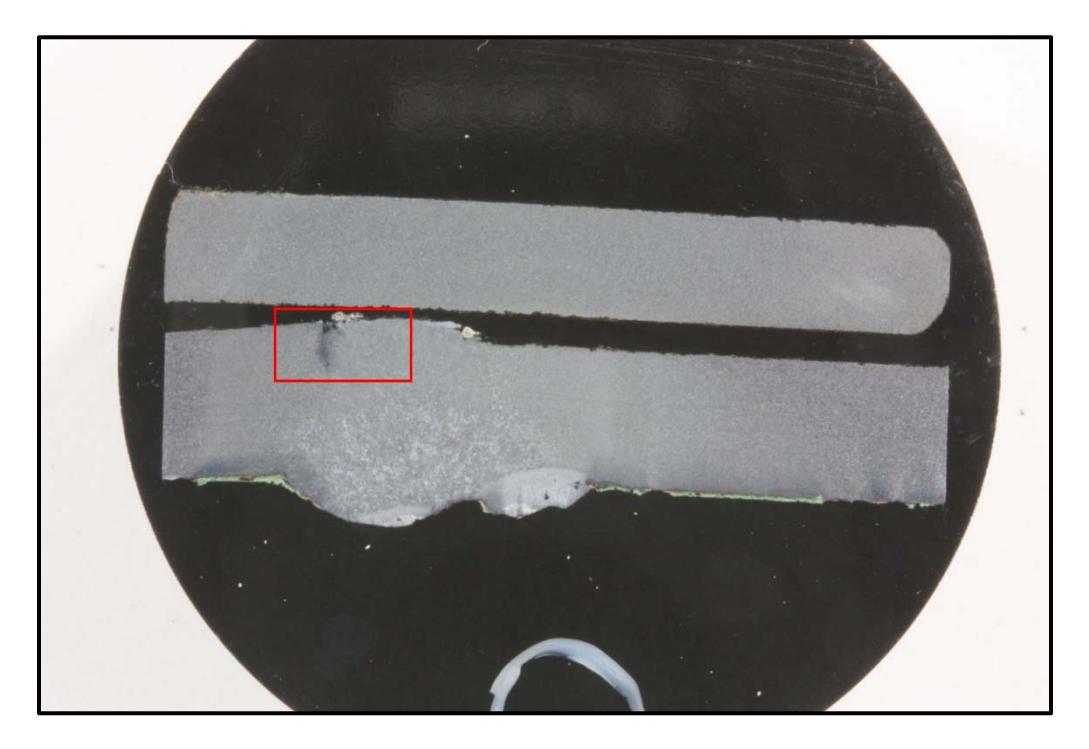
Coupon 8 exhibited what is presumed to be a prior weld repair and/or addition of a backing plate, where a patch was made on the tank wall. Representative images of the welds are presented as Figures 208 through 213. A full weld evaluation is outside the scope of this effort. The results are thus provided for information only.

Figure 208. The prepared metallographic cross-section through welded sample 8-1 is shown in an overall view. The painted exterior surface is along the bottom section. The area identified by the red box is shown in the next figure at higher magnification.
