SECTION 2.2: TANK INSPECTION, REPAIR, AND MAINTENANCE REPORT, dated
11 October 2016

**SITE SPECIFIC REPORT
SSR-NAVFAC EXWC-CI-1655
11 OCTOBER 2016**

**RED HILL FACILITY
TANK INSPECTION, REPAIR, AND MAINTENANCE
REPORT
ADMINISTRATIVE ORDER ON CONSENT (AOC)
STATEMENT OF WORK (SOW), SECTION 2.2**

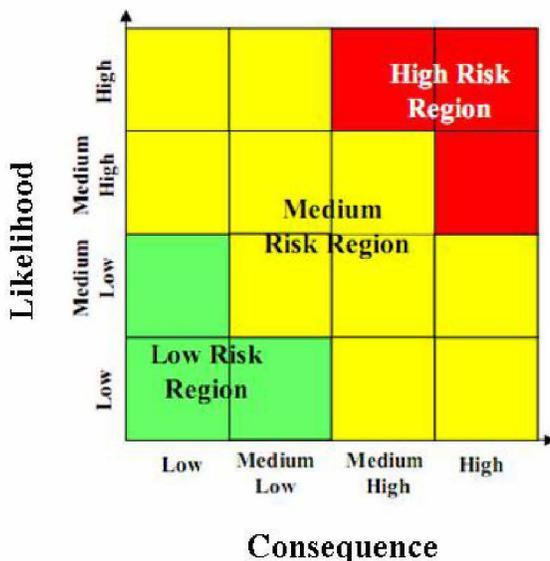
19-3.1 API RP 580 was first published in 2002 and provides a method to determine the frequency of inspection based on the probability of failure verses consequence of failure.

API RP 580 was developed to provide specific guidelines to use in performing a risk-based analysis for tanks, pressure vessels, piping, etc. The document first describes risk assessments. The risks are first identified, and then a determination is made on how to reduce or manage the risk. The document further states that there can never be zero risk based on inspection alone, since there are residual risks due to outside influences such as human error, natural disasters, external events, etc.

API RP 580 discusses how to “determine what incident could occur (consequence)” and “how likely (probability) is that the incident could happen.” This exercise is performed and documented for a variety of events. The document describes the qualitative, quantitative, and semi-quantitative approaches, and then provides the process in combining the approaches for defining probability and consequences.
