DECLARATION OF JAMES G. MEYER

Underground Storage Tank System Evaluation Final Report

FINAL 2015 ANNUAL LEAK DETECTION TESTING REPORT OF 14 BULK FIELD- CONSTRUCTED UNDERGROUND STORAGE TANKS AT RED HILL UNDERGROUND FUEL STORAGE FACILITY

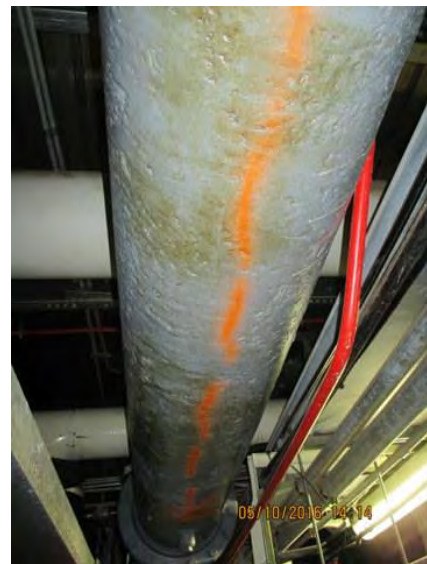
Figure 1. Example of Pitting on Pipeline in Lower Access Tunnel

After the evaluation, Navy personnel indicated that some of the rectifiers had zero readings as a result of the Upper Tank Farm piping and AST cathodic protection system awaiting repairs at the time of the evaluation. As of May 9, 2017, the cathodic protection contractor has made repairs to all rectifiers with the exception of rectifiers 9, 12, and 13 which are scheduled for repair in June 2017. Navy personnel noted that the cathodic protection system has a number of redundancies that still enable cathodic protection coverage with the noted rectifiers off line.

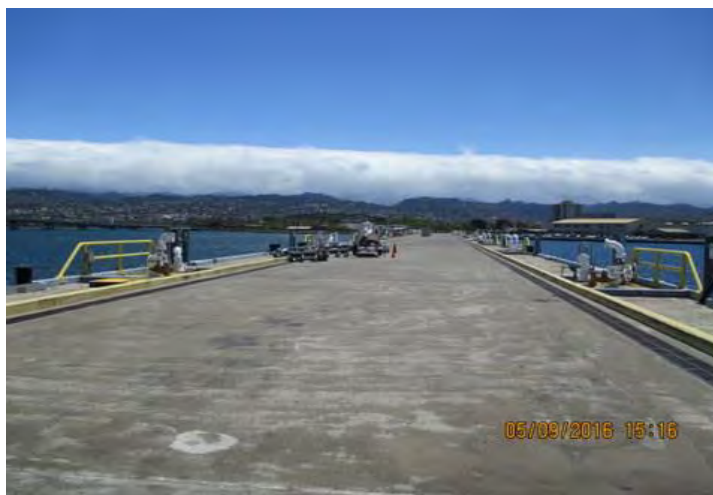
ERG observed multiple visible and audible alarms on the Hotel Pier, but did not test the alarms during the evaluation.

Figure 2. Overview Photo of the Hotel Pier

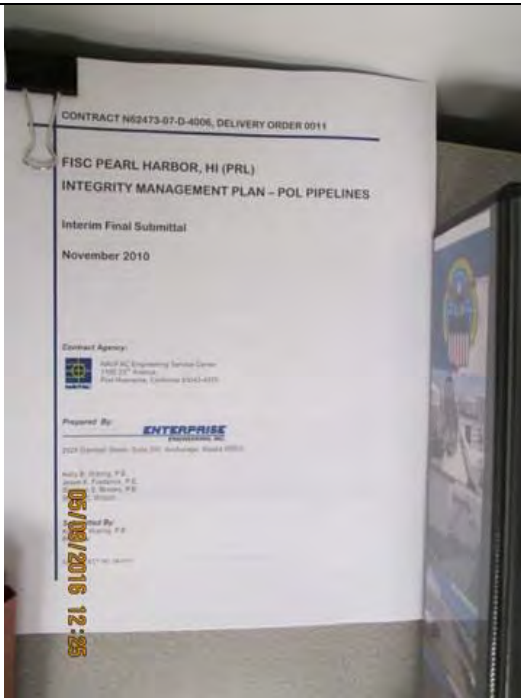
DATE TAKEN: 5/9/2016	
TAKEN BY: Chris Krejci	SITE LOCATION: Red Hill Facility
PHOTO #: 8	
COMMENTS: Tank Tightness Test Binder

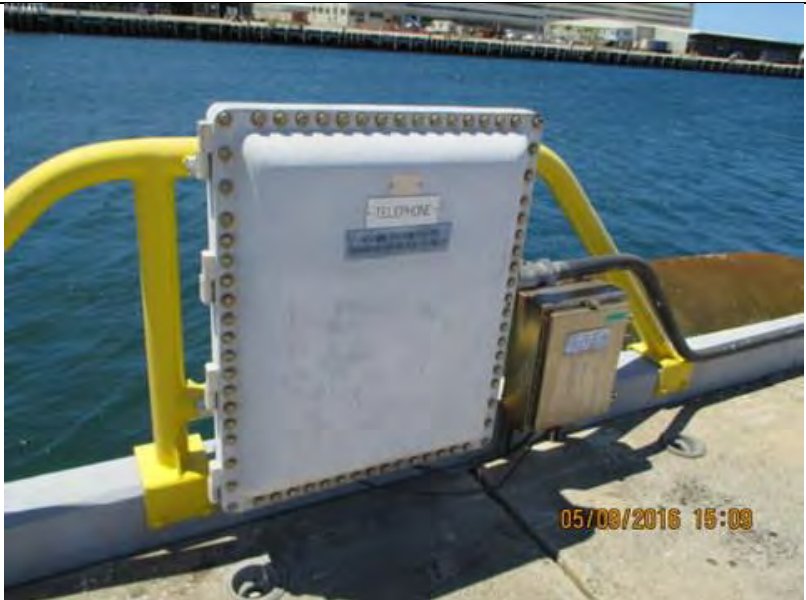
DATE TAKEN: 5/9/2016	
TAKEN BY: Chris Krejci	SITE LOCATION: Red Hill Facility
PHOTO #: 17	
COMMENTS: Trailer mounted flowmeter

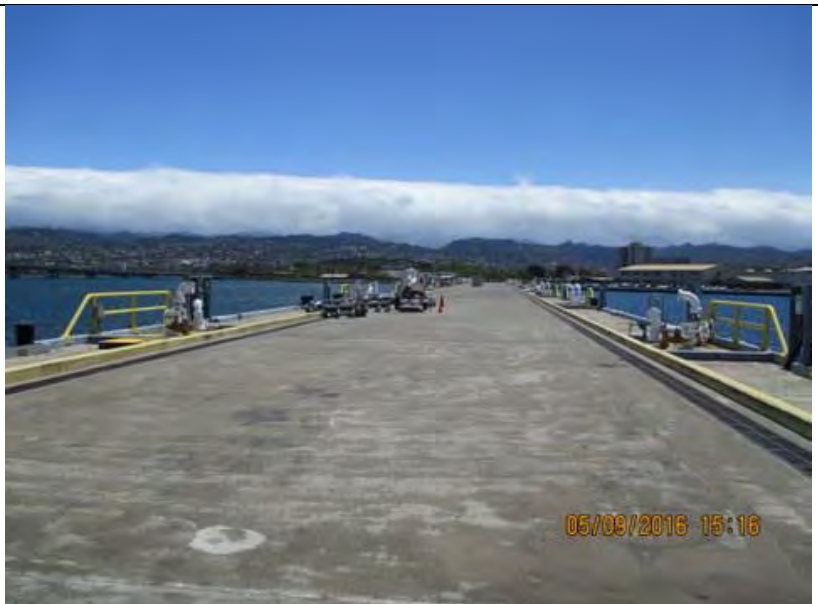
DATE TAKEN: 5/9/2016	
TAKEN BY: Chris Krejci	SITE LOCATION: Red Hill Facility
PHOTO #: 19	
COMMENTS: View of docks adjacent to pier illustrating the boom system in place to control oil spills in emergencies

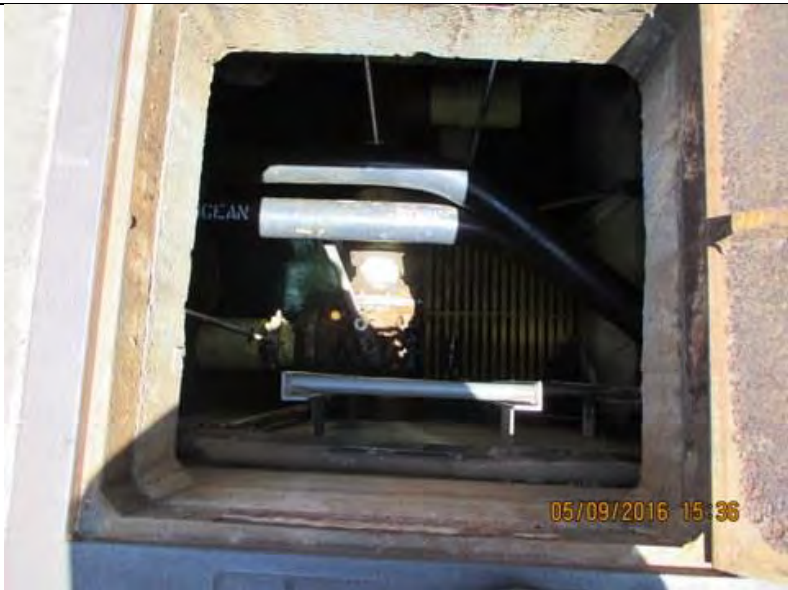
DATE TAKEN: 5/9/2016	
TAKEN BY: Chris Krejci	SITE LOCATION: Red Hill Facility
PHOTO #: 24	
COMMENTS: Hotel Pier alarms

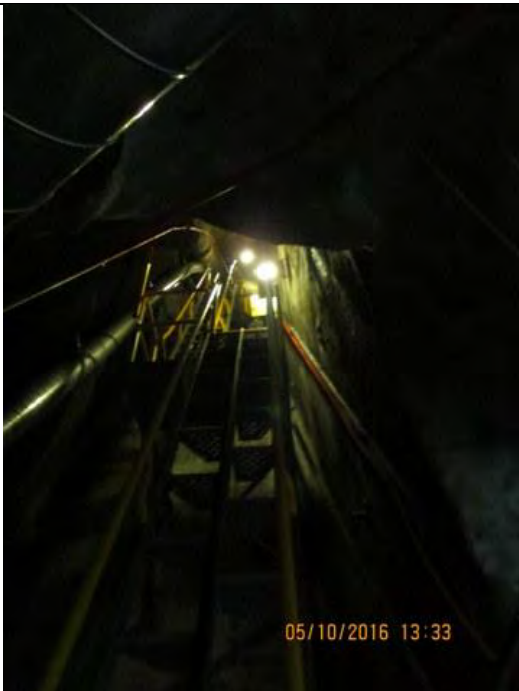
DATE TAKEN: 5/10/2016	
TAKEN BY: Chris Krejci	SITE LOCATION: Red Hill Facility
PHOTO #: 36	
COMMENTS: SP-26 Underground storage tank nozzle and skin valve

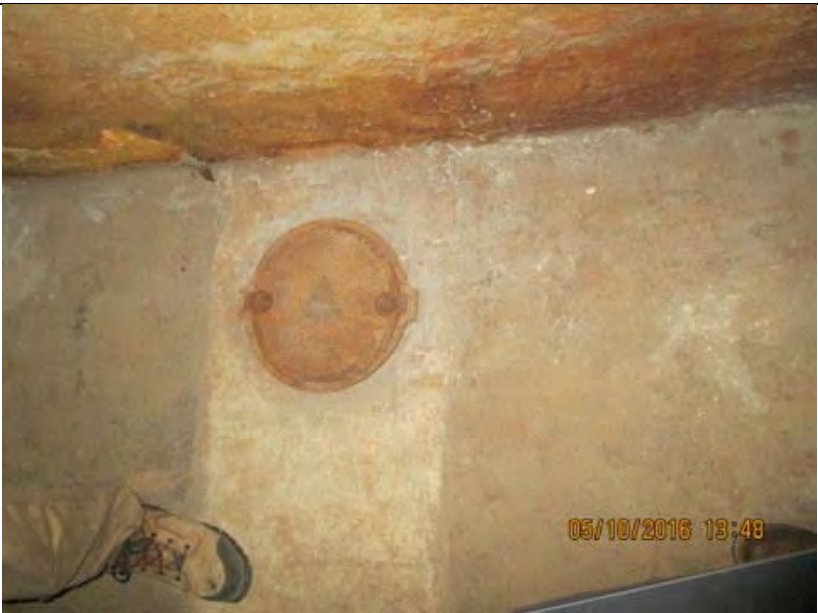
DATE TAKEN: 5/10/2016	
TAKEN BY: Chris Krejci	SITE LOCATION: Red Hill Facility
PHOTO #: 38	
COMMENTS: Pipeline running to fuel oil recovery (FOR) process

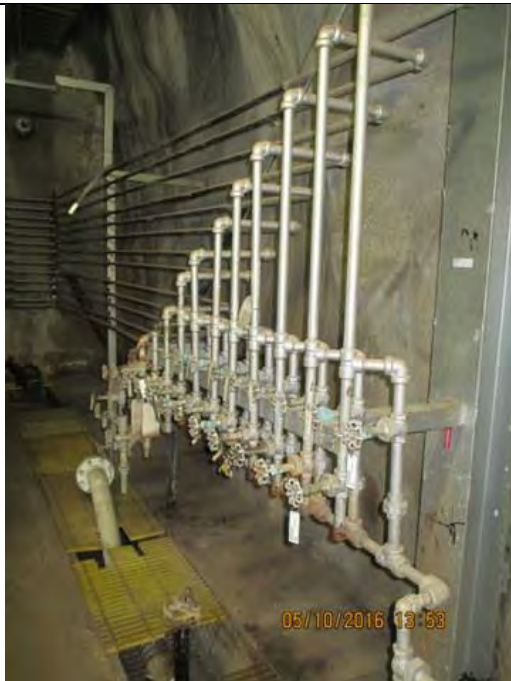
DATE TAKEN: 5/10/2016	
TAKEN BY: Chris Krejci	SITE LOCATION: Red Hill Facility
PHOTO #: 40	
COMMENTS: Tell-tale system on Tank 19 (Tank 19 has been permanently removed from service and the tell-tale system has been decommissioned).

The Red Hill Facility employs three methods of leak detection: (1) annual tank tightness testing; (2) ATG; and (3) soil gas monitoring. Although the Navy conducts groundwater monitoring, EPA does not consider this activity to be a leak detection method at this site. Each of these methods, including groundwater monitoring, is described in the subsections below. In addition to these methods, the Red Hill Facility previously employed the use of a tell-tale system comprising a series of steel pipes that penetrated the walls of the USTs near the tank bottom to observe fluid outside the steel shell of each tank; however, this system was decommissioned at all of the tanks and is no longer used due to concerns regarding corrosion and vulnerability of the tell-tale piping to leakage.

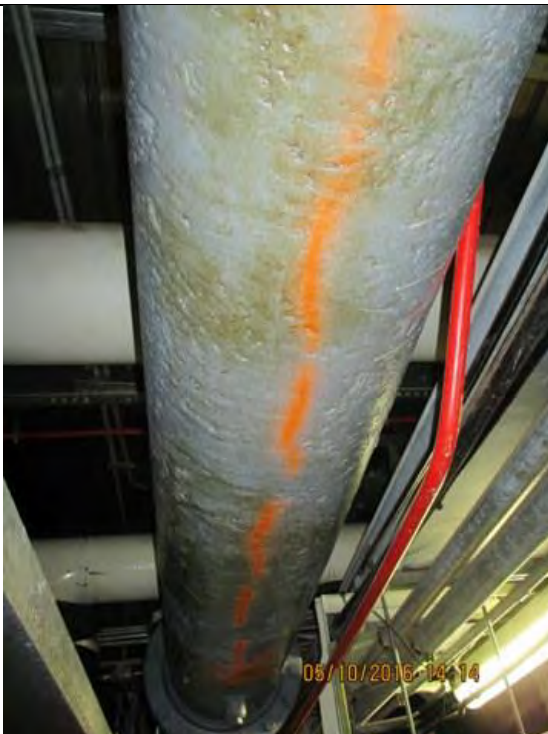
DATE TAKEN: 5/10/2016	
TAKEN BY: Chris Krejci	SITE LOCATION: Red Hill Facility
PHOTO #: 43	
COMMENTS: Typical surface defects on pipeline

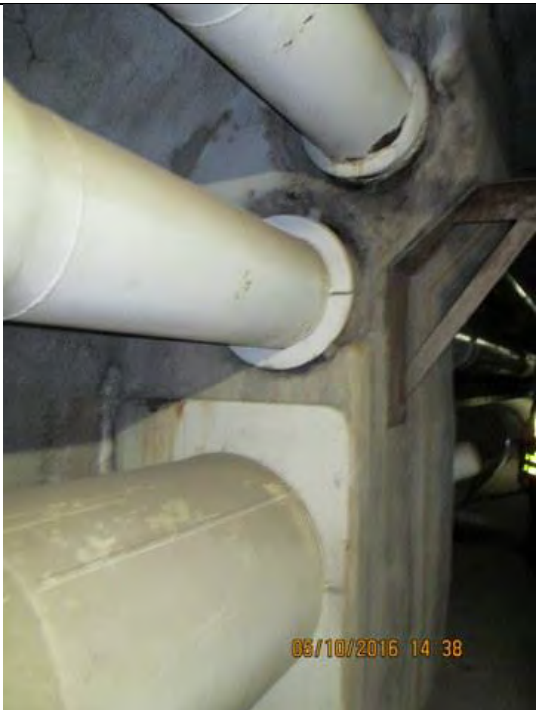
DATE TAKEN: 5/10/2016	
TAKEN BY: Chris Krejci	SITE LOCATION: Red Hill Facility
PHOTO #: 50	
COMMENTS: Pipelines supported by concrete wall in tunnel

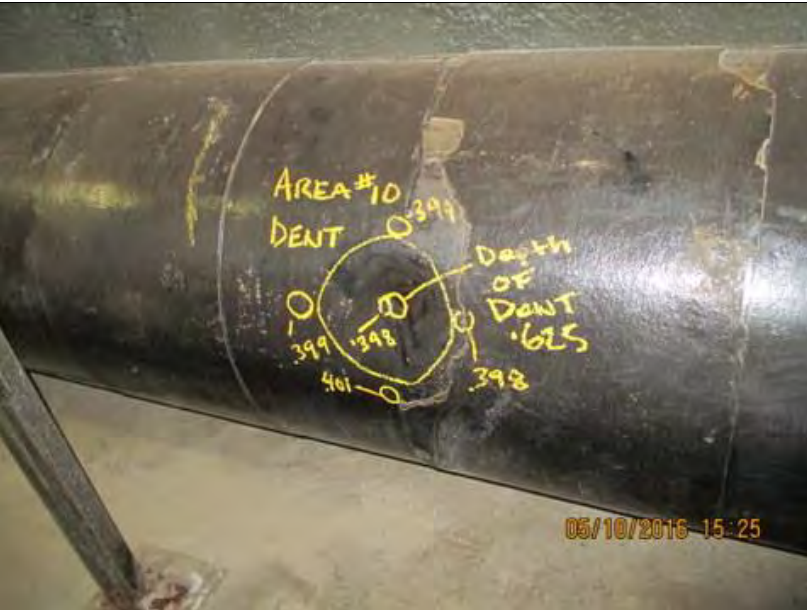
DATE TAKEN: 5/10/2016	
TAKEN BY: Chris Krejci	SITE LOCATION: Red Hill Facility
PHOTO #: 56	
COMMENTS: Markings describing pipe defects

A photograph of a pipe with a circular dent. Handwritten in yellow paint are the markings 'AREA #10 DENT' and 'Depth OF DENT .625'. Several small circles are drawn around the dent with measurements: '399', '398', '401', and '398'. A timestamp '05/10/2016 15:25' is visible in the bottom right corner.
