INITIAL PHASE II
SITE CHARACTERIZATION REPORT
FLEET INDUSTRIAL SUPPLY CENTER
BULK FUEL STORAGE FACILITY
AT
RED HILL

Pacific Division
Naval Facilities Engineering Command
Pearl Harbor, Hawaii 96860

Ogden Environmental and Energy Services Co., Inc. 680 Iwilei Road, Suite 660 Honolulu, HI 96817

March 1999

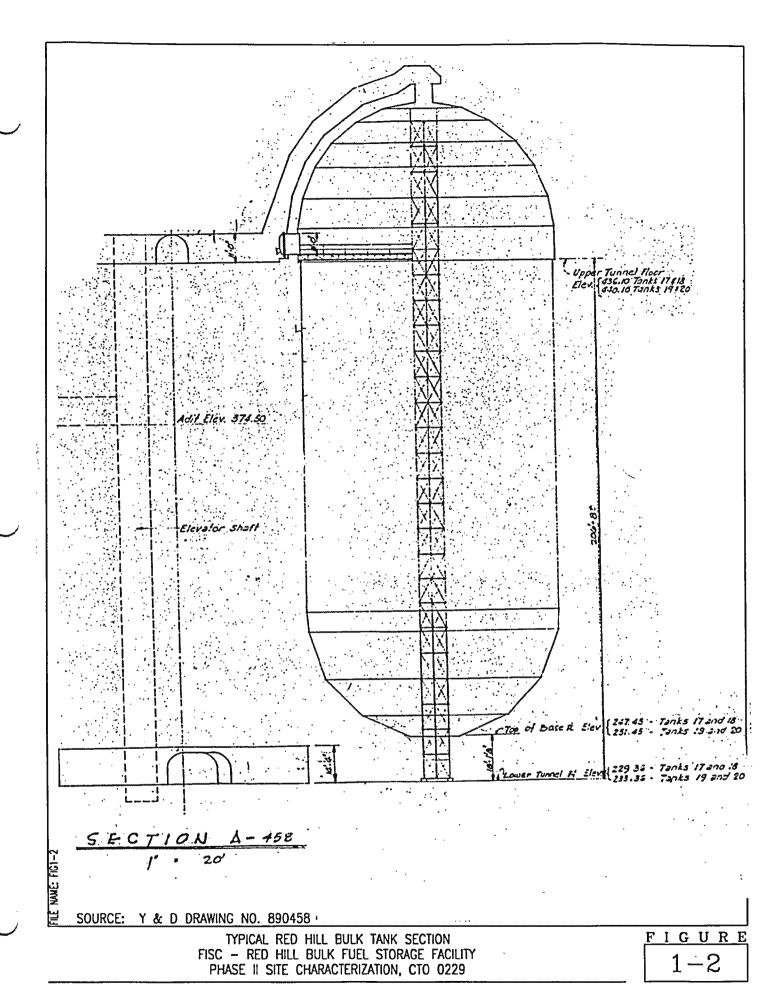
Based on interviews and plan file drawings, construction of the bulk fuel farm began with the surface of Red Hill being removed to allow for vertical construction. Each tank pit was blasted from the basalt, utilizing a central vertical tunnel and radial blast tubes. Once the tank pits were opened, the steel tank segments were field constructed and placed into the pits in sections. The construction started with the lower dome being built in place. Once the lower dome was in place, the lowest portion was encased in a concrete bed. This method was generally followed for an entire tank as it progressed to the upper dome. Upon completion of the tank, small diameter holes were drilled in the sides of the tank and through the concrete bed. A 10 to 1 grout mixture was injected into the surrounding bedrock at approximately 300 pounds of pressure per square inch (psi). This method was utilized to close all possible seams and blasting fractures that may have been created during construction. (Please refer to Figure 1-2; Typical Red Hill Bulk Tank Section).

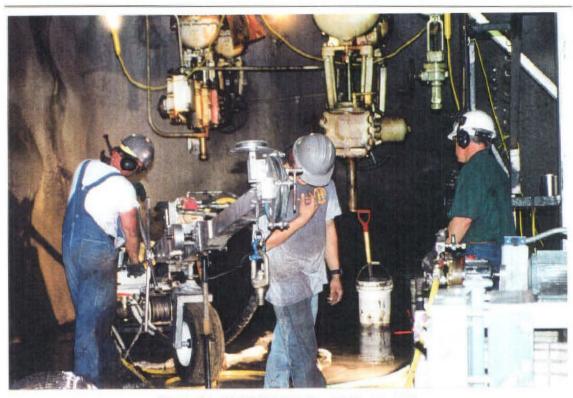
Figure 4-1 SAITECH EH5 Core Drill - Tank 16

The drilling equipment utilized for this project consisted of a SAITECH EH5 portable hydraulic diamond tip core drill, a remote hydraulic pump system, an electrical converter, and a remote water supply assembly. The core drill was a conventional mobile system,

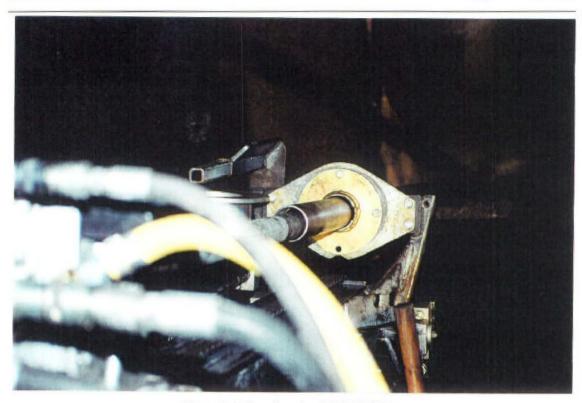
Figure 4-5 Core Barrel - SAITECH EH5

utilizing a recovery tube capable of retrieving 1¼" diameter size rock core. This drill method was chosen based upon the shallow coring depths, and restricted tunnel height. The configuration of this rig allowed for the capacity to drill to a depth of 400 feet if needed.

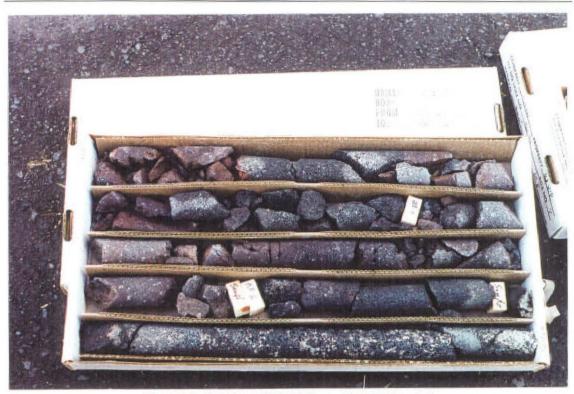
Petroleum staining/saturation was observed on core segments collected from borings 16A and 16C. The petroleum substance appeared to be a mixture of a thick, heavy oil with an odor similar to diesel. Specifically, the stained segments were encountered in boring 16A at two locations (approximately 83' to 86' and 101' to 104') and in boring 16C between 60' and 69'. Core samples from these segments were retained for analytical evaluation. (Please refer to Figures 4-1 through 4-10, located at the end of this section for core sample photos.)

Figure 4-7 Petroleum Stained Core - B16C, 49' to 60'

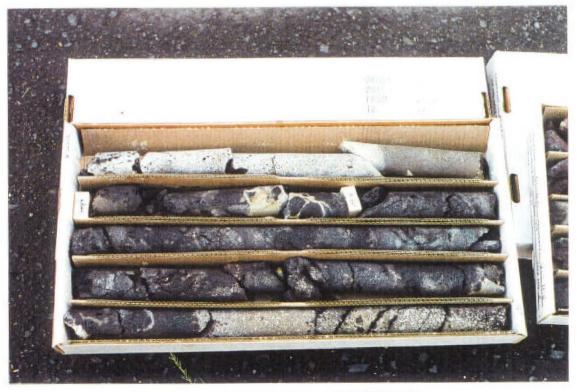
Figure 4-8 Petroleum Stained Core - B16C, 60° to 69°

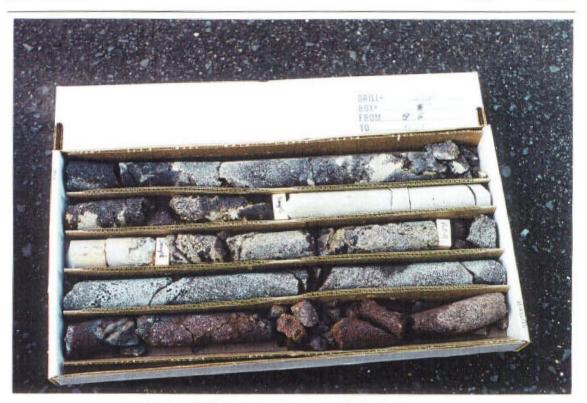
Figure 4-9 Petroleum Stained Core - B16A, 81' to 91'

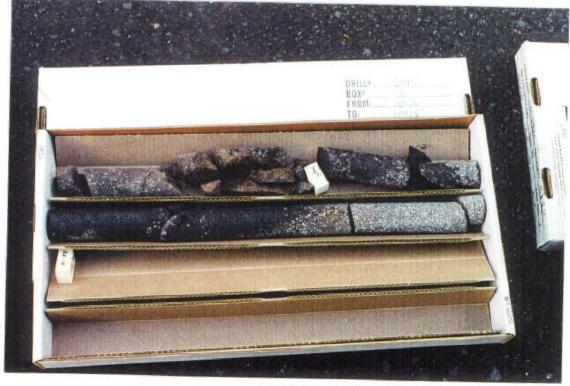
Figure 4-10 Petroleum Stained Core - B16A, 100' to 104'
