**CONAM MMP INSPECTION INC**  
PROJECT: RED HILL TANK # 13  
ITEM: FLOOR LAYOUT  
BY: L. Woodman DATE: 7/3/95  
CLIENT: AMAN ENVIRONMENTAL  
REMARKS: \_\_\_\_\_

PROJECT: RED HILL TANK # 13

ITEM: FLOOR LAYOUT

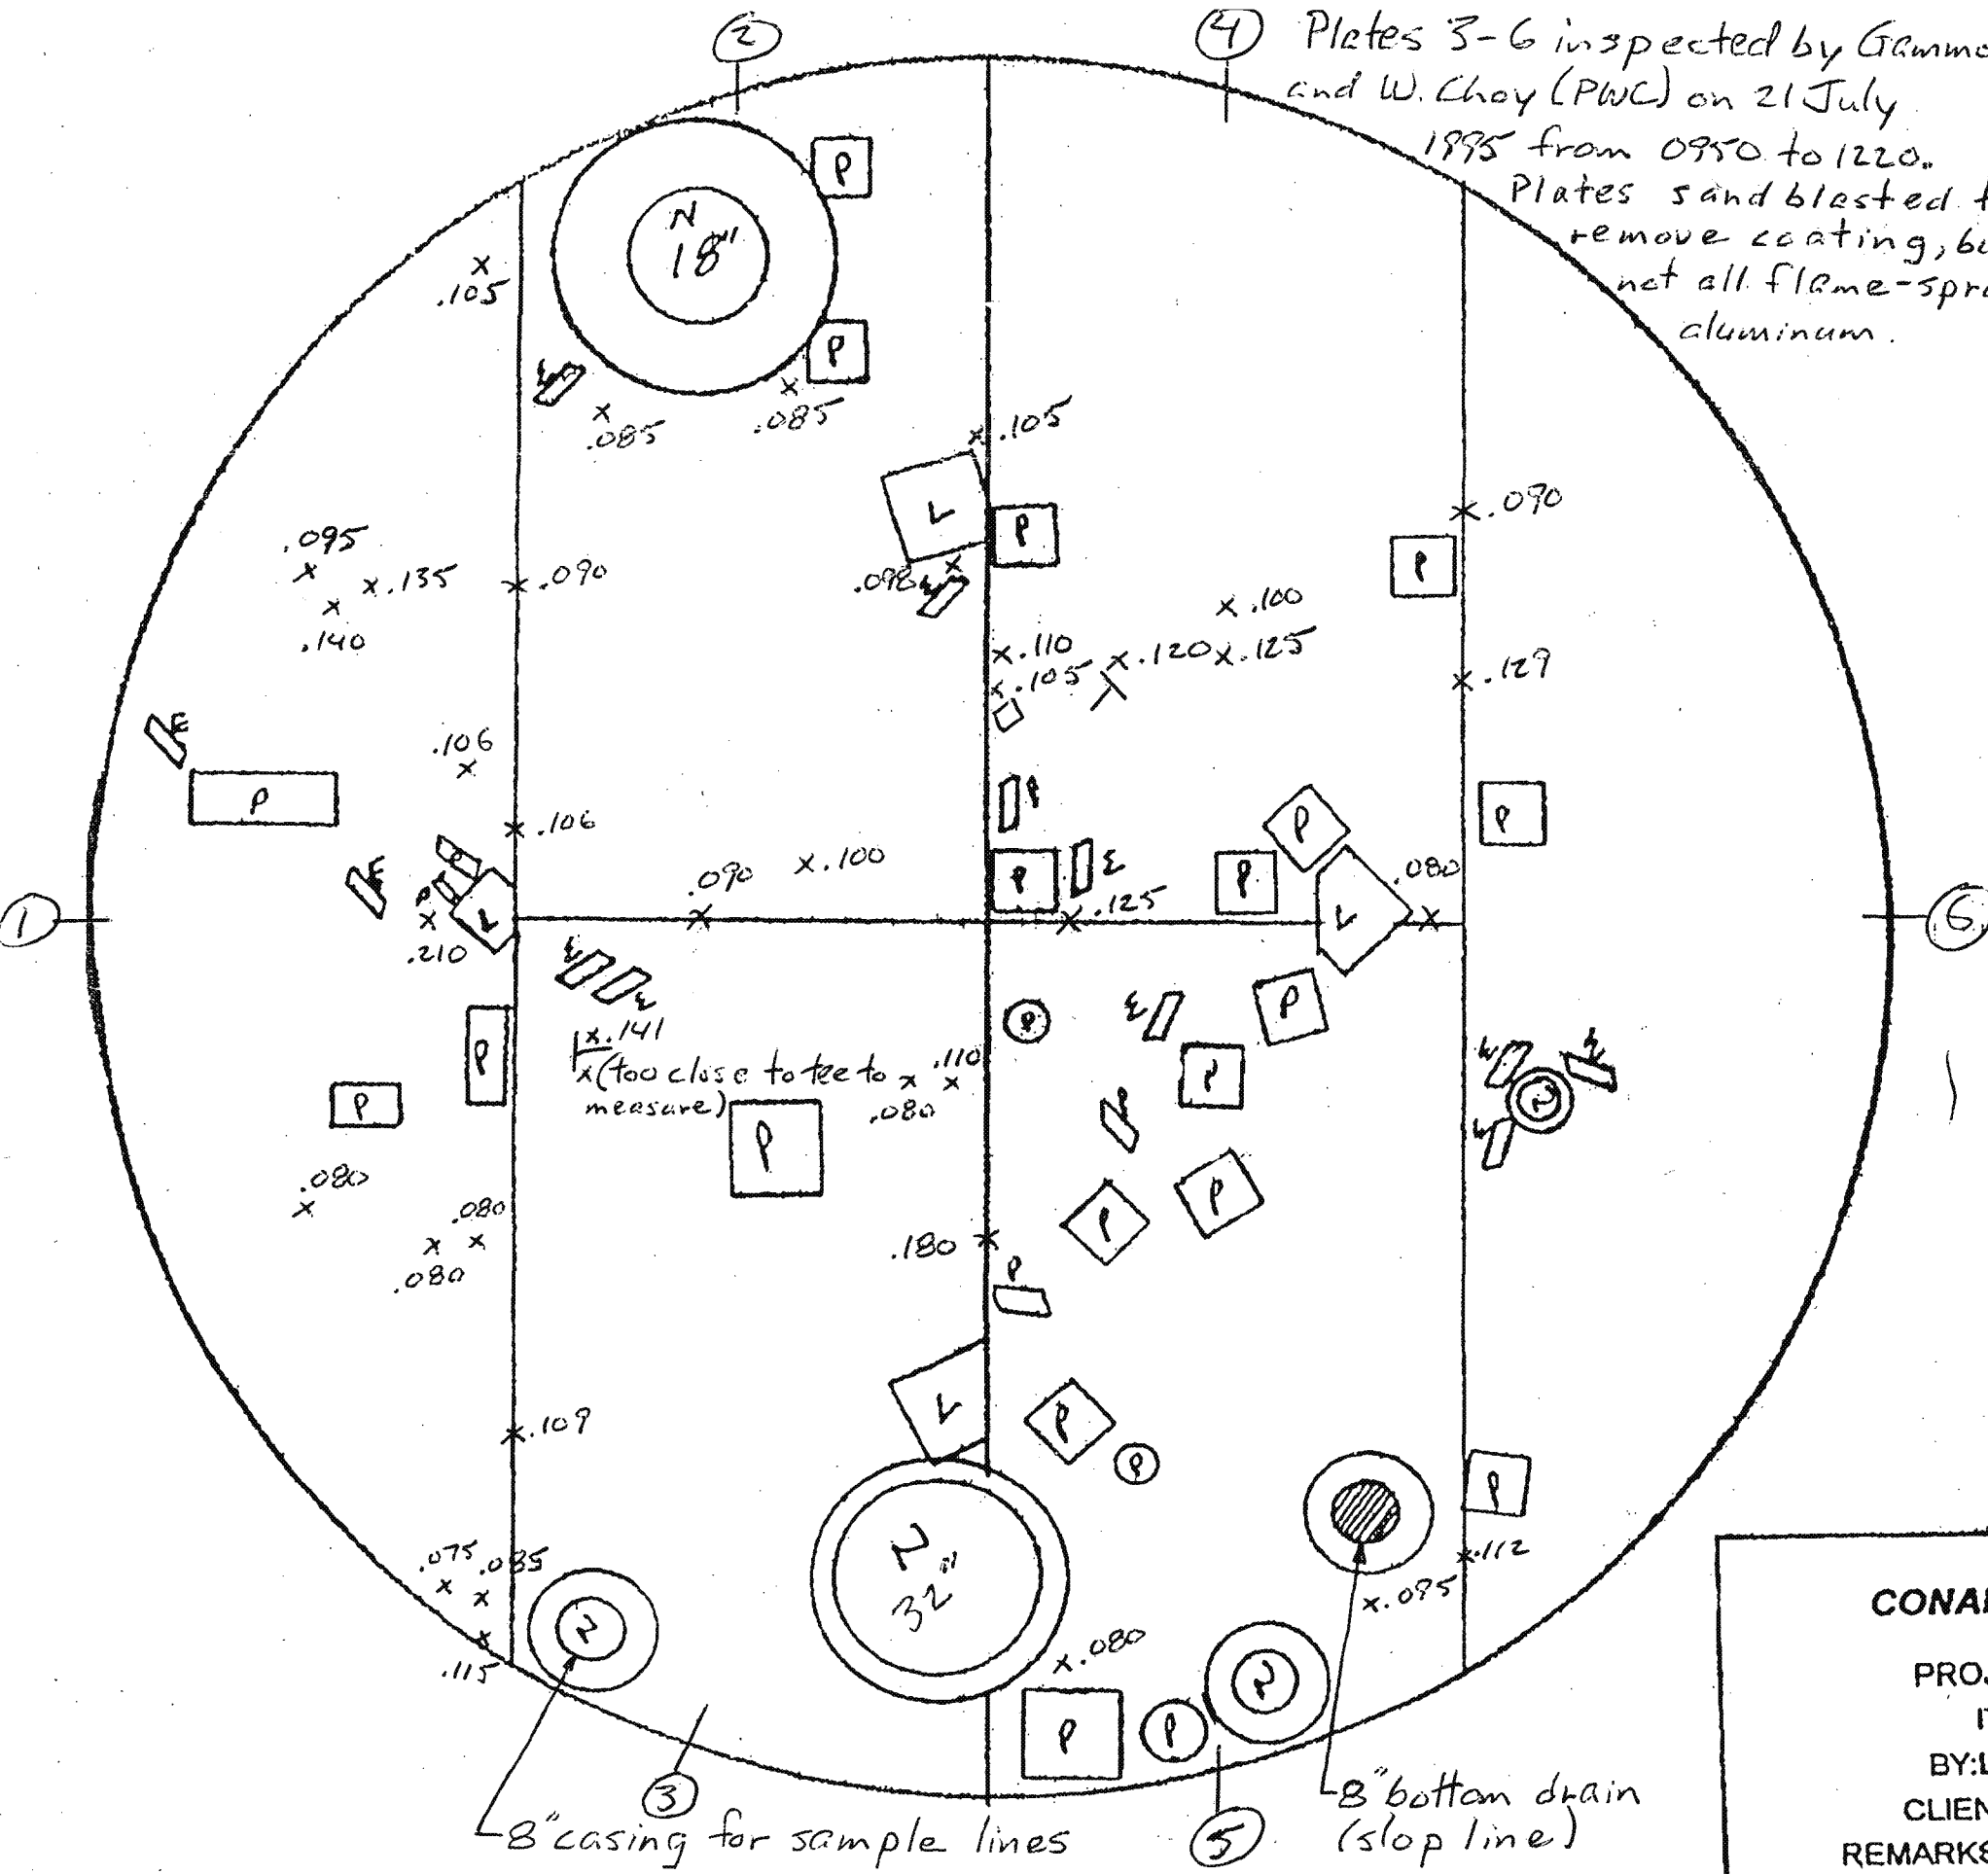
Plates 3-6 inspected by Gammon and W. Choy (PWC) on 21 July 1995 from 0950 to 1220. Plates sand blasted to remove coating, but not all flame-sprayed aluminum.

Plates 1 and 2 inspected by J. Gammon (FSC) and R. Koyama (PWC) on 20 July 1995 from 1005 to 1115. Plates sandblasted as noted above.

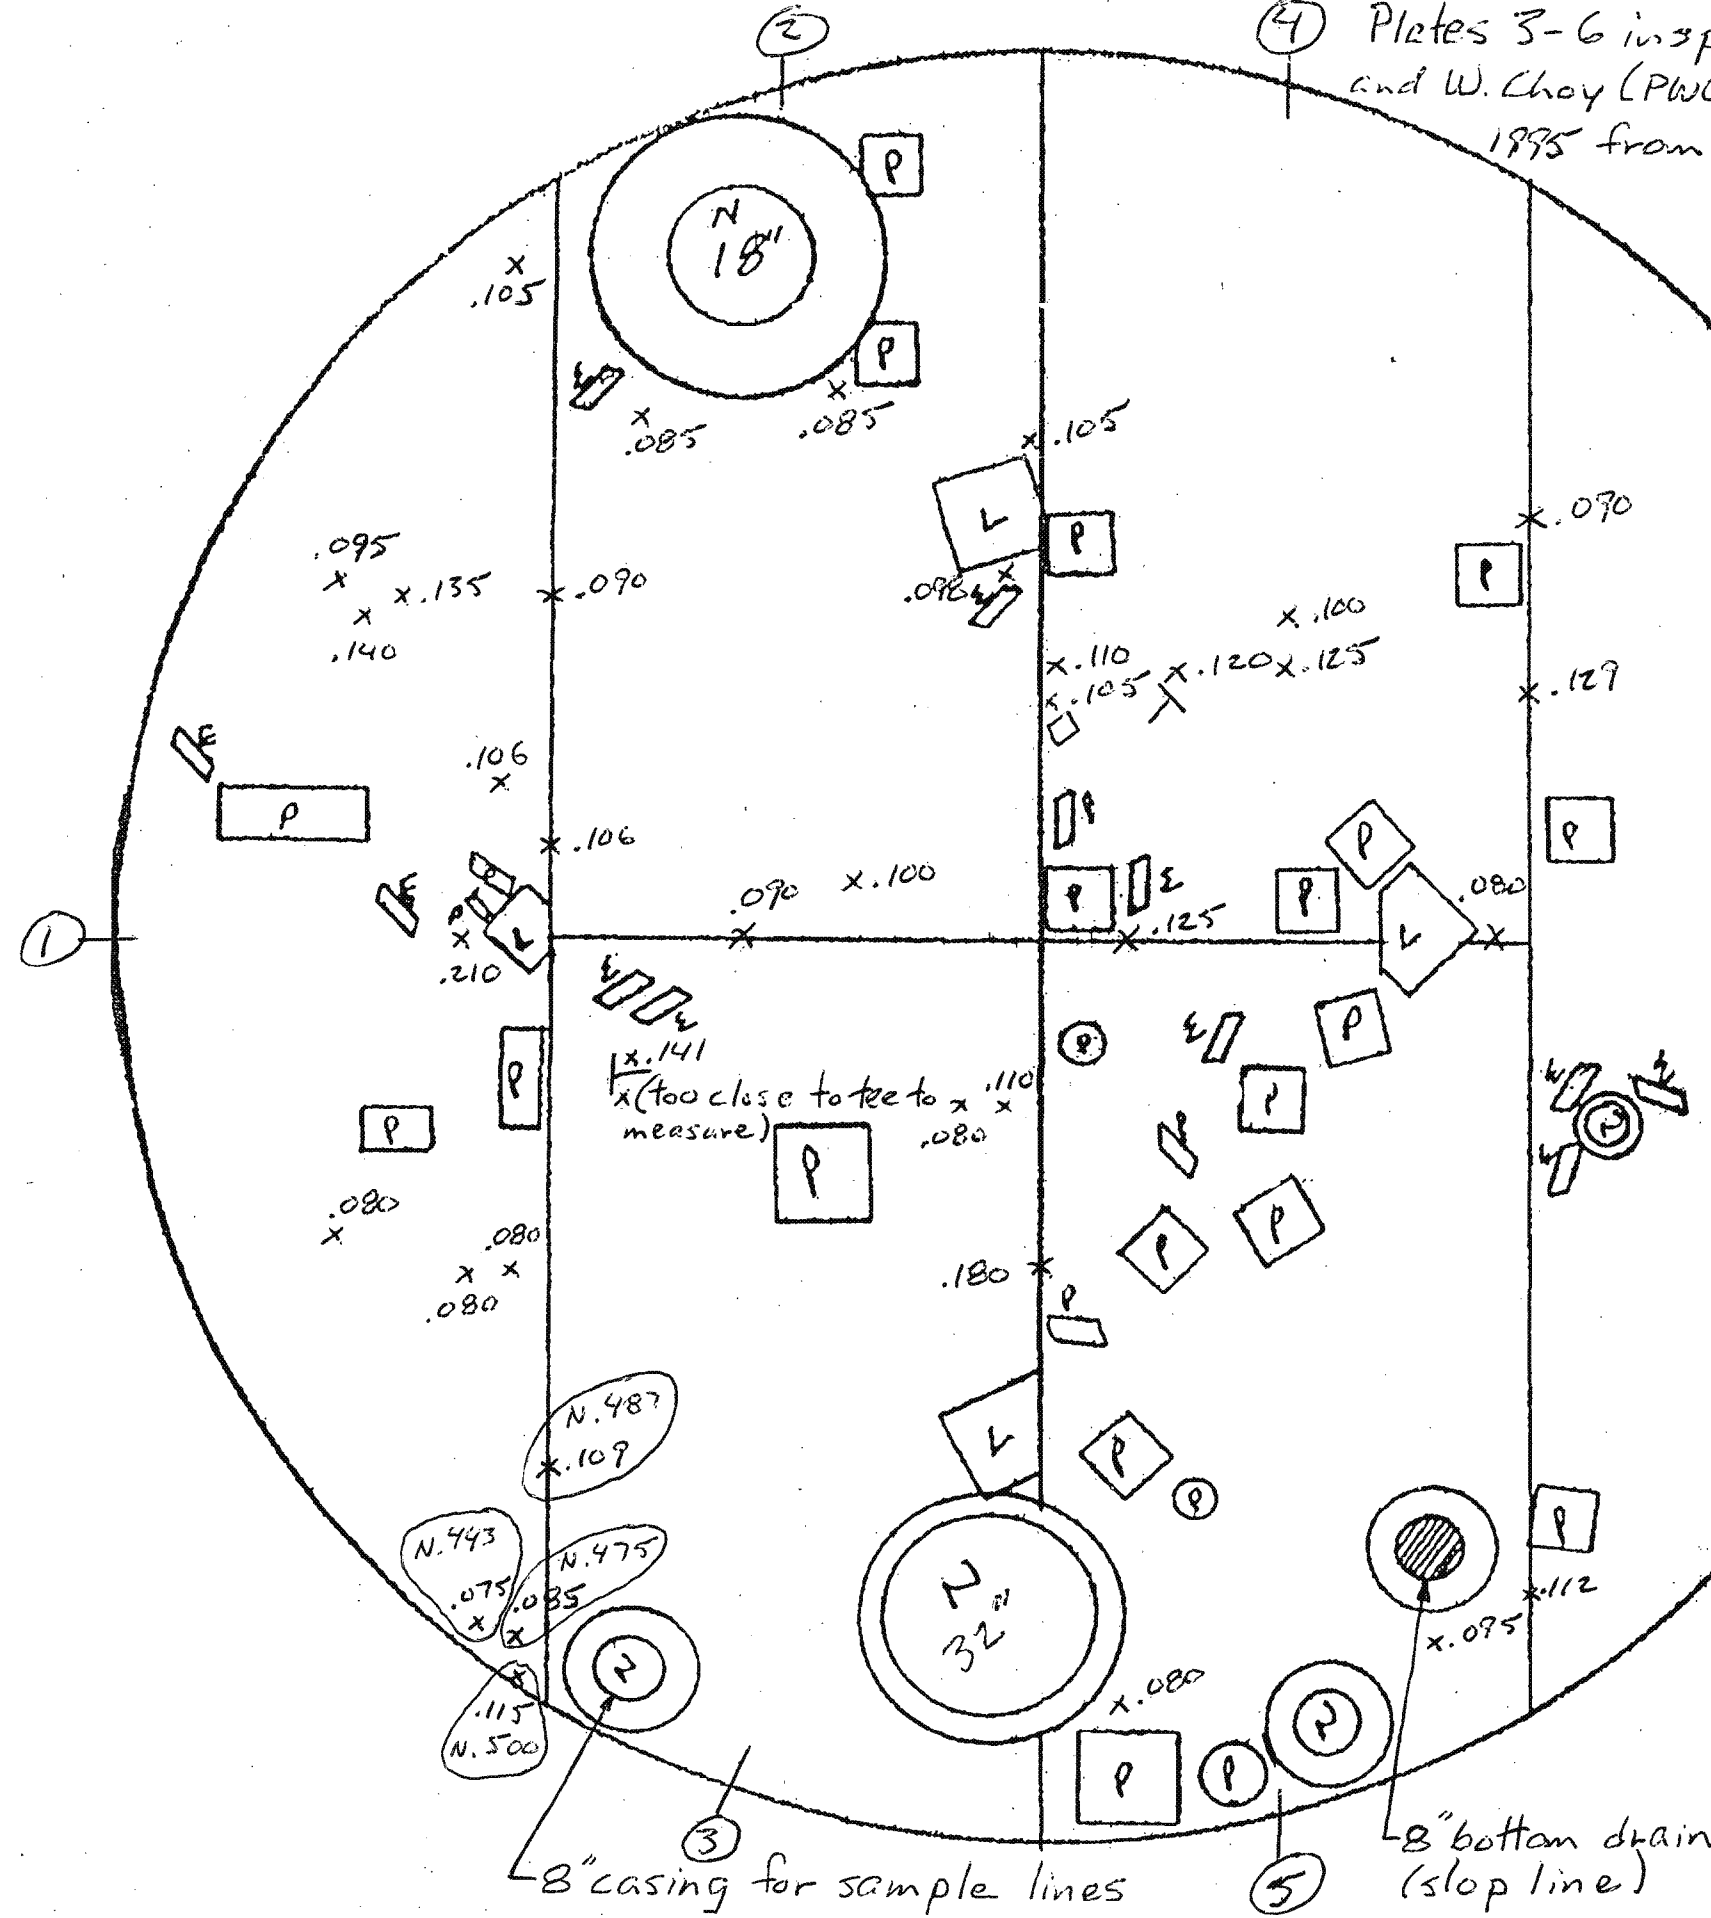
Plates 3-6 inspected by Gammon and W. Choy (PWC) on 21 July 1995 from 0950 to 1220

N = plate thickness next to pit  
 B = plate thickness at bottom of pit

Plates 1-6 inspected by B. Dmitrijev and J. Gammon (KISC), R. Koyama (PWC); and HT1 J. Shell and HT1 R. Hall (SUBASE IMF NDT Shop) on 28 July 1995 from 1610 to 1800. Shell and Hall are certified Level 2 inspectors. Plates 1, 2, and part of plates 2 and 3 outside of tower were blasted to white metal.

Plates 1 and 2 inspected by J. Gammon (KISC) and R. Koyama (PWC) on 20 July 1995 from 1005 to 1115. No 5063

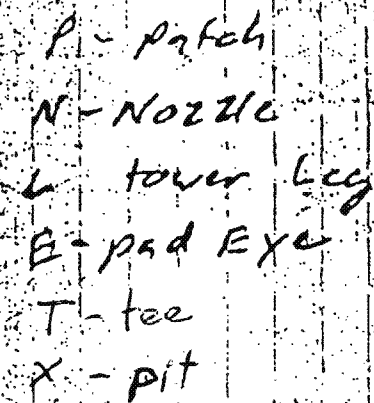
No 5063

P - patch  
 N - Nozzle  
 L - tower Leg  
 E - pad Eye  
 T - tee  
 X - pit location and depth

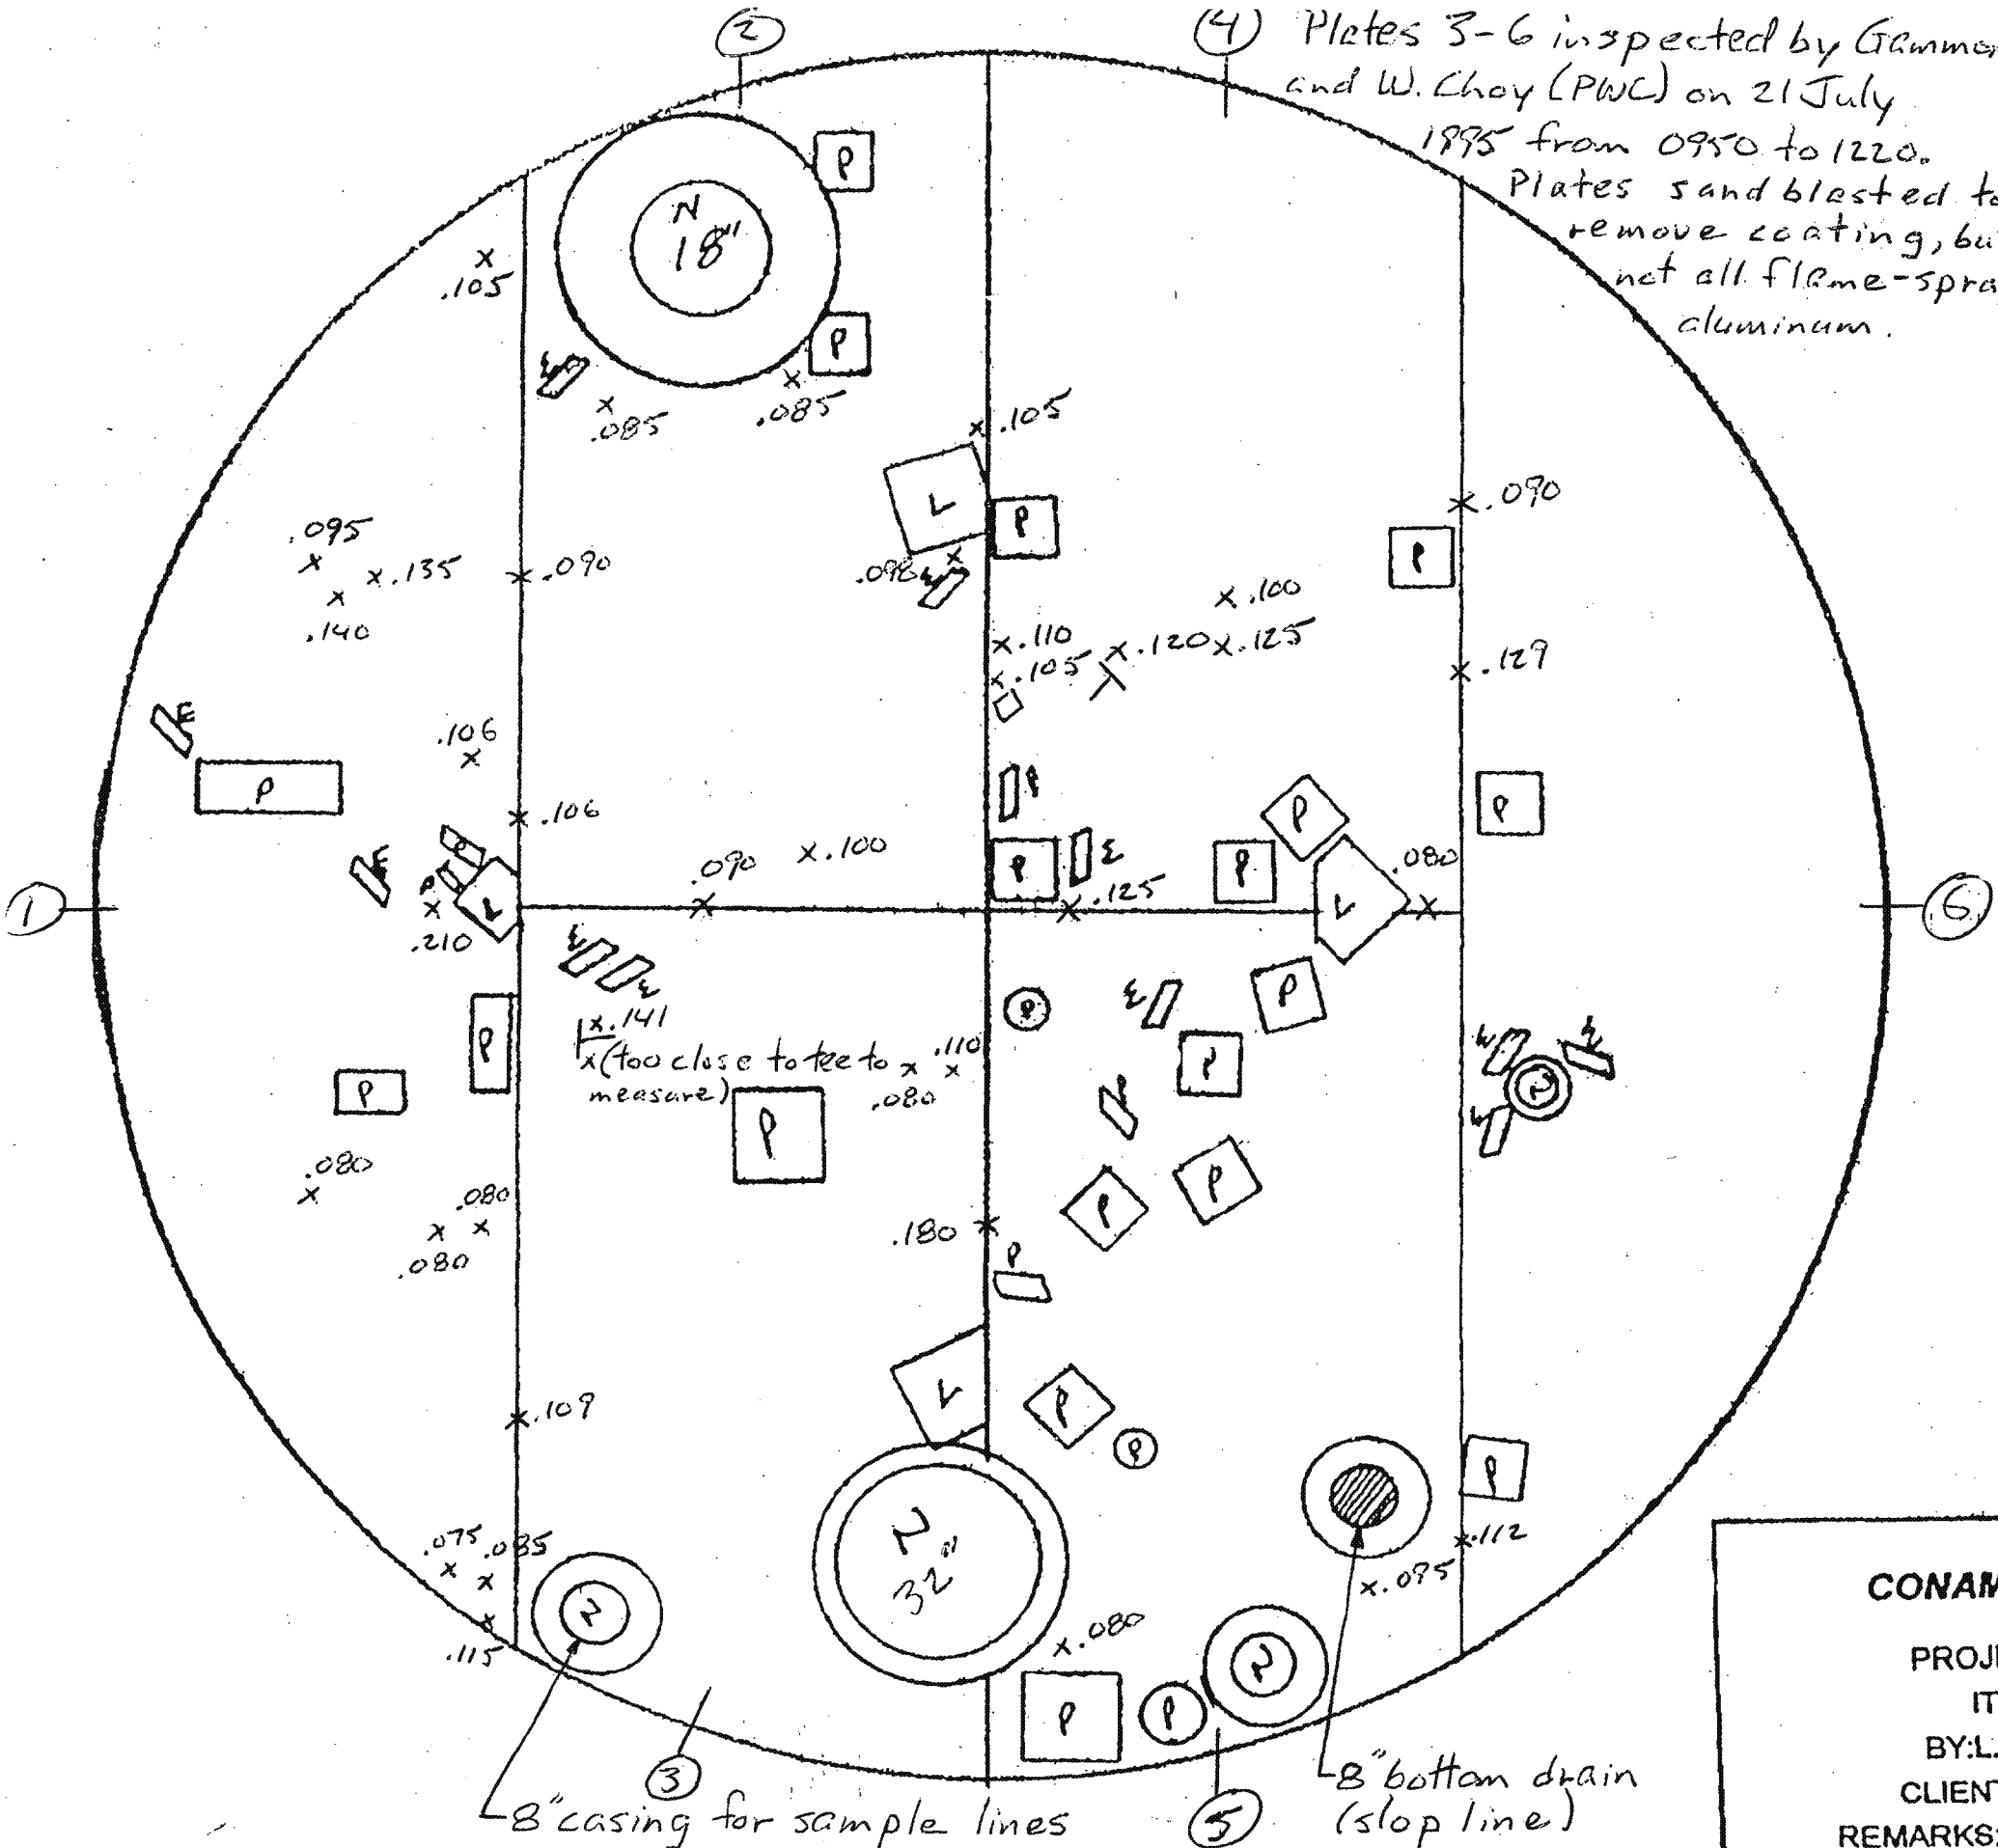
I.P. Form No. 09011 Rev. 2/92  
 Plates 1 and 2 inspected by J. Gammon (FSL) and R. Koyama (PWC) on 20 July, 1995 from 1005 to 1115. Plates sandblasted as noted above.

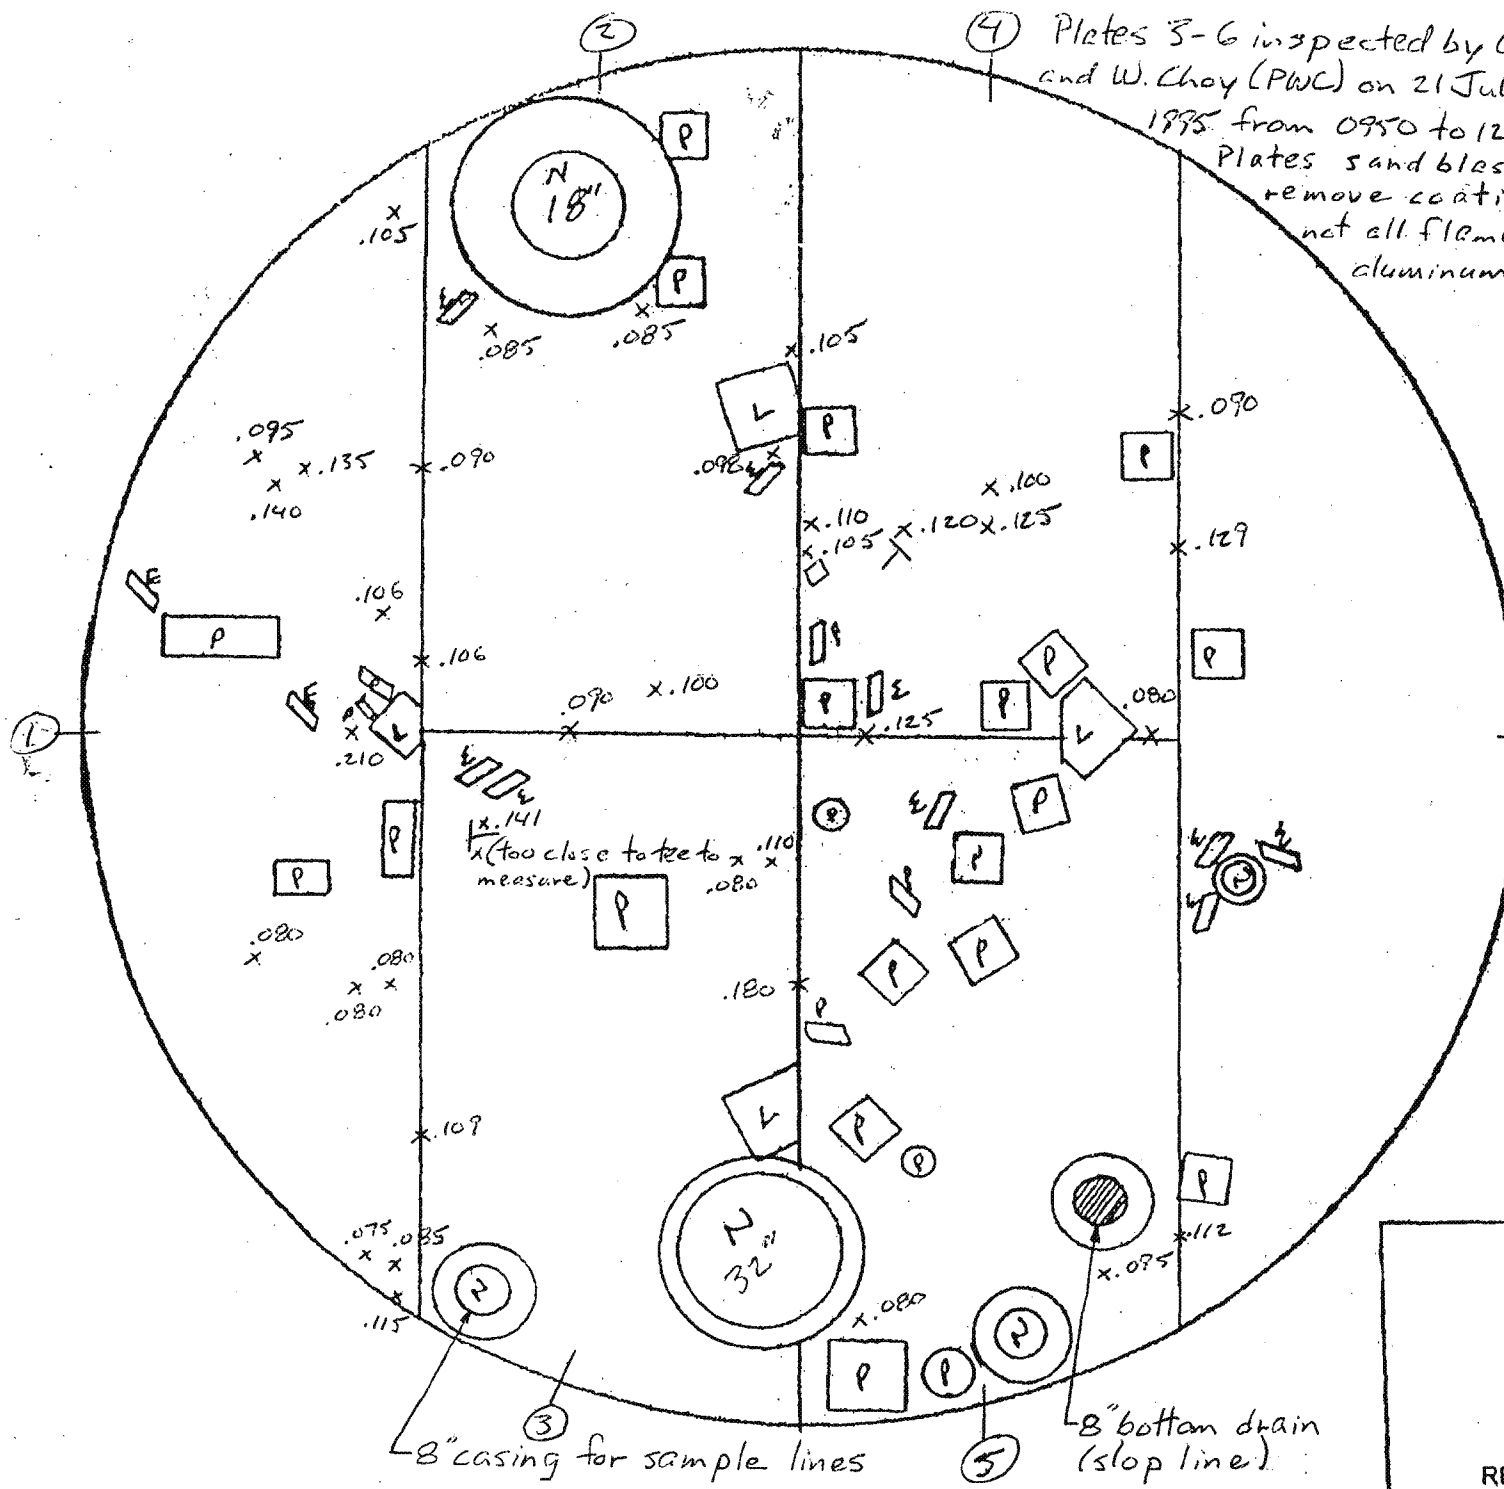
Plates 3-6 inspected by Gammon and W. Choy (PWC) on 21 July 1995 from 0950 to 1220. Plates sand blasted to remove coating, but not all flame-sprayed aluminum.

Pits found by our follow up inspection

Plates 1 and 2 inspected by J. Gammon (FSC) and R. Koyama (PWC) on 20 July 1995 from 1005 to 1115

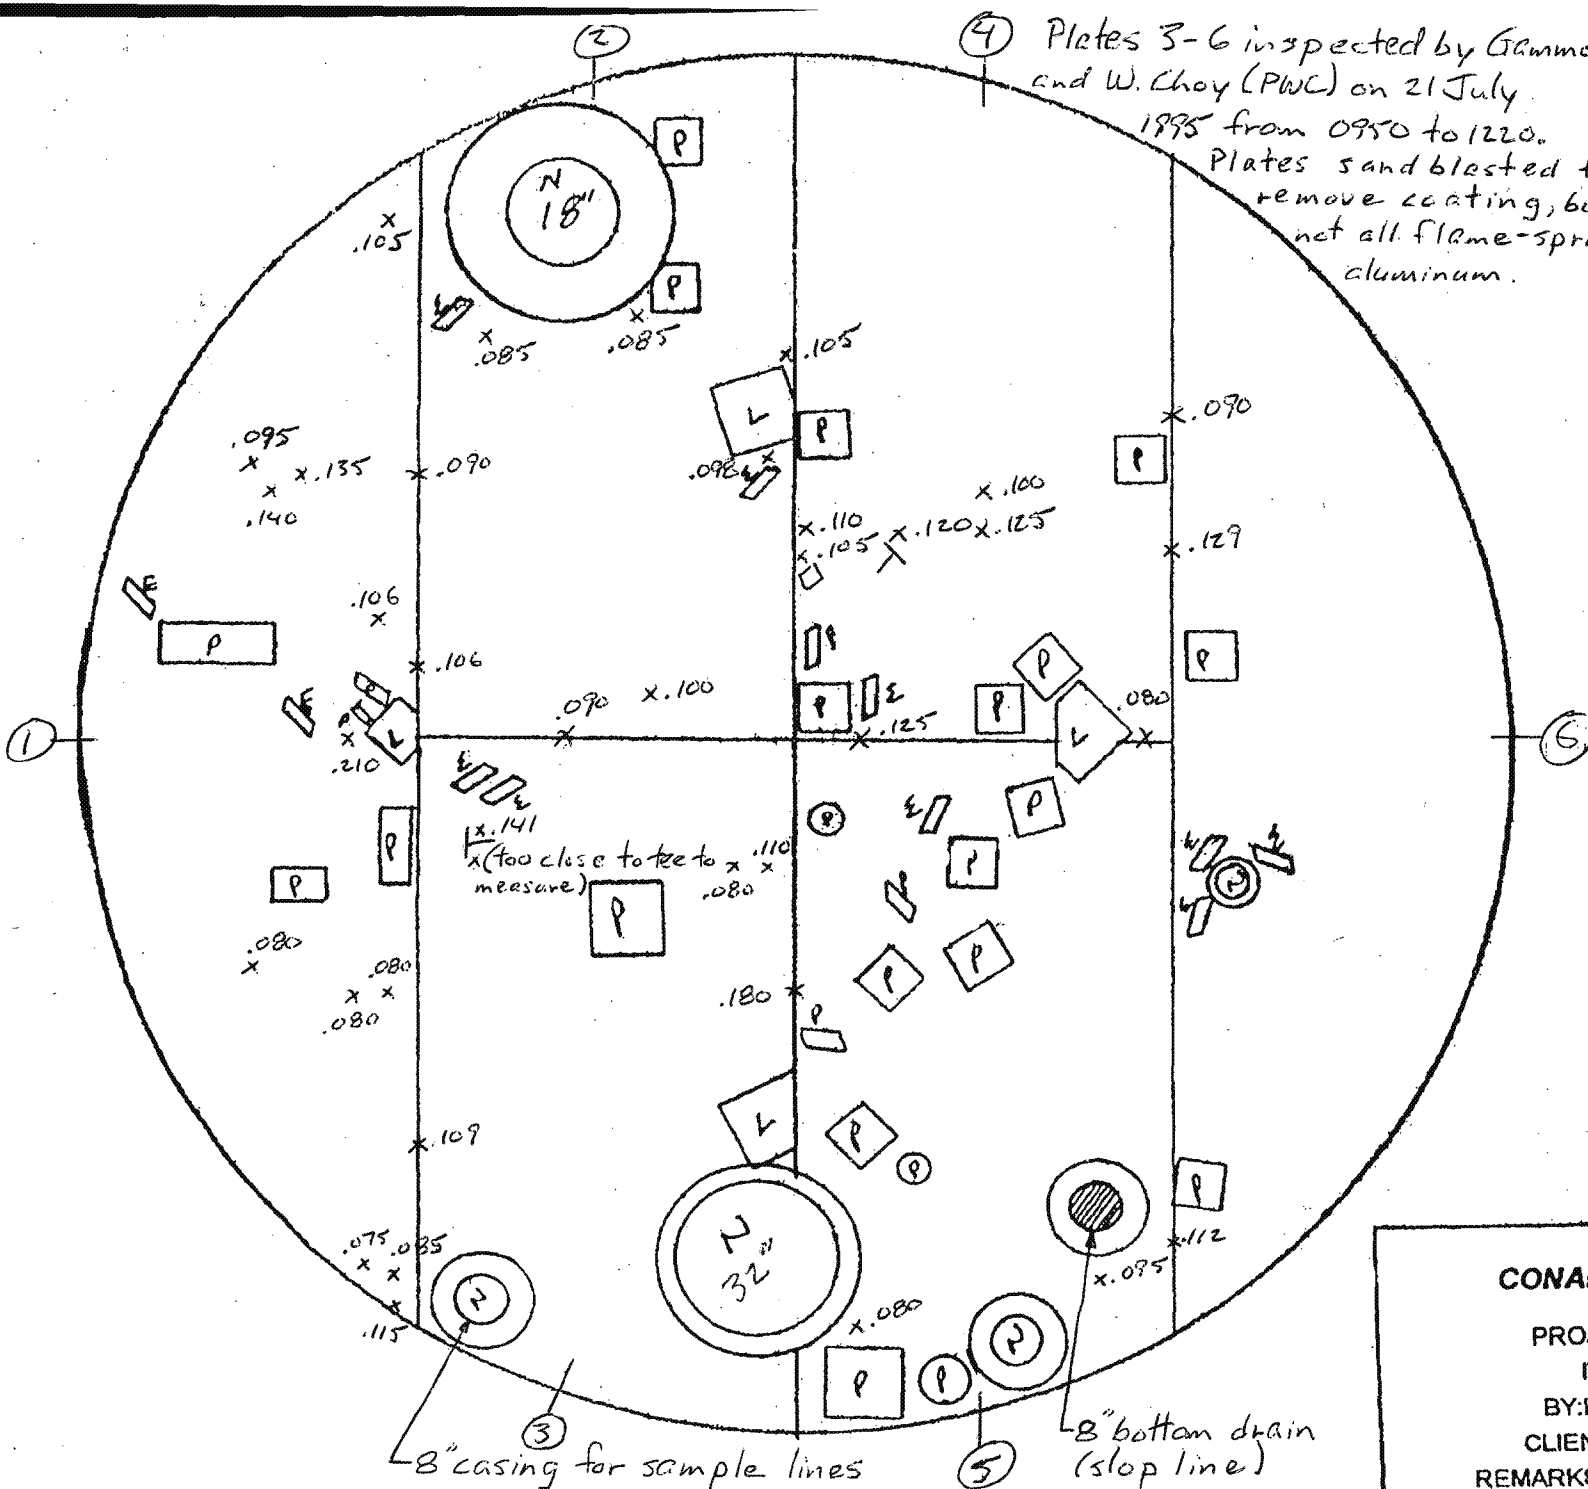
Plates 3-6 inspected by Gammon and W. Choy (PWC) on 21 July 1995 from 0950 to 1220. Plates sand blasted to remove coating, but not all flame-sprayed aluminum.

Plates 1 and 2 inspected by J. Gammon (PWC) and R. Koyama (PWC) on 20 July 1995 from 1005 to 1115. Plates sand blasted as noted above.
