## BOARD OF WATER SUPPLY

Subject: Red Hill Bulk Fuel Storage Facility - Red Hill Tanks 14, 17, and 18 Non-Destructive Examination Plan Document Dated October 2017

**ALTERNATIVE NDT TECHNIQUES FOR PRUDHOE BAY PIPELINE FAILURES**

## Alternative NDT Techniques for Prudhoe Bay Pipeline Failures

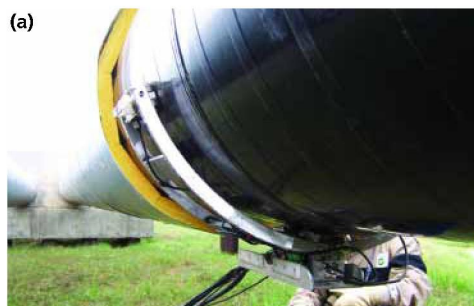
**Figure 5.** Field trial conducted for EMAT scanner shows (a) scanner installed on test pipe with pitting example described in Fig. 4 and (b) EMAT response to pitting sample (75% wall loss). Red line represents EMAT signal amplitude and blue line is time-of-flight. Saw-tooth pattern indicates tape bonding effects. Flat data segment to right of pitting response represents area where anti-corrosion tape was removed from pipeline for comparison purposes.

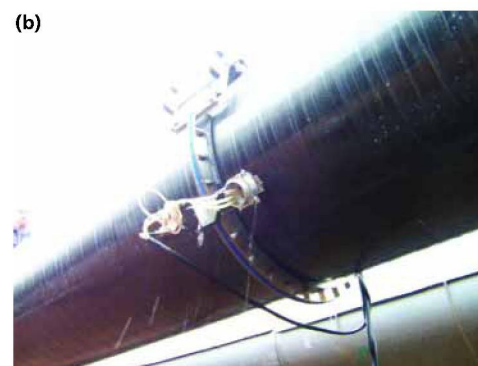
**Figure 7.** Axial scanning automated UT crawler; (a) closeup of scanner in trial tests, (b) in use on petroleum transit pipeline, and (c) C-scan image of pitting generated by crawler in trial testing.

Upon USDOT approval, the company NDT lab in Houston, Texas began work on robotic multi-channel sensor arrays for LFET and automated UT. Most of the UT and LFET work done to this point had been done by hand. Automated UT had continued to be inefficient. To obtain the needed tenfold increase in inspection production, further mechanization of these techniques was necessary. Deep water NDE research and development projects already underway at the Houston lab included LFET and automated UT. Mechanical phases of the projects showed potential for application at the North

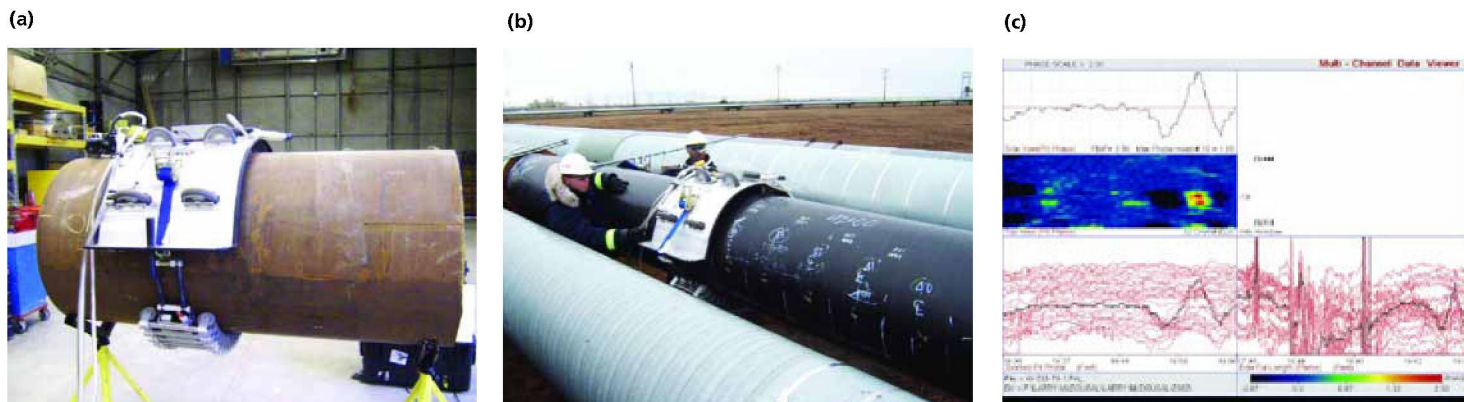
**Figure 8.** LFET axial scanning array; (a) closeup in trial configuration, (b) in use on petroleum transit pipeline, and (c) LFET data from pipe segment in trial configuration in 8a (compare to C-scan image of pitting in same pipe segment in Fig. 7c).

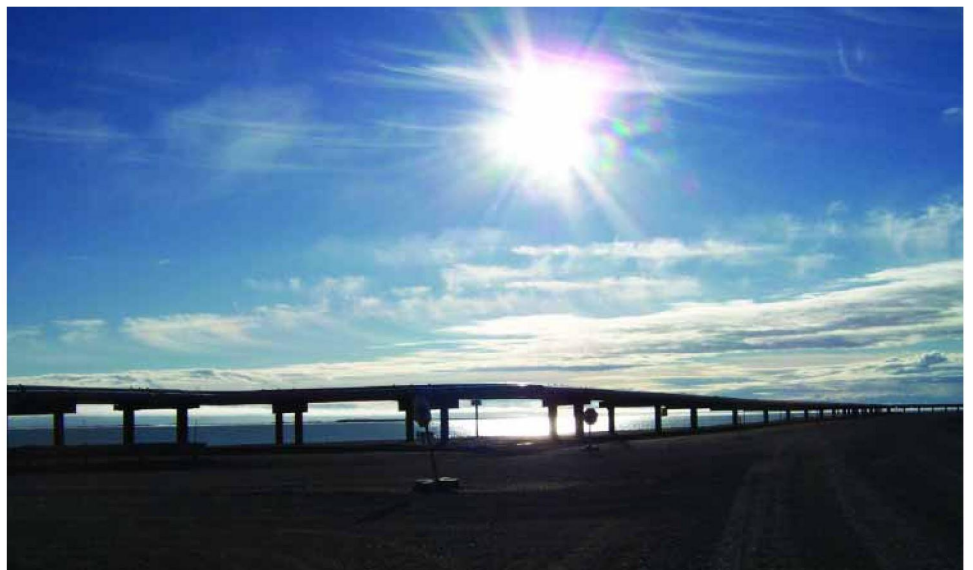
Figure 9. Petroleum transit pipelines at Prudhoe Bay cross 11 miles of eco-sensitive Alaskan tundra. The eastern and western transit lines deliver a total of 400 000 barrels of North Slope crude petroleum to the lower 48 states on a daily basis.
