SUBJECT: ADMINISTRATIVE ORDER ON CONSENT STATEMENT OF WORK SECTION 3.3 TANK  
UPGRADE ALTERNATIVES REPORT, RED HILL BULK FUEL STORAGE FACILITY (RED  
HILL), JOINT BASE PEARL HARBOR-HICKAM, OAHU, HAWAII

Enclosure: Red Hill AOC SOW Section 3.3 Tank Upgrade Alternatives Report, December 08, 2017

Section: 3.3 Tank Upgrade Alternatives Report

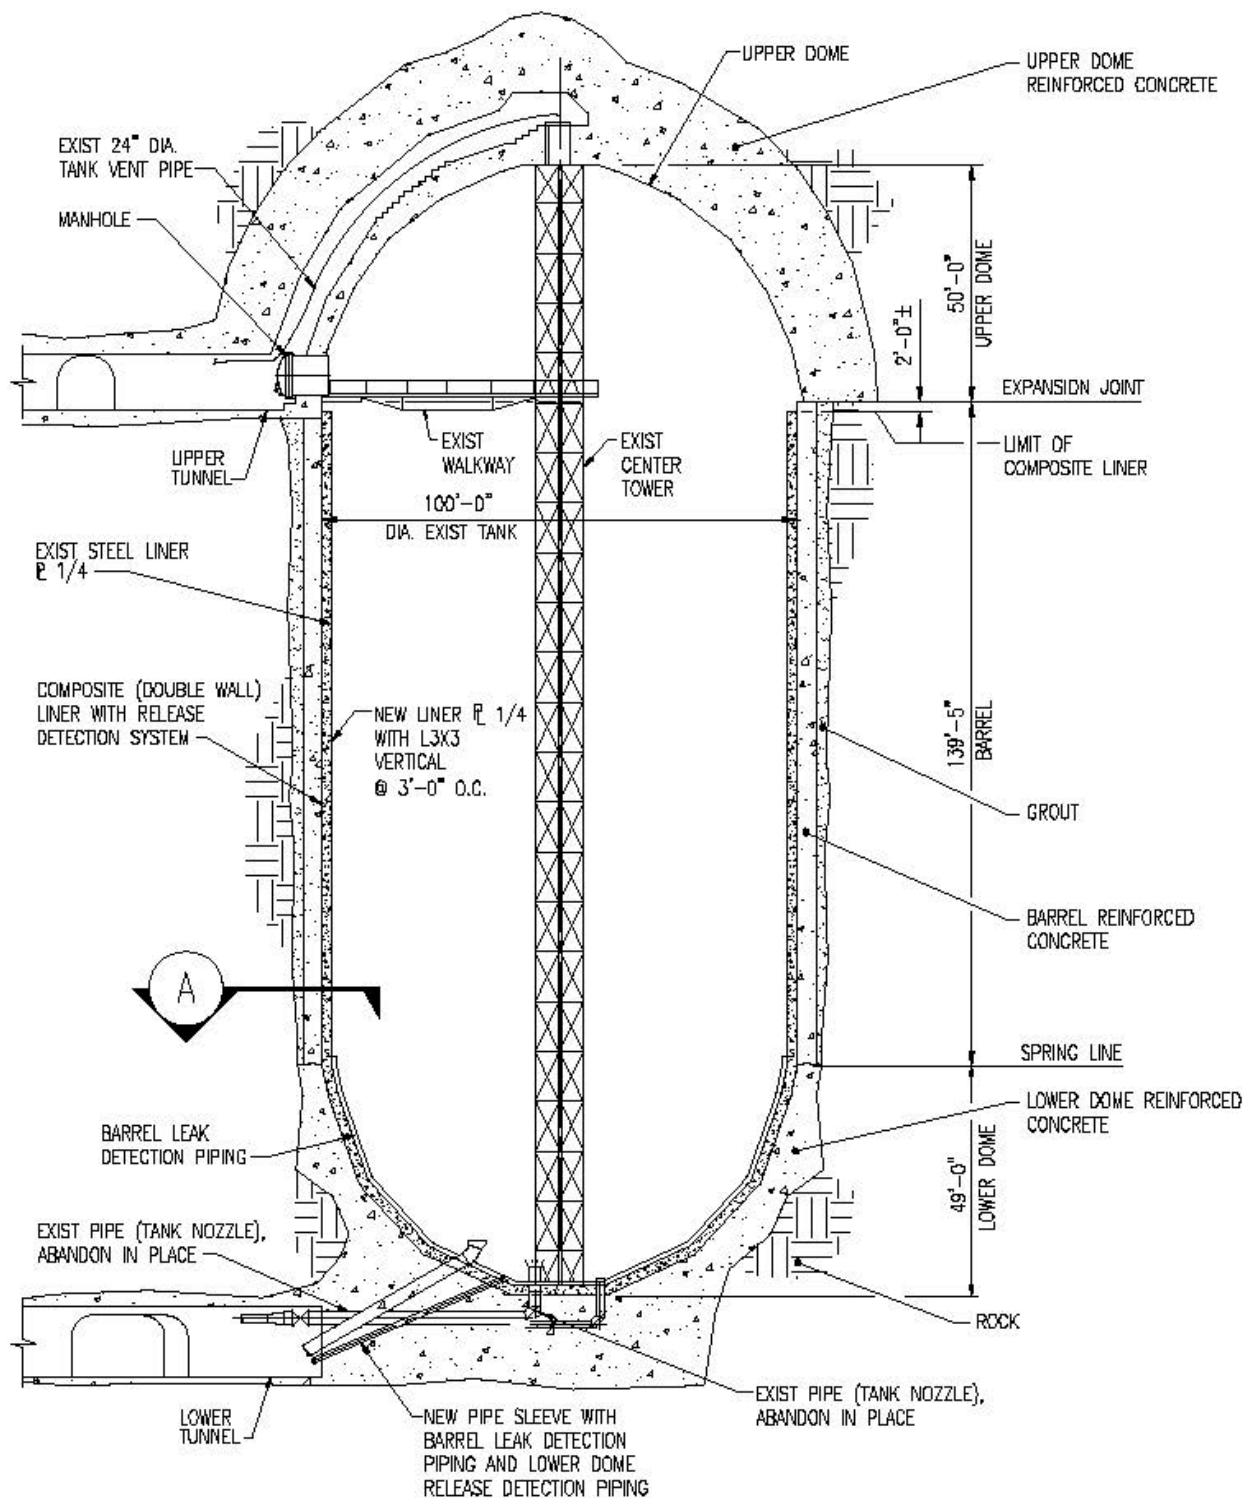
Figure E-4.0-1 TUA 2A Composite Tanks 1 - 4 Elevation

In this alternative, the composite tank construction will be below the barrel expansion joint near the upper dome, down the shell, and include the lower dome. The upper dome will not be used for fuel storage.

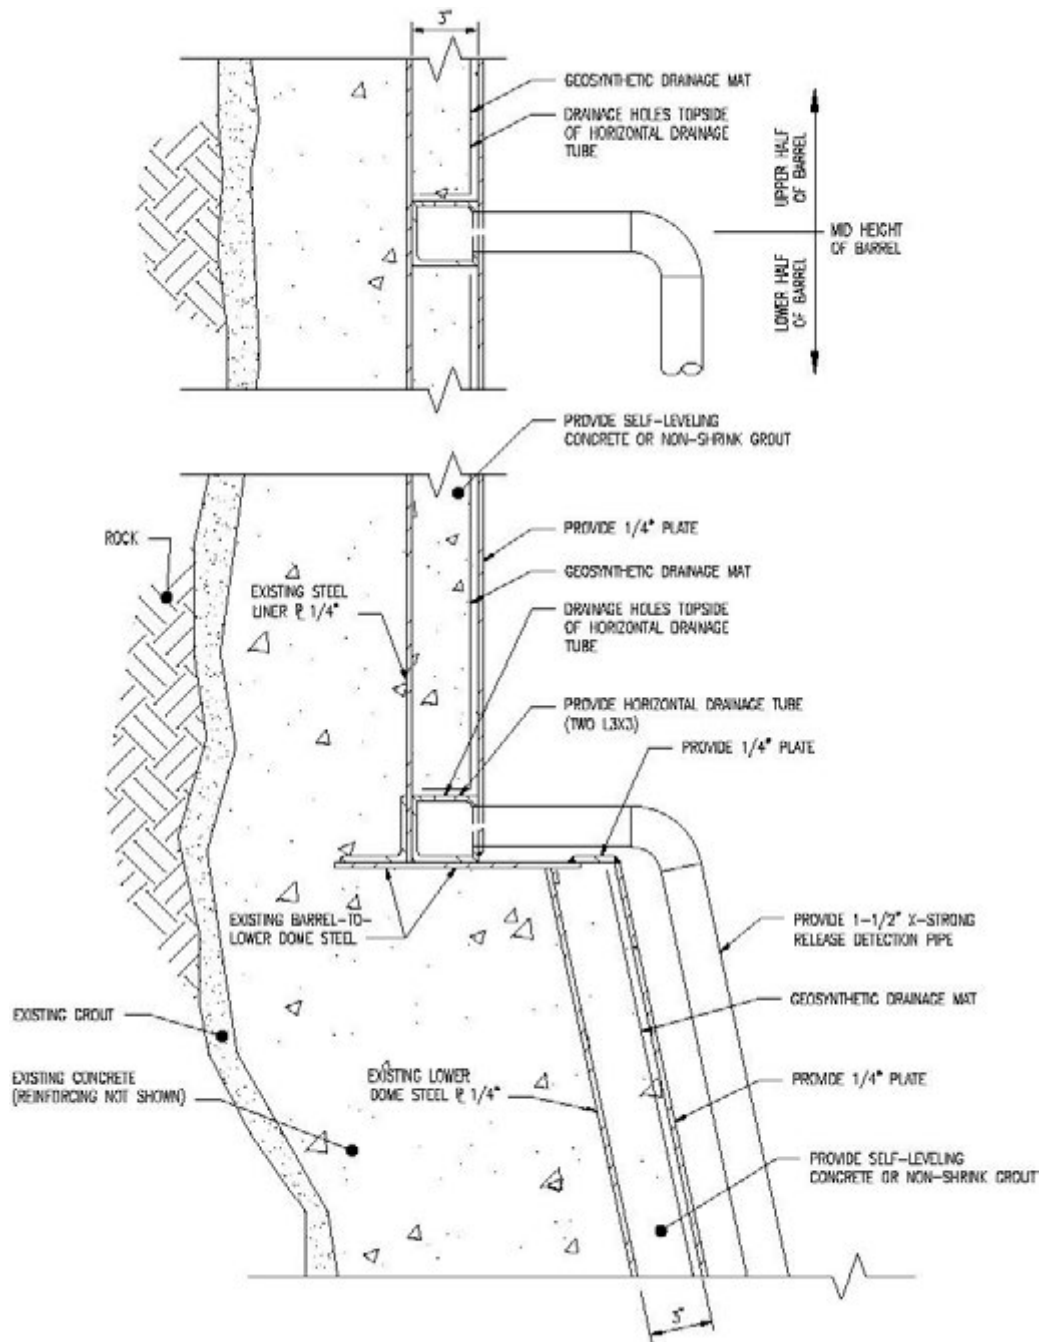
Figure E-4.0-6 TUA 2A Composite Tank Wall Section at Barrel and Lower Dome

Another important feature of the release detection system is the ability to test the system for integrity and connectivity between the interstitial space and Lower Tunnel collection chamber. The general concept suggested is to connect the top of the interstitial space segments with piping inside the tank, with several lines to the upper gauging station above the dome roof, or to a penetration through the access manhole to the upper tunnel. By doing so, a gas inoculant could be introduced under low pressure, and each of the 28 leak detection lines leading to the lower tunnel chamber could be tested for inoculant gas. There are many details to be developed by the eventual design engineering firm. Specific technical requirements and system configuration is discussed in the engineering section below.

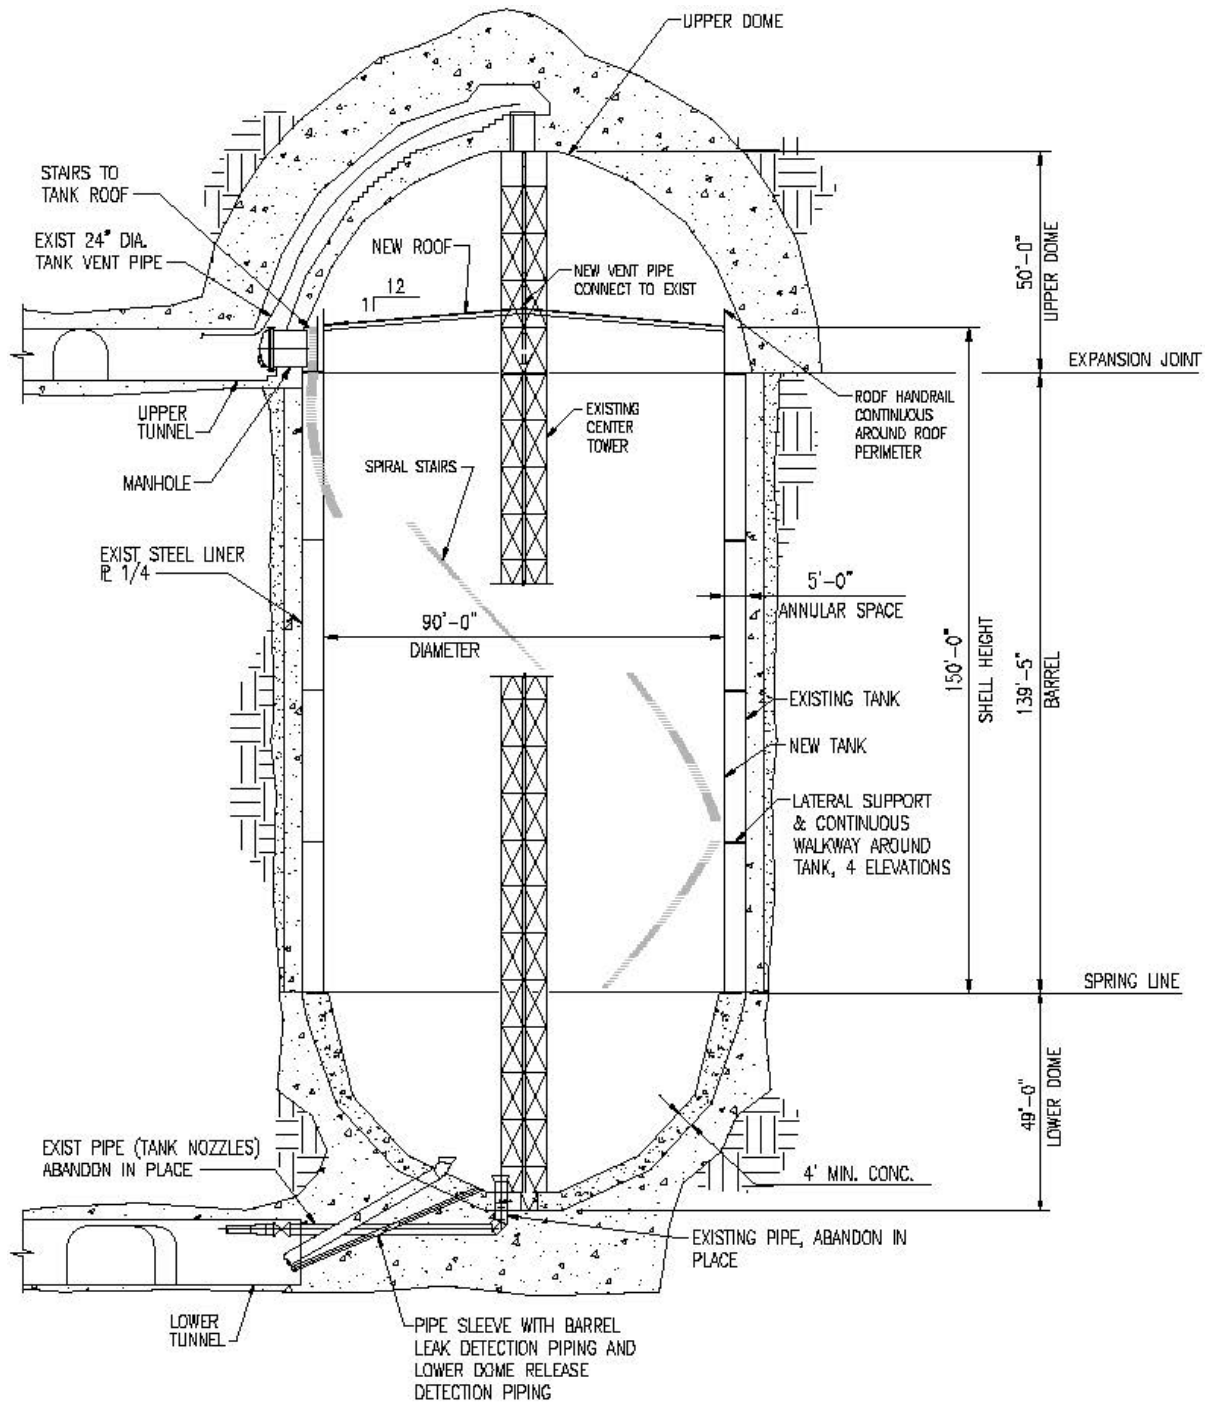
Figure E-6.0-1 TUA 3A Tank within a Tank - Tanks 1 - 4 Elevation

Alternative 3A includes taking out of service the existing single wall concrete encased piping (i.e. tank nozzles) from the tank to the first valve outside tank and providing new nozzle piping within pipe sleeves (i.e. double wall construction), as they are considered an extension of the tank. Most likely they will require boring from inside the tank, to the lower access tunnel, a distance of approximately 45 feet.

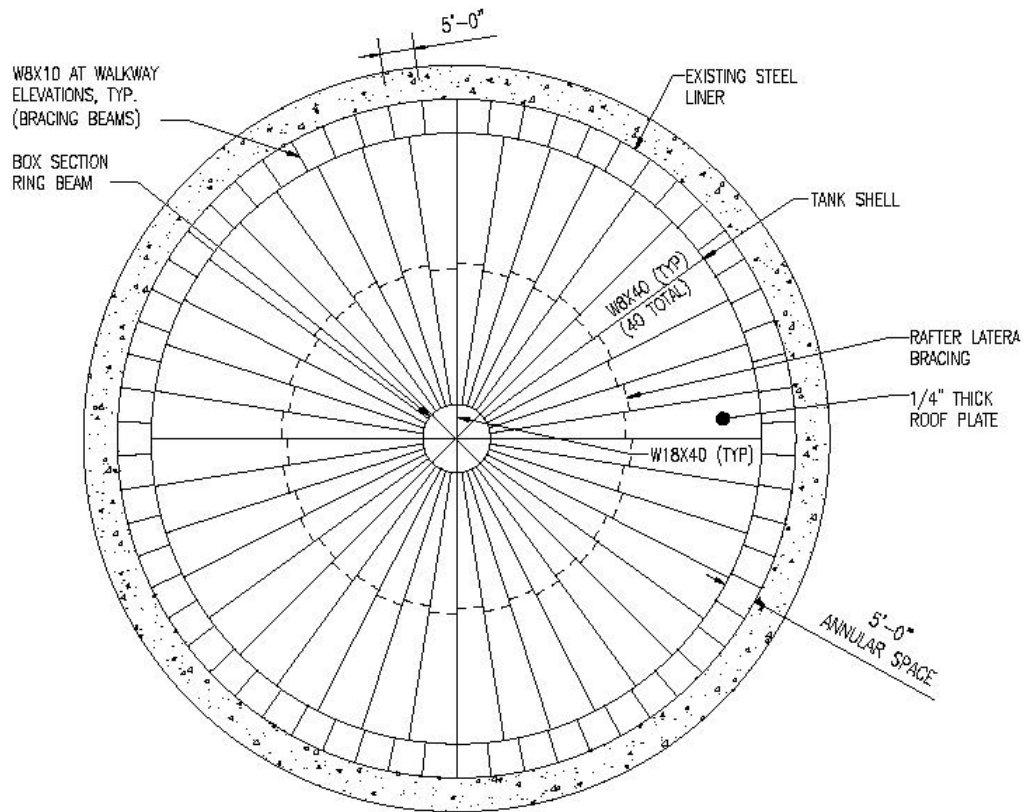
Figure E-6.0-4 TUA 3A Tank within a Tank Roof Framing Plan

- Inspection of the existing steel liner following requirements in Red Hill AOC SOW Section 2.4 TIRM Procedure Decision Document. This document in turn, refers to materials developed under the Red Hill AOC SOW Section 2.2 TIRM Report. In the case of Alternative 3A, the procedures and repair thresholds will be adjusted to reflect the fact that the existing barrel will be used for secondary containment for the new tank and thus will be visible/accessible in the future during tank integrity inspections.
- 5-feet wide annular space between the tank and existing tank.
- Tank anchored to resist overturning from seismic ground motion and braced against lateral movement and overturning from seismic ground motion with horizontal struts.
- Self-supported fixed cone roof with a vent pipe connected to the existing tank vent pipe at the top of the upper dome.

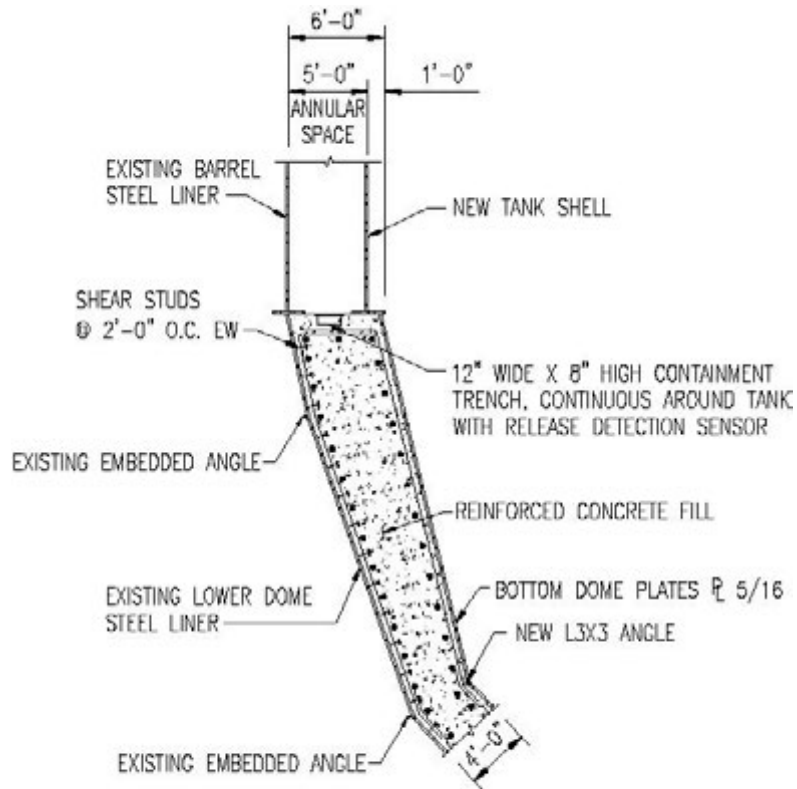
Figure E-6.0-6 TUA 3A Tank within a Tank Section at Lower Dome

will be provided to anchor the concrete fill to the existing steel liner. It is estimated that the concrete fill will be 4'-0" thick below the floor of the new dome bottom and increase in thickness up the sides of the lower dome to 6'-0" thick at the top of the lower dome. The floor of dome bottom will be flat and constructed of 1/2-inch thick plates for additional strength and corrosion allowance. A dome bottom concept relies on the reinforced concrete fill acting as an inverted dome in compression to support the entire weight of the new tank.

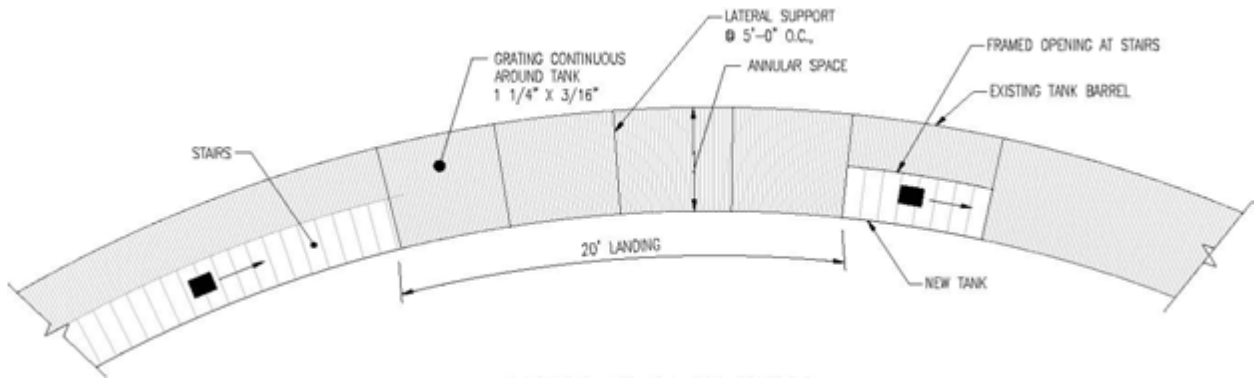
Figure E-6.0-7 TUA 3A Tank within a Tank Section Partial Plan at Stairs

- Drainage channels in the concrete fill in the interstitial space of the dome bottom with release detection piping into the Lower Tunnel.
- Spiral stair on the exterior of the tank to access the annular space.

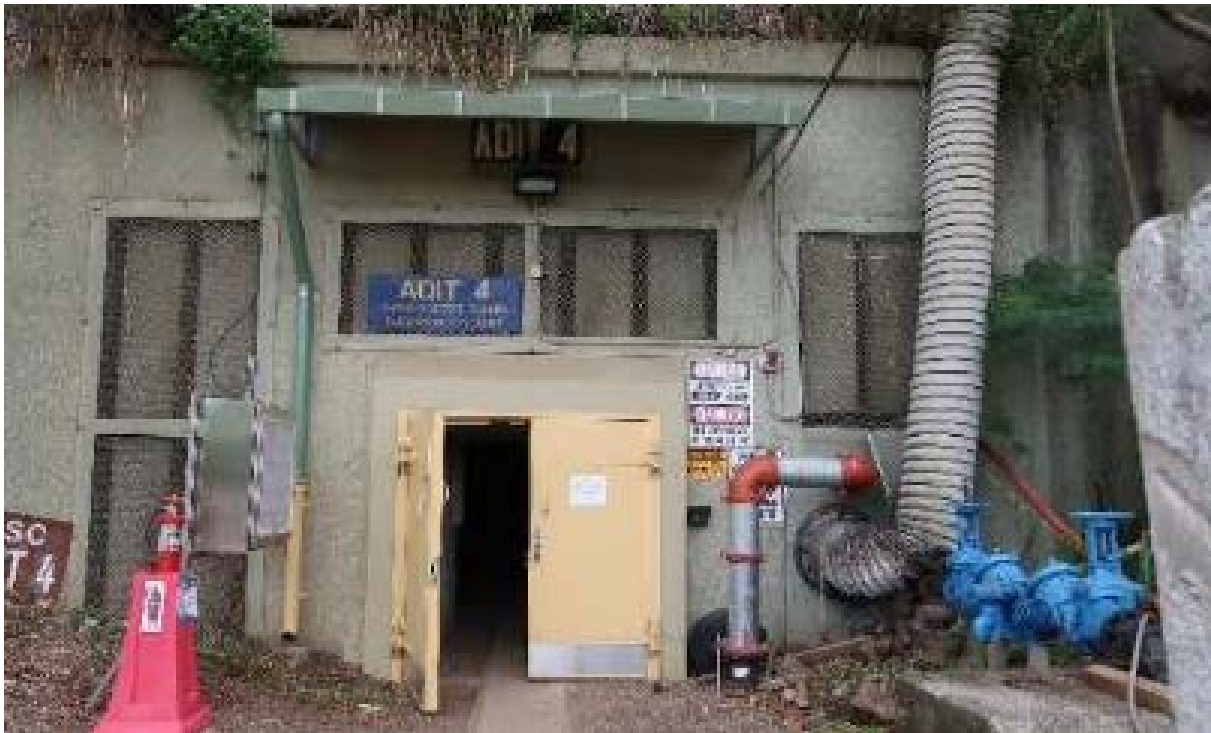
All Material must pass through this door

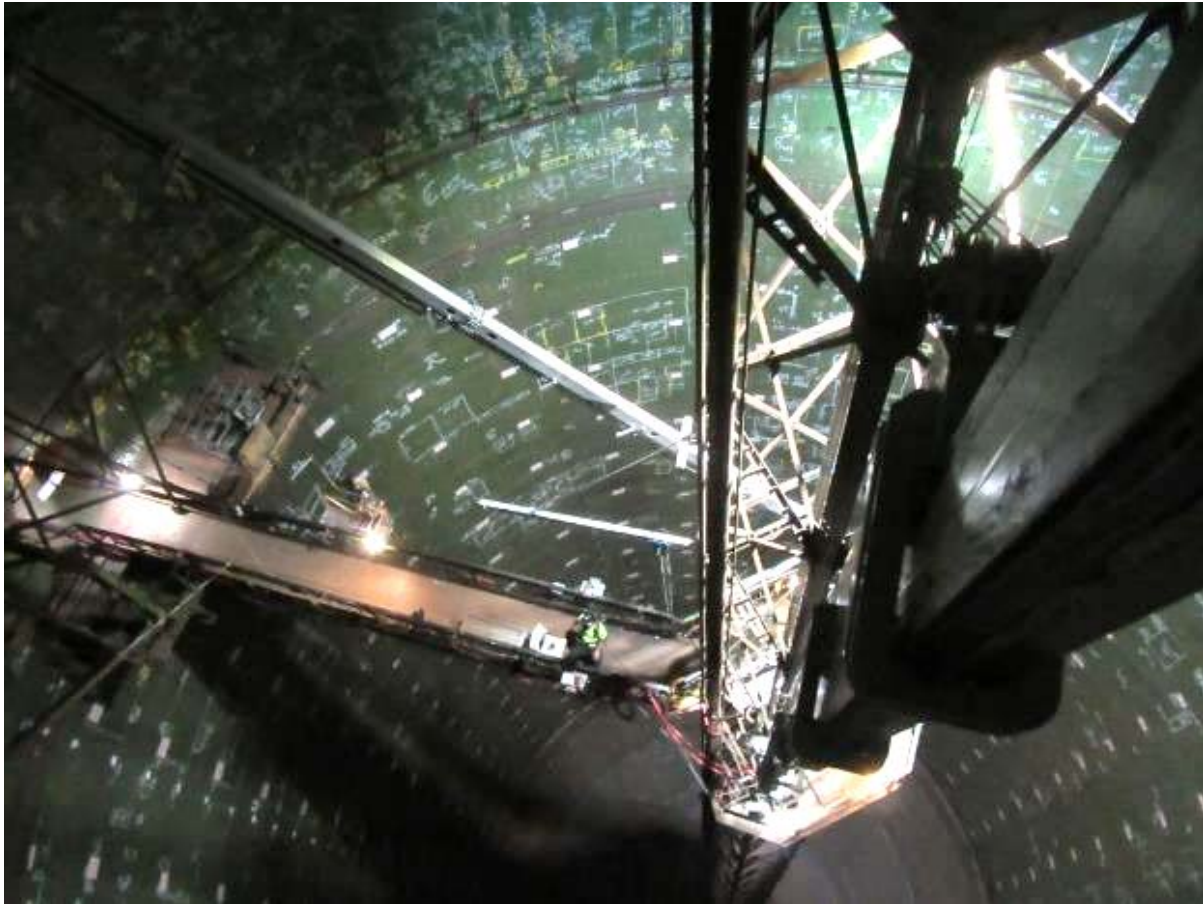
Catwalk and Small Access Platform from Tank Manhole. Note boom on right hand side.  
Photo was taken from basket on boom.

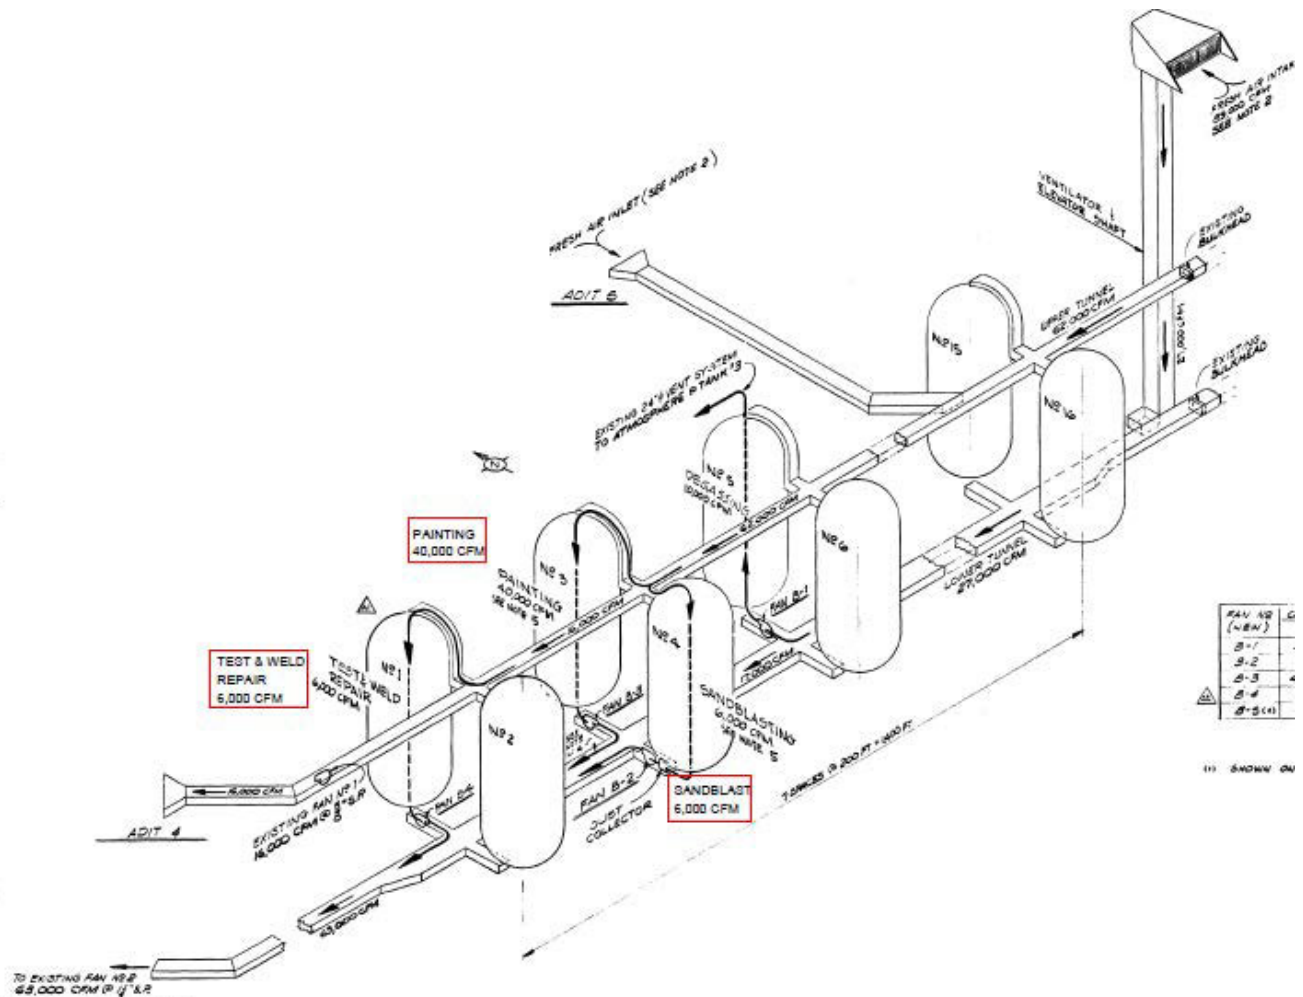
Ventilation Scheme - Excerpt from NAVFAC drawing 7019559 dated 1985

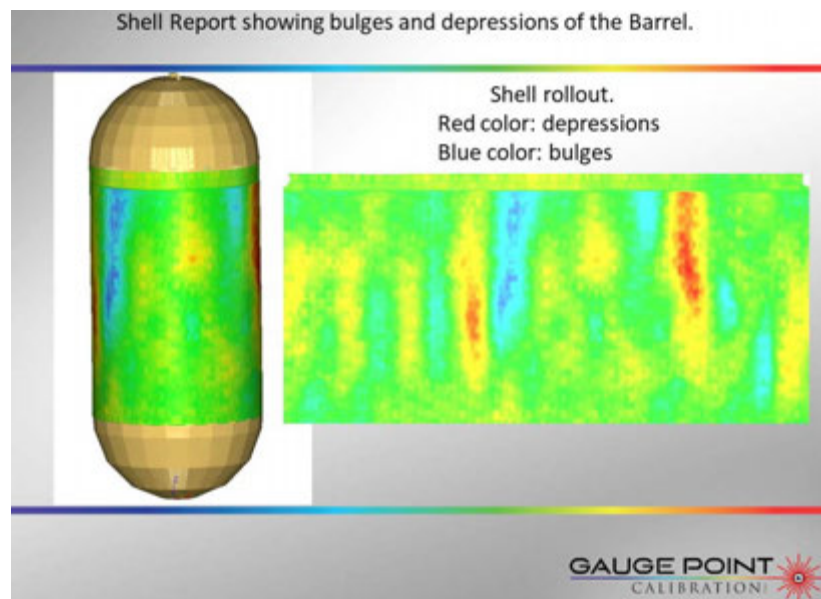
Tank 5 section from recent tank gauging project. Large areas of the barrel are out of round and could cause issues

Additional cost is also assumed for Alternative 1D because plate is welded to existing embedded structural steel. This steel will follow the contour of existing shell making it difficult to install new plates that do not match the contour of the plate that was removed. In addition, the embedded steel that is needed structurally could be corroded or covered with grout. If the embedded steel is not viable structurally, dowels will have to be drilled into existing concrete to provide attachment point for steel plates.

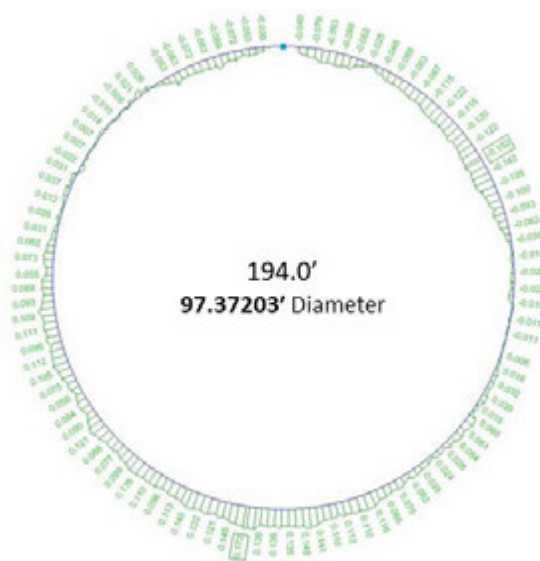
Tank 5 shell condition at 194 feet, note that it is 97.3 feet diameter

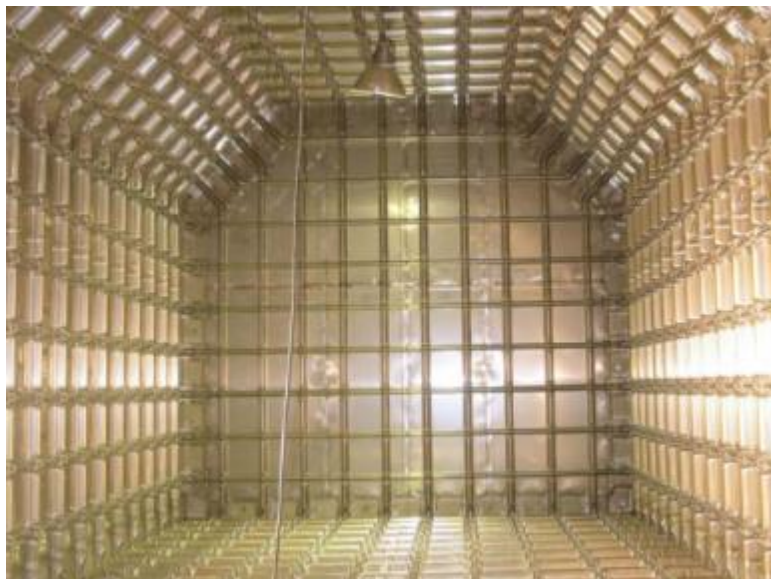
This technology consisted of insulated panels with a thin stainless steel membrane liner that is installed inside LNG tanks. It is possible to monitor the space between the membrane liner system and storage tank.

Image inside LNG Tank (26)

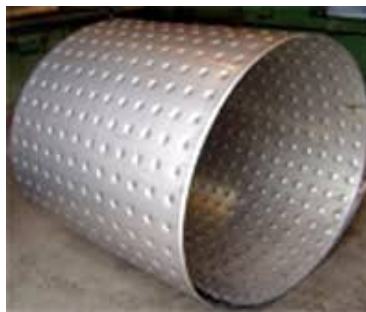
Dimple jackets are typically used in tanks where uniform heating or cooling is required throughout the tank contents. Dimples are punched or pressing into thin gauge stainless steel sheets that are welded to the exterior of a tank. Dimple jackets are also available in thin gauge carbon steel. The dimple jacket creates turbulence in the heating or cooling fluid flowing over it. This increases heat transfer from heating or cooling medium to the product in the tank. (29)

Dimple Jacket Material

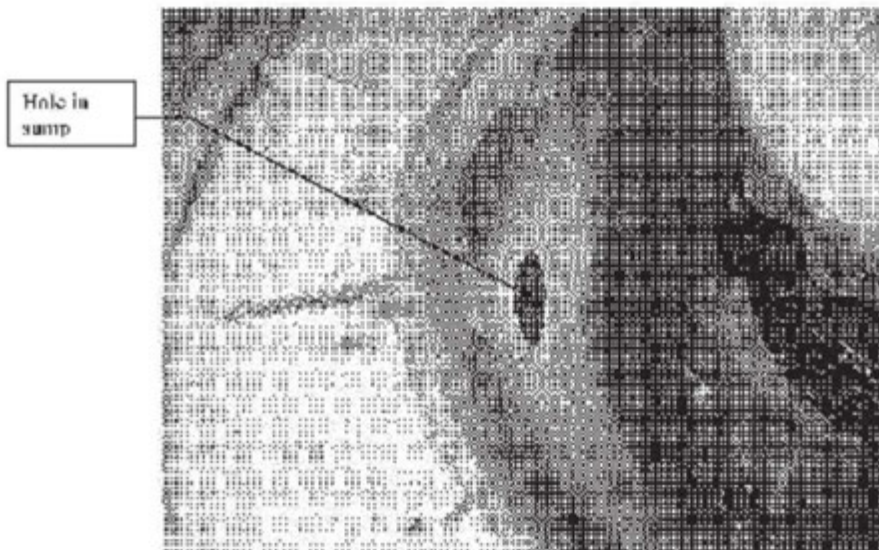
Wear Area and Hole in Sump

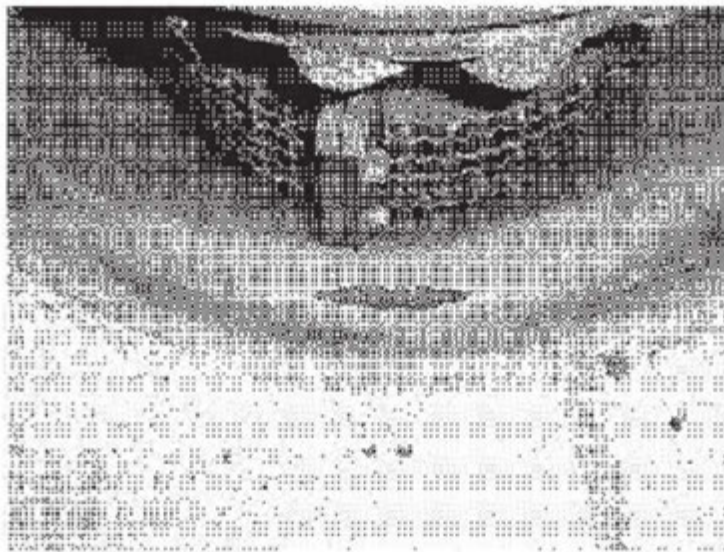
Wear Area in Sump

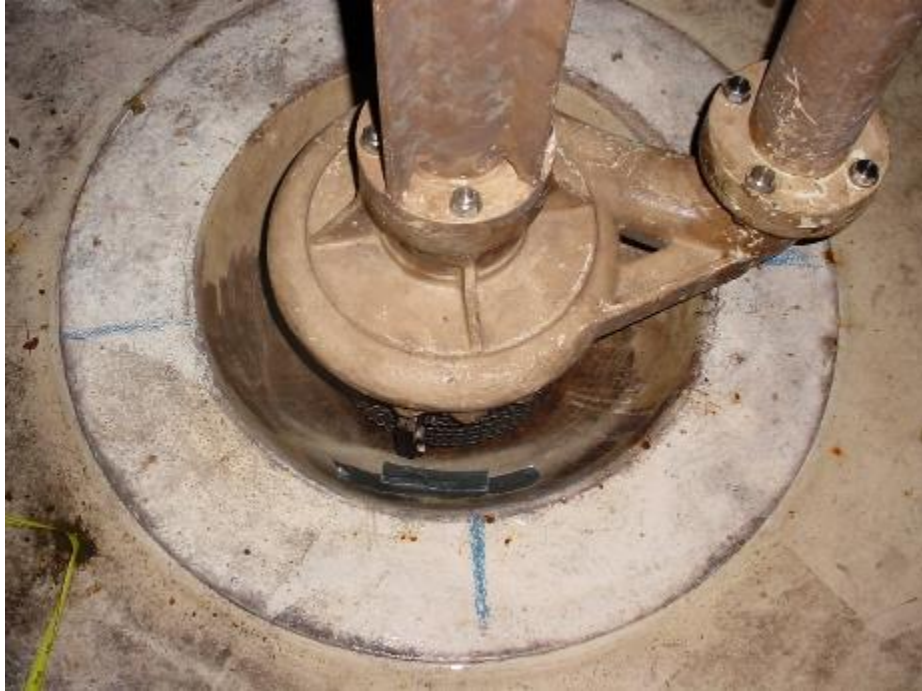
Sump Pump

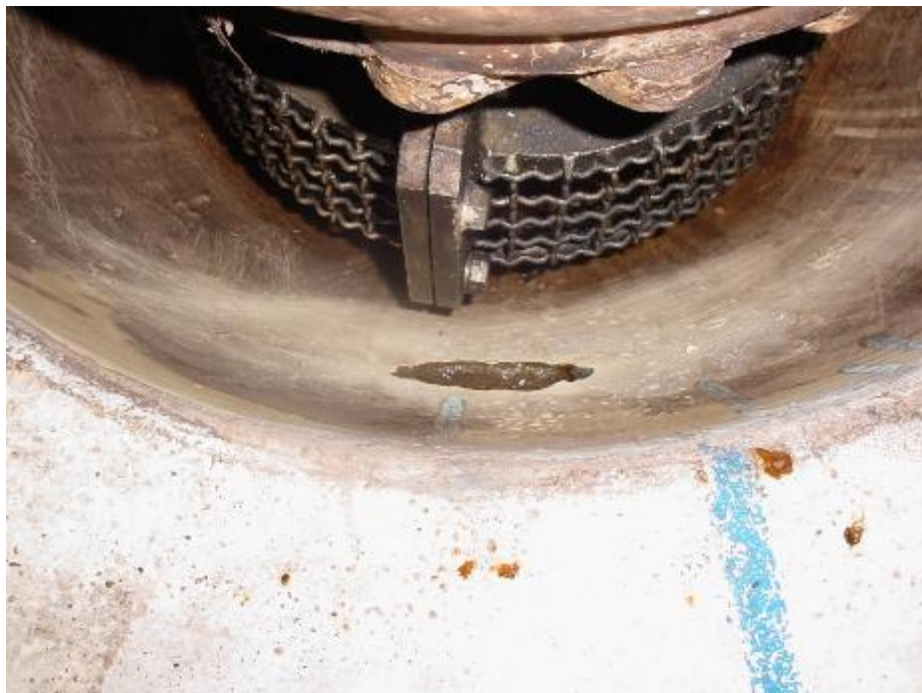
Wear Hole in Sump

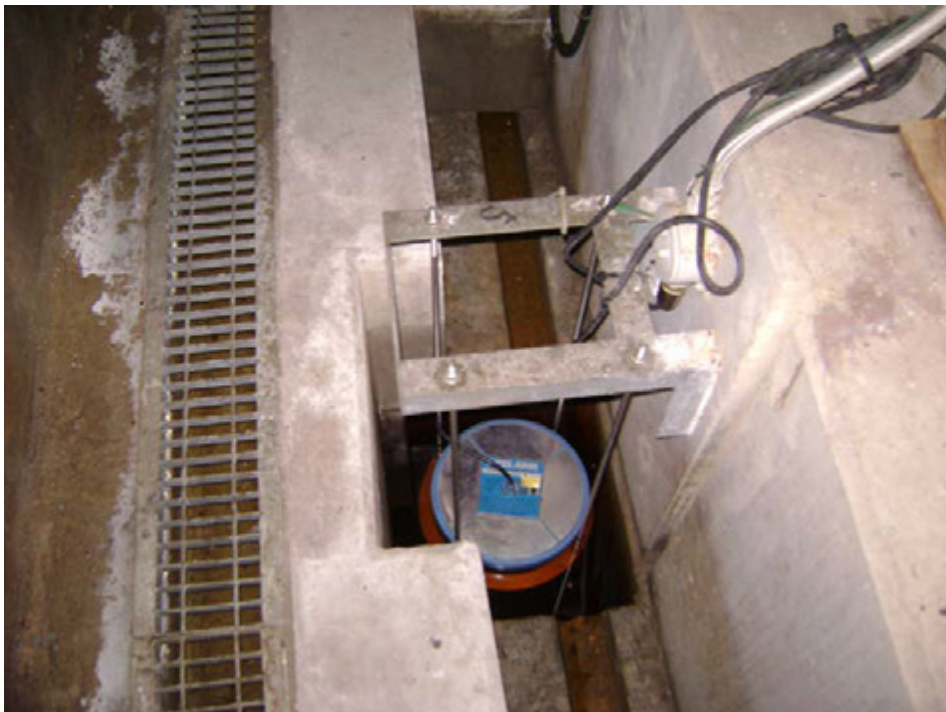
Oil Leak Detection Alarm in Gallery Space

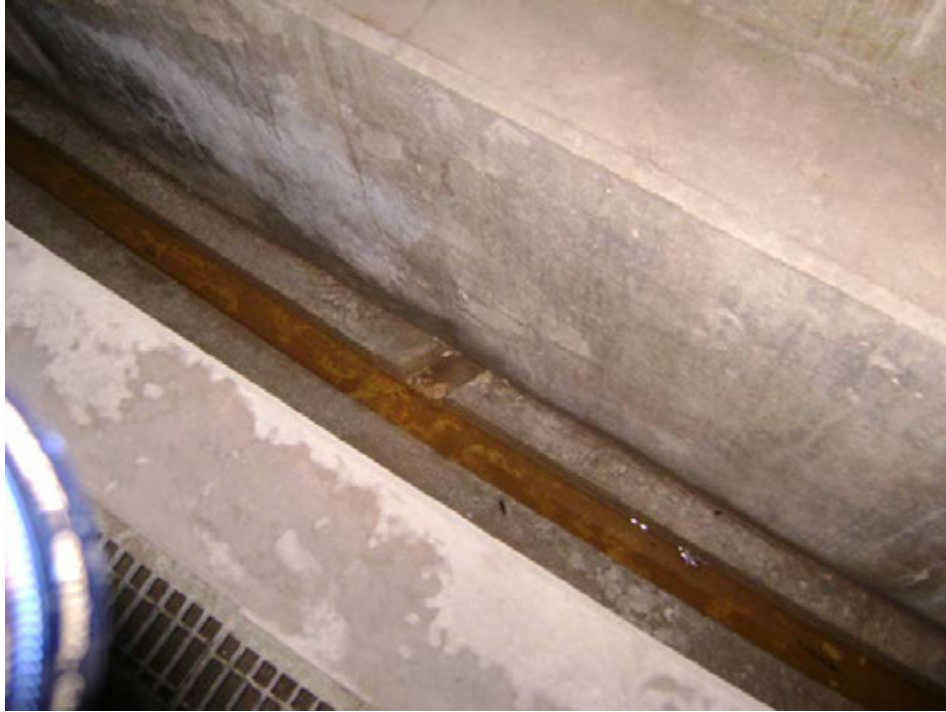
Drainage Slots Below Tank Floor  
Note: Slots exit to gallery trough

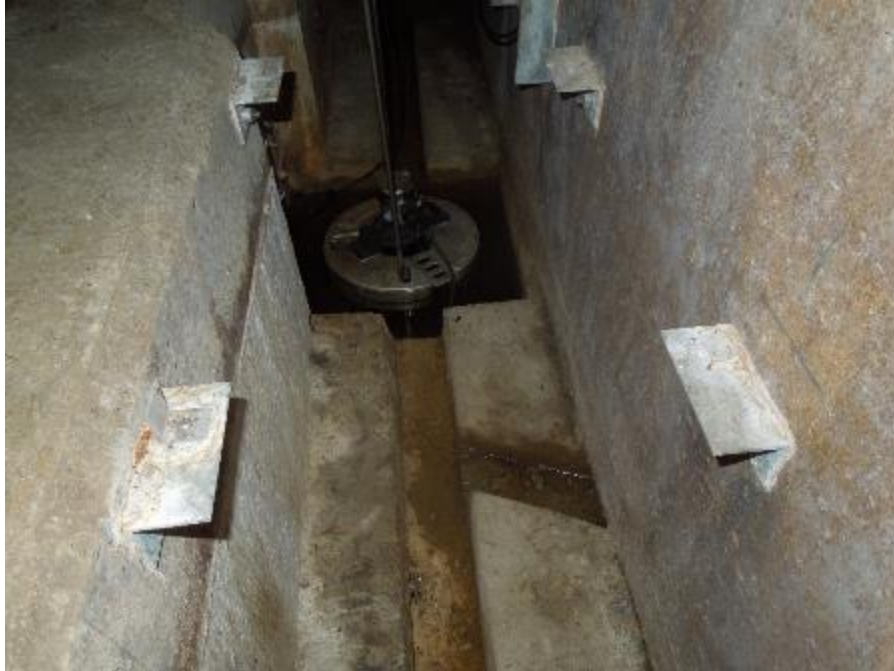
Oil Leak Detection Alarm in Gallery Space, Drainage Slots Below Floor  
Note: Floor grating removed for photo. Drainage slots exit to gallery trough.

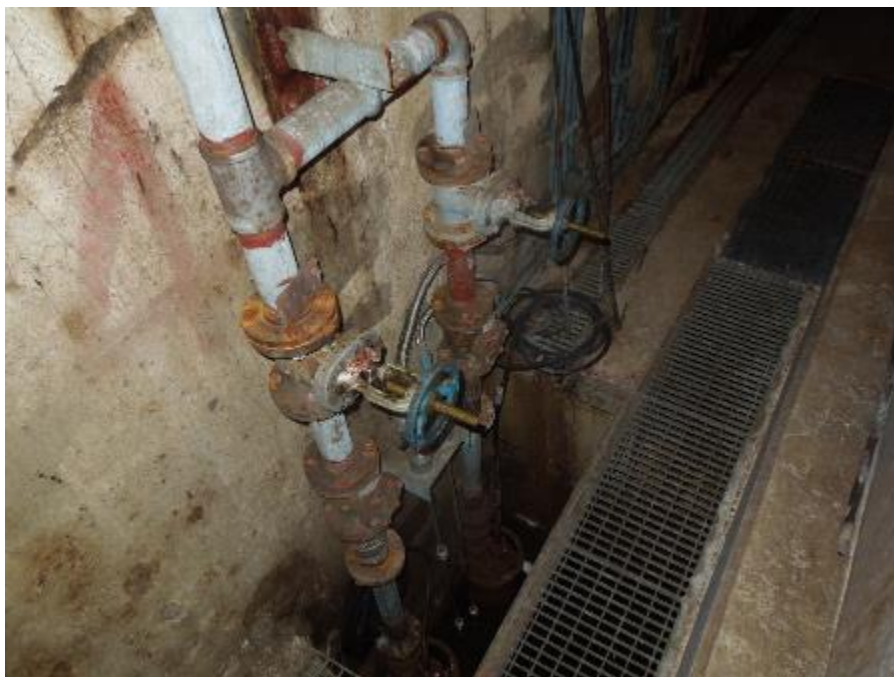
Gallery Space Sump Pump  
Note: This location is the gallery low point and main sump pump.
