Red Hill Administrative Order on Consent Scope of Work Deliverable

SECTION 2.2: TANK INSPECTION, REPAIR, AND MAINTENANCE REPORT, dated  
11 October 2016

**SITE SPECIFIC REPORT  
SSR-NAVFAC EXWC-CI-1655  
11 OCTOBER 2016**

**RED HILL FACILITY  
TANK INSPECTION, REPAIR, AND MAINTENANCE  
REPORT  
ADMINISTRATIVE ORDER ON CONSENT (AOC)  
STATEMENT OF WORK (SOW), SECTION 2.2**

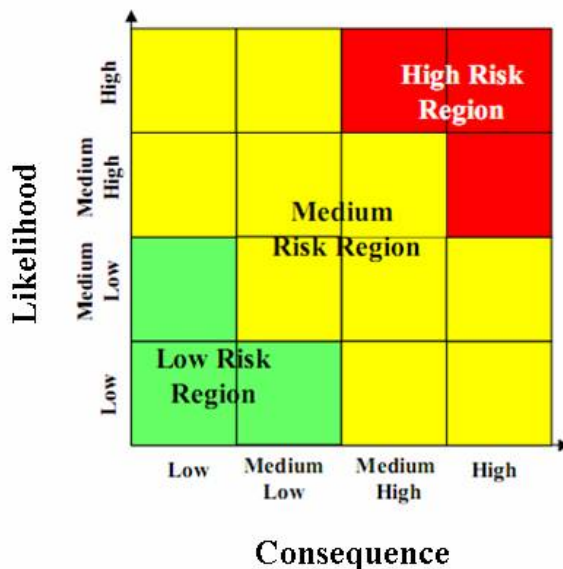
- 19-3.1 API RP 580 was first published in 2002 and provides a method to determine the frequency of inspection based on the probability of failure verses consequence of failure.

API RP 580 was developed to provide specific guidelines to use in performing a risk-based analysis for tanks, pressure vessels, piping, etc. The document first describes risk assessments. The risks are first identified, and then a determination is made on how to reduce or manage the risk. The document further states that there can never be zero risk based on inspection alone, since there are residual risks due to outside influences such as human error, natural disasters, external events, etc.

API RP 580 discusses how to “determine what incident could occur (consequence)” and “how likely (probability) is that the incident could happen.” This exercise is performed and documented for a variety of events. The document describes the qualitative, quantitative, and semi-quantitative approaches, and then provides the process in combining the approaches for defining probability and consequences.
