SECTION 2.2: TANK INSPECTION, REPAIR, AND MAINTENANCE REPORT, dated  
11 October 2016

**SITE SPECIFIC REPORT  
SSR-NAVFAC EXWC-CI-1655  
11 OCTOBER 2016**

**RED HILL FACILITY  
TANK INSPECTION, REPAIR, AND MAINTENANCE  
REPORT  
ADMINISTRATIVE ORDER ON CONSENT (AOC)  
STATEMENT OF WORK (SOW), SECTION 2.2**

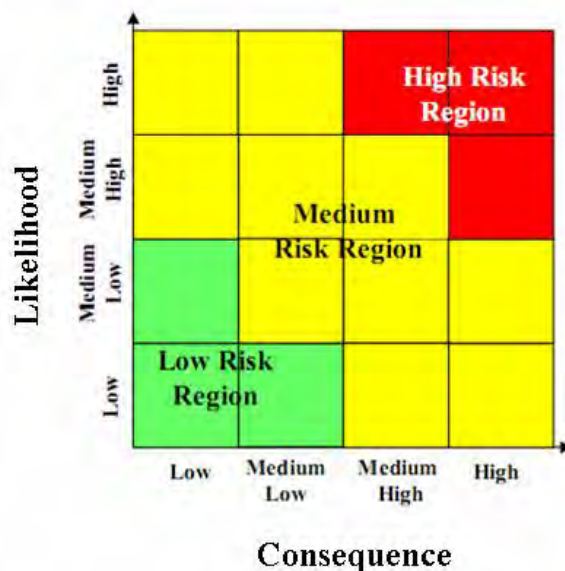
- 19-3.1 API RP 580 was first published in 2002 and provides a method to determine the frequency of inspection based on the probability of failure verses consequence of failure.

API RP 580 was developed to provide specific guidelines to use in performing a risk-based analysis for tanks, pressure vessels, piping, etc. The document first describes risk assessments. The risks are first identified, and then a determination is made on how to reduce or manage the risk. The document further states that there can never be zero risk based on inspection alone, since there are residual risks due to outside influences such as human error, natural disasters, external events, etc.

API RP 580 discusses how to “determine what incident could occur (consequence)” and “how likely (probability) is that the incident could happen.” This exercise is performed and documented for a variety of events. The document describes the qualitative, quantitative, and semi-quantitative approaches, and then provides the process in combining the approaches for defining probability and consequences.
