# Long-Term Structural Integrity Assessment of the Red Hill Underground Storage Tanks

Joint Base Pearl  
Harbor-Hickam, Hawaii

SGH Project No. 221162, Phase 02

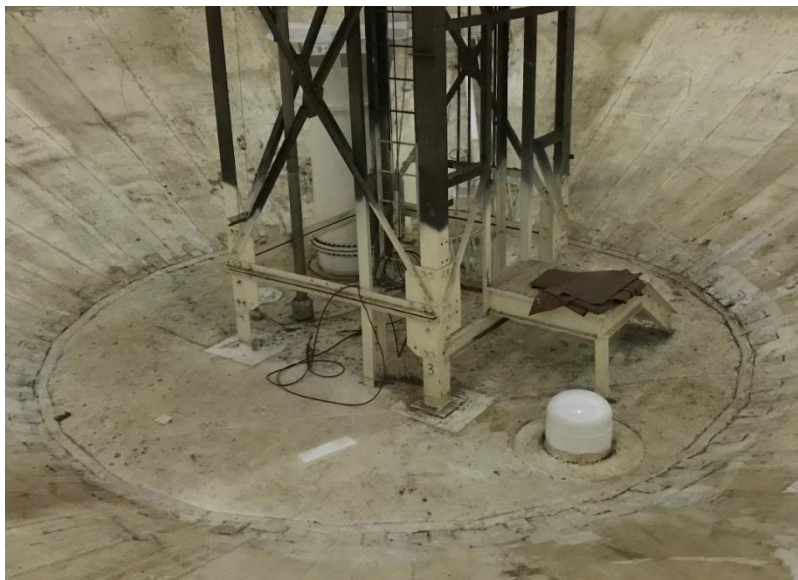
**Figure 2-15 – Base of Tank 5 Tower**

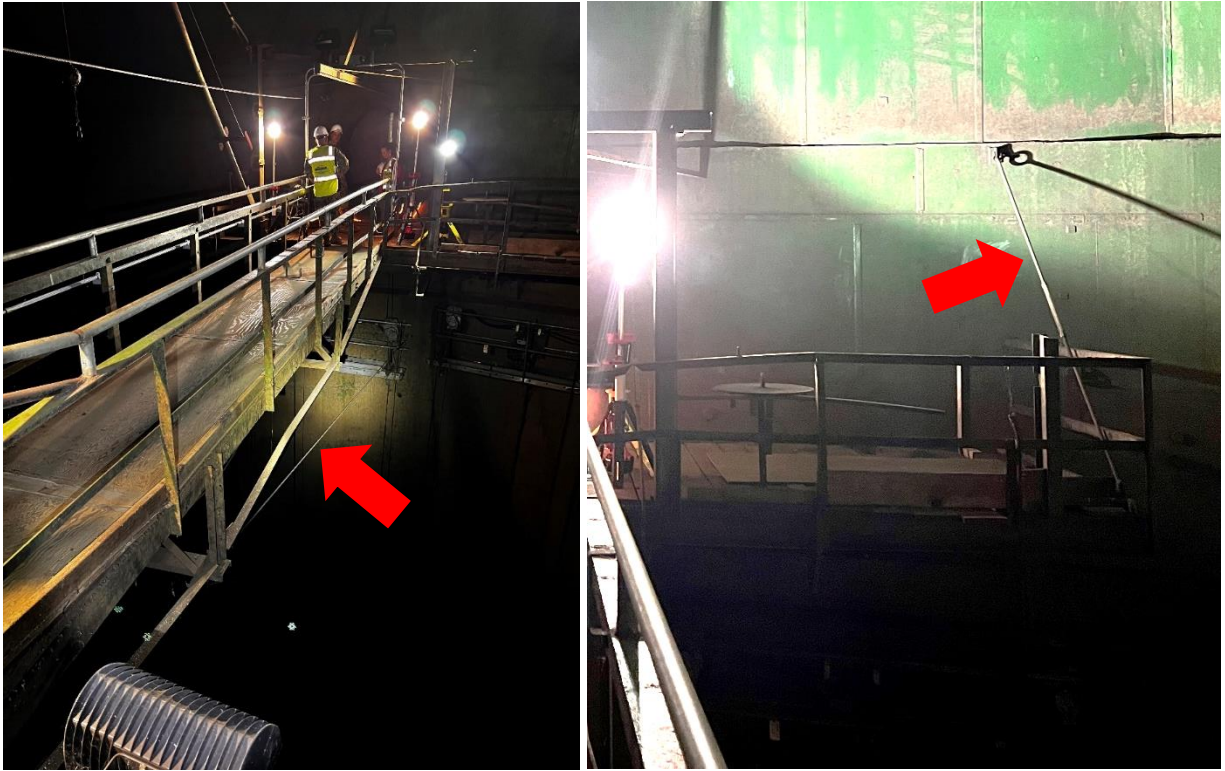
**Figure 2-18 – Tank Tower Access Bridge (Left) and Entry Platform (Right)**

During the site visits in January 2022 and February 2023, we observed the tower access bridge spans from the internal tank wall to the tank tower and consists of steel and timber construction (Figure 2-18). The bridge comprises steel girders and support beams, steel braces, timber panels and beams along the walking surface, cable stays, and steel railing.

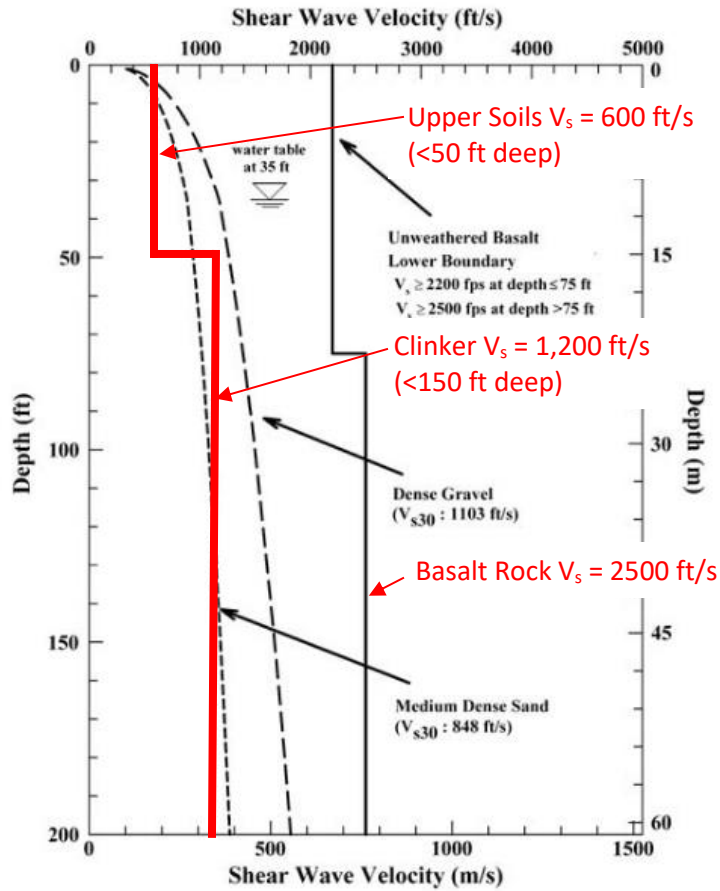
**Figure 12.** Template of  $V_s$ -depth relationships used to categorize geotechnical materials of the 22 sites.

### Figure 2-22 – Recommended Shear Wave Velocities

To develop a site-specific response, we assigned shear wave velocities to the three main materials being modeled (upper soils, clinker, and basalt rock) following Figure 12 by Wong et al. (2011), as shown in Figure 2-22 of this report.

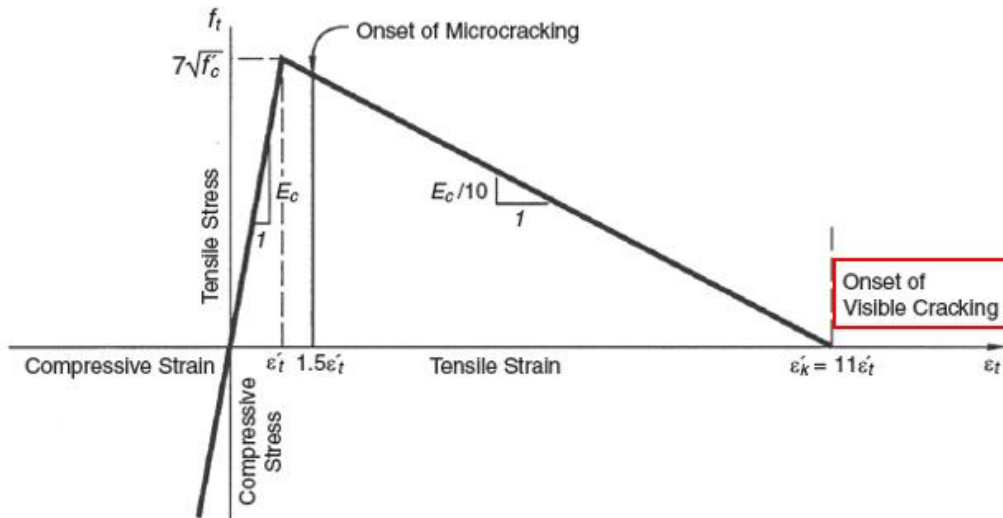
**Figure 4-1 – Stress-strain Curve of Concrete in Tension Showing Onset of Visible Cracking (AWWA 2014)**

According to American Water Works Association (AWWA) Standard, AWWA C304-14, "Design of Prestressed Concrete Cylinder Pipe," and other references, the onset of visible cracking of concrete occurs when the total tensile strain reaches about eleven times the tensile strain at the elastic limit in tension (which is an equivalent plastic strain in the tension of about ten times the tensile strain at the elastic limit), as shown Figure 4-1 (excerpted from Figure 2 of AWWA C304-14).

For normal concrete with compressive strength of  $f'_c = 3,000$  psi at twenty-eight days, the corresponding elastic modulus ( $E_c$ ) and tensile strength ( $f'_t = 7\sqrt{f'_c}$ ) are 3,122 ksi and 383 psi, respectively. This results in an elastic tensile strain limit ( $f'_t/E_c$ ) of 0.00012. The onset of visible cracking of concrete would occur when the total tensile strain reaches about 0.00135 (eleven times elastic strain limit), equivalent to a plastic strain in the tension of about 0.0012 (ten times elastic strain limit). In our analysis, we conservatively used a concrete tensile strength of  $f'_t = 6\sqrt{f'_c}$ , resulting in a plastic strain in the tension of about 0.0010 at the onset of concrete visible cracking.

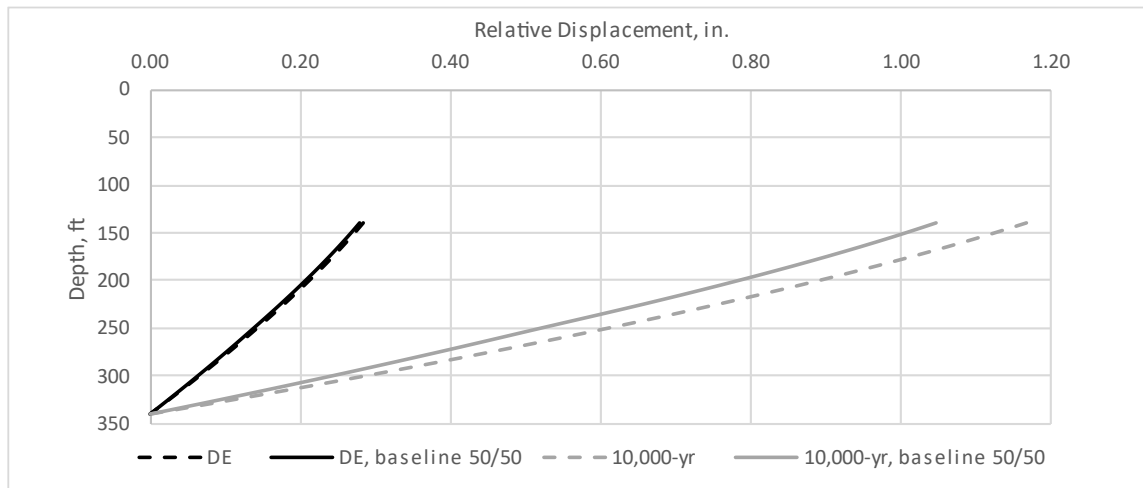
Figure 5-5 – Comparison of Relative Displacements for Increased Degradation

Because we assumed a degradation curve for soils that have different characteristics than the smeared rock/clinker, we calculated results with increased degradation of the smeared rock/clinker layers (Figure 5-5). To perform this, we used degradation curves for soils at depths of 50 – 120 ft instead of those corresponding to actual layer depth. This resulted in a maximum increase in degradation of approximately 10% at maximum effective strain for the 10,000-year event. We observed slight to moderate increases in relative displacement for design earthquakes, of 2.6% for DBE and 3.2% for MCE to 11.7% for the 10,000-year case. This demonstrates that this analysis is somewhat sensitive to the degradation curves, especially at higher strains. However, at this level of analysis, we believe this difference is reasonable given the uncertainty of the site conditions.

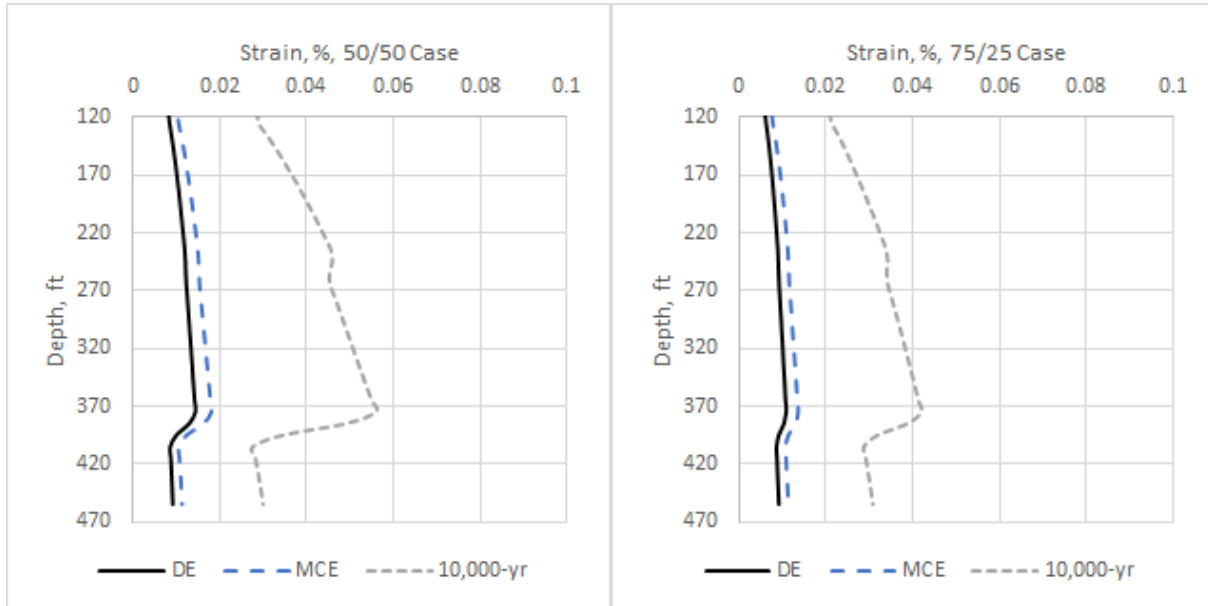
Figure 5-6 – Strain Profiles, 50/50 and 75/25 Cases

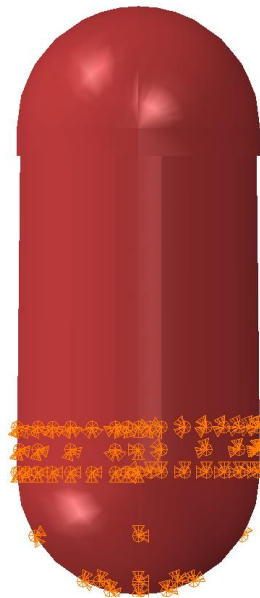
**Figure 5-19 – Boundary Conditions in the Model, Tank Elevation**

We used pinned boundary conditions for the nodes at the exterior of the bottom dome to represent the bottom dome encased in mass concrete and at the bottom 20 ft of the barrel section to represent the resistance provided by the sound rock layer, as shown in Figure 5-19. Note that these boundary conditions are representative of the strata around tanks based on our review of the log of formations of all the underground tanks.

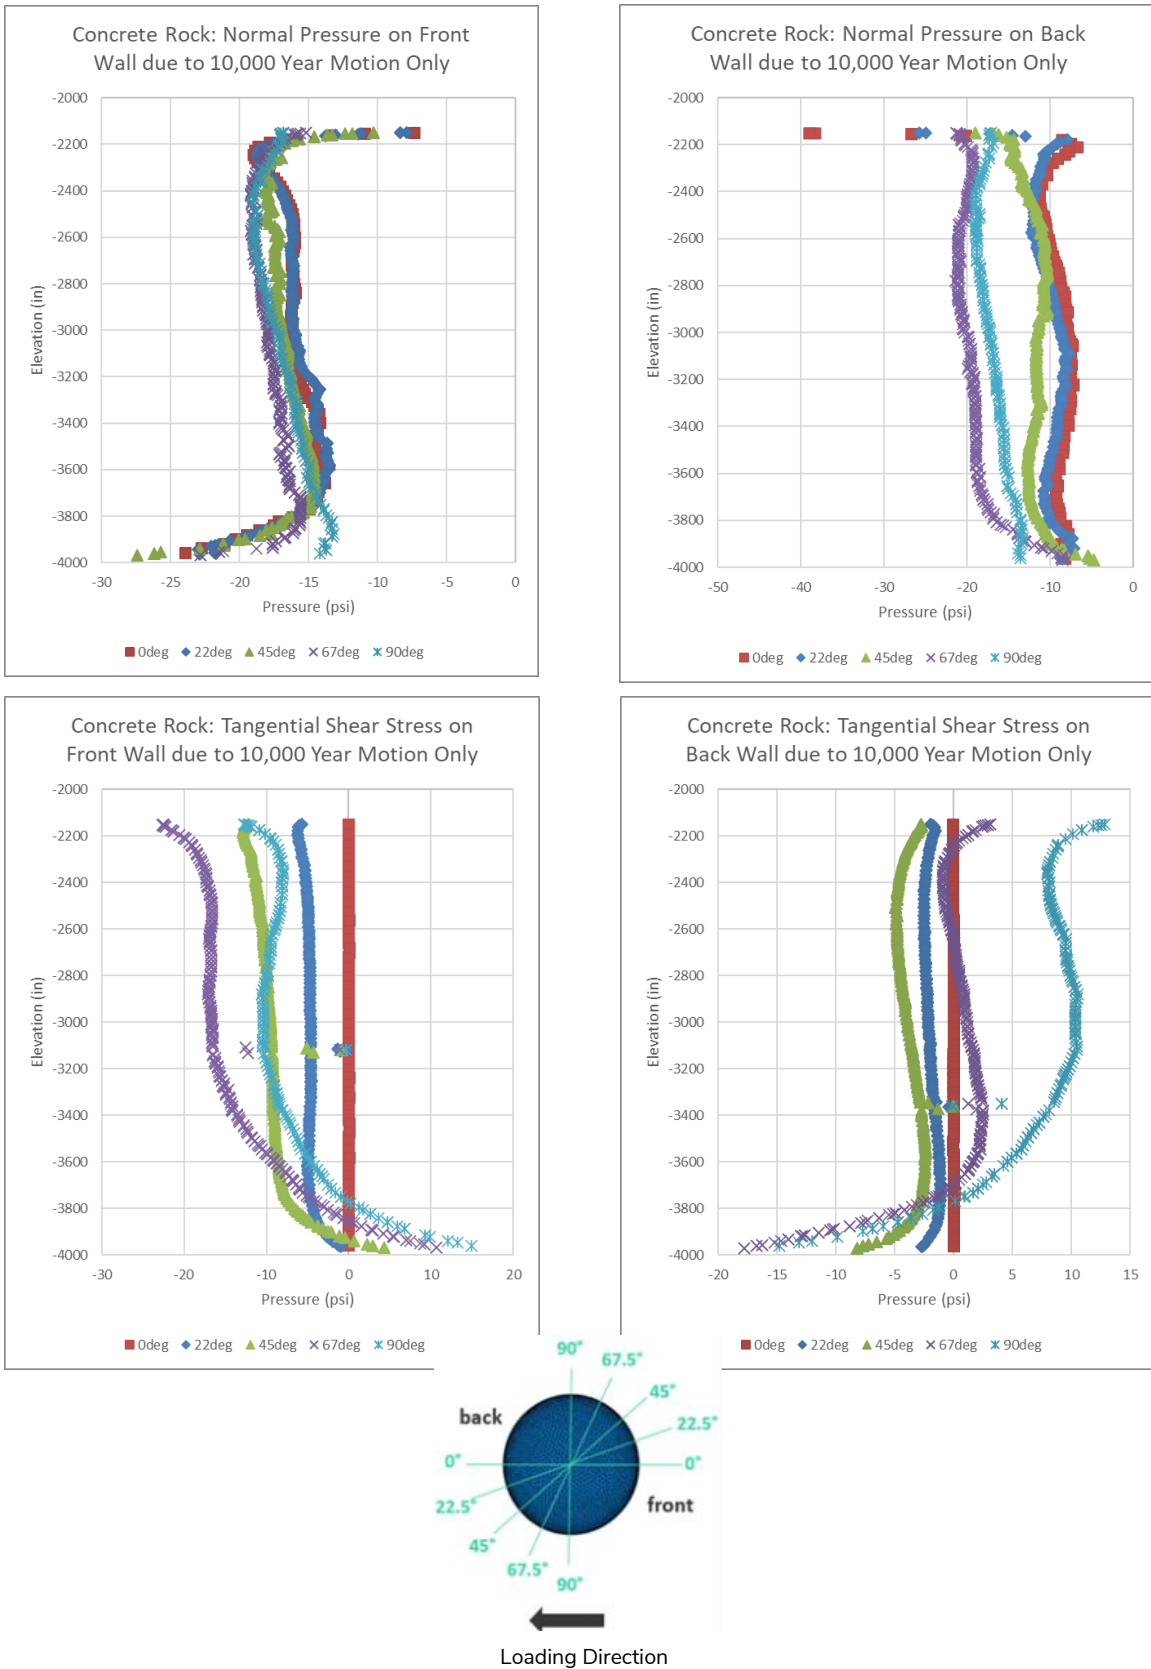
Figure 5-20 – Normal and Tangential Soil Pressure Distribution from SSI Analysis

We used the soil pressures predicted from our SSI analysis. As described in Section 5.2, the SSI analysis predicts the normal pressures and tangential and vertical shear pressures at the periphery of the tank caused by the strata around the tank due to a design basis earthquake considering Risk Categories II and III and a 10,000-year event. We used the soil pressures for the case of 75% rock/25% clinker strata around the tank, which is a representative case for most of the tanks at Red Hill. For a few of the tanks, 50% rock/50% clinker strata consideration is deemed more appropriate. Since the 75% rock/25% clinker strata model represents a conservative case yielding in higher soil pressures compared to 50% rock/50% clinker strata models, we used soil pressures calculated based on 75% rock/25% clinker strata in our response analysis.

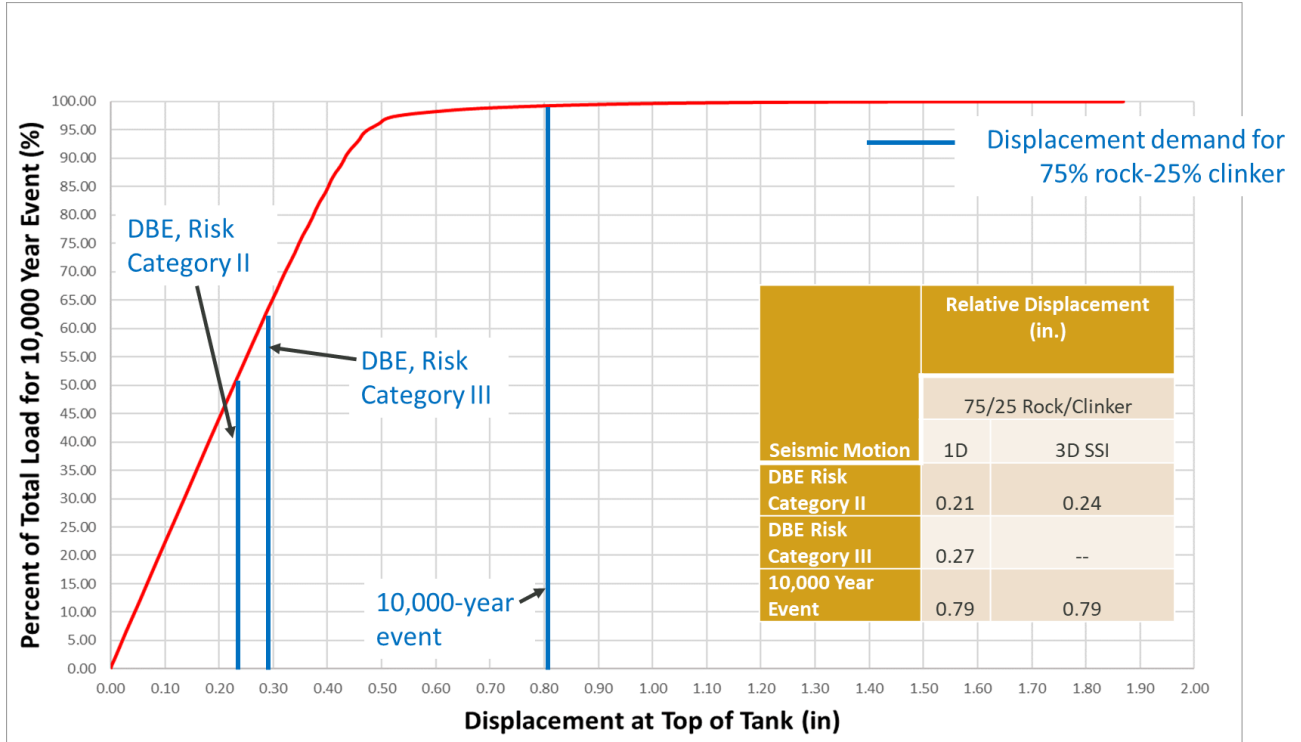
Figure 5-22 – Load vs. Displacement Curve for Tanks Subjected to Seismic Soil Pressures (No Liner Case)

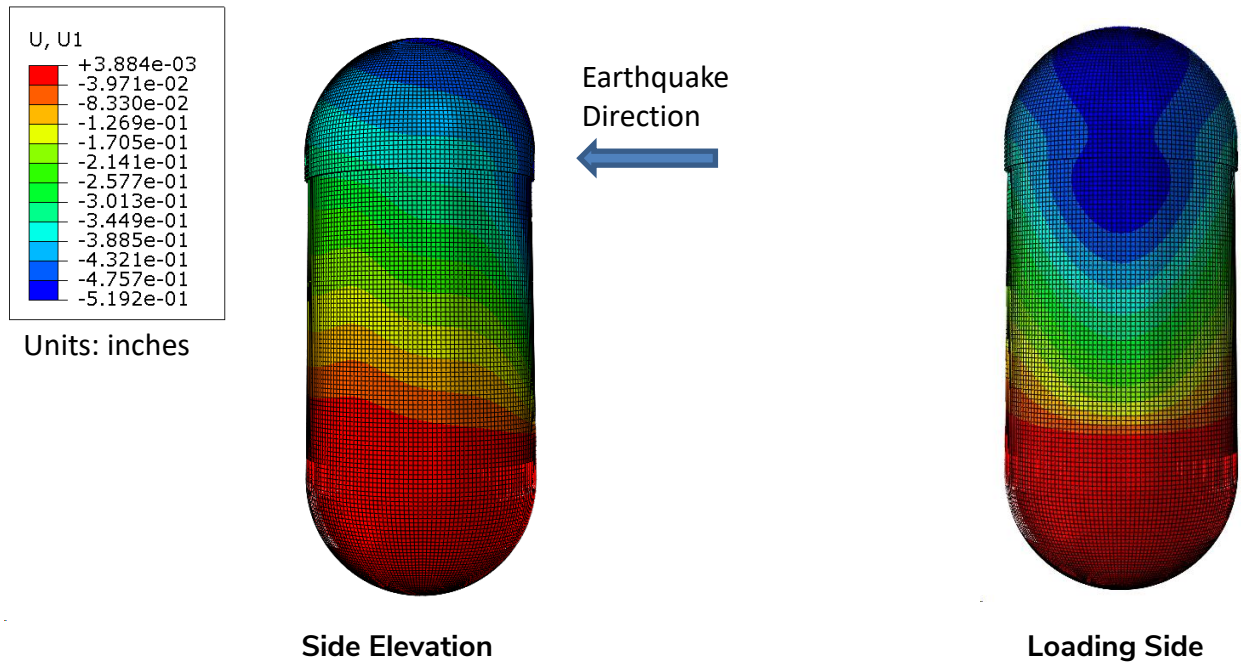
Figure 5-34 – Deflection Contours Shown on Deformed Shape for Seismic Demand for a 10,000-Year Earthquake (With Liner Case)

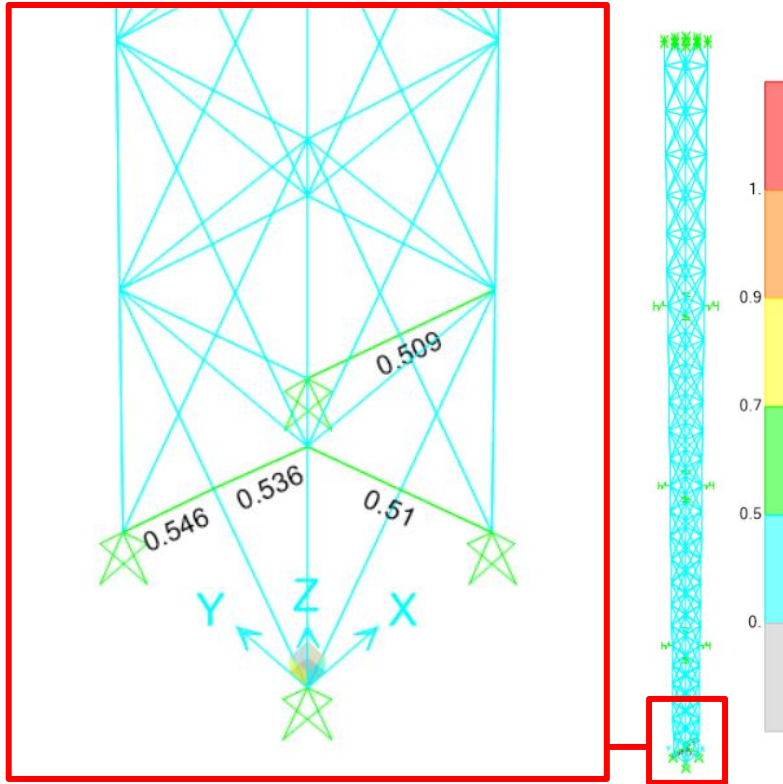
**Figure 6-8 – ASCE 7 DBE Risk Category III DCRs**

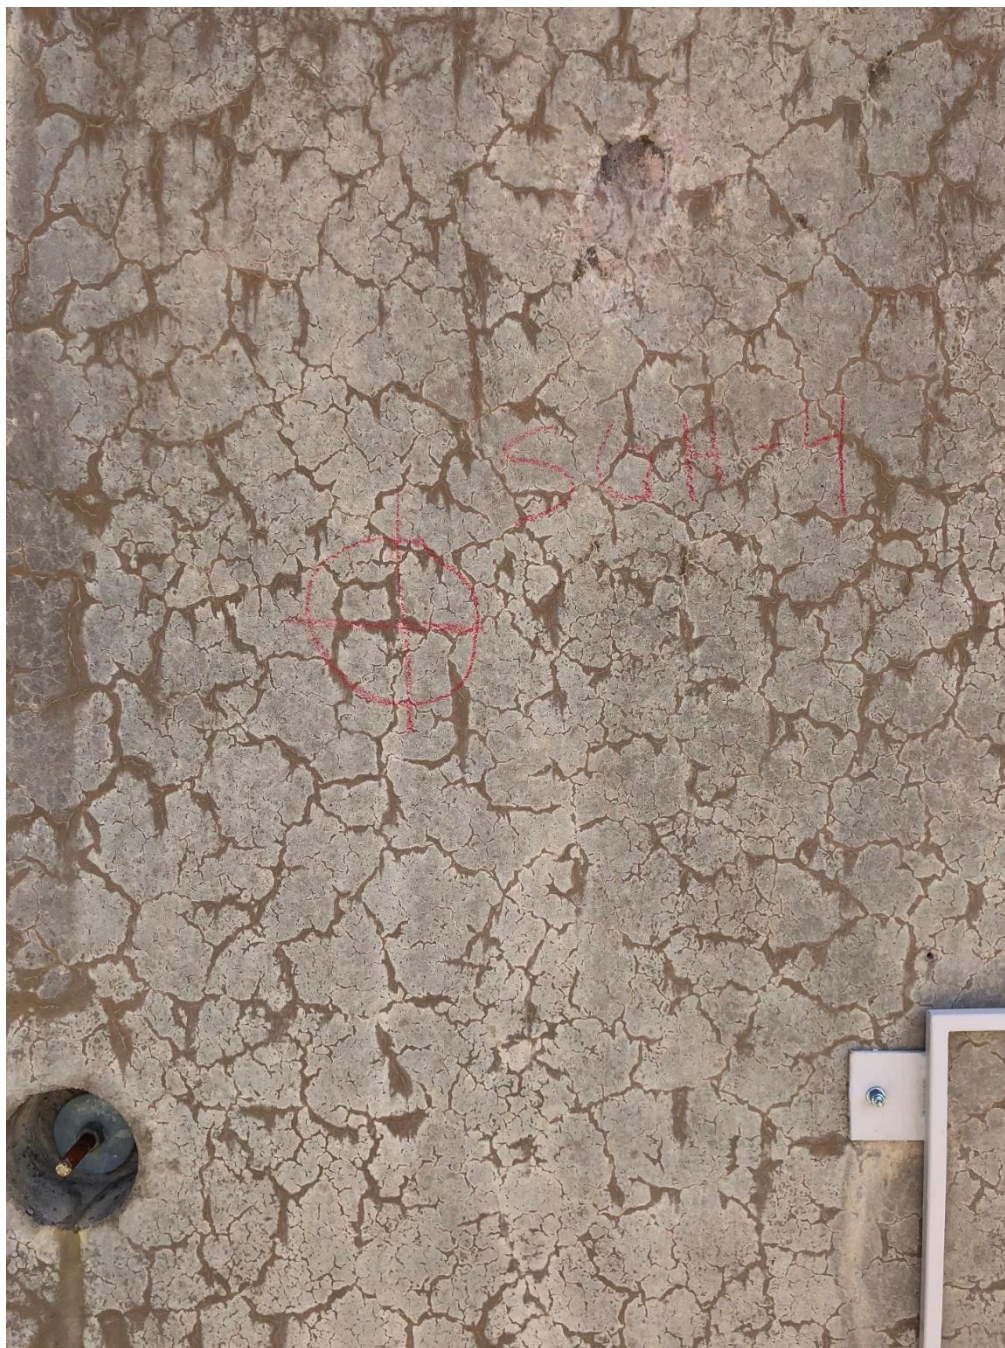
**Figure 7-1 – Typical ASR Cracking (Not from Subject Site)**

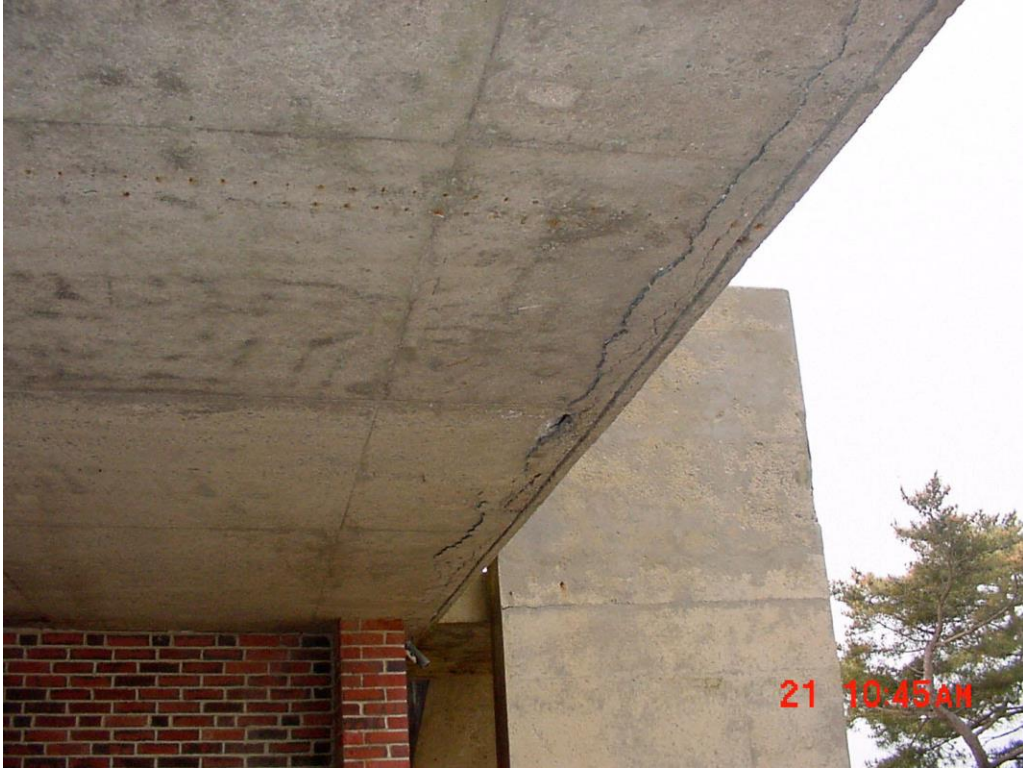
Figure 7-2 – Typical Incipient Spall (Not from Subject Site)

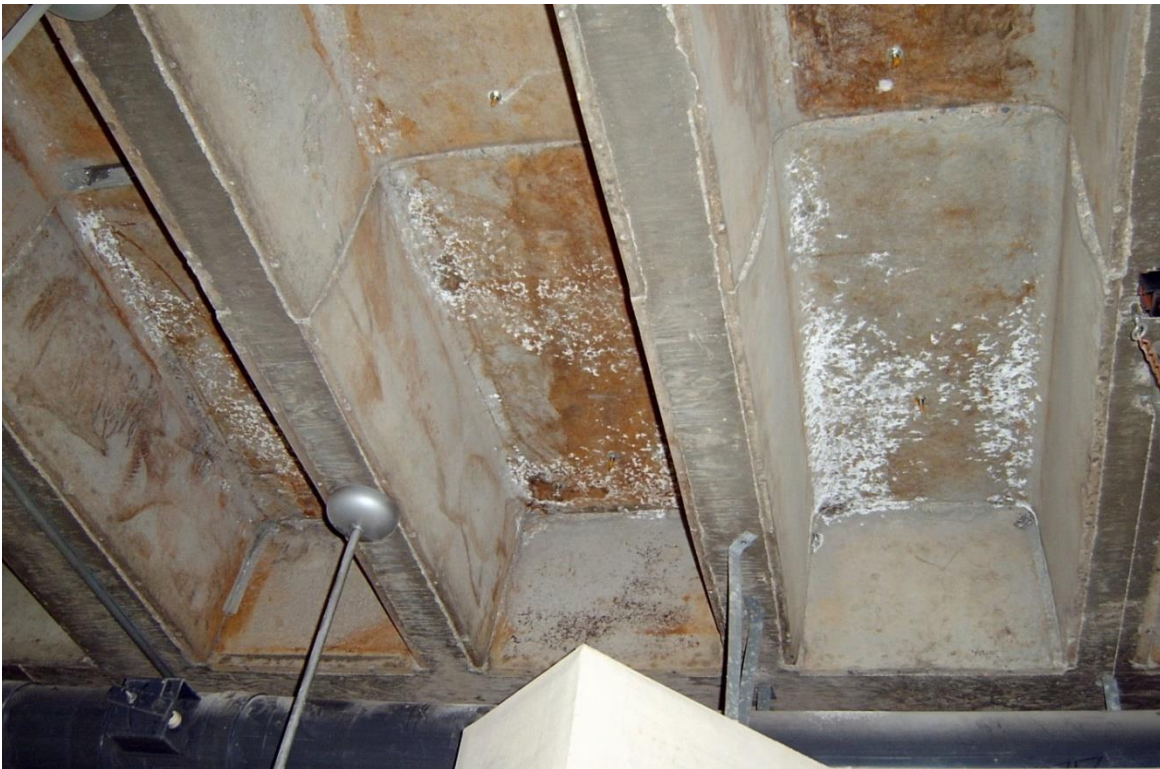
Figure 7-3 – Rust-Colored Staining (Not from Subject Site)

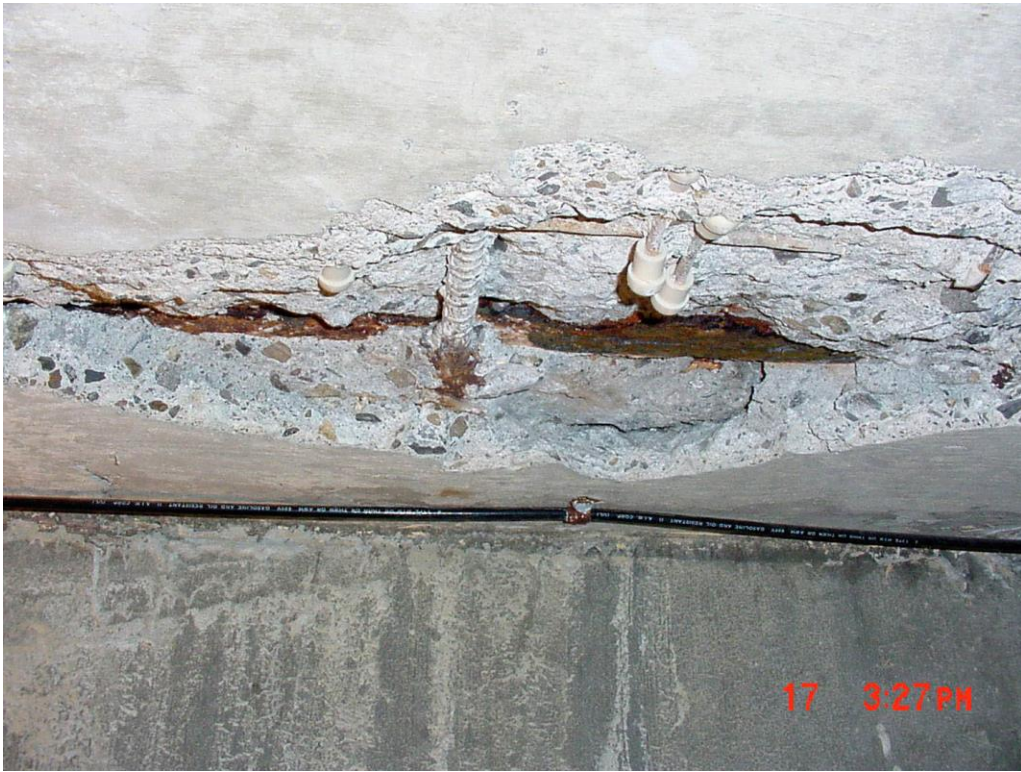
**Figure 7-4 – Typical Exposed Reinforcement at Spall (Not from Subject Site)**
