# ***Joint Task Force-Red Hill***

## ***Bi-Monthly Quality Validation Working Group Meeting***

**10 Aug 2023**

## QUALITY VALIDATION (QV) REPORT

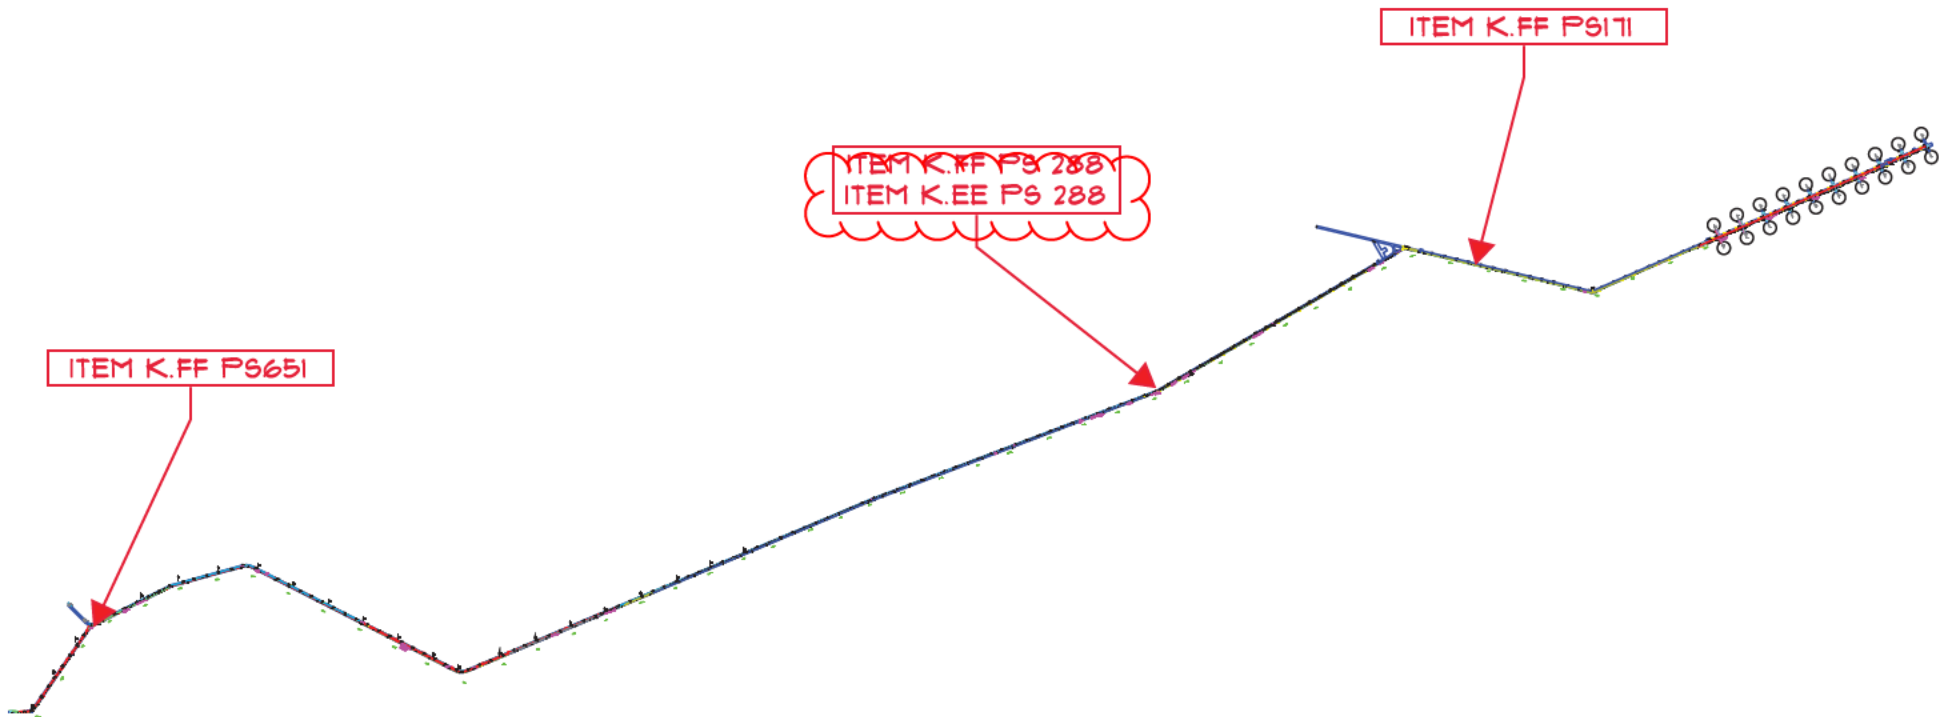
**EMERGENT PIPELINE REPAIRS**  
**Repair 188**

REPAIR ID	FIT-UP				ROOT PASS				COVER PASS				NDE					HYDROTEST				
SHOP / FIELD	PROCEDURE	FITUP P/F	DATE	WELDER	DATE	VT P/F	INSPECTOR	DATE	WELDER	DATE	VT P/F	DATE	INSPECTOR	MT / PT P/F	DATE	INSPECTOR	RT P/F	DATE	INSPECTOR	P / F	DATE	
(b) (3) (A)	FIELD	OCI FW M1-d-1	FILLET WELD						(b) (6)	03 / 31 / 2023	P	03 / 31 / 2023	(b) (6)								N/A	
										STRUCTURAL WELD												
REWORK 2

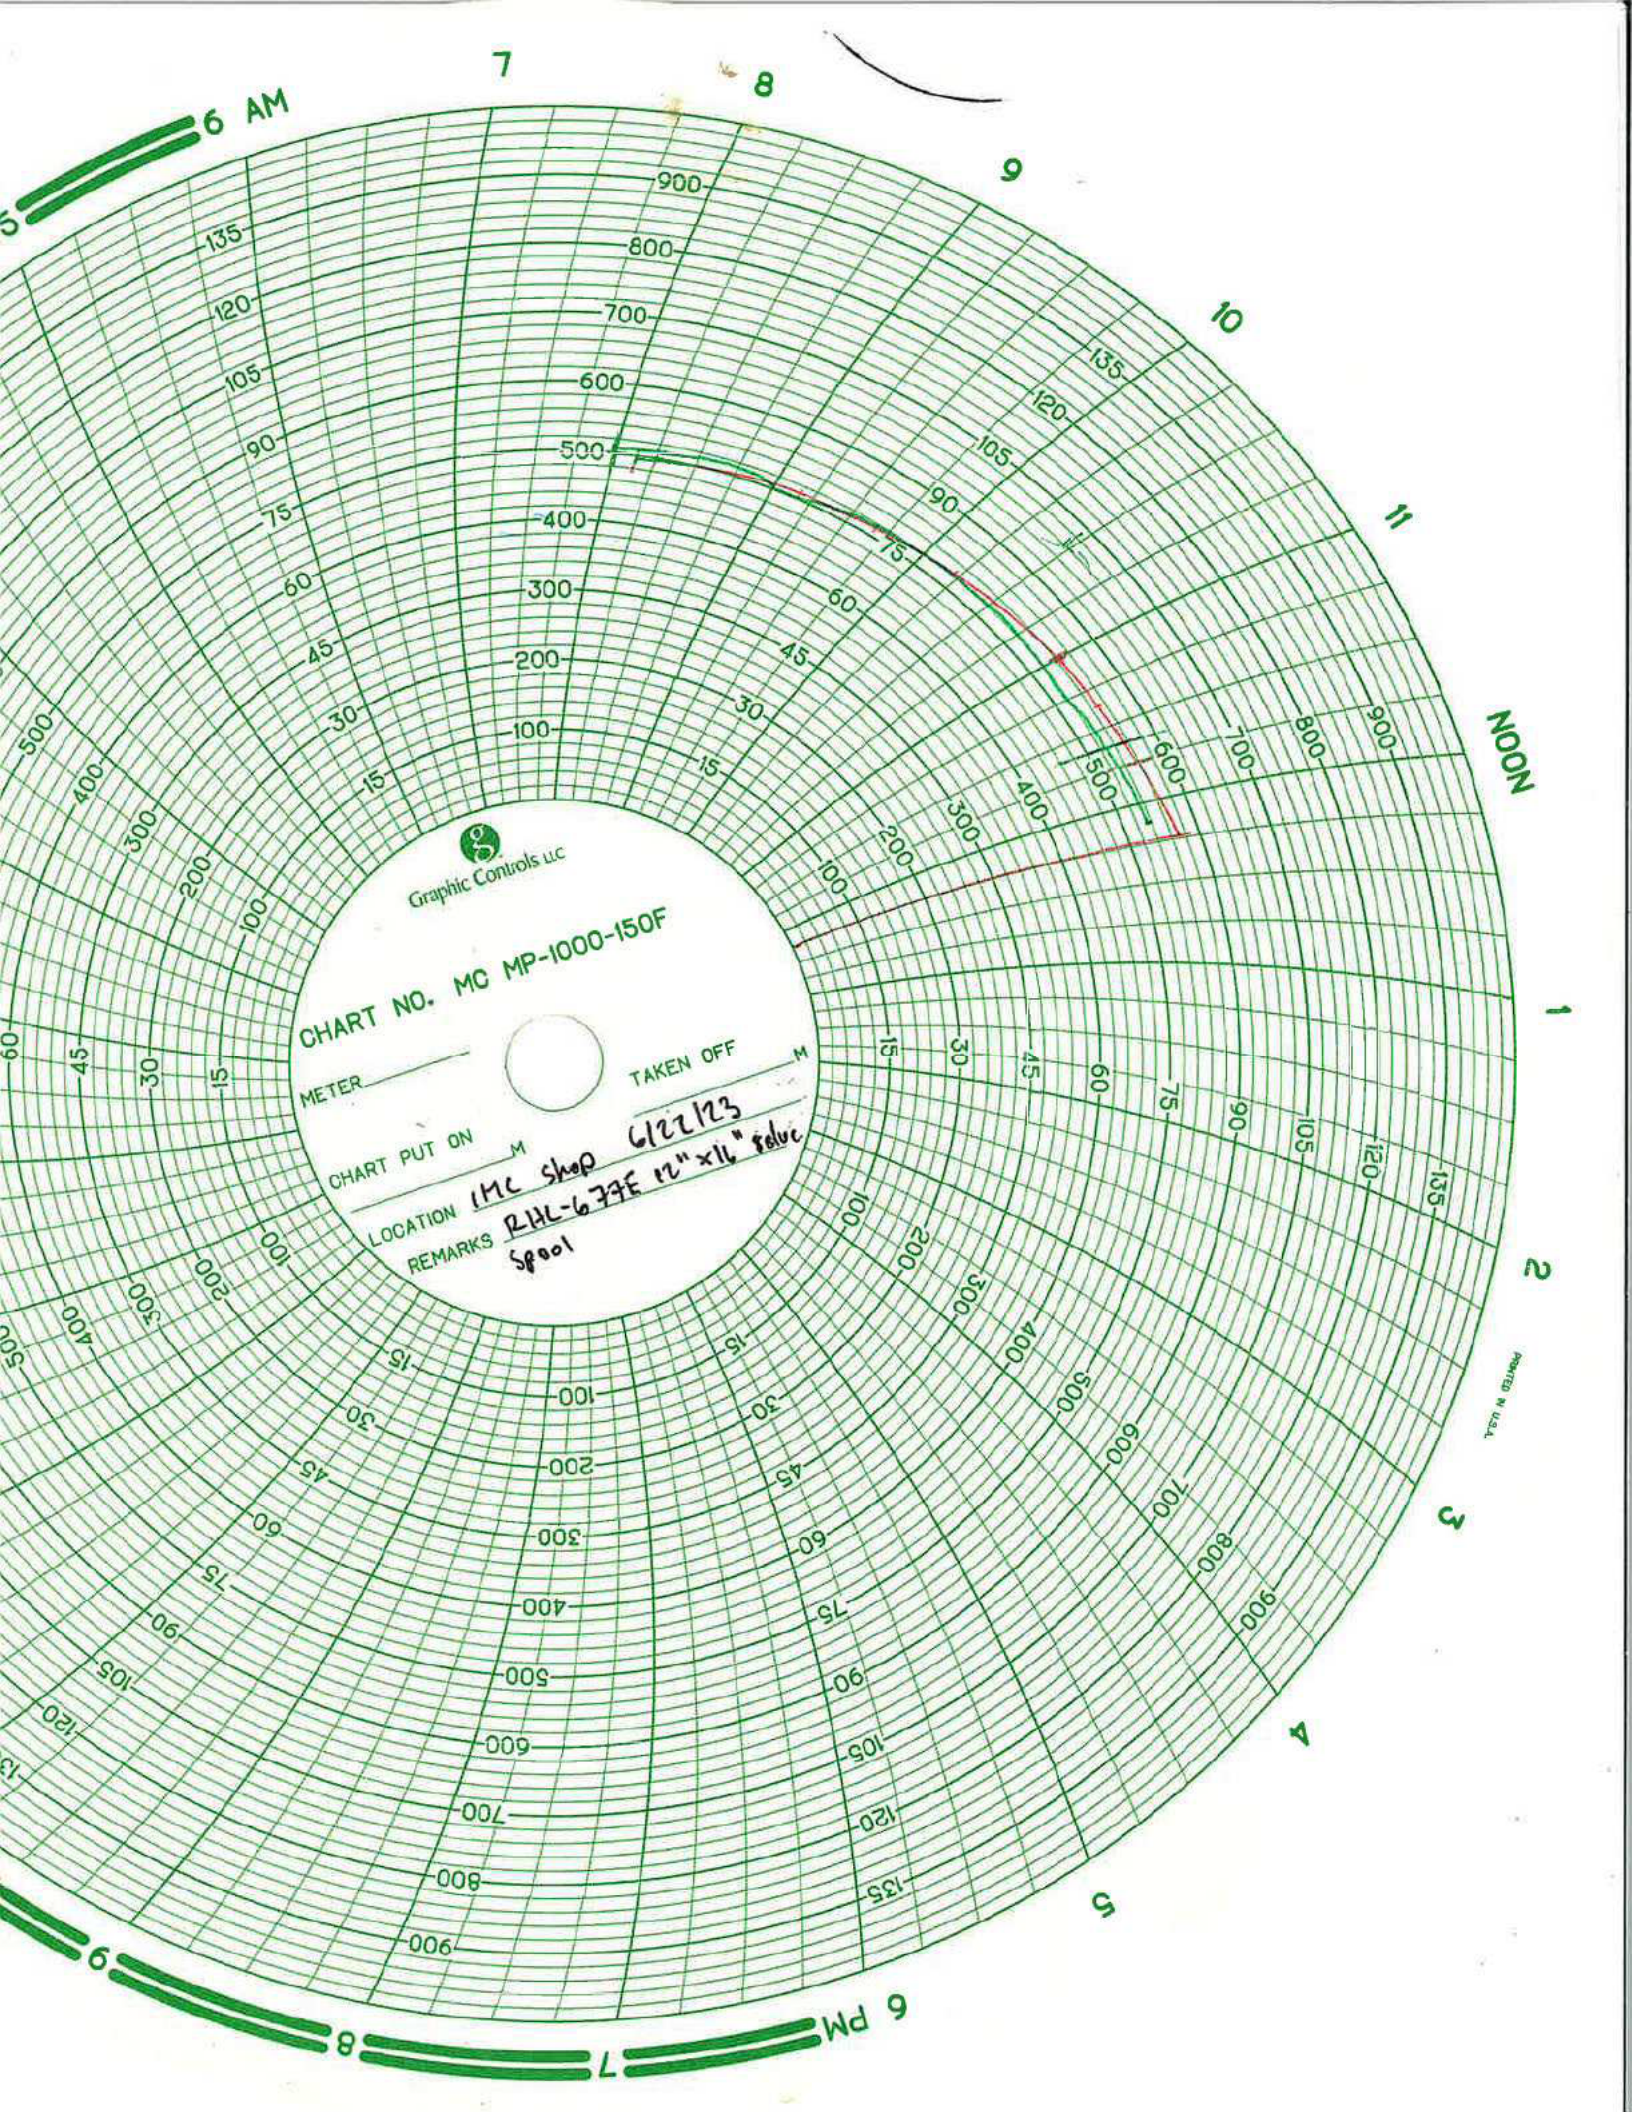
CHART NO. MC MP-1000-150F

Item(s)	Accept	Reject	Sketch/Notes
Reducing Spool Socket Welds			PT Inspection performed on the reducing spools socket welds for the high and low points. Project RHL-677E  No relevant indications noted.
High Point	<input checked="" type="checkbox"/>	<input type="checkbox"/>	
Low Point	<input checked="" type="checkbox"/>	<input type="checkbox"/>	
Performed By: (b) (6)	Level II	Date: 06-22-23	Reviewed By: _____ Date: _____

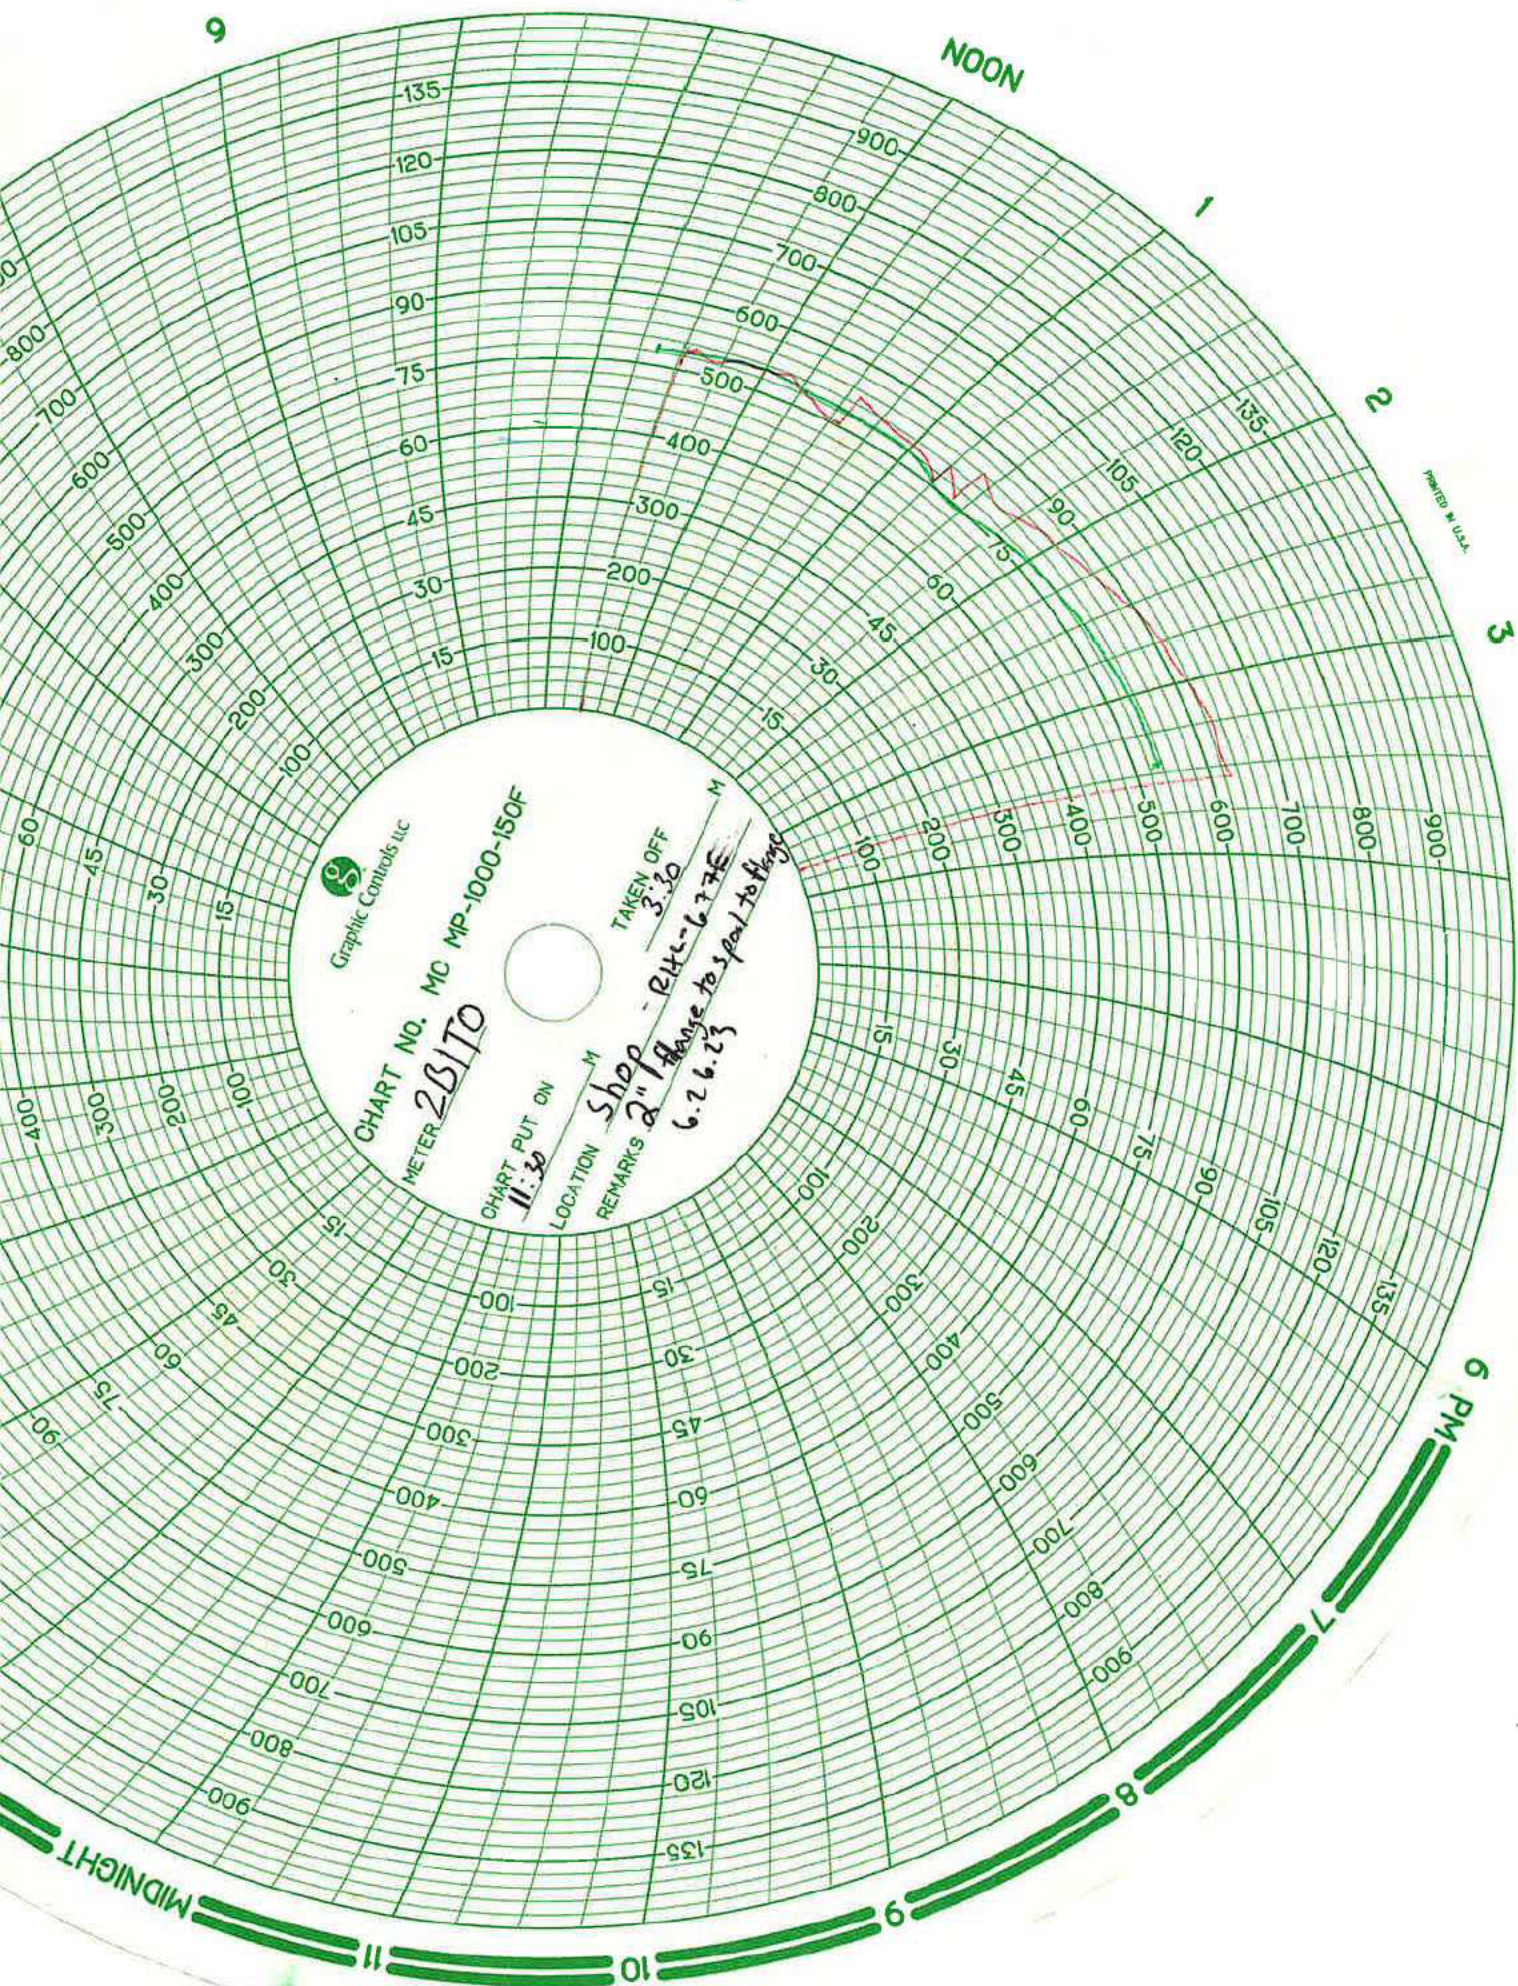
10 A second round of Hydrostatic Testing was performed after Contractor changed the LPP configuration.
