Pelekane Bay Watershed Management Plan South Kohala, Hawaii

**Prepared by
M. Carolyn Stewart
Marine and Coastal Solutions International, Inc.**

May 31, 2005

Mauna Kea Soil and Water Conservation District

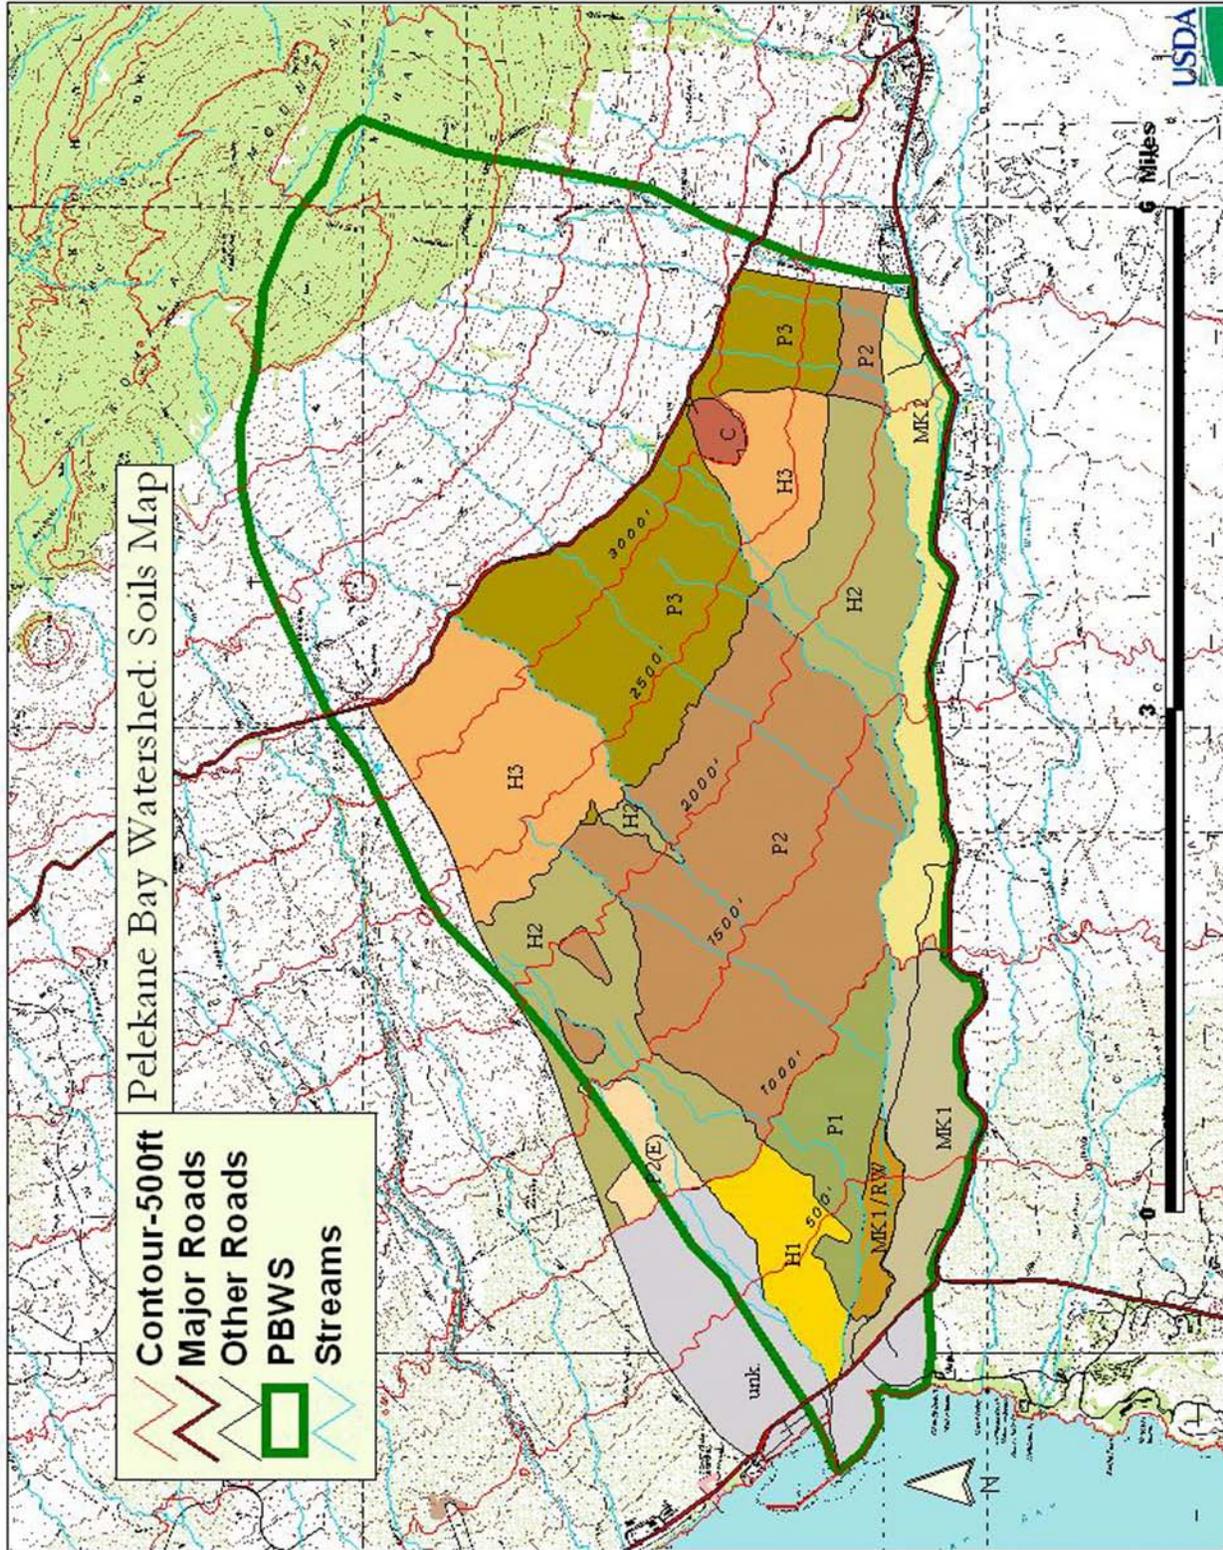
Figure 2: DRAFT Soil Types in the Pelekane Bay Watershed

Table 1, also in draft form, provides additional information about each of the soil types. The “depth class” is the normal depth of the soil; if the depth in the field is less, then the soil is eroded. The “Kf value” is the soil erodibility factor for the fine earth fraction or soil material less than 2.00 mm in diameter. The higher this number, the more erodible the soil. Amorphous clays in the soils keep the K values in Hawaii lower than on the Mainland. Sand, which is highly erodible, has a K value of 0.5 or 0.6. Hydrophobic soils repel water, and the water beads up rather than infiltrating the soil. Hydrophobic soils can occur naturally or as a result of intense heating from a fire. Water repellence may cause erosion of sloping land by contributing to surface runoff.

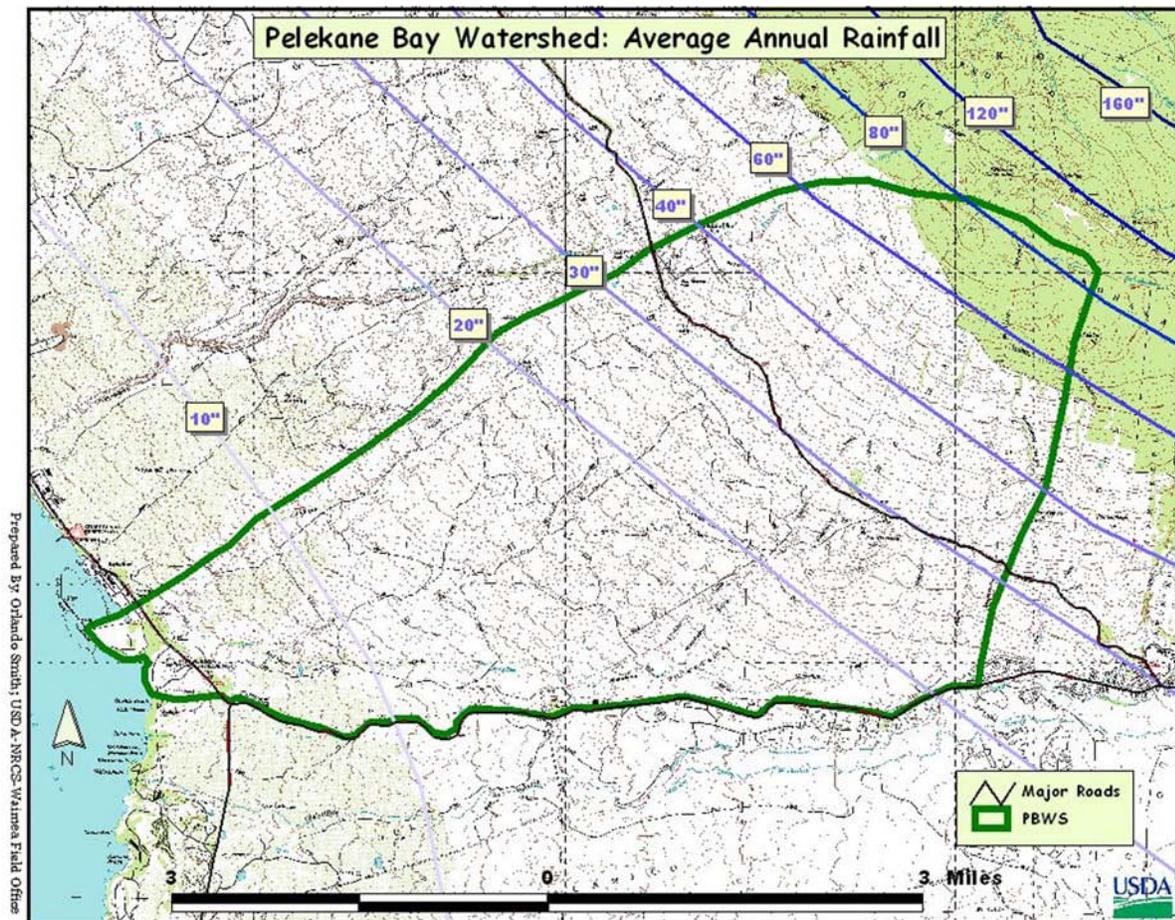
Figure 4: Average Annual Rainfall (in inches)

The average annual rainfall in Pelekane Bay, adjacent to Kawaihae Harbor, is about 5 inches a year, while up to 150 inches a year fall at the summit of Kohala Mountain. Figure 4 delineates average annual rainfall amounts in the watershed. Heavy windward blow-over during the winter months (November to March) normally accounts for most of the annual precipitation in the *mauka* areas. *Kona* storms and localized convection events on the leeward side of the mountain account for much of the moisture in the *makai* areas. Drought conditions in the watershed in recent years have exacerbated the dry conditions in the lower watershed. According to DLNR's Commission on Water Resources Management, severe drought conditions affected North Hawaii or Kohala in 1996, 1998-1999, and 2002-2003.

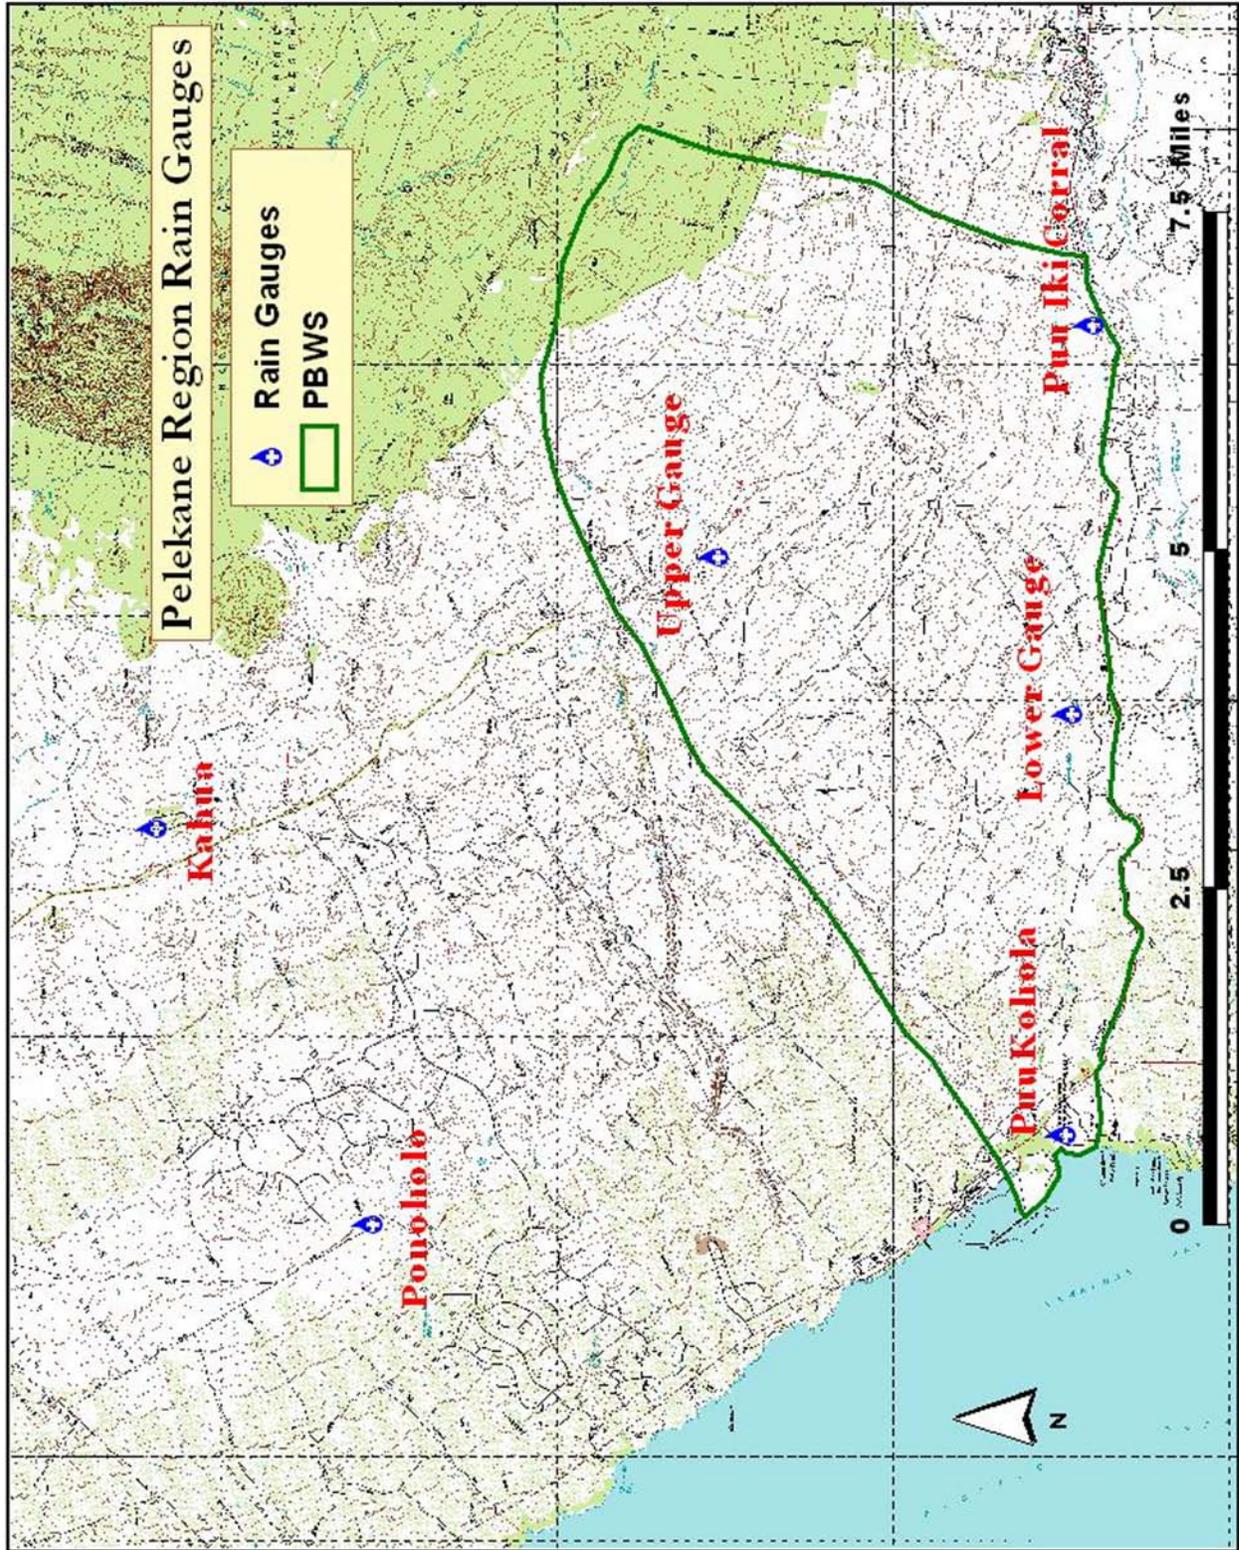
Figure 5: Locations of Regional Rain Gauges

In addition to the rain gauges located within the watershed, there are two gauges located on nearby ranches, which provide data relevant to this project. There is a National Weather Service rain gauge located at 3,250-ft. elevation at Kahua Ranch, located about four miles from the watershed. There is also a rain gauge at the 1,390-ft. elevation at Ponoholo Ranch (middlepen), from which rainfall data has been recorded since the 1930s. This gauge is located 4-5 miles north of the watershed, just north of the Kohala Ranch subdivision.

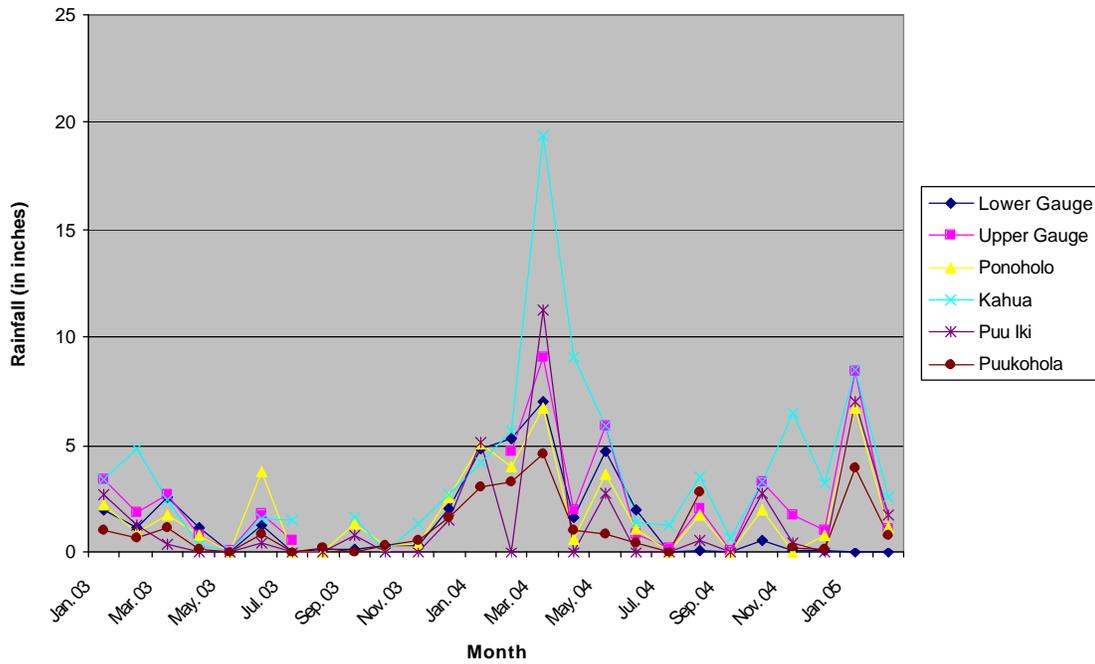
Figure 6: Monthly Rainfall (in inches) at Six Rain Gauges

In November 2002, Dr. Michaud also installed two automatic rain gauges and data loggers in the watershed. These rain gauges enable the District to begin to make correlations between changes on the landscape and rainfall amounts. Over the long-term, they will help the District to obtain an understanding of the relationship between rainfall, runoff events, and sedimentation events in Pelekane Bay. Data from these rain gauges is downloaded periodically; data from September 2002 to February 2005 are summarized in Table 3 and in Figure 6.

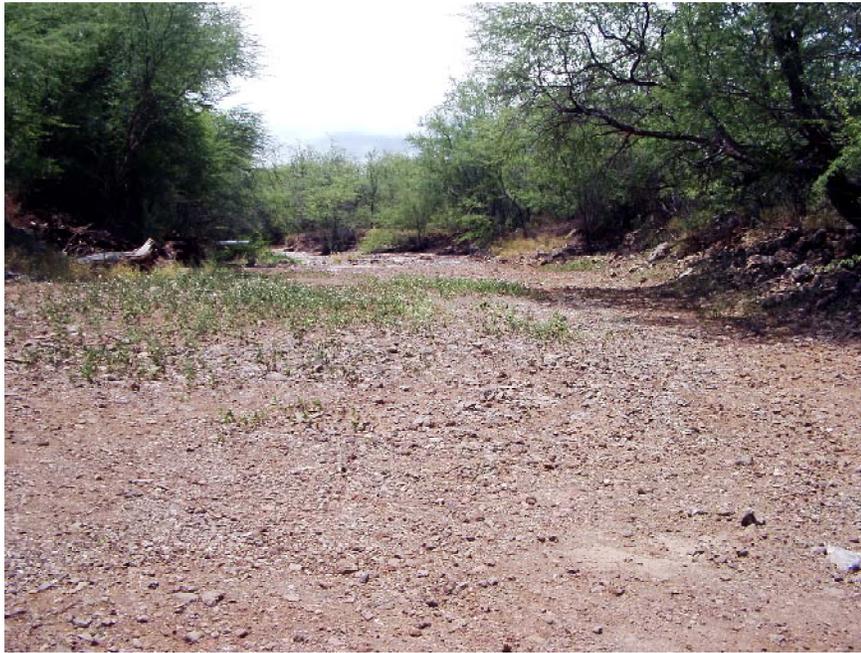
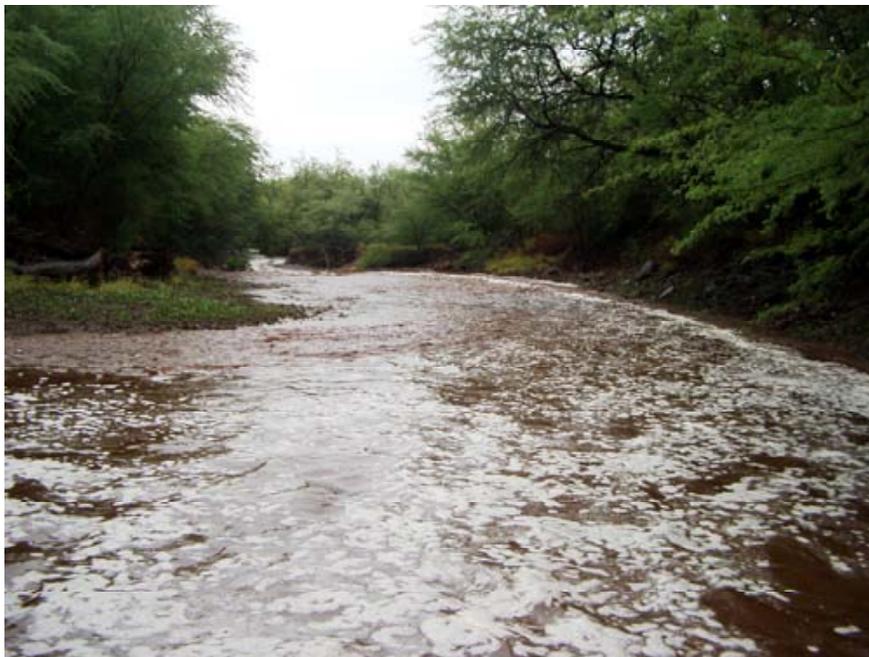
elevations. Streamflow is generally limited to flows in the gulches and overland during rainfall events. Localized heavy rainfall and storms cause flooding, called freshets or spates, which contribute to the flashy characteristic of Hawaiian streams. The photos in Appendix A provide a classic illustration of this flashy characteristic.

Photos: Stream channel in normal dry condition (top) and following storm event (below)

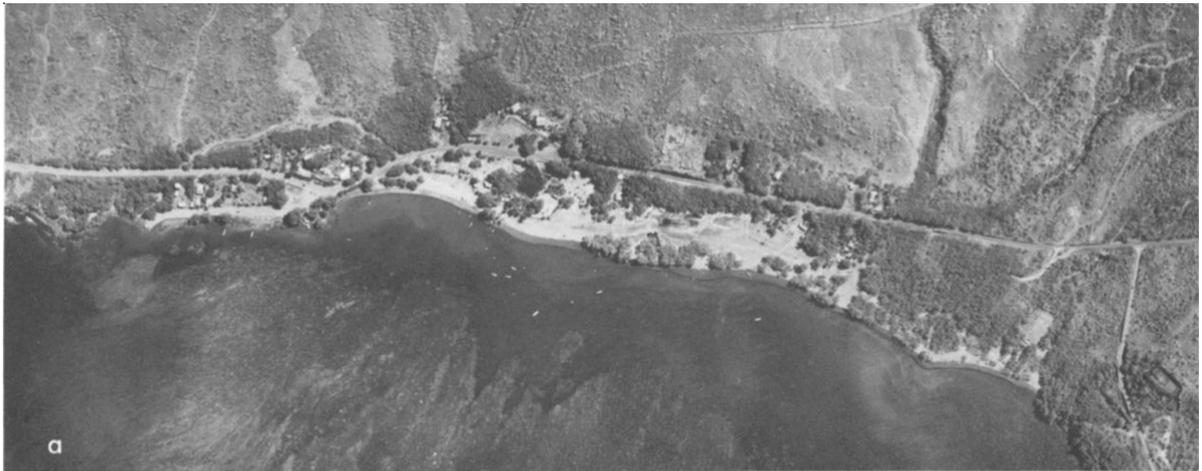
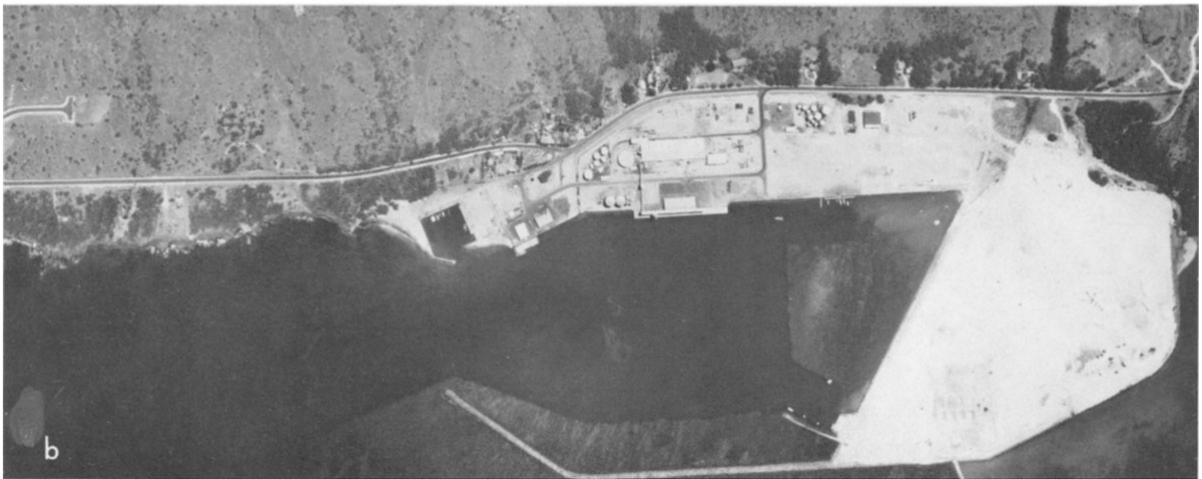
Experts have noted that much of the sediment retention in Pelekane Bay may be attributable to the lack of nearshore circulation caused by the construction of Kawaihae Harbor in 1959. In fact, Jokiel

“considers the loss of the littoral drift current carrying sediment out of Pelekane Bay to be the major reason for the present siltation of the bay” (MKSWCD 1998). The virtual absence of consistent circulation means that

Photos: Kawaihae Bay before (top) and after (bottom) construction of Kawaihae Harbor in 1959

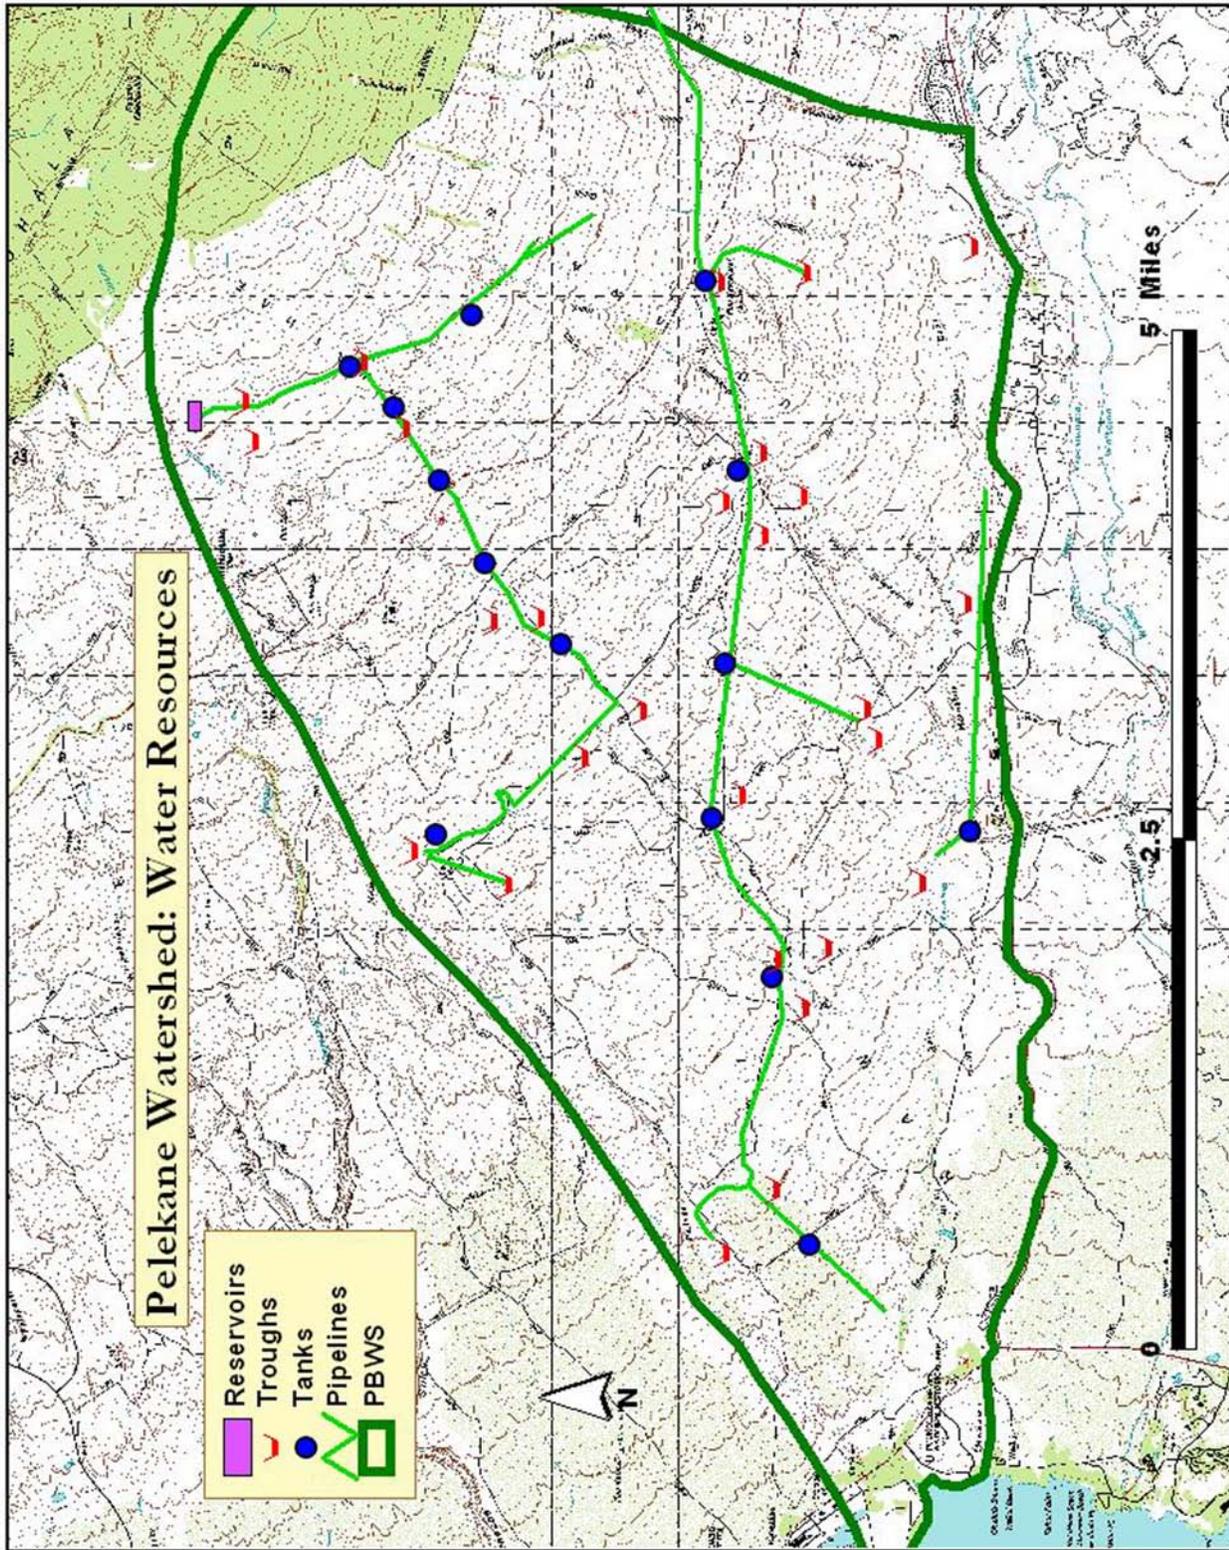
Figure 8: Water Resources in the Pelekane Watershed

to enhance fire-fighting capabilities within the watershed. With the fittings, the Hawaii Fire Department can readily access water to fill tanker trucks and dip ponds. Figure 8 shows water resources within the watershed.

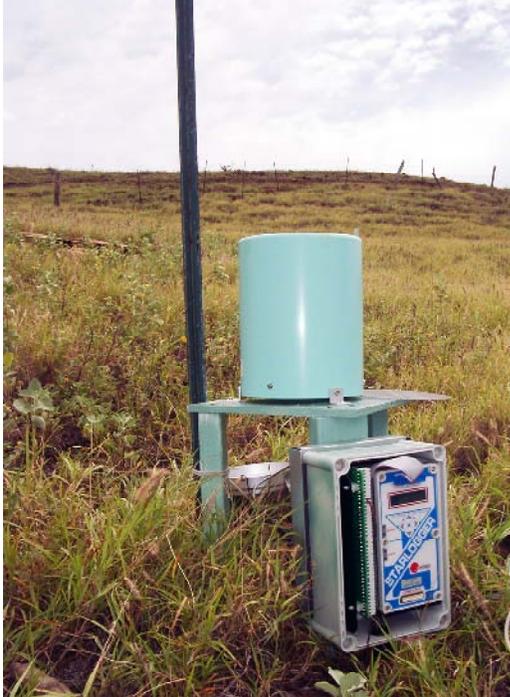
Photo: Rain Gauge in Pelekane Watershed

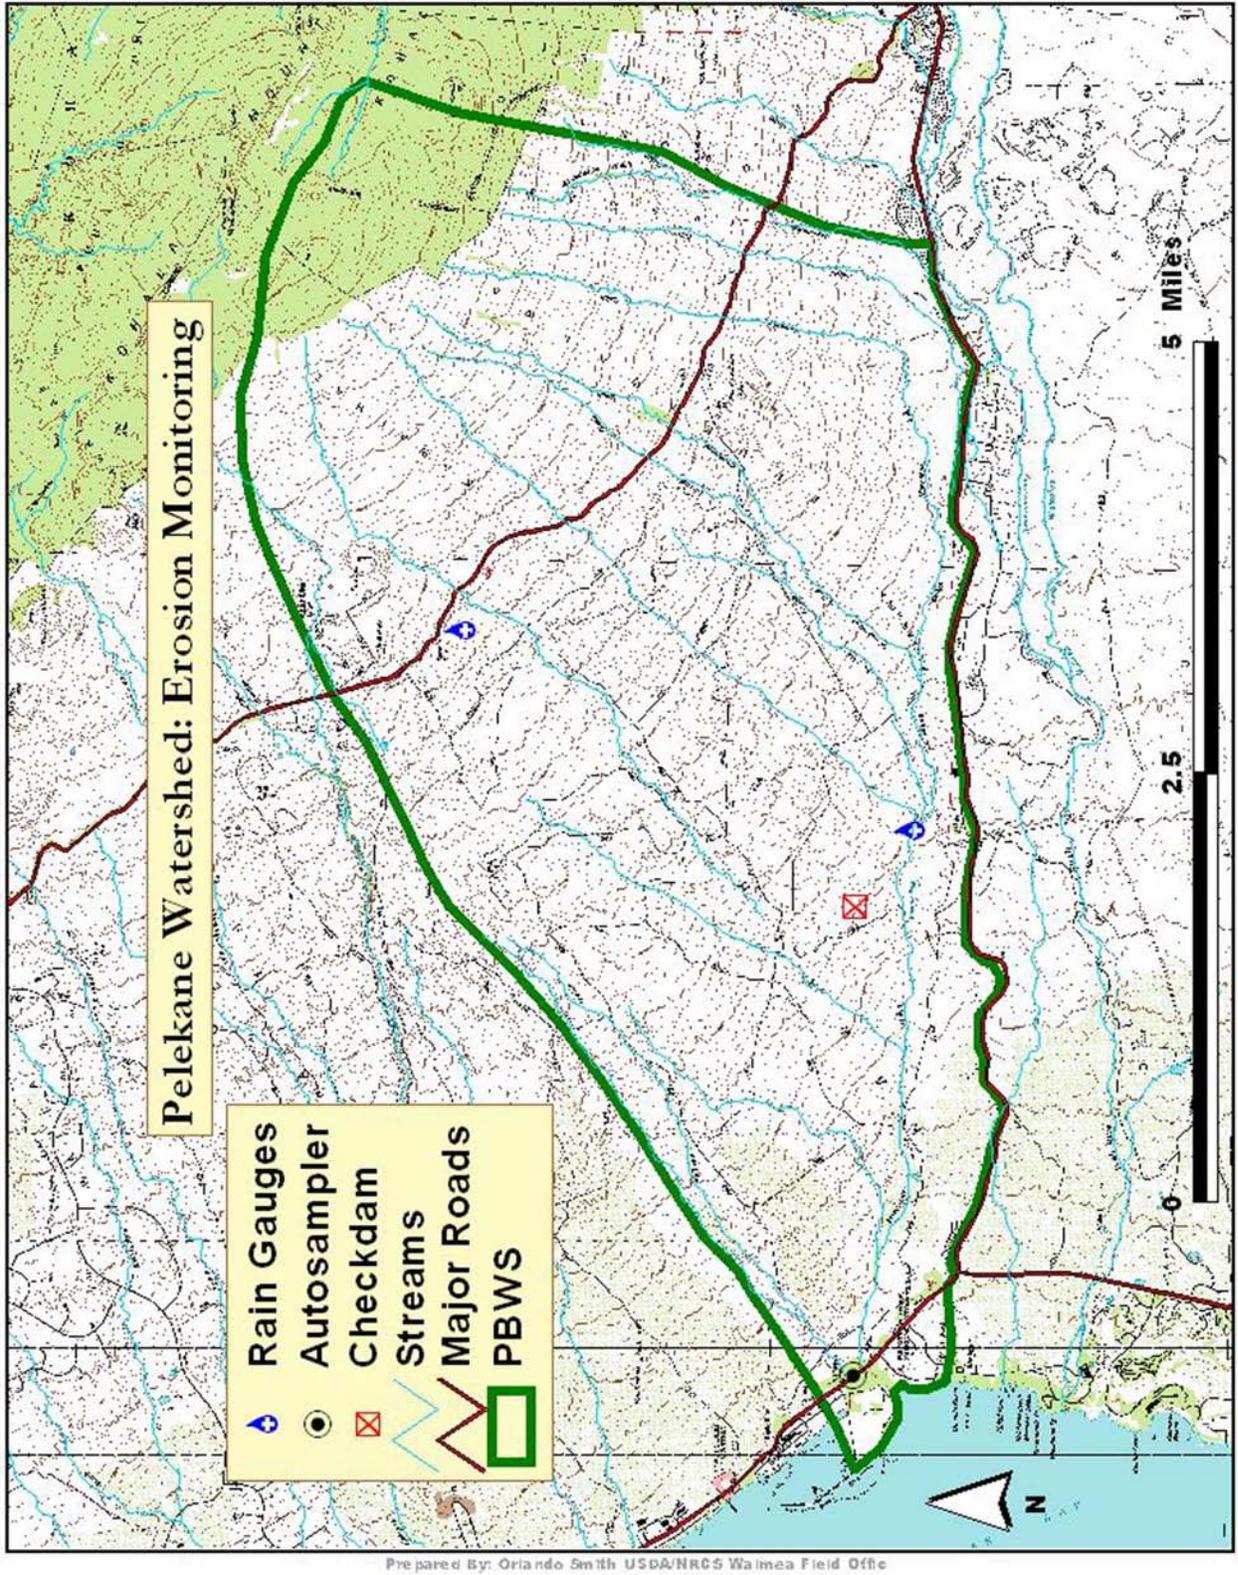
Figure 10: Erosion Monitoring Sites

Figure 10 identifies the locations of the rain gauges and check dam.

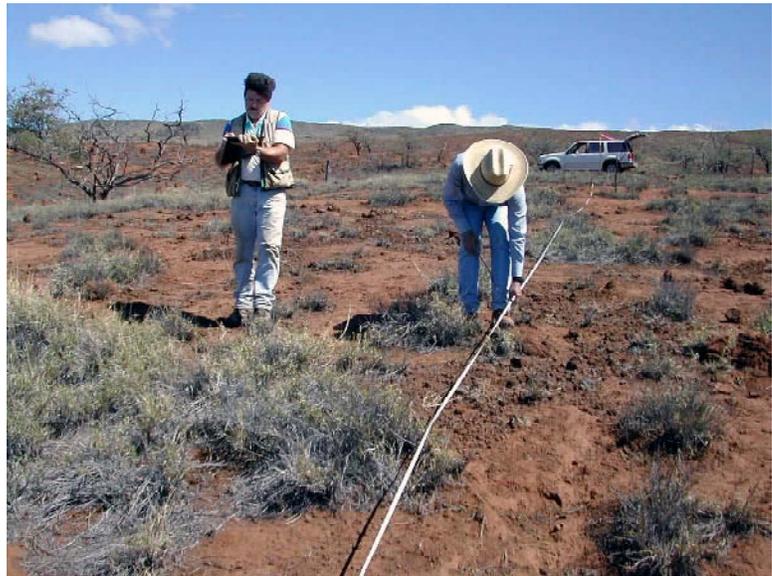
Photo: Vegetative Cover Monitoring Transect

A linear interval transect is used to monitor vegetational changes over intervals of time on a fixed line or location. A 100-ft. tape is stretched between two point and a 1-ft. interval used. A vegetational hit is recorded if all or part of the basal component of a plant lies totally or partially within that 1-ft. interval, directly under the tape. Bare ground, rock and litter are also recorded if they are at least one square-inch in area. To provide further precision, the 100-ft. line is subdivided into 20-ft. sections with subtotals calculated for each section. This helps more clearly define where changes in vegetation are actually occurring along the 100-ft. line.

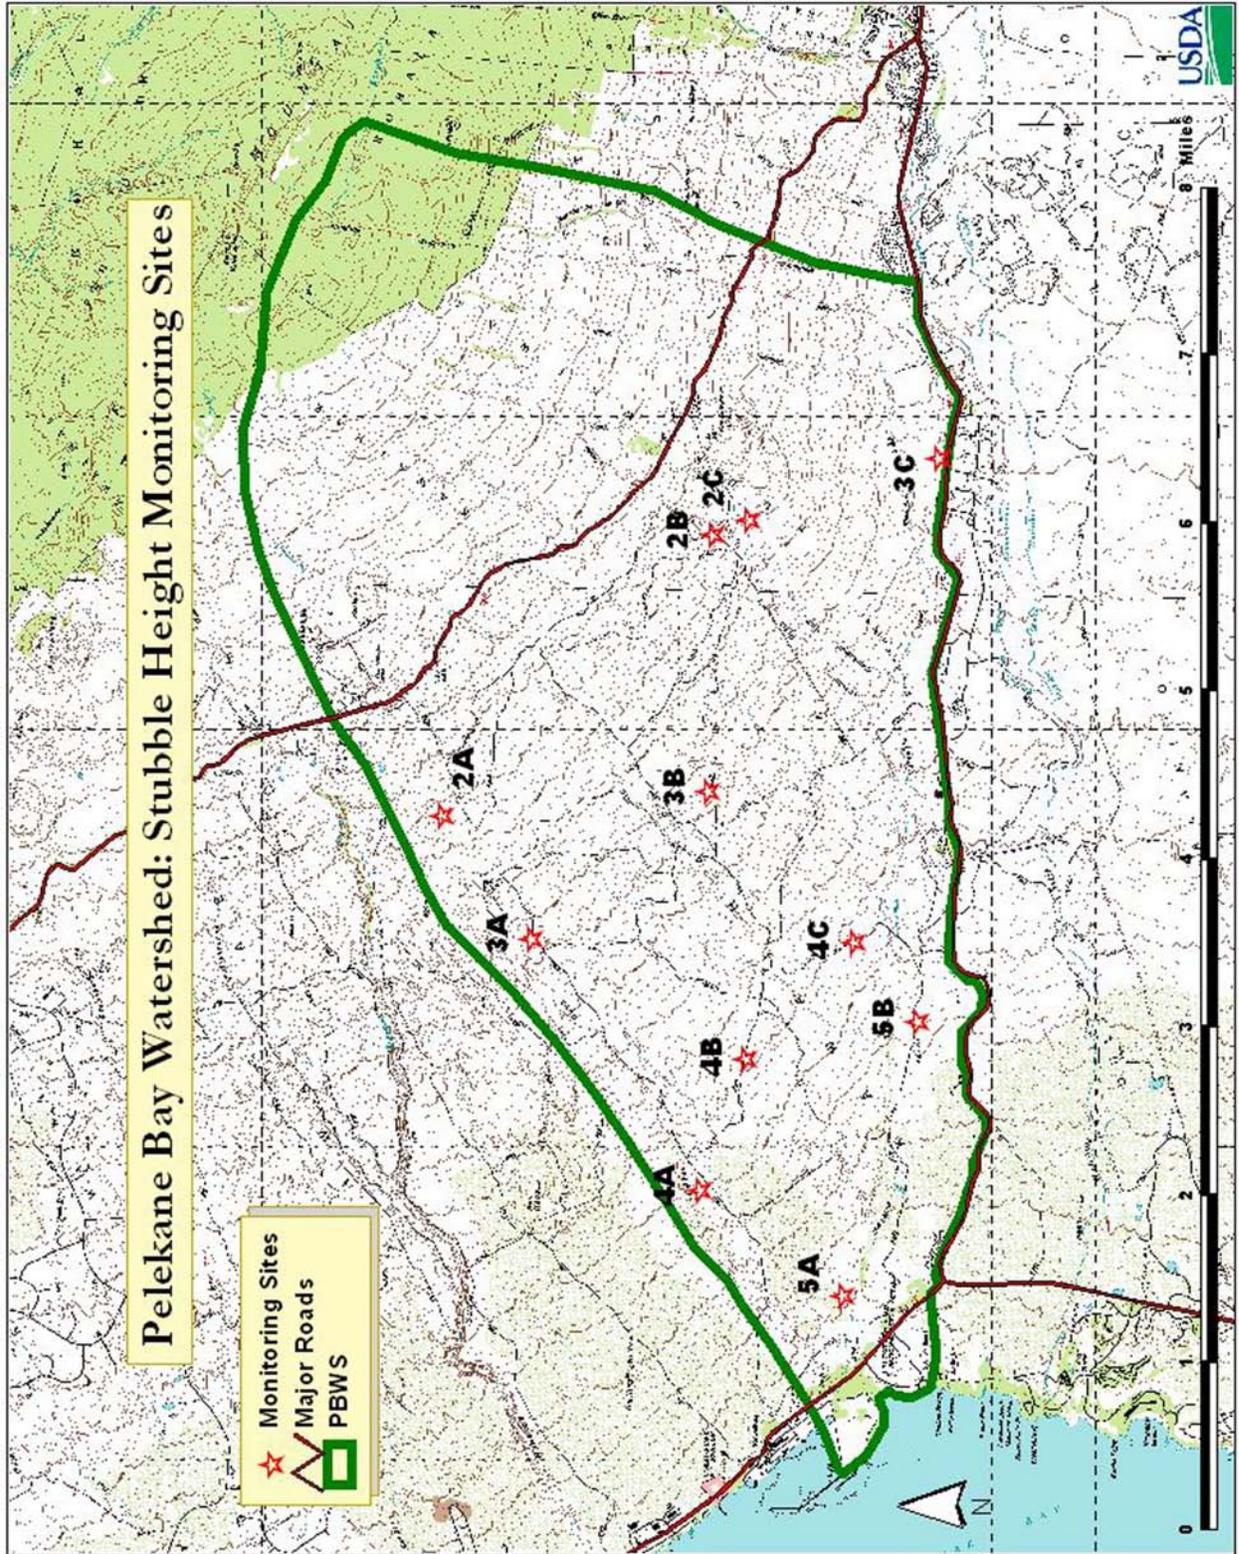
Figure 11: Stubble Height Monitoring Sites

Eleven monitoring sites have been established in the watershed below the Kohala Mountain Road (Figure 11). Other sites will be established above the Kohala Mountain Road at a later time. These key grazing areas are identified in each paddock by their latitudinal and longitudinal coordinates. The key forage plant, subject to monitoring, was identified for each key area. The monitoring consists of measuring the average height of grasses within the vicinity of each key area. Stubble height monitoring began in early 2001. Monitoring sites in Paddocks 5A and 5B, which have never been grazed, were

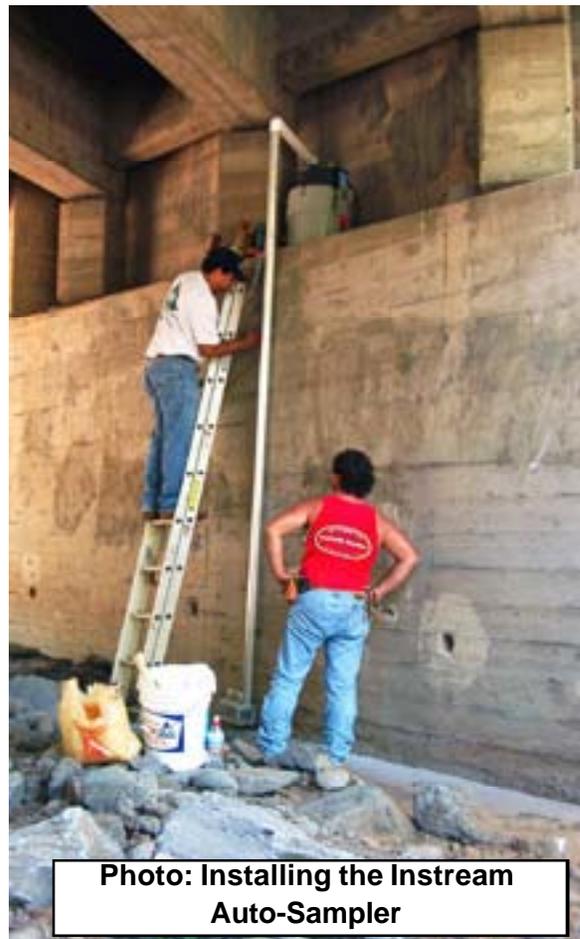
In May 2004, after waiting seven months for permission from the State Department of Transportation (DOT), an ISCO 6712C Compact Sampler, with flow module, was installed on a high ledge under the bridge over Makeahua Stream and secured to a concrete post. Figure 10 identifies the location of the autosampler. A pipe attached to the face of the bridge support contains the suction tubing and other wires. A cage at the bottom of the pipe contains and protects the water intake tubing. The flow meter is attached to the bottom of the cage. The sampler collects stormwater samples and flow rate data during times of stream flow.

Photo: Installing the Instream Auto-Sampler
