KAIKA BAY  
WATERSHED-BASED PLAN

APPENDIX A:  
GEOMORPHIC ASSESSMENT OF  
POAMOHO STREAM

# Geomorphic Assessment of Poamoho Stream

**Kaiaka Bay Watershed-Based Plan  
Oahu, Hawaii**

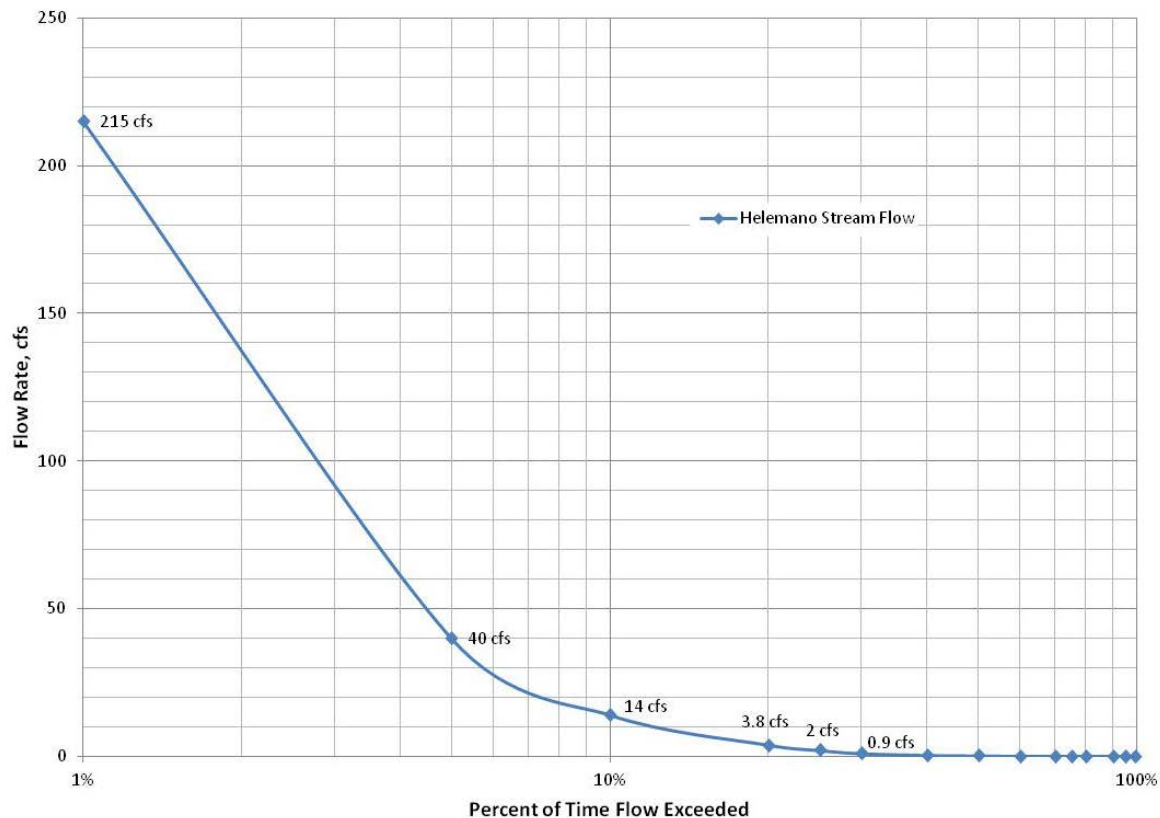
**Figure 2-2 Helemano Stream Duration Curve**

Another important aspect of stream flow is the amount of time a flow occurs in a stream. Because of the small, steep watersheds found in Hawaii as well as high rainfall intensity, Hawaiian streams tend to be flashy in nature with high flows only lasting over a short period. Duration curves are used to illustrate the percentage of time flows are exceeded within a stream and therefore the amount of time energy is available to impact the watershed health. Using the daily flow data from the Helemano gage, the USGS established the duration curve shown in Figure 2-2. For the Helemano Stream duration curve 10percent of the time flow at the recording gage is going to be greater than 14 cubic feet per second (cfs), with flows of 215 cfs being exceeded only 1percent of the water year (Oct 1 through Sept 30). Based on the duration curve in Figure 2-2, the Helemano Stream at the gage site is ephemeral with no flows approximately 60 percent of the time.

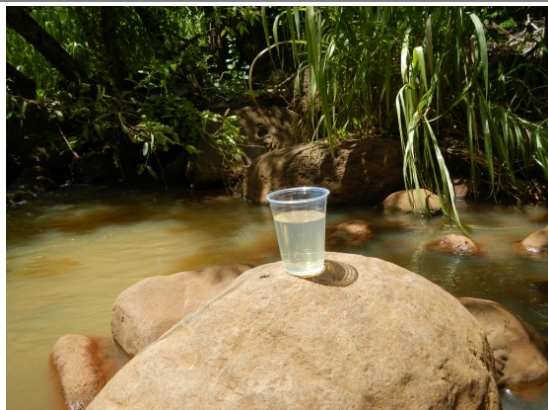
Photos of the water color and clarity were collected at multiple locations along the stream. The color of the water was generally consistent at all the locations recorded in the lower reach (first day). On the second day the middle stream reach was found to be orange in color, likely from high sediment content. The origins of the high sediment load were not identified but the potential location of the sources was likely a side tributary as the upper stream reaches did not exhibit the orange color. The following series of photos provide a representative example of the condition of the stream flow.

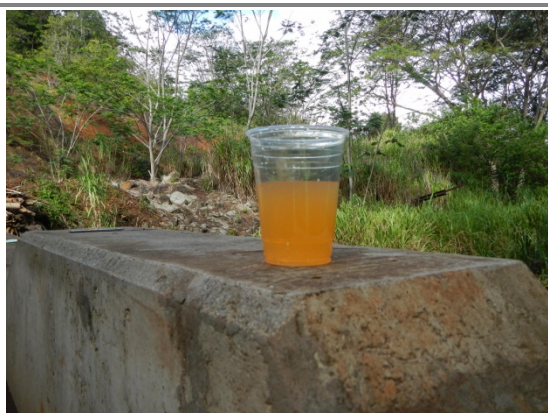
Throughout the Day 1 field investigation the water color and clarity was found to be relatively consistent. The flow appears to be turbid, likely due to remnant suspended material from the earlier high flows.

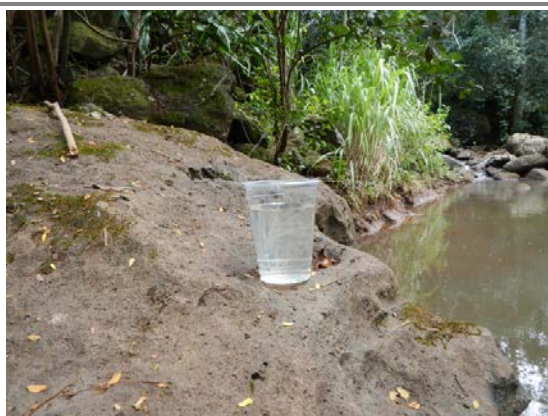
This sample is taken at the Striker Brigade crossing approximately 2,000-ft downstream of Kamehameha Highway crossing. The orange color suggests high suspended clay content. A visual inspection of the stream from the Kamehameha Highway bridge also found the flow to be orange.

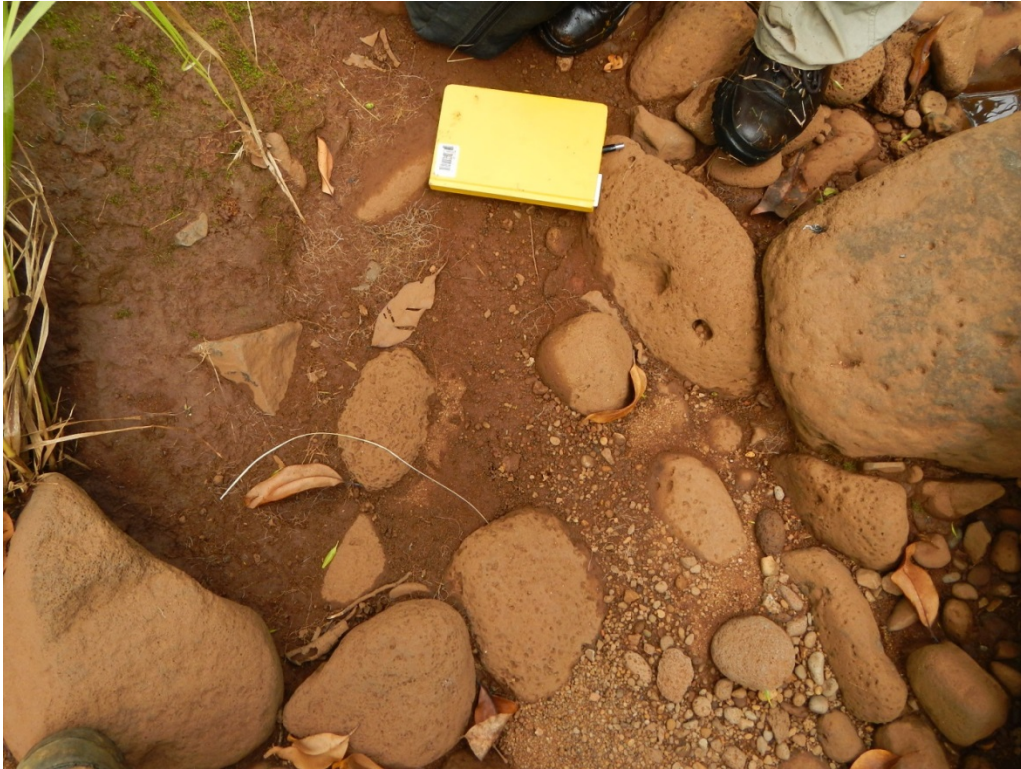
**Photo 3-2 Fine Material Deposited in Protected Areas**

In portions of the stream channel protected from high flow velocities the accumulated sediment is much finer. The finer material in Photo 3-2 is covering the coarse material which means it was deposited on the falling limb of the flow hydrograph. Photo 3-3 illustrates the consistency of the bed material from Poamoho Stream in the reach near the Tanada Reservoir.

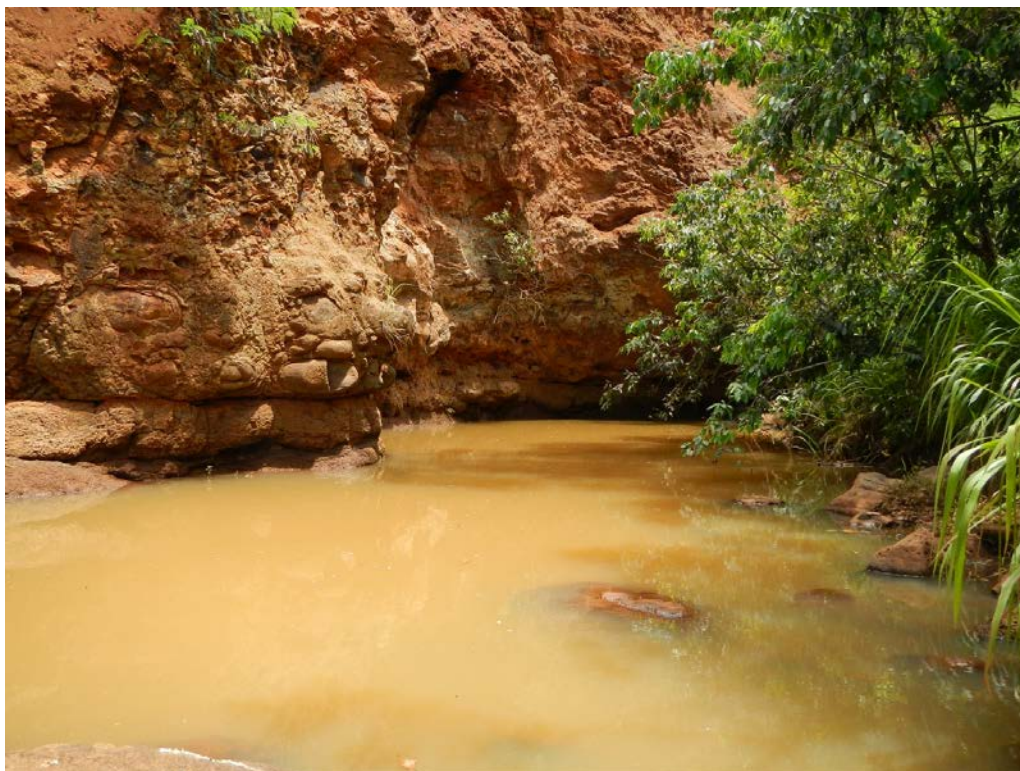
**Photo 3-4 Under-cutting of a Vertical Face on Poamoho Stream**

Throughout the field investigation multiple sites were found that provided local source material to the stream. These locations were all associated with near vertical slopes. As the desktop land slope revealed (Figure 2-8), the study area streams are confined in canyons with canyon walls of varying slopes. Photo 3-4 is a typical pool at the base of a vertical face.

Rock material from the exposed face in Photo 3-4 created the pool. The size of the material that fell into the stream at this location is too large to be transported by stream energy. As the pool creates a near zero velocity environment, suspended and transported loads will settle in the pool creating an aggradation area that has the potential to become higher than the adjacent floodplain. During future high flow events the increased stream bed elevation may cause a channel avulsion, creating a new stream alignment. The stream at the base of this vertical slope is typical of those found in the lower reach of Poamoho Stream.

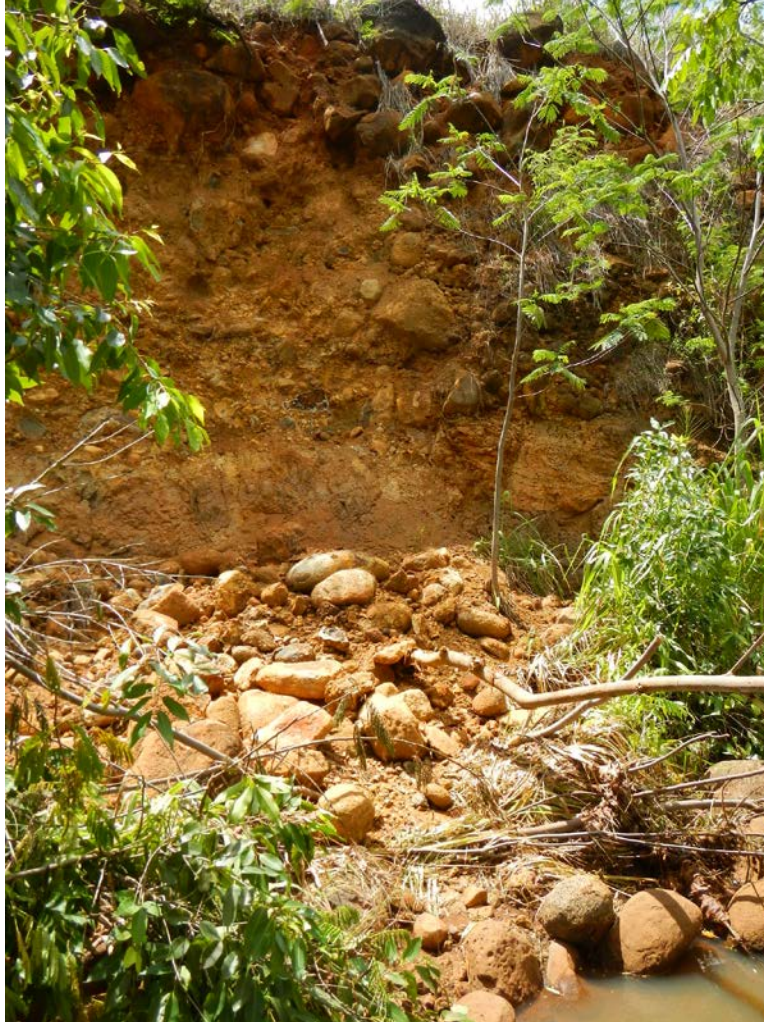
**Photo 3-5 Recent Slope Failure Adjacent to Poamoho Stream**

Smaller material released by slope failures also was observed to be entering the channel. The site shown in Photo 3-5 is an example of the recent small debris slide on banks of the stream. Future high flow events will transport this material through the lower reach of Poamoho Stream and discharge into the Kaiaka Bay.

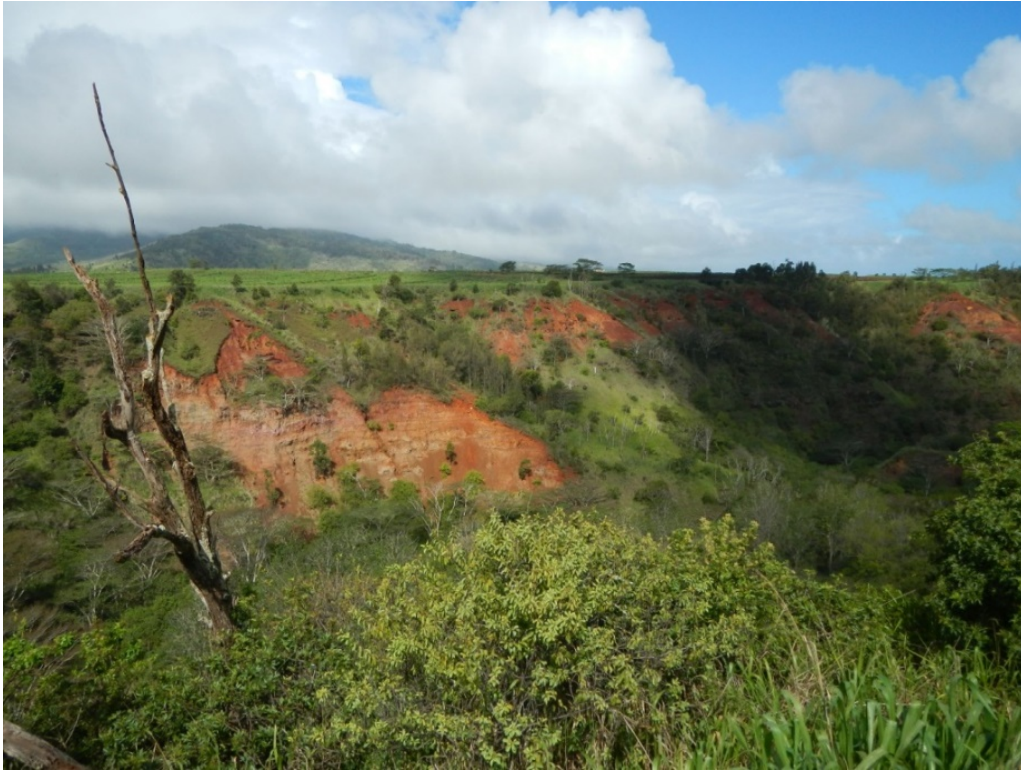
**Photo 3-6 Evidence of Slope Failure on the Poamoho Canyon**

The Poamoho Stream canyon walls have multiple areas of recent slope movement. In many cases the volume of the material fills a portion of the valley floor with a portion entering the stream. The finer material is transported downstream while the larger material remains in place. The material that does not enter the stream comes to rest at a stable slope, as shown in Figure 2-8, and becomes vegetated with invasive grasses. The exposed surfaces in Photo 3-6 are from recent slides and grasses can be seen vegetating the debris slopes.

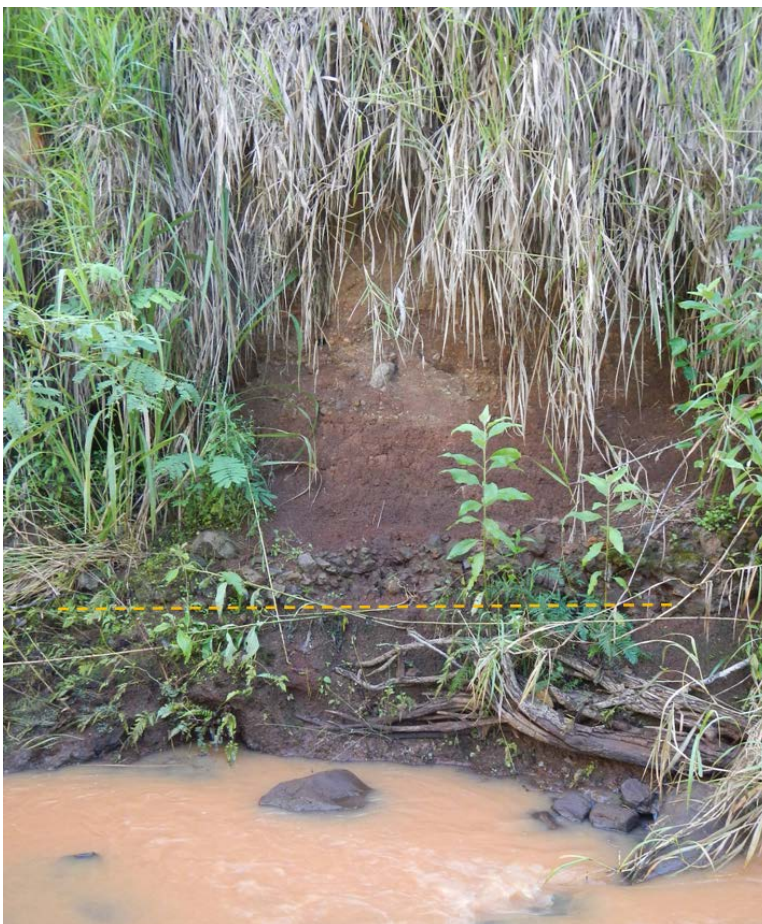
**Photo 3-7 Evidence of Previous Streambed Elevation**

Exposed streambanks provide the opportunity to see historic fluvial geomorphic characteristics. The dotted line in Photo 3-7 illustrates a layer of gravel approximately 3-feet above the water surface. The gravel material is streambed deposits and marks a historic streambed elevation. As the Lane's Diagram (Figure 1-2) suggests, for the stream to drop the channel invert, there must have been changes related to some aspect of flow and/or sediment volume and size.

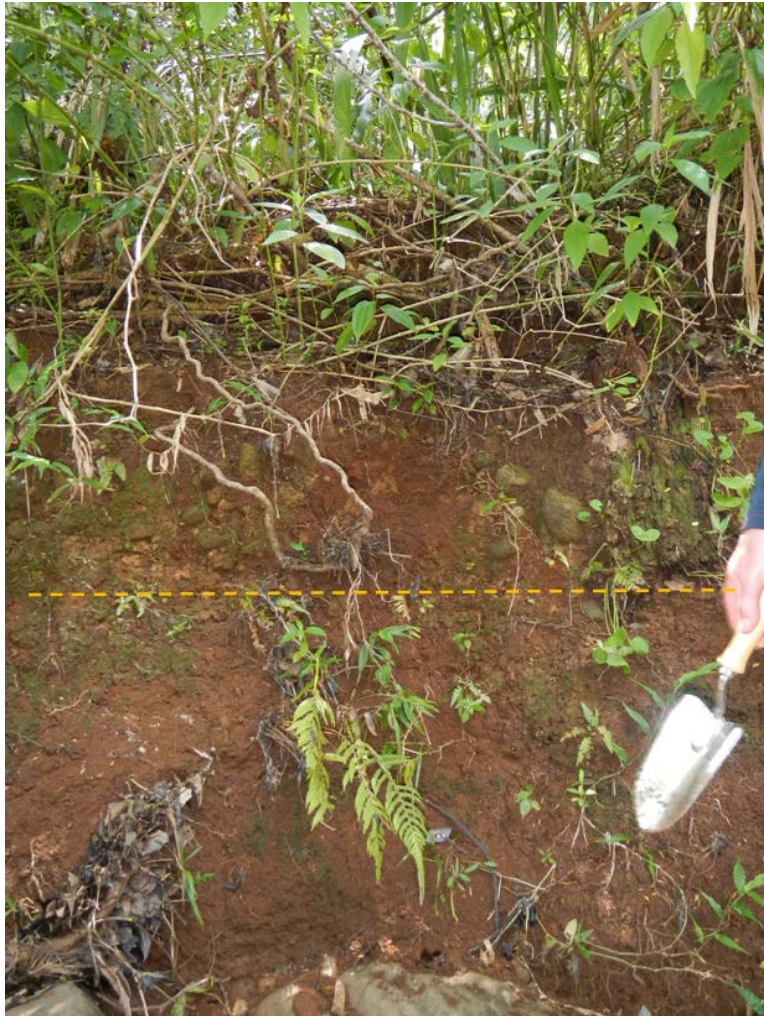
**Photo 3-8 Upper Poamoho Watershed Historic Streambed**

Similarly in the upper watershed, the exposed Poamoho stream bank reveals a layer of rocks that represents a historic deposition of stream bed materials. The rock layer in Photo 3-8 is likely a remnant of historic bed channel invert.

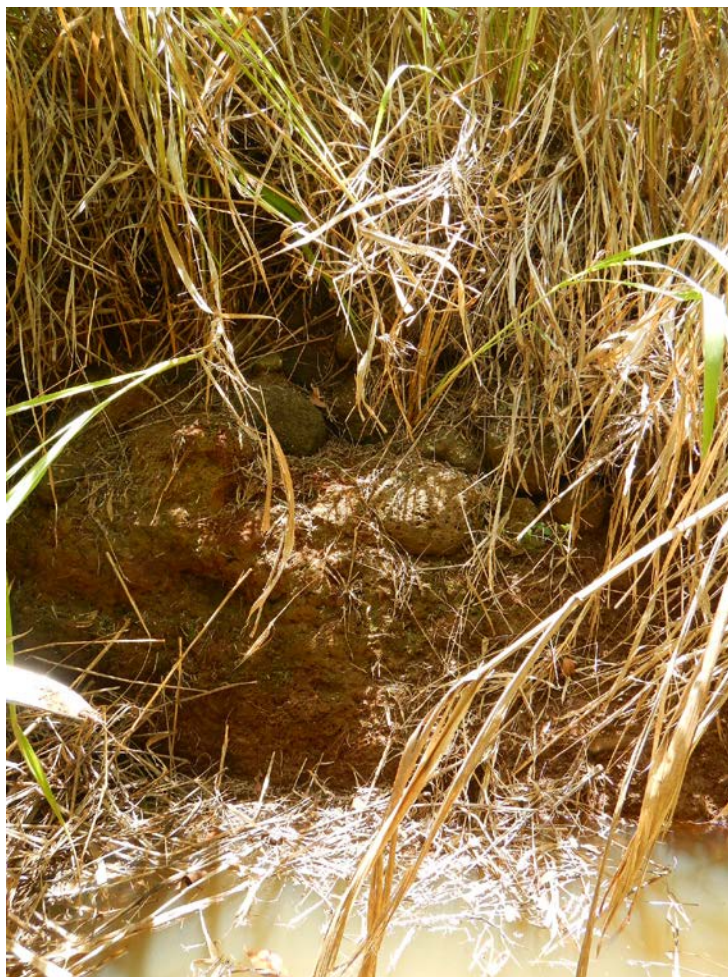
**Photo 3-9 Evidence of Earlier Poamoho Streambed Elevations**

In Photo 3-9, the deposition of the larger material is indicative that the stream alignment has migrated across the partially confined canyon floor and that the bed elevation has lowered. The historic channel was located in the floodplain where fine sediment was deposited during high flow events. When the current channel alignment with lower elevations crossed the historic channel alignment, it exposed the historic remnant channel.

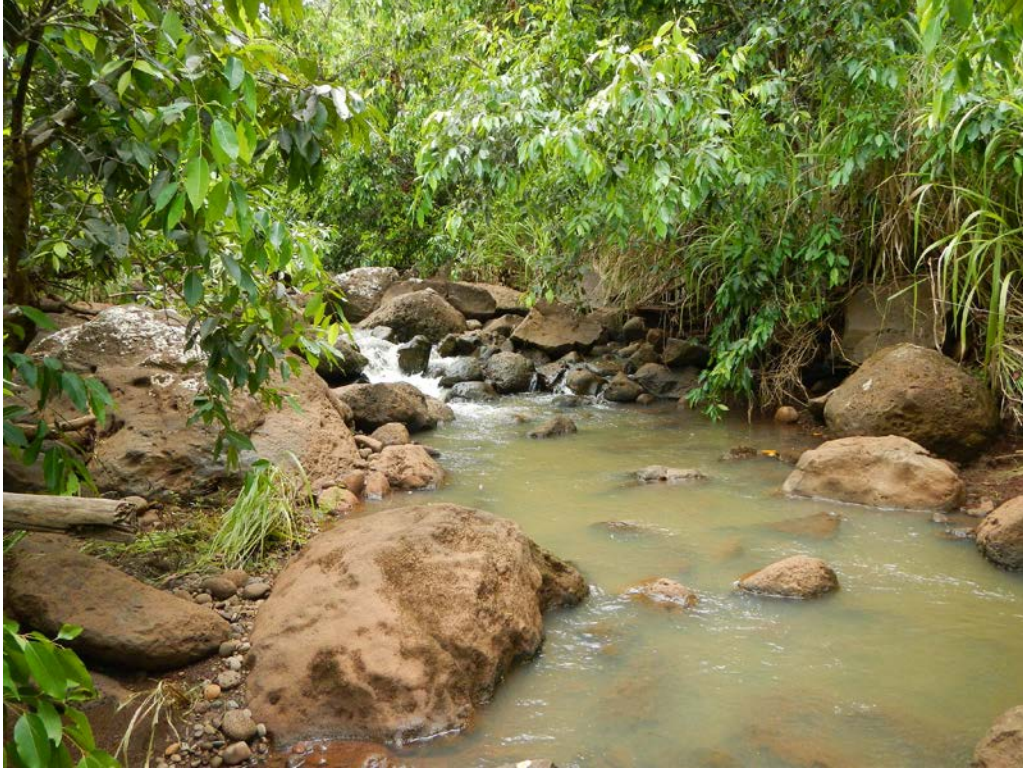
**Photo 3-10 Step-Pool Channel Classification on Poamoho Stream**

The upper reach of Poamoho Stream is classified as a Cascade channel. For this classification the channel is described as confined by valley walls and in direct contact with hillslopes. The channel slope provides for efficient transport of sand and gravel sized materials supplied from adjacent hillslopes. Boulders found in the stream channel are deposited from adjacent hillslopes with typical stream energy too low to transport. Photo 3-11 shows the Poamoho Stream within the confined portion of the watershed.

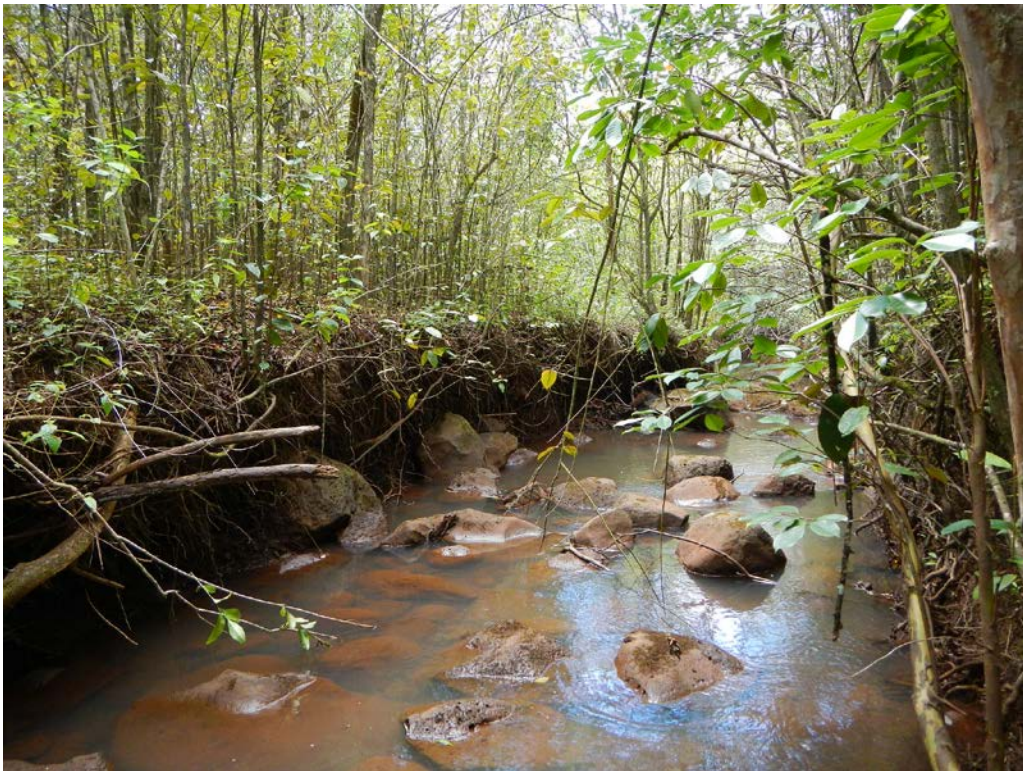
**Photo 3-11 Upper Poamoho Stream Channel**

The boulders shown in the photo have been deposited from the adjacent slopes and have come to rest on the far side of the stream. The stream energy is configured to transport large volumes of sediment resulting from landslides. When there is not a source of sediment the stream energy is directed toward the channel bed and banks. The small drainage area in the upper watershed leads to low flows between storm events, limiting the overall sediment transport capacity of the stream.

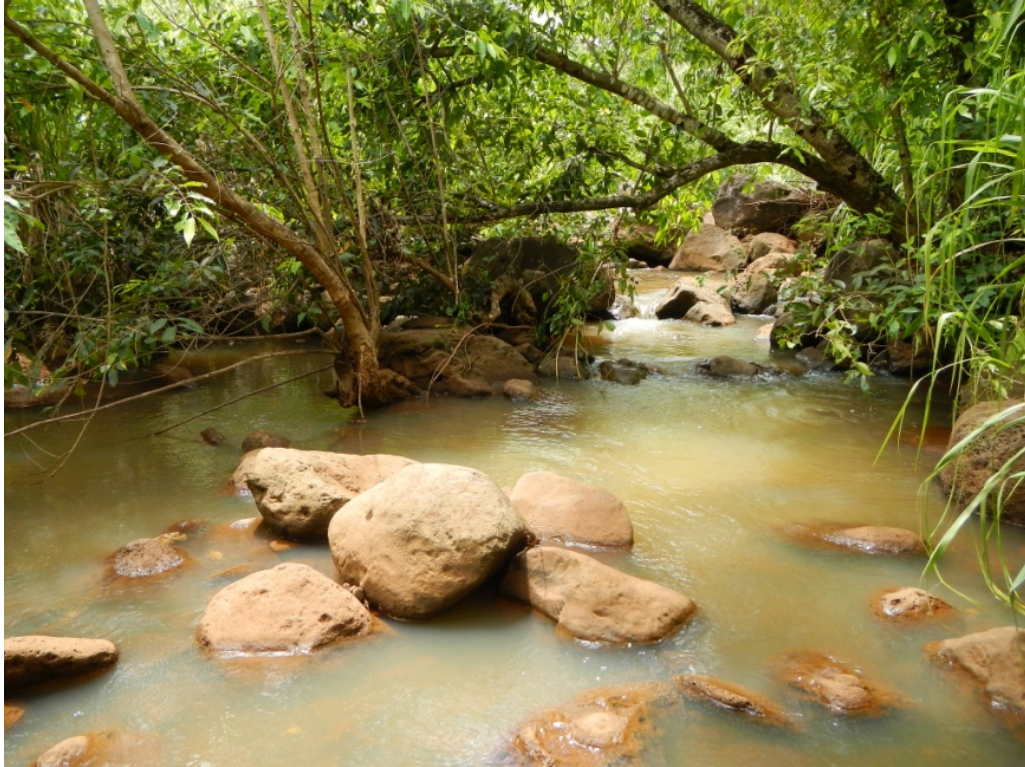
**Photo 3-12 Split Flow Conditions and a Vegetated Gravel Bar in Lower Poamoho Stream**

In the partially confined channel lower reach, geomorphic features suggesting the natural dynamic of Poamoho Stream were identified. Photo 3-12 shows a section of the stream with multiple channels. In many locations in the lower reach, gravel bars had become stabilized with vegetation creating multiple channels. Multiple channels mean flow conditions can provide additional, temporary storage of transported sediment.

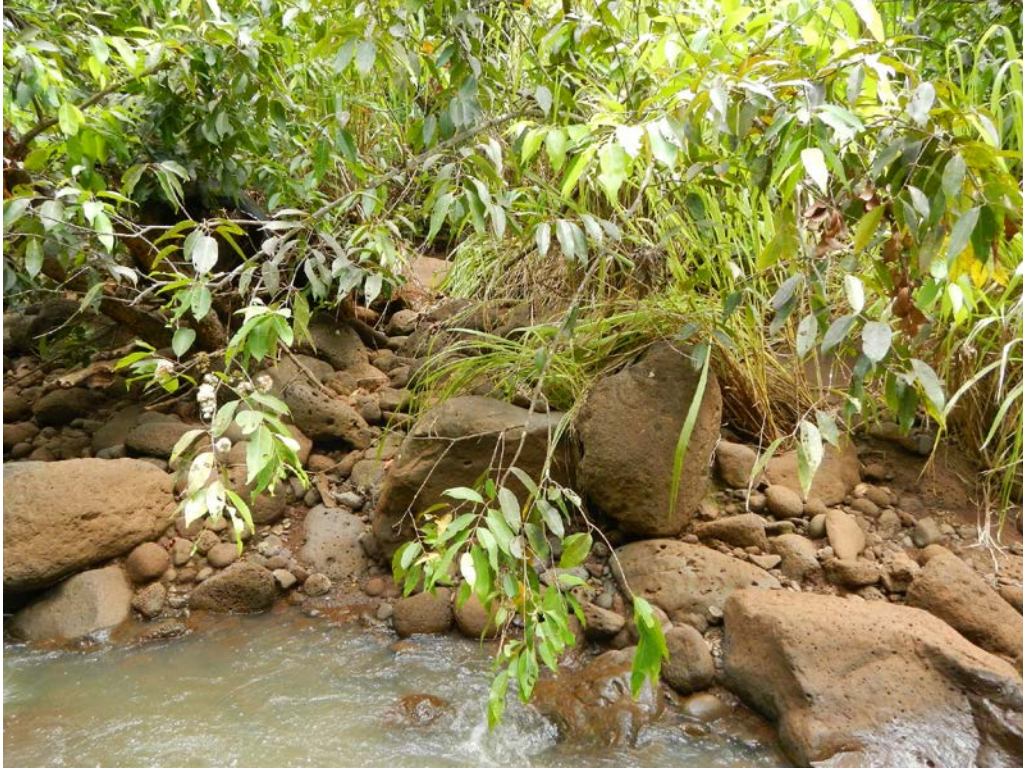
**Photo 3-13 Evidence of Side Channels along Lower Poamoho Stream**

Multiple side channels were found on the canyon floor. The typical side channel was less than 10-feet wide with larger bed material. Photo 3-13 shows the exposed flow path of a side channel entering Poamoho Stream. Because of the dense guinea grass, many of the channels were only identified at the bifurcation or confluence points.

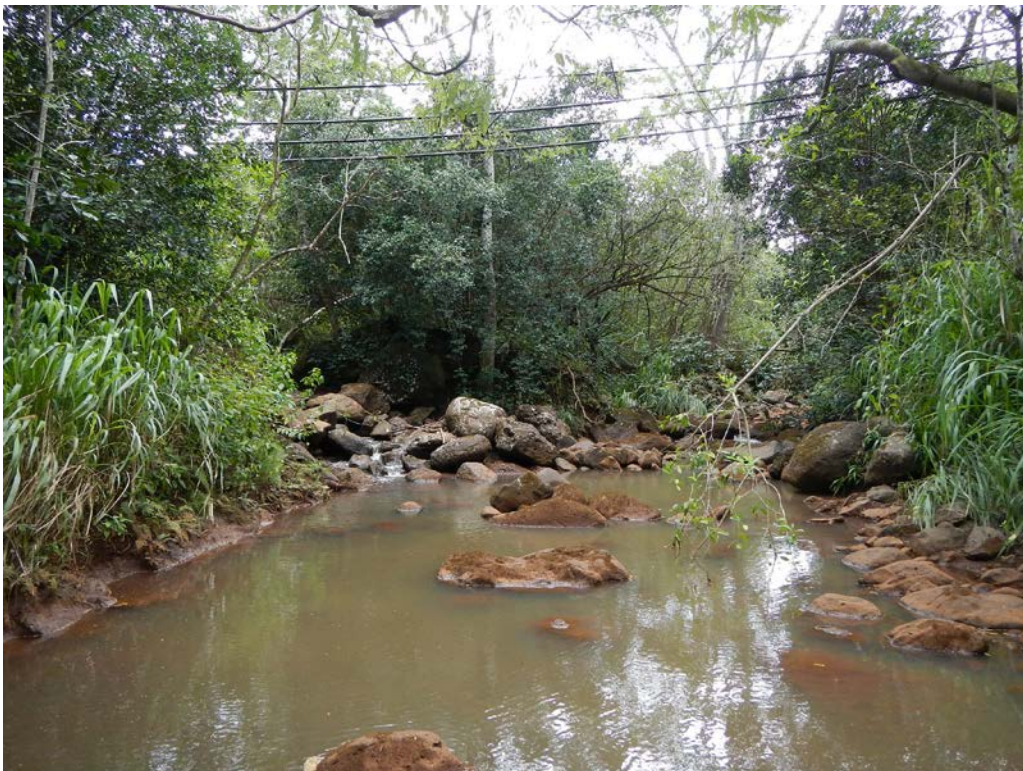
**Photo 3-14 A Confluence on the Poamoho Stream**

The dynamic geomorphic conditions at stream confluences are shown in Photo 3-14. Upstream of the confluence the stream channel contains large boulders. After the confluence the stream bed has fewer boulders and the stream banks are composed of finer material.

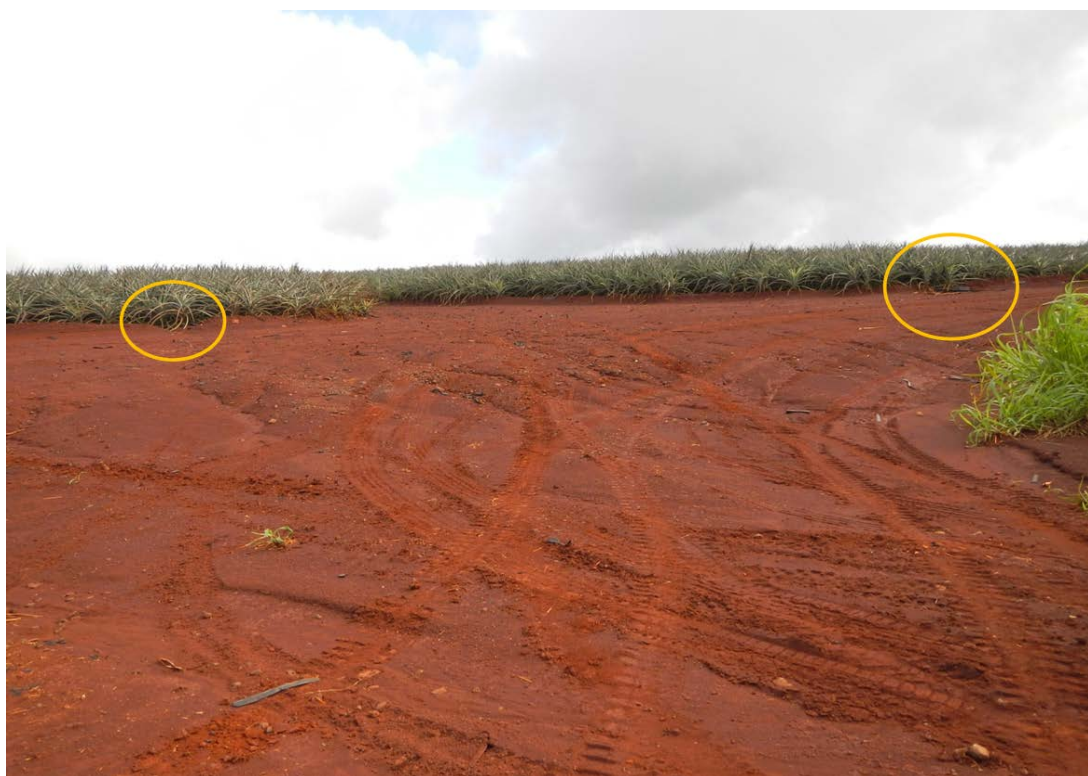
**Photo 3-15 Sediment near the Rim of the Poamoho Stream Canyon**

On August 23<sup>rd</sup>, the week prior to the site visit, the Dole Pineapple field received over 2.6-inches of precipitation over a 6-hour period. Photo 3-15 shows accumulated sediment that washed off one of the pineapple fields as well as surface erosion channel developing in the hardened driving surface. For this to occur, the intensity of the rainfall likely was greater than the infiltration rate of the soil, allowing for surface runoff. As shown in Table 2-4, the saturated infiltration rate for the Wahiawa silty clay is 1-inch per hour.

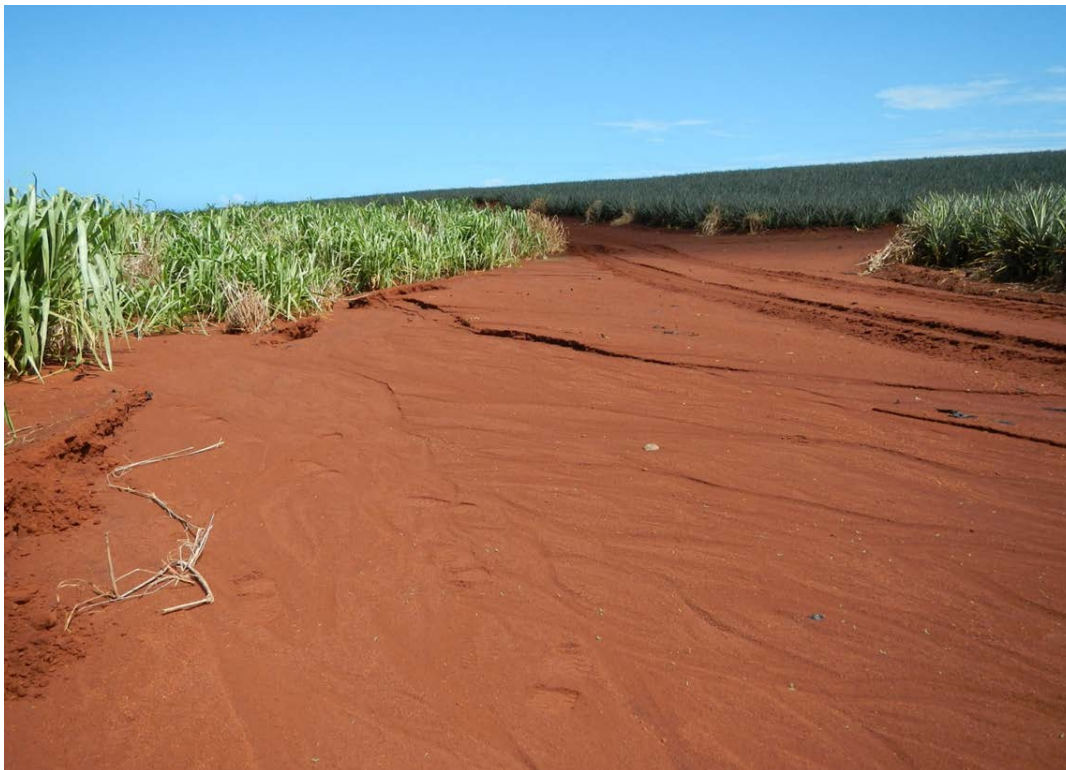
**Photo 3-16 Accumulated Sediment Washed from the Pineapple Fields**

Larger berms were found constructed along the top of the canyon. In most cases it appeared the larger berms succeeded in trapping the sediment prior to flowing over the edge into the canyon. Photo 3-16 shows a location where the larger berms have trapped sediment along the canyon rim.

Evidence of sediment flowing into the guinea grass bordering the canyon rim indicates material may have reached the walls of the canyon and potentially Poamoho Stream. Limited access due to thick vegetation and steep slope limited the investigation of sediment flows and whether they eventually reached the stream or were trapped on the banks. It is likely that any runoff carrying sediment would infiltrate into the accumulated debris field at the base of the cliffs. As the flow infiltrates the loosely compacted material, the larger sediment is filtered out prior to the flow eventually reaching Poamoho Stream.
