Field Study of High-Density Passive Sampler and Large-Volume Purge Methods to Characterize Subslab Vapor Plumes

Former Al Phillips Cleaners
515 Lagoon Drive, Honolulu, Oahu, Hawaii

**State of Hawaii Department of Health
Hazard Evaluation and Emergency Response Office
2385 Waimano Home Rd., Uluakupu Building 4
Pearl City, HI 96782**

July 2017

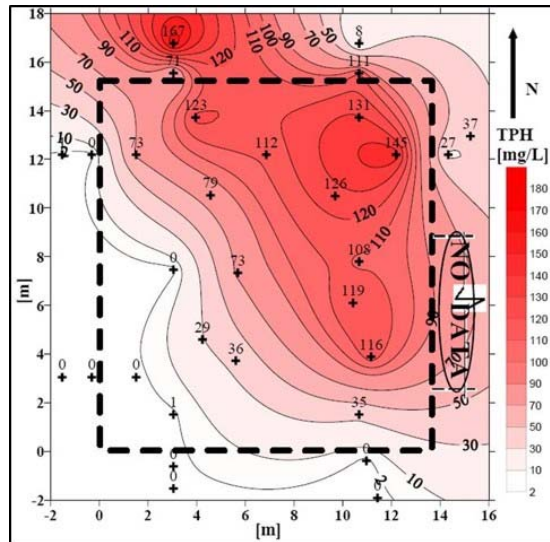
Figure 1-1. Example of vapor plume heterogeneity beneath a building slab (Luo et al. 2009).

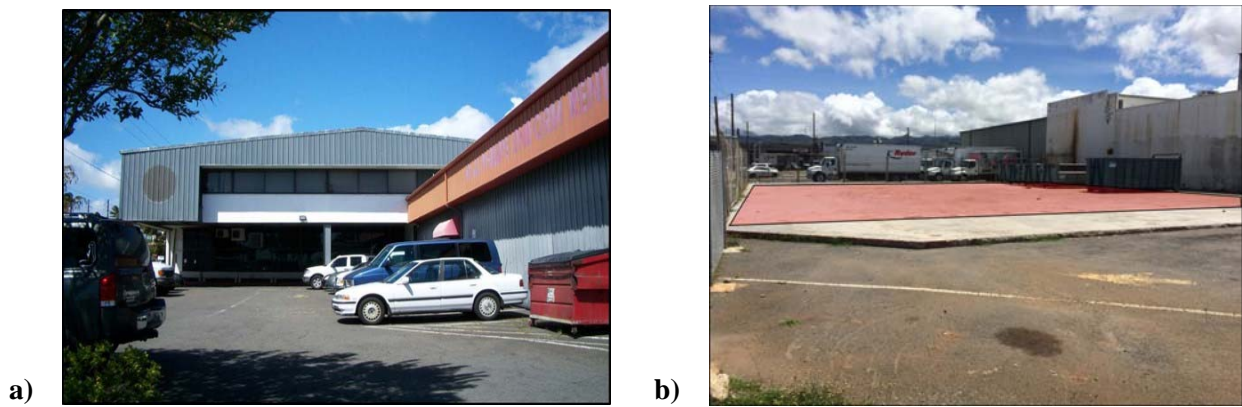
Figure 2-2. Dry cleaner operating at the site until 1997 (AECOM 2013a); a) photo of facility prior to closure (looking north), b) photo of facility in 2016 after removal of structure with only the original slab remaining (study area portion of slab highlighted in red).

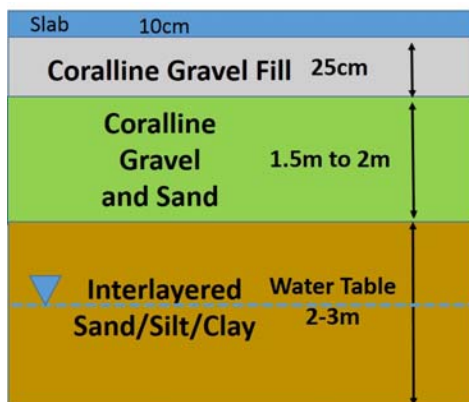
Figure 2-4. Site Stratigraphy.

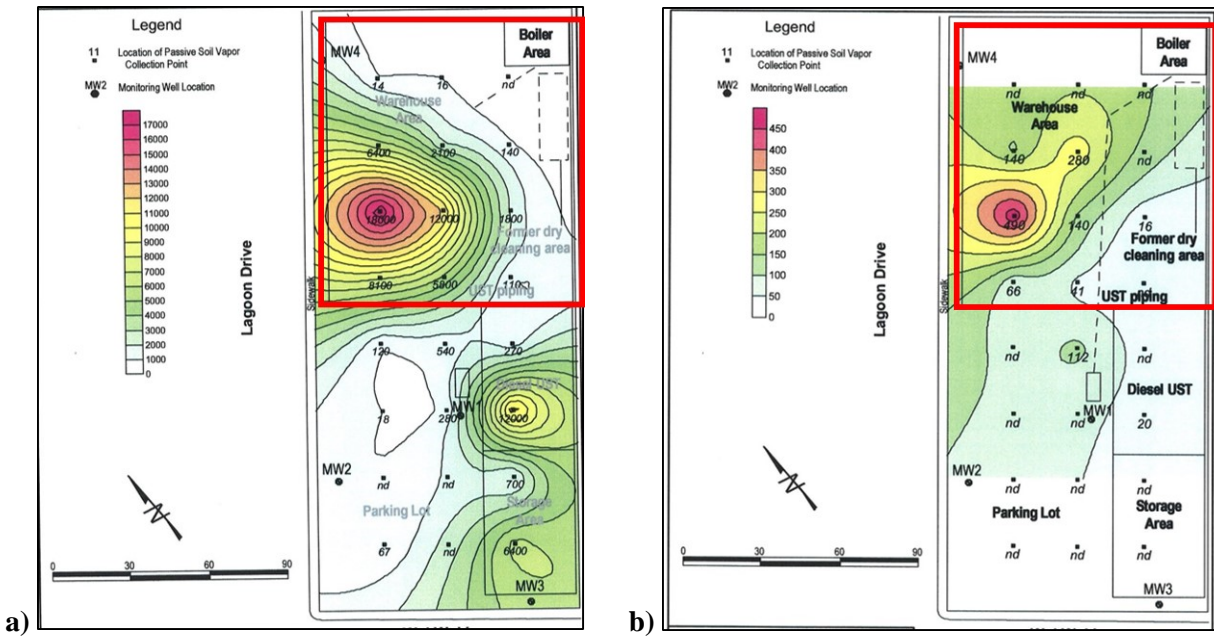
Figure 2-6. Isoconcentration map of 2002 passive soil vapor data (EST 2002b); a) PCE vapors; b) TCE vapors.

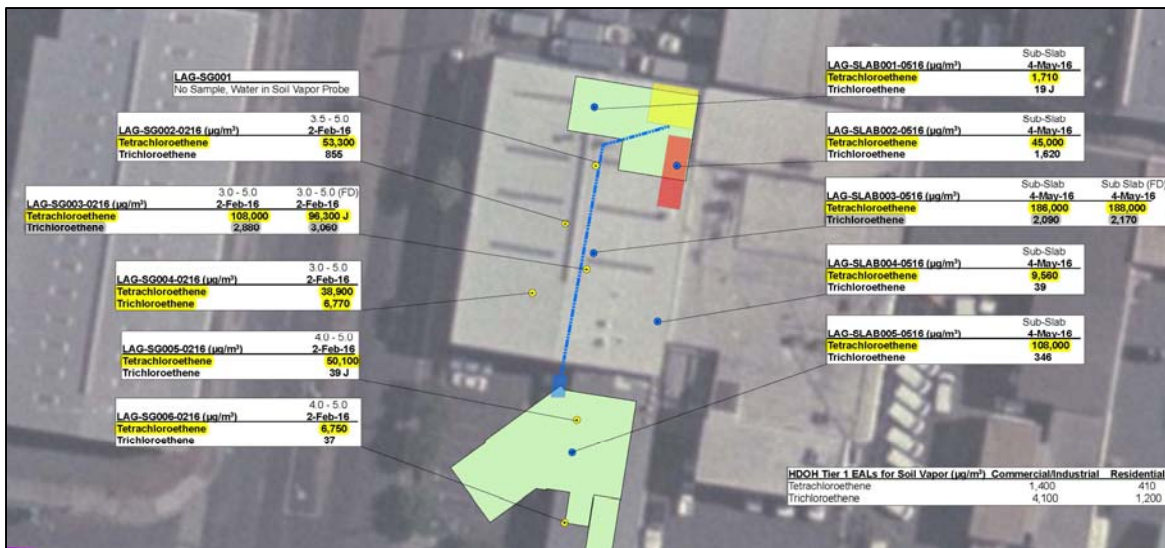
Figure 2-11. Summary of 2016 active soil gas data (CH2M 2017; preliminary data).

A summary of the soil vapor data for PCE and TCE is provide in Table 2-7 and depicted in Figure 2-11. The data indicate a substantially larger vapor plume beneath the slab than identified in the 2002 investigation. Vapors are dominated by PCE, with a maximum reported concentration of 186,000 $\mu\text{g}/\text{m}^3$. Less than 10% of the vapors are on average comprised by TCE and other breakdown products of PCE. This support the apparent lack of significant petroleum contamination beneath the slab, since dramatic degradation of chlorinated solvents is typically noted in cases where releases of both two types of chemicals are intermingled.

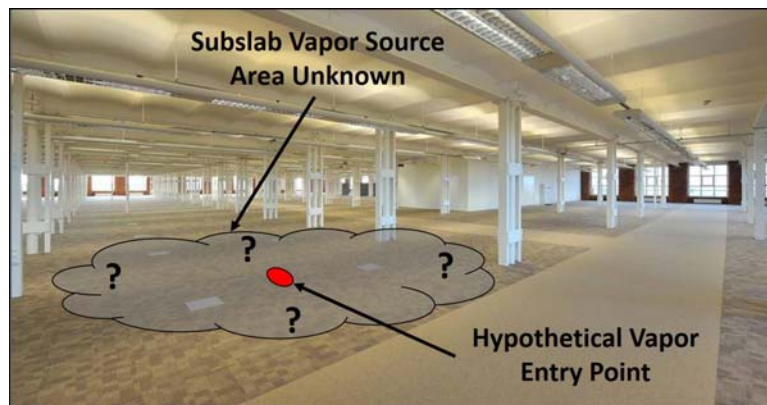
Figure 3-5. Hypothetical vapor entry point in a build slab to be used for the collection of Large Purge Volume (LVP) subslab vapor samples. The exact source area of the vapors is unknown and unimportant in terms of assessment of vapor intrusion risk.

Factors to be considered for designation of a vapor sample collection point or points include (CalEPA 2015; USEPA 2015a,b): 1) Location of known or suspect vapor entry points through the slab; 2) Locations of known or suspect source areas beneath the slab; 3) Apparent high-concentration areas of the vapor plume based on existing data; or 4) Center point of the slab in the absence of other information regarding the anticipated distribution of vapors beneath the slab. Consideration the first factor, if known, is most appropriate for assessment of vapor intrusion risk under current site conditions. Consideration of the second or third factors is intended assess worst-case vapor intrusion scenarios that might or not be realistic of current or even future site conditions. Only the location of the vapor entry point requires designation (Figure 3-5).

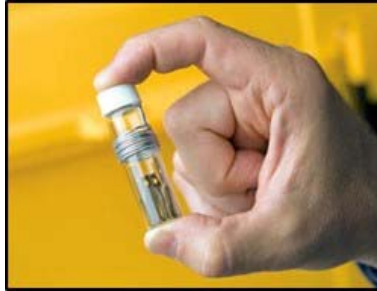
Figure 4-1. Passive vapor sampler produced by Beacon Environmental.

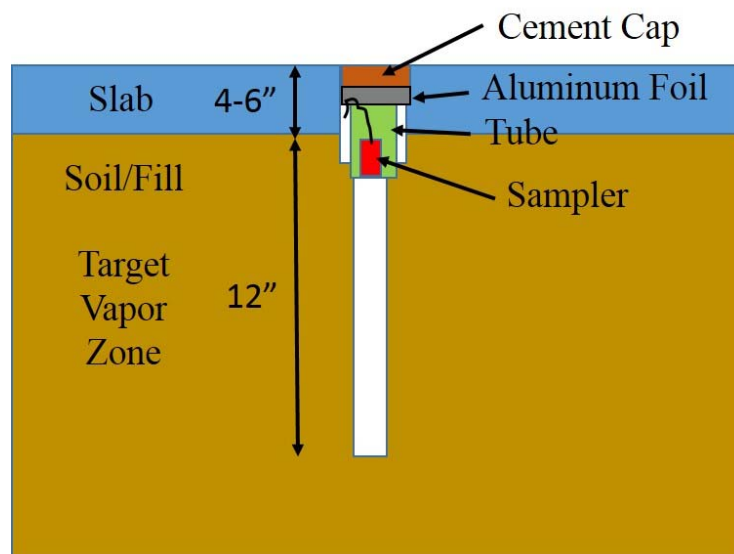
Figure 4-2. Passive sampler installation schematic.

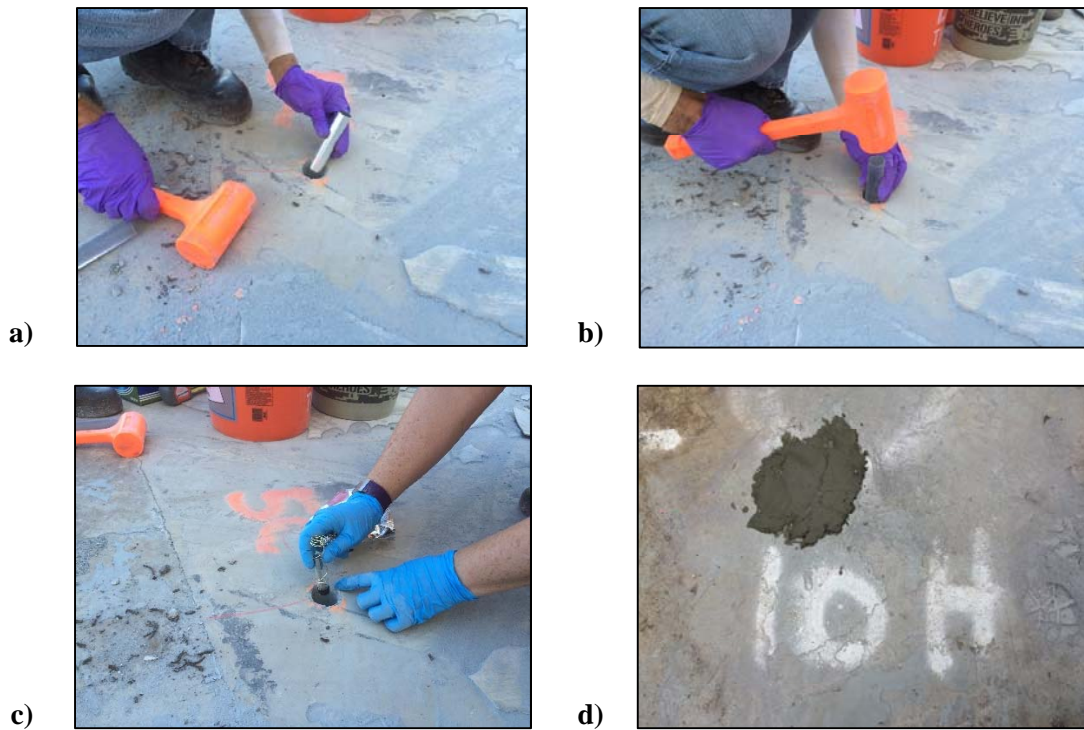
Figure 4-3. Passive sampler installation (see Figure 4-2): a) One-inch, aluminum tube inserted into 1 ½ inch boring through slab; b) Tube tamped into underling soil; c) Beacon passive sampler placed in tube; d) Sample point sealed with aluminum foil and concrete grout.

Photos of sampler installation are provided in Figure 4-3. The original, plastic cap of each sampler vile was replaced with a vapor-permeable cap immediately prior to installation. Sample points were marked on the slab ahead of time. Installation of the samplers took approximately four hours, with a crew of two drilling the boreholes and a crew of three installing samplers and sealing the holes.

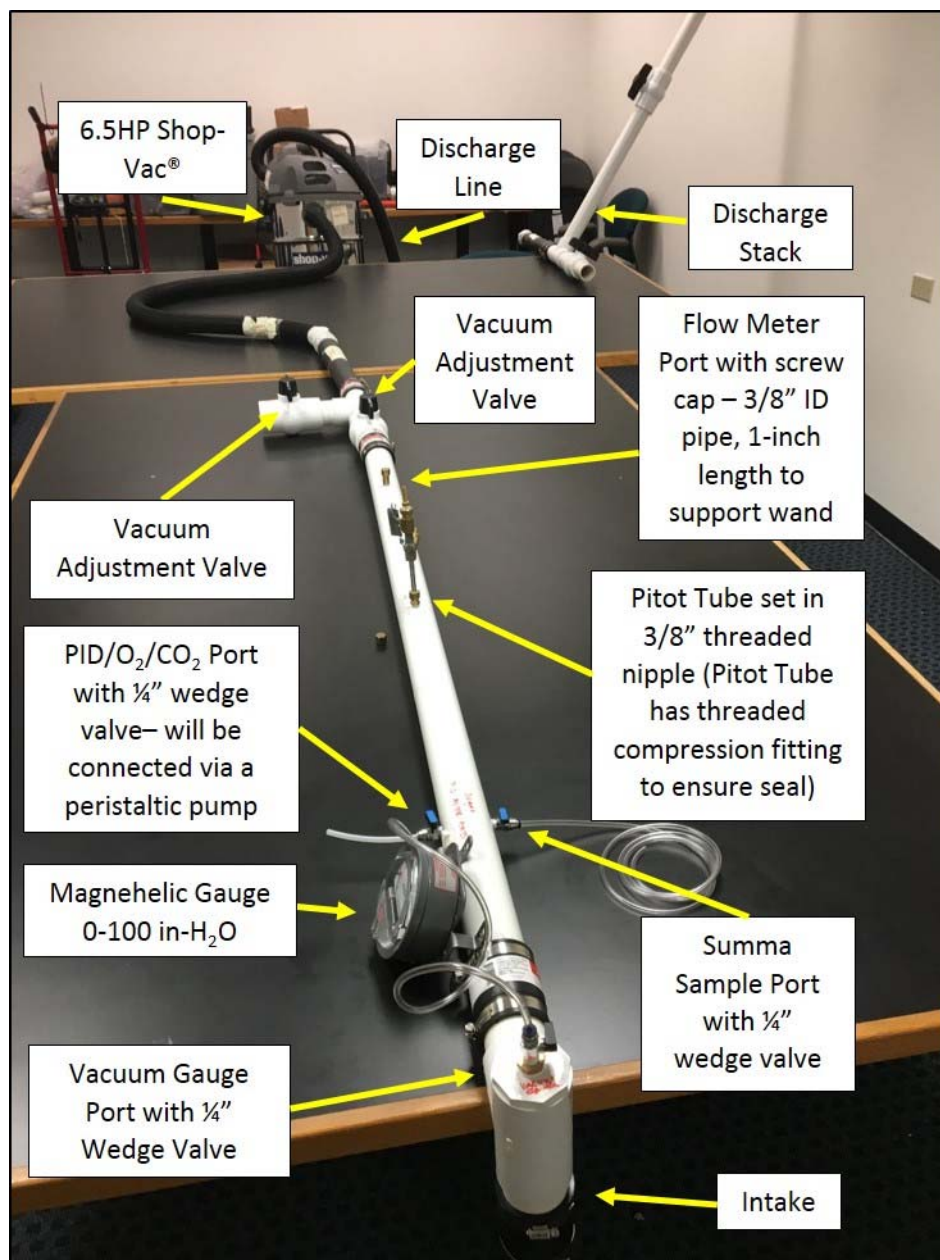
Figure 4-5b. Detailed design of LVP purge stream (plan view).

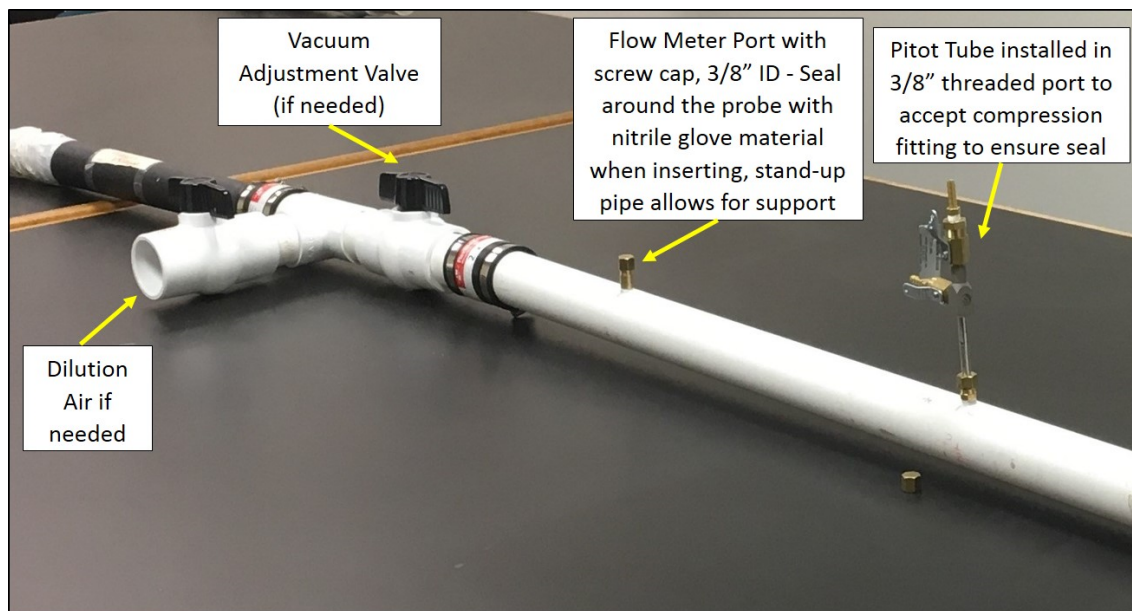
Figure 4-6. Close-up of LVP purge valves.

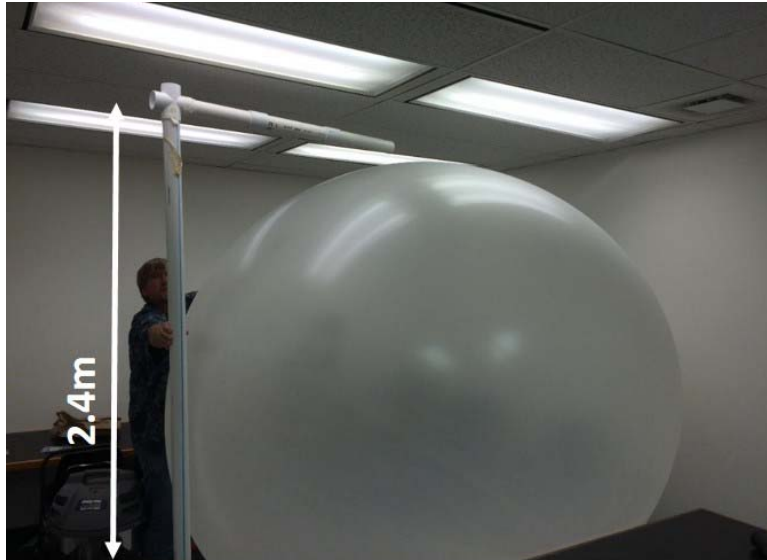
Figure 4-7. Latex, weather balloon used to check flow rate meters and evaluate purge times required to reach target, 7,000-liter purge volumes (target volume reached when balloon diameter = 2.4 m or 7.8 ft).

Additional indoor and outdoor tests were run using a seven-foot diameter PVC vinyl weather balloon (approximately 6,200-liter volume), which was selected due to the anticipated durability for multiple test runs. The latex rubber balloon was not expected to be used more than one time under field conditions, due to sun/heat and susceptibility to perforation if contact with a rough surface (i.e. asphalt or concrete).

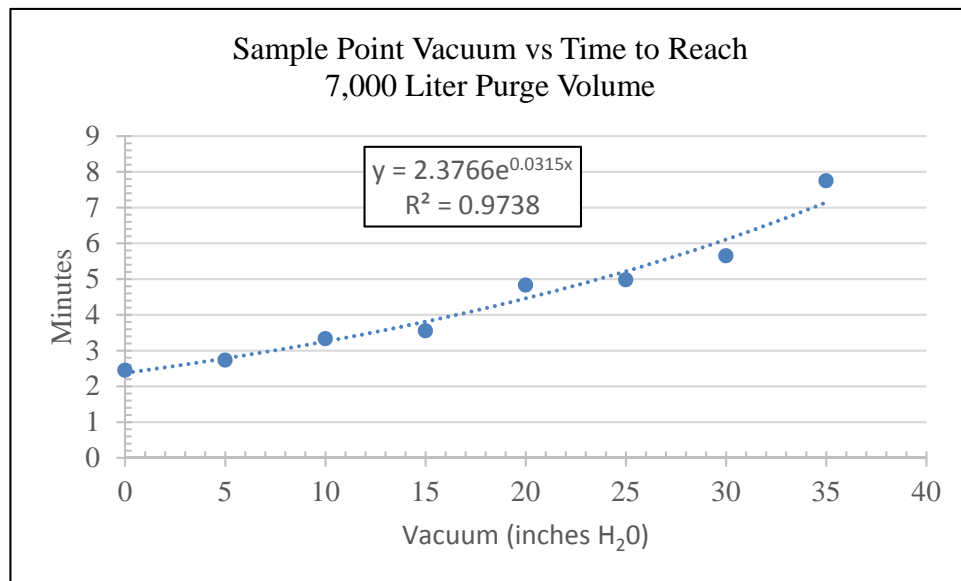
Figure 4-8. Data plot of well point vacuum versus time.

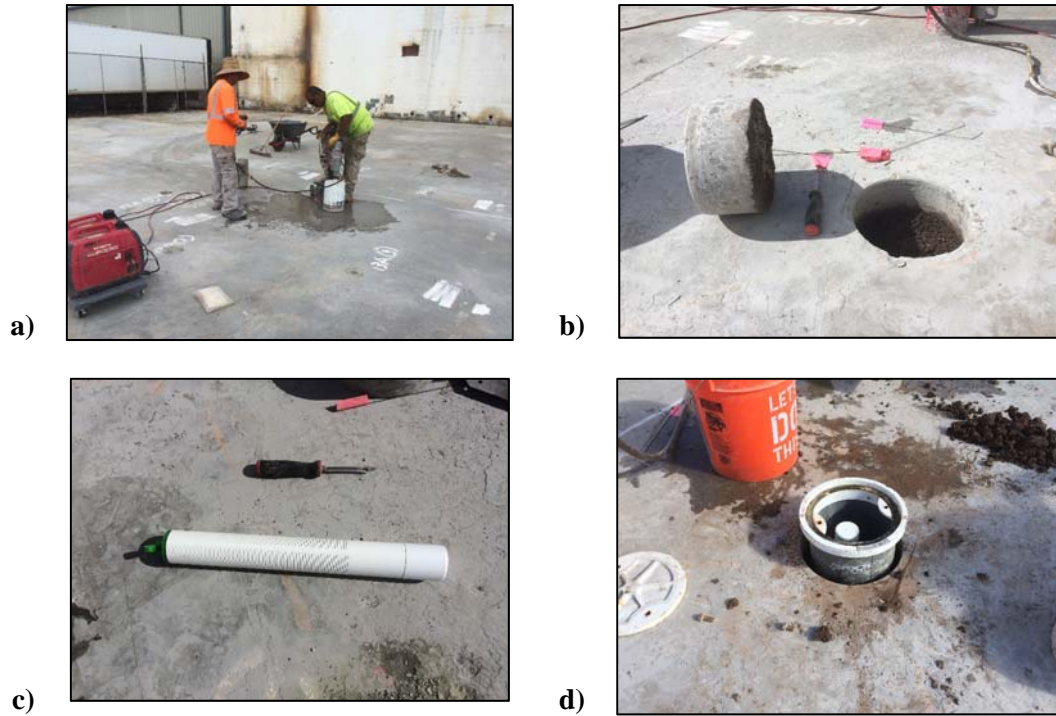
Figure 4-9. Installation of LVP vapor extraction point: a) Circular saw used to cut eight-inch hole in concrete for installation of vapor point and protective casing (latter not normally included); b) Completed hole; c) Two-inch PVC vapor point; d) Completed vapor point (interior sealed with cement grout).

Note that installation of a protective casing around a vapor point is not normally required for one-time sample collection (see McAlary et al. 2010). A steel casing was deemed necessary for this study to protect the vapor point over the course of the study. It is imperative that the vapor extraction point be well sealed to prevent leakage of outside air under the slab during sample collection.

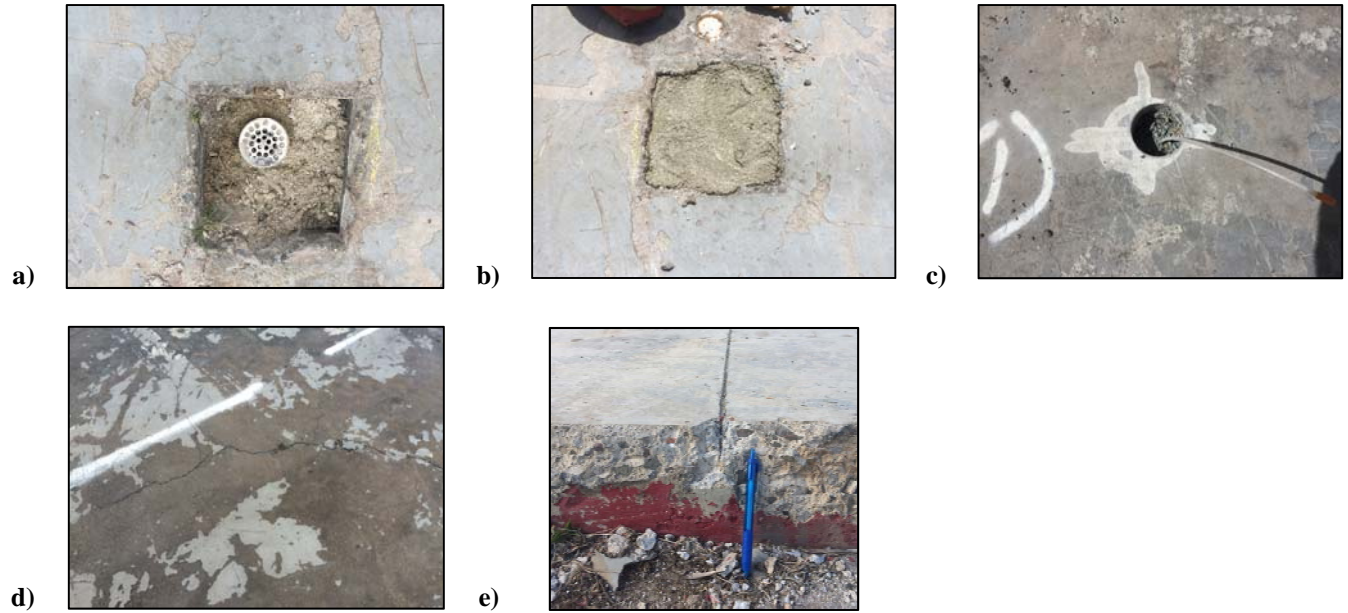
Figure 4-11. Sealing of slab drains and utility gaps in within immediate vicinity of vapor extraction point:
a) Floor drain (common source of leaks into subsurface soil); b) sealed drain; c) Soil vapor point in slab from previous investigations; d) Cracks in surface of pad; e) Side view of slab depicting lack of crack penetration through full slab thickness at expansion joints.

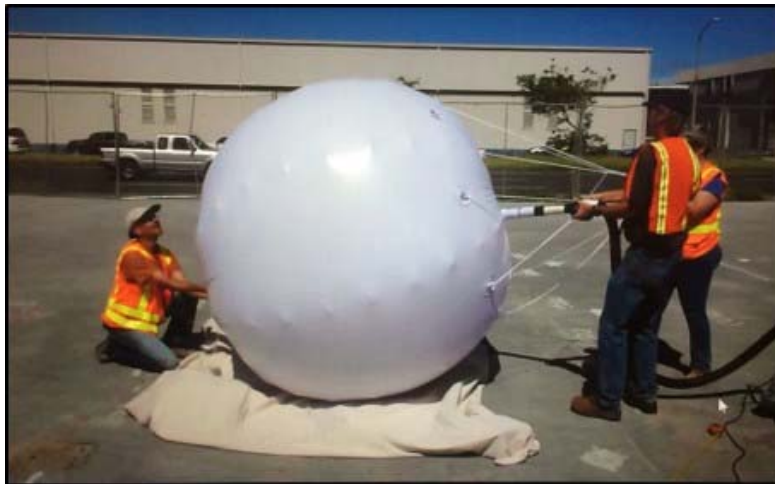
Figure 4-12. Weather balloon (vinyl) field test used to cross-check the purge volumes estimated from by flow rate meters; comparison of balloon volume to flow rate measurements and purge time indicated good correlation.

A balloon test was successfully performed as a cross-check regarding the purge volume as related to measured flow rates (Figure 4-12). However, wind conditions indicated that use of the weather balloon during the actual sampling event would likely not be possible. It was very difficult to control the balloon, even in standard light to moderate trade wind conditions. Based upon the information obtained during the bench study, as well as field flow readings recorded during the pilot test (using both the TSI flow meter and the Pitot tube cross-check), the accuracy of the field equipment negated the necessity to use a weather balloon in the field during the sampling event for purge volume confirmation.

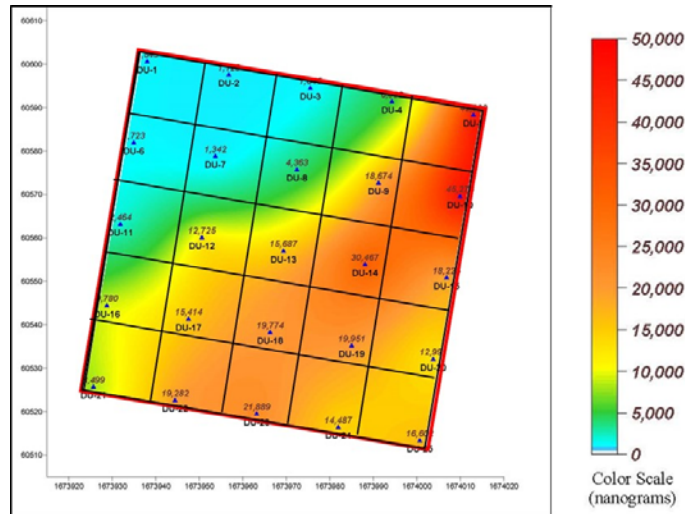
Figure 5-3. Alternative interpretation of the PCE passive sampler data by Beacon Environmental Services, generated by assigning the reported mass for each grid cell set to the center point of the grid cell and inputting the data into an isoconcentration mapping program (compare to Figure 5-1; grid cells superimposed on image). Resolution of program set to reduce emphasis on any single point and minimize the generation of seemingly isolated and potentially artificial hot spots and cold spots. Precision of variability predicted within individual cells is unknown.

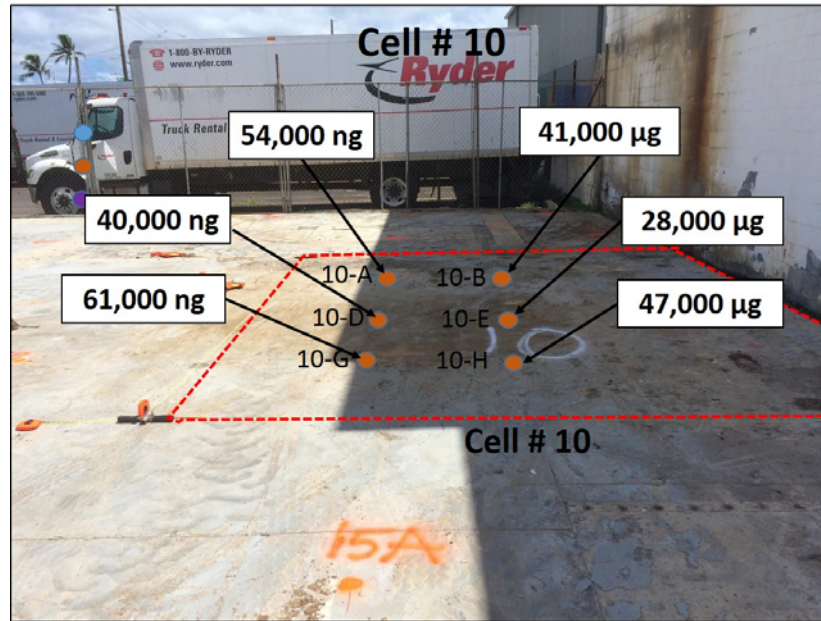
Figure 5-5. Variability of PCE in six passive samplers installed in Grid Cell 10 which were individually tested.

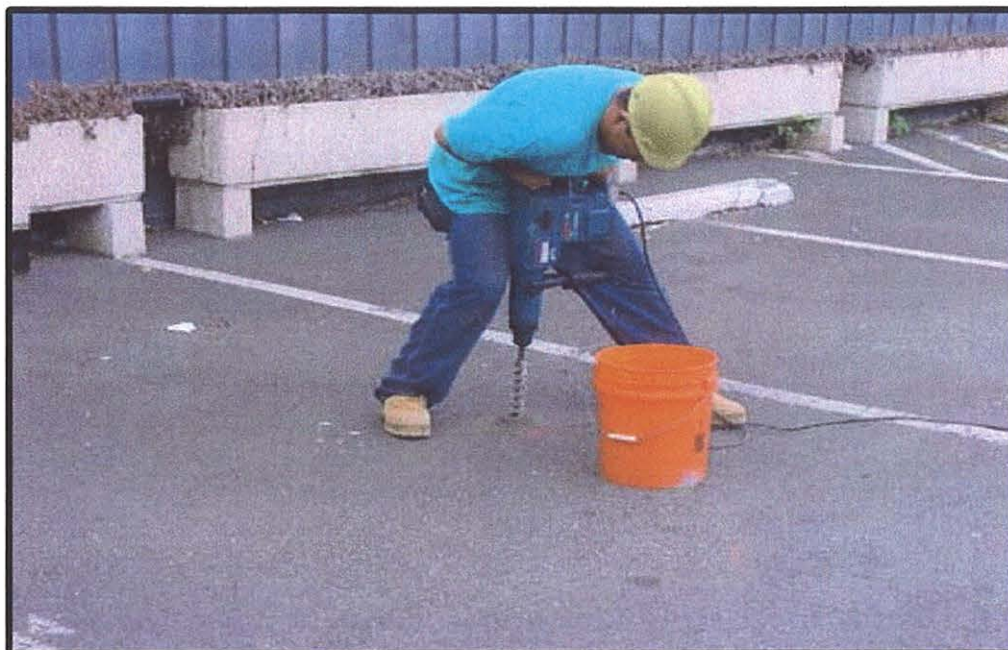
Photograph 1: View of passive soil vapor boring advancement.

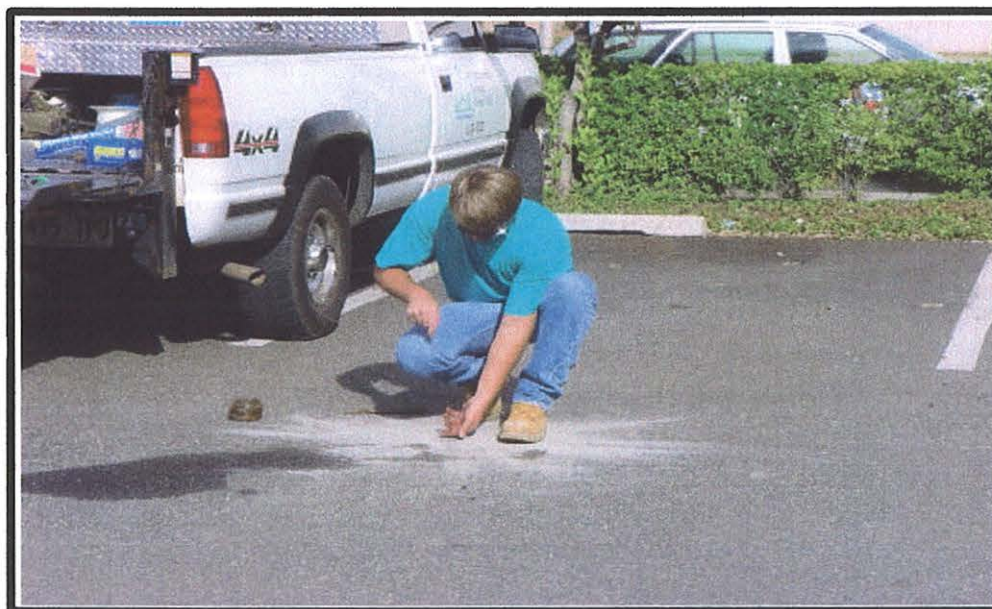
Photograph 2 : View of passive soil vapor module being installed.

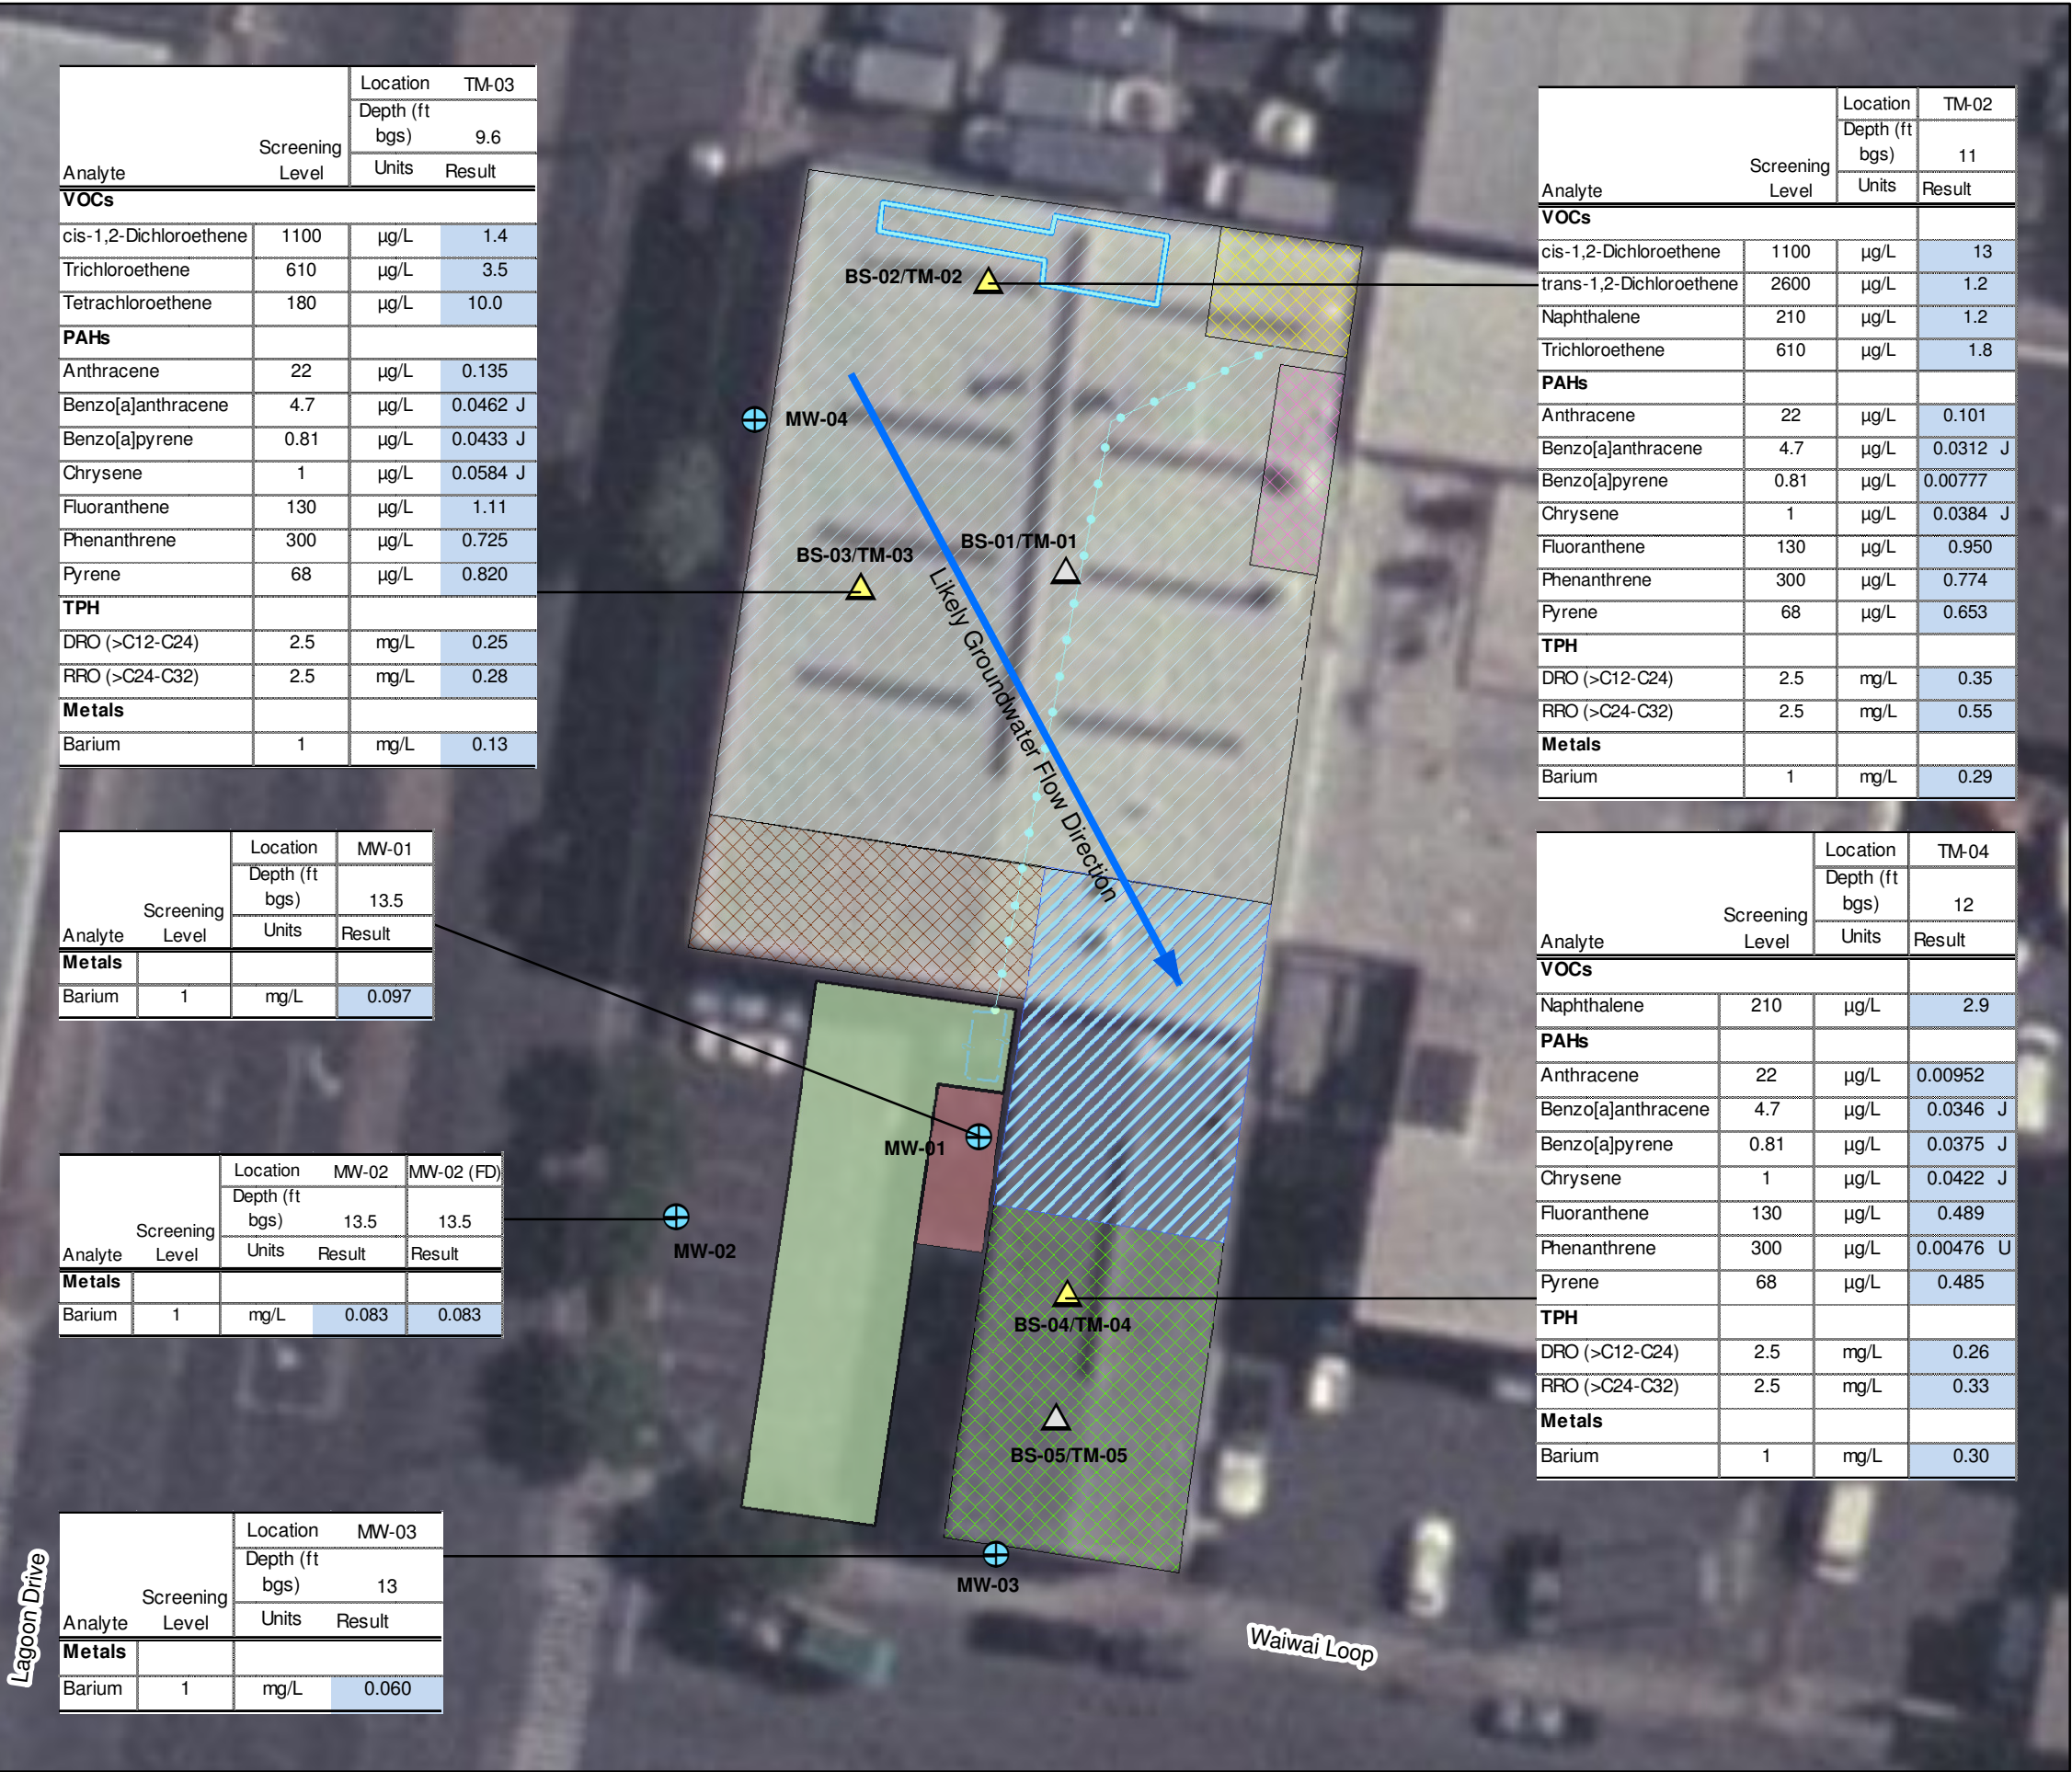
Figure 4
Detected Target Analytes in Groundwater
and Geophysical Survey Coverage for Locating UST
Phase II ESA
515 Lagoon Drive, Parcel 15
Honolulu, Oahu, Hawaii

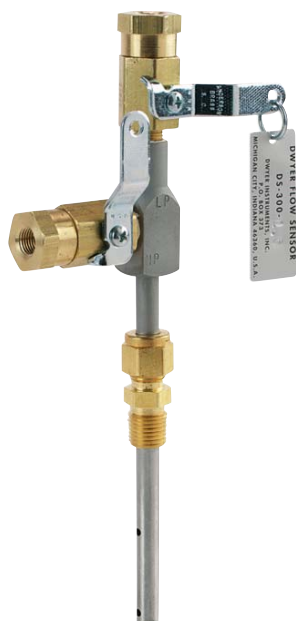
Series DS-300 Flow Sensors are averaging pitot tubes that provide accurate, convenient flow rate sensing. When purchased with a Dwyer Capsuhelic® for liquid flow or Magnehelic® for air flow, differential pressure gage of appropriate range, the result is a flow-indicating system delivered off the shelf at an economical price. Series DS-300 Flow Sensors are designed to be inserted in the pipeline through a compression fitting and are furnished with instrument shut-off valves on both pressure connections. Valves are fitted with 1/8" female NPT connections. Accessories include adapters with 1/4" SAE 45° flared ends compatible with hoses supplied with the Model A-471 Portable Capsuhelic® kit. Standard valves are rated at 200°F (93.3°C). Where valves are not required, they can be omitted at reduced cost. Series DS-300 Flow Sensors are available for pipe sizes from 1" to 10".
