# FACT SHEET

## Soil Contamination Response Action for Hakalau Stream Bridge and Hakalau Beach Park Hakalau, Hawai'i

Portions of TMK: (3) 3-1-001:001, (3) 3-1-001:002, (3) 3-1-001:003, (3) 3-1-001:004, (3) 2-9-002:025, and (3) 2-9-002:080. Old Mamalahoa Highway, Hakalau, Hawai'i Island

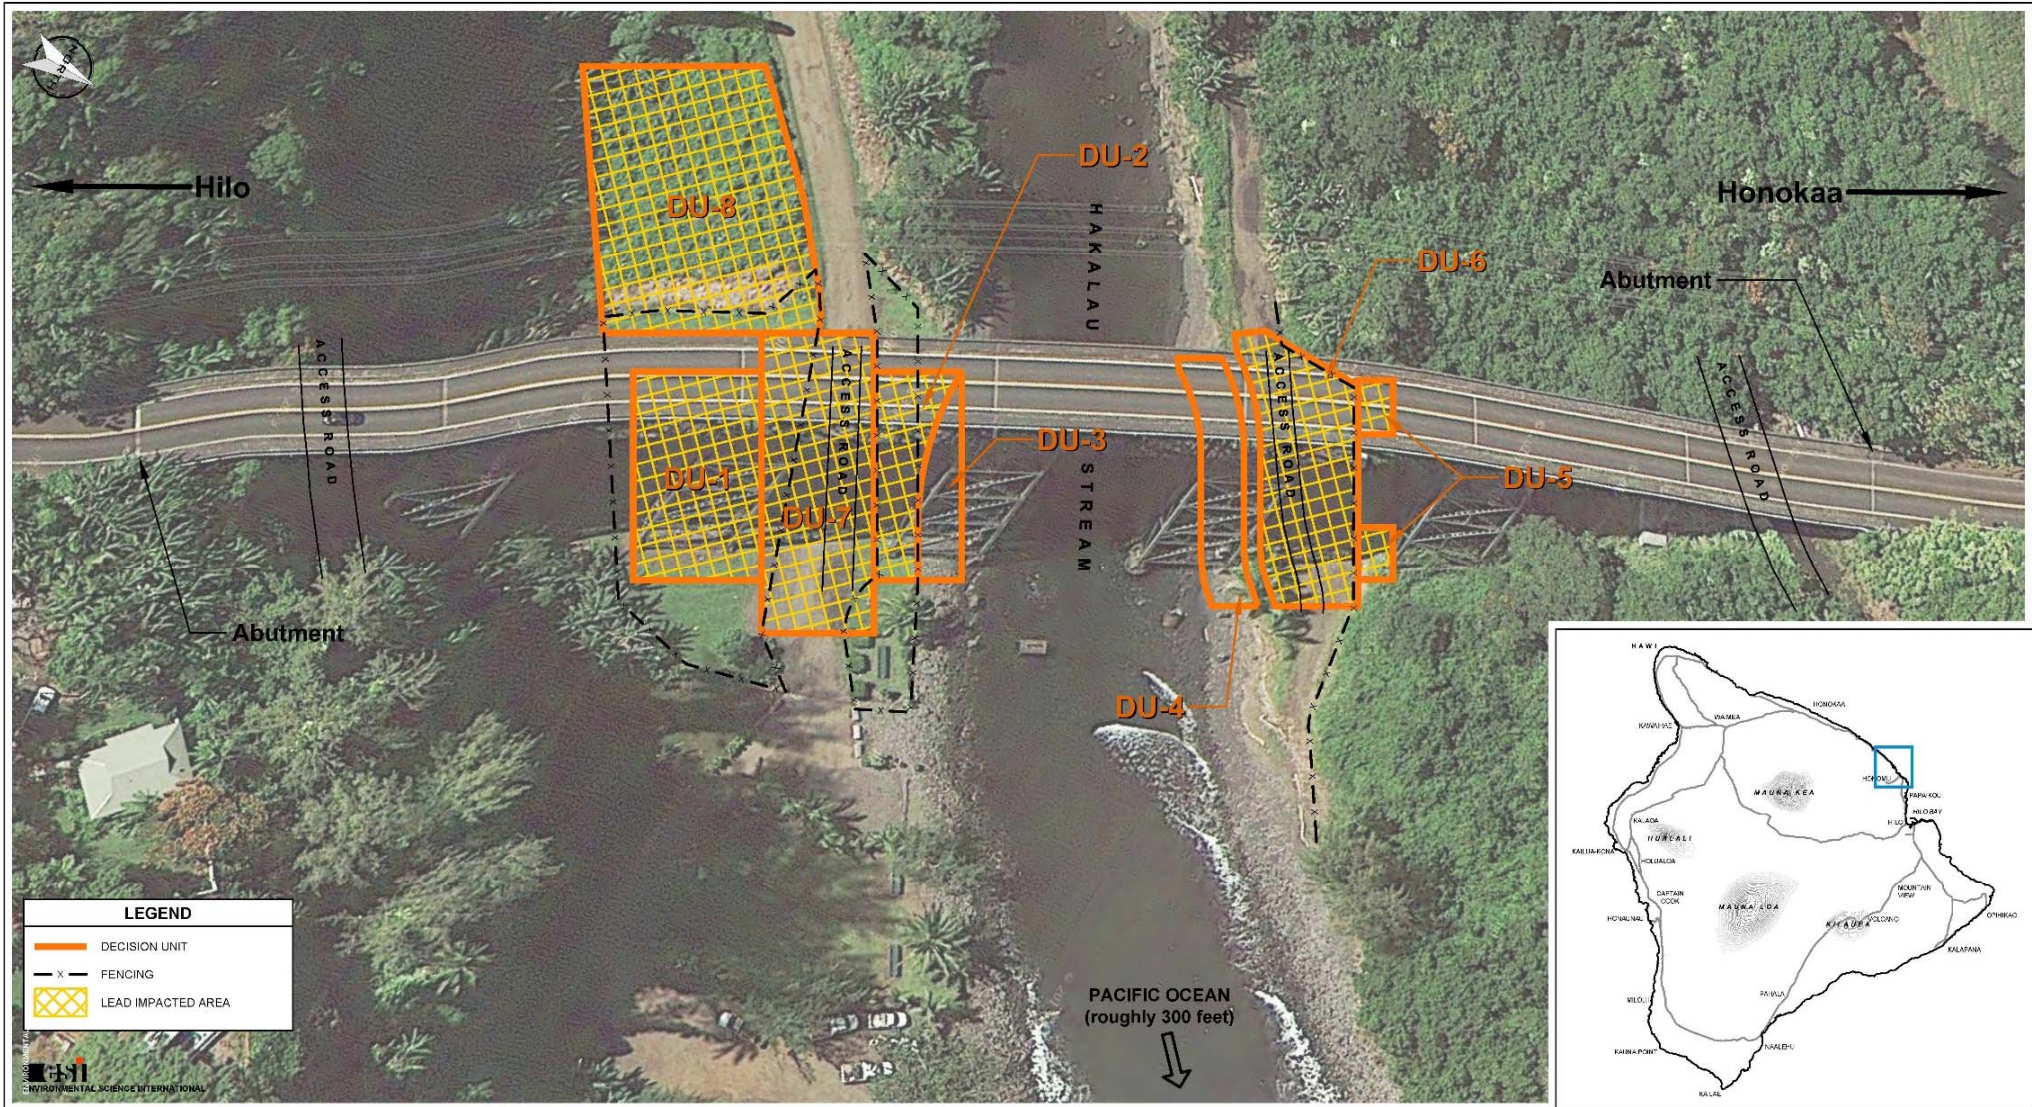
# Map of Soil Sampling Areas from Hakalau Bridge Environmental Assessment

The full lateral and vertical extent of lead contaminated soil has not been delineated, though the highest lead levels in soil would be expected close to the base of the steel columns where old lead paint (chips) would most commonly be expected. Additional soil sampling and analysis will begin in October 2016. A map showing the general area and the specific areas that have been found to be impacted by lead contamination from the initial testing is provided below. Note that "DU-3" and "DU-4", areas that were tested on the stream banks under

the bridge, were **not** found to have elevated lead levels. Any lead residue in these areas was likely removed long ago by the periodic flooding and flushing action of the stream. The map also illustrates the areas where fencing and signs have been erected to keep people out until additional testing and follow-up actions are taken.

To prevent exposure of the public to the contaminated soils, fencing and warning signs have been posted around areas where soil containing high lead concentrations were found. An assessment of hazards for construction workers and the general public is also underway. Once lead contamination is fully delineated at the Project site, cleanup options will be evaluated (to include public input) and an action plan selected and approved by the HDOH HEER Office will be implemented.
