Documentation to Amend Drinking Water Health Advisory in Zone I1 JBPHH, O‘ahu, Hawai‘i

Removal Action Report

February 2022

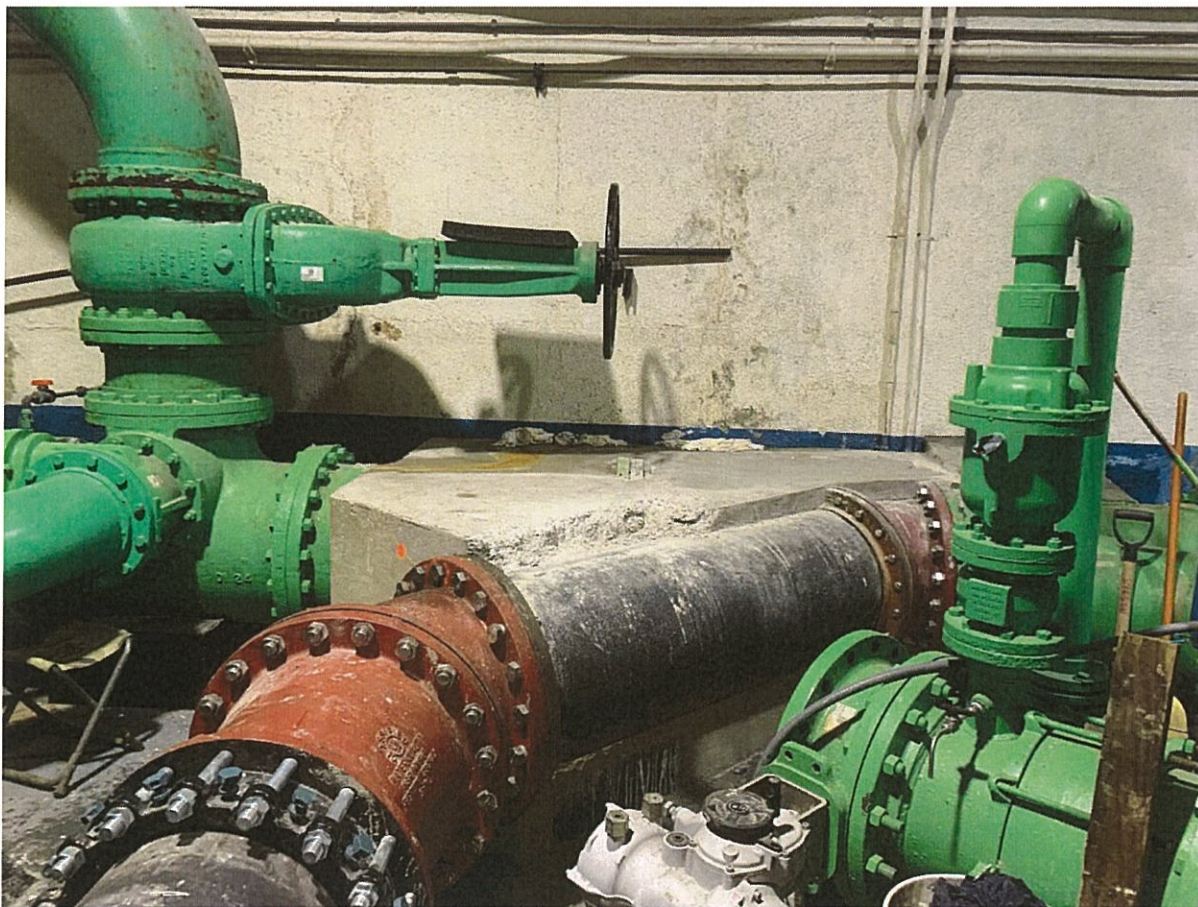
Red Hill Pump Station Photographs
Repurposed Pumps for 5 MGD GAC Treatment

2. In response to fuel contaminants found in the Red Hill Shaft aquifer/development tunnel, the main Red Hill Pumping Station pumps were secured from the Potable Water system. On 3 December 2021, all four Red Hill pumps were electrically Locked Out, Tagged Out (LOTO), see Enclosure (2). (Note: Pump #1 was LOTO on 10 June 2020 due to an unrelated pump issue, and is still out of service, LOTO.) After initially being shut down operationally, and LOTO electrically, the Red Hill pumps were physically isolated from the Potable Water system on 24 December 2021.

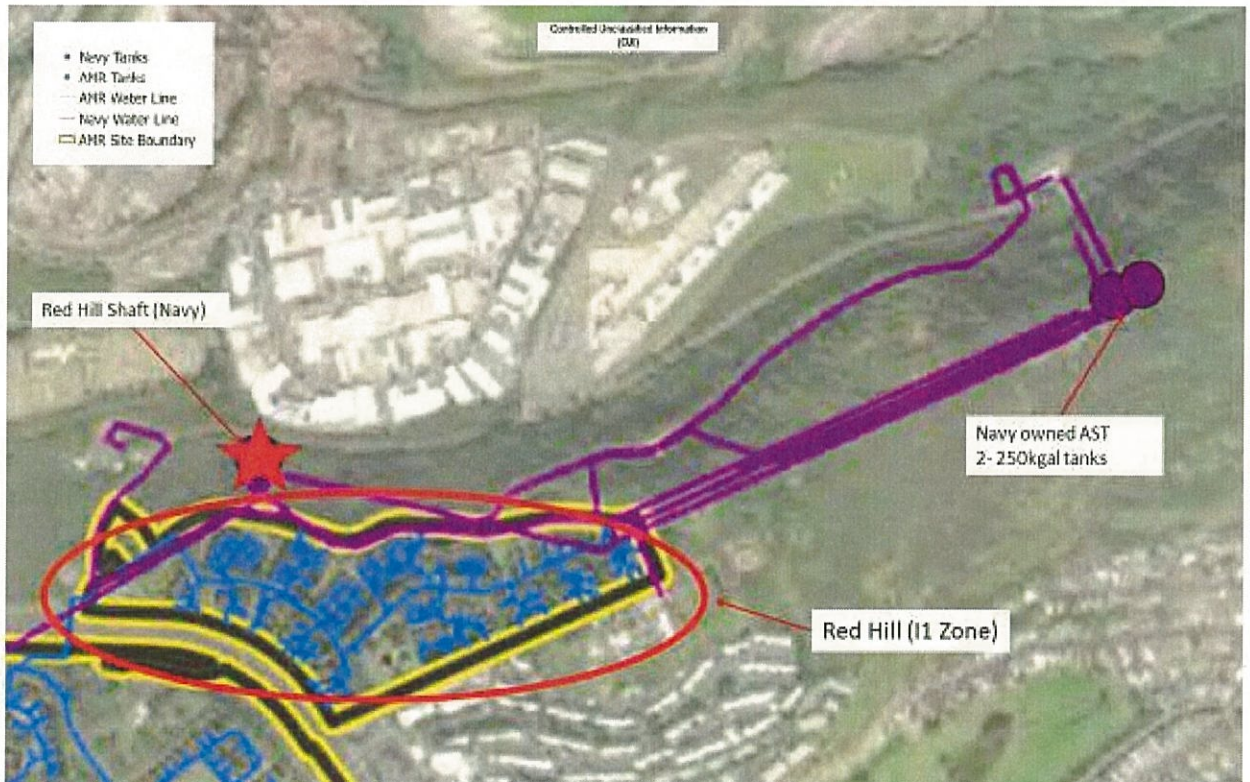
MAP OF THE DRINKING WATER STORAGE TANKS:

Water is supplied to Red Hill Housing by the JBPHH water system via a 30" water main which is pumped to two (2) 250K storage tank and gravity fed to consumers. Red Hill Housing (Zone I1) is hydraulically distinct after water is conveyed to the storage tank.

A U.S. Army Corps of Engineer project is currently underway to construct two Granulated Activated Carbon (GAC) filters that run in parallel at the Red Hill Housing Zone I1 that will filter 150,000 gallons/day each. The project is not complete and will be commissioned and implemented only with Hawaii Department of Health approval.
