CONCRETE SAMPLE SPECIFICS

ON SITE VISUAL EXAMINATION

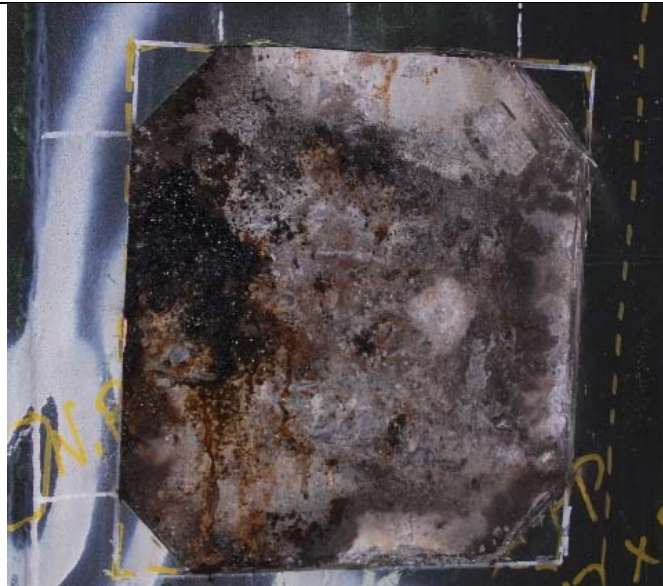
Sample ID	3	3
Sample Location	14-ER-E3-13-7-18	
Sample Dimensions	12X12 INCHES

Checks	Observations	
	Exterior	Units
Void space between concrete and liner (if any)	On left side, uneven corrosion product and a 1/16-inch void. Otherwise, no voids.	
Biological Materials	None	
Wet or Dry	Mostly dry, with some damp spots	
Smell	None	
Temperature	79.3	F
Surface pH	11-12 dry areas, 7-8 in areas with corrosion product	
Structure to Electrolyte	-0.488	Volts/CSE
Concrete Resistivity	27.8 Horizontal 31.2 Vertical	K-Ohm-cm
General Condition	Good, with some corrosion products. Corrosion product was black on the left side, and brown in some other areas. Concrete was hard and difficult to drill for powder samples. Coupons required some hammering and prying to remove after cutting.

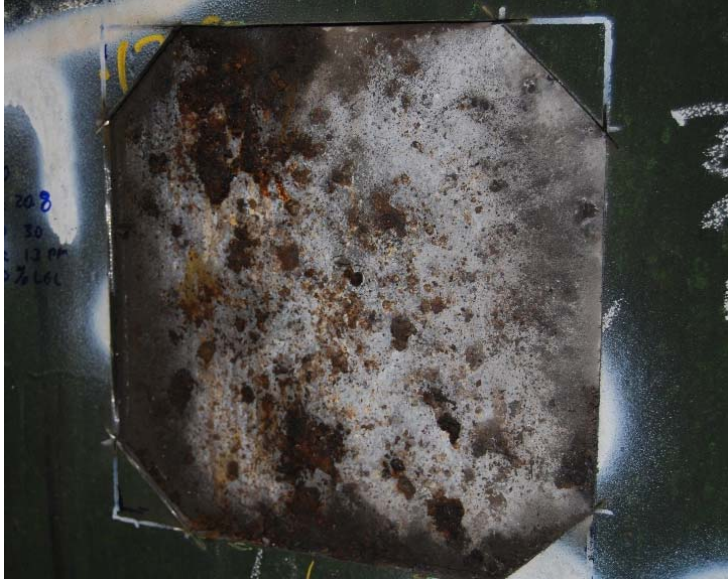
CONCRETE SAMPLE SPECIFICS		
Sample ID	7	7
Sample Location	14-BA-23-7-38-49	
Sample Dimensions	12X12 INCHES	
ON SITE VISUAL EXAMINATION		
Checks	Observations	
	Exterior	Units
Void space between concrete and liner (if any)	3/8" void on left side. 1/16" void on top right otherwise no voids	
Biological Materials	None	
Wet or Dry		
Smell	none	
Temperature	77.5F	F
Surface pH	9- 10	
Structure to Electrolyte		Volts/CSE
Concrete Resistivity	Horizontal = 39.3 Vertical = 42.4	k-ohm-cm k-ohm-cm
General Condition	Concrete is sound with no delamination or cracks. Some brown and black corrosion products on concrete

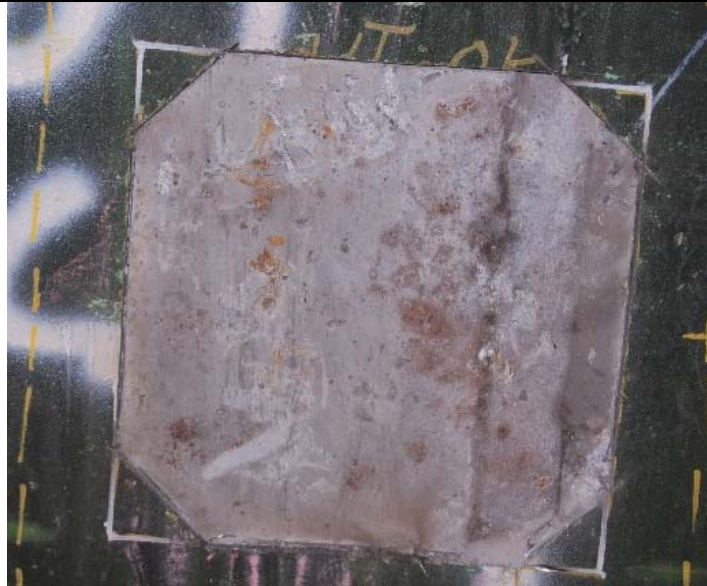
Sample ID	8	8
Sample Location	14-BA-20-13-23-4	
Sample Dimensions	12X12 INCHES

Checks	Observations	
	Exterior	Units
Void space between concrete and liner (if any)	1/16" Void on left side, no voids in all other areas	
Biological Materials	None	
Wet or Dry	Dry	
Smell	None	
Temperature	80.0	F
Surface pH	11-12	
Structure to Electrolyte	-0.248	Volts/CSE
Concrete Resistivity	30.9 Horizontal 27.5 Vertical	k-ohm-cm k-ohm-cm
General Condition	Excellent, sound concrete with no cracks or delamination. Coupon had steel backing plate

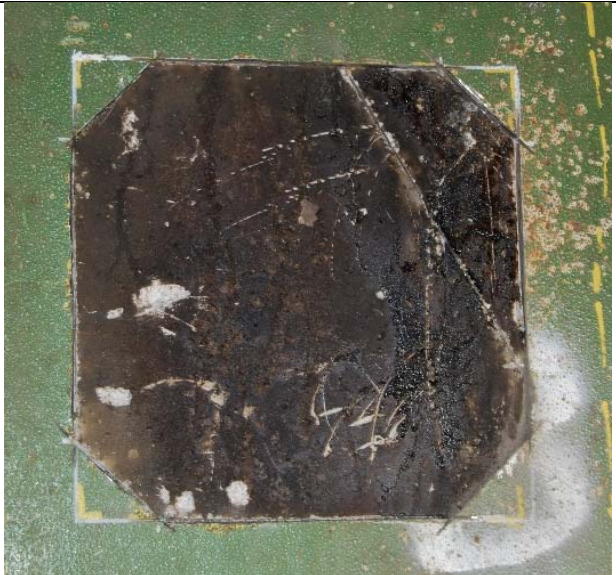
Sample ID	10	10
Sample Location	14-LD-3-9-24-215	
Sample Dimensions	12X12 INCHES

Checks	Observations	
	Exterior	Units
Void space between concrete and liner (if any)	None	
Biological Materials	None	
Wet or Dry	Dry	
Smell	Smells like coal tar	
Temperature	77.6	F
Surface pH	12-12.5	
Structure to Electrolyte	-0.181	Volts/CSE
Concrete Resistivity	27.3 Horizontal 38.1 Vertical	k-ohm-cm k-ohm-cm
General Condition	Excellent, sound concrete with no cracks or delamination. Coupon had to be cut into two pieces to remove. What appears to be coal tar coating present on backside of coupon and concrete.
