**County of Kaua'i Solid Waste Division**

**REPORT OF  
CONSTRUCTION QUALITY ASSURANCE  
CELL 1 (1A THROUGH 1D)**

**Phase II Lateral Expansion, Cell 1 Base Liner Construction  
Kekaha Sanitary Landfill  
Kaua'i, Hawai'i**

Project Number: WG1298  
18 October 2010

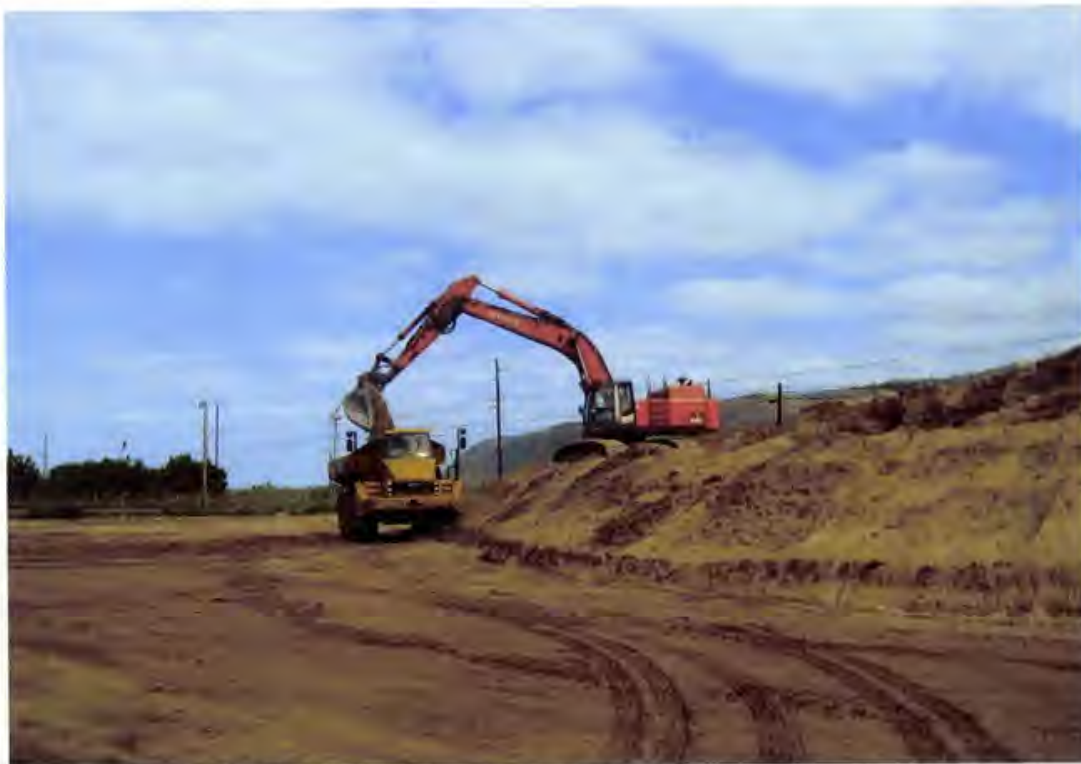
Photo 5. A fully loaded Caterpillar (Cat.) 740 haul truck drives over the existing subbase to verify that the subbase is firm and non-yielding (looking north)

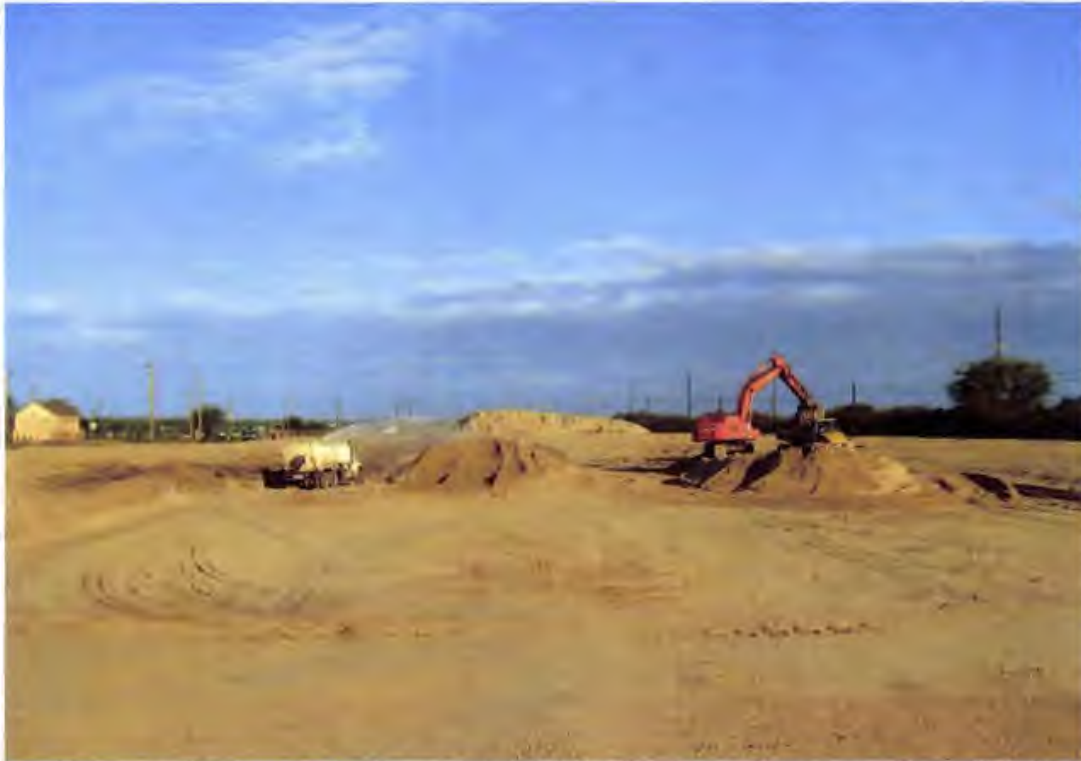
Photo 6. Compacted Fill (onsite soils) material is hauled from the existing sand stockpile and the new infiltration basin (NIB) to construct the Cell 1 subbase grades (looking northwest)

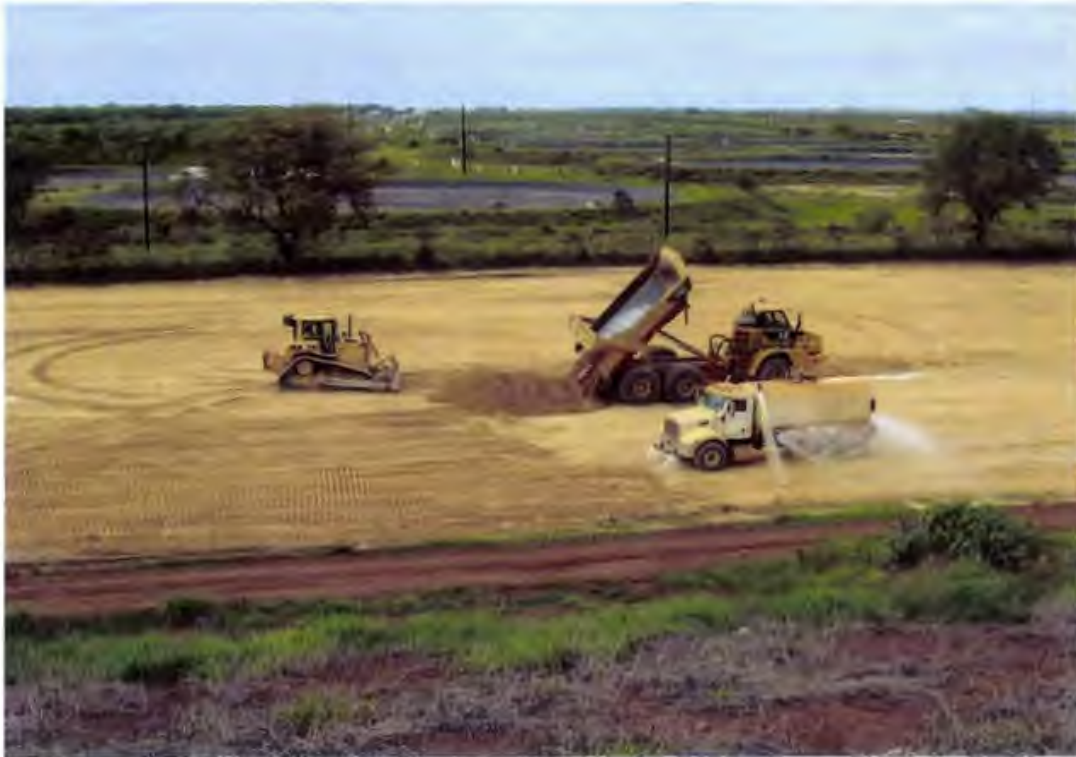
Photo 8. Compacted fill (offsite soils) material is imported from the local Kauai Aggregates quarry to construct the Cells 1A/1B subbase grades (looking west)

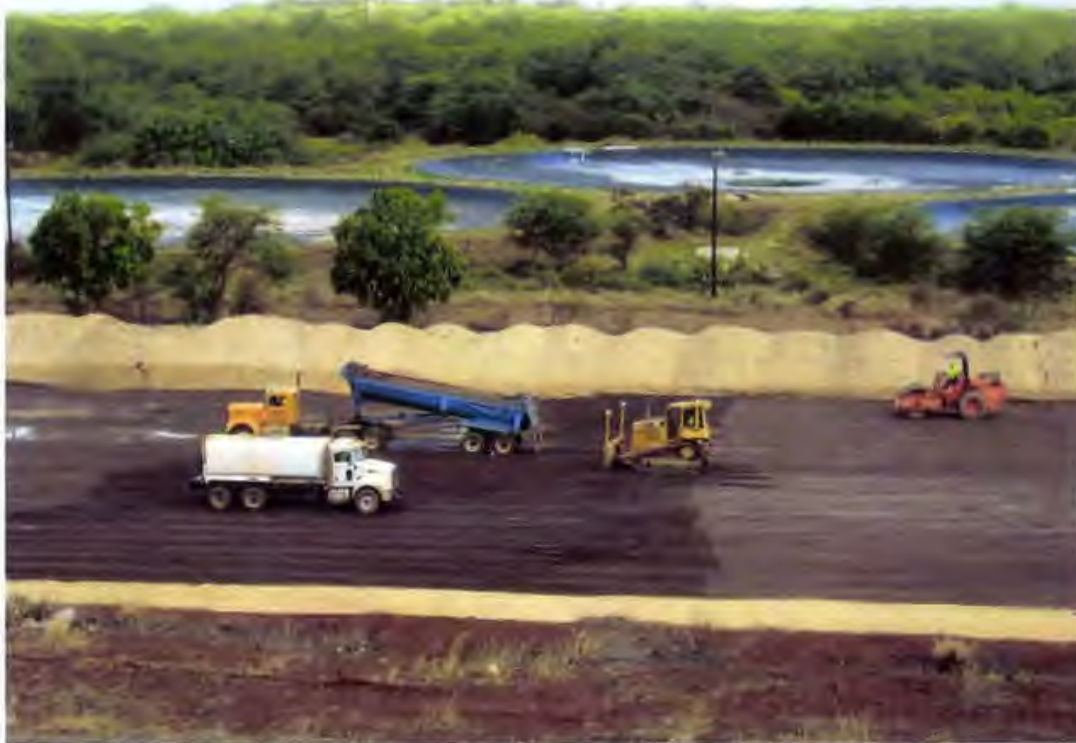
Photo 9. The compacted fill (onsite soils) materials are hauled to Cell 1 using Cat. articulated haul trucks, spread with a Cat. D6 LGP dozer, and then moisture conditioned with the water truck (looking west)

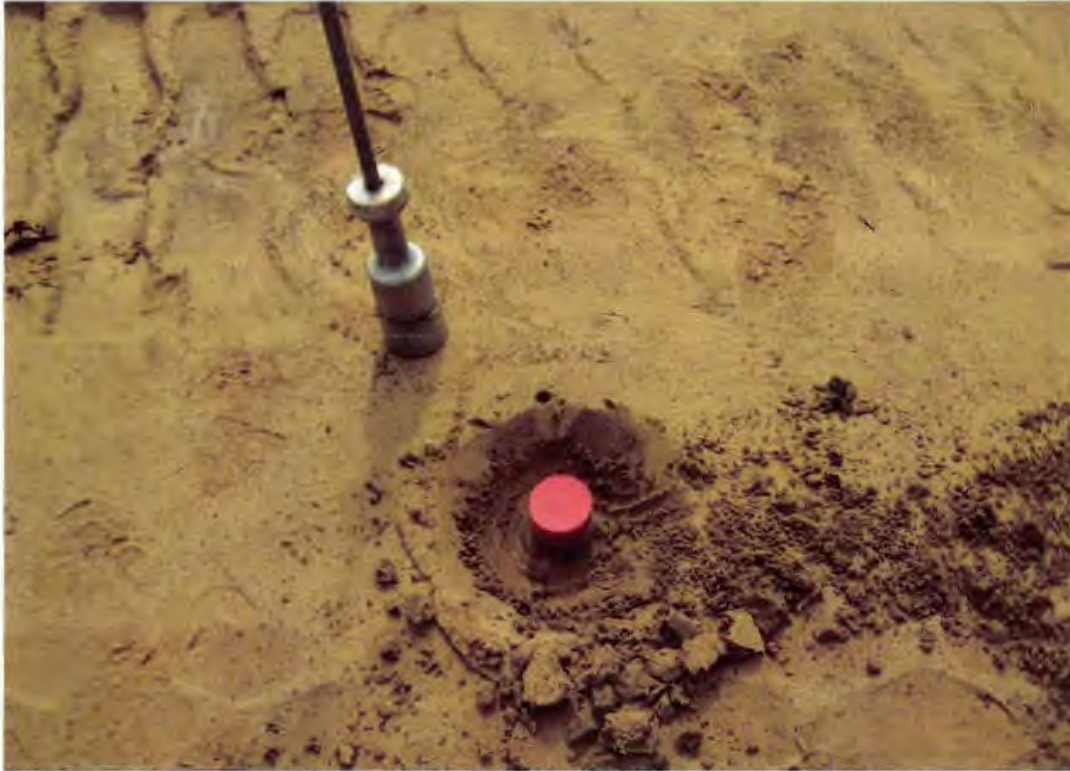
Photo 12. Verifying compaction effort using a Troxler portable nuclear moisture density gauge (looking north)

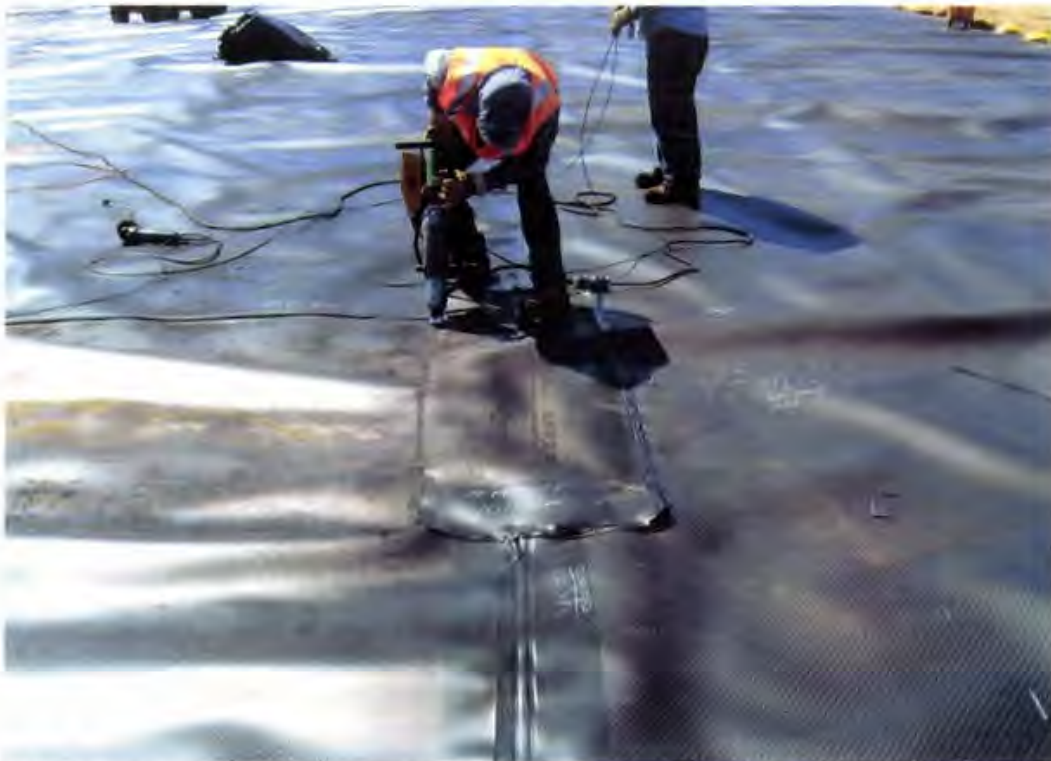
Photo 95. Destructive seam sample collected on the subbase tie-in to Phase II containment system

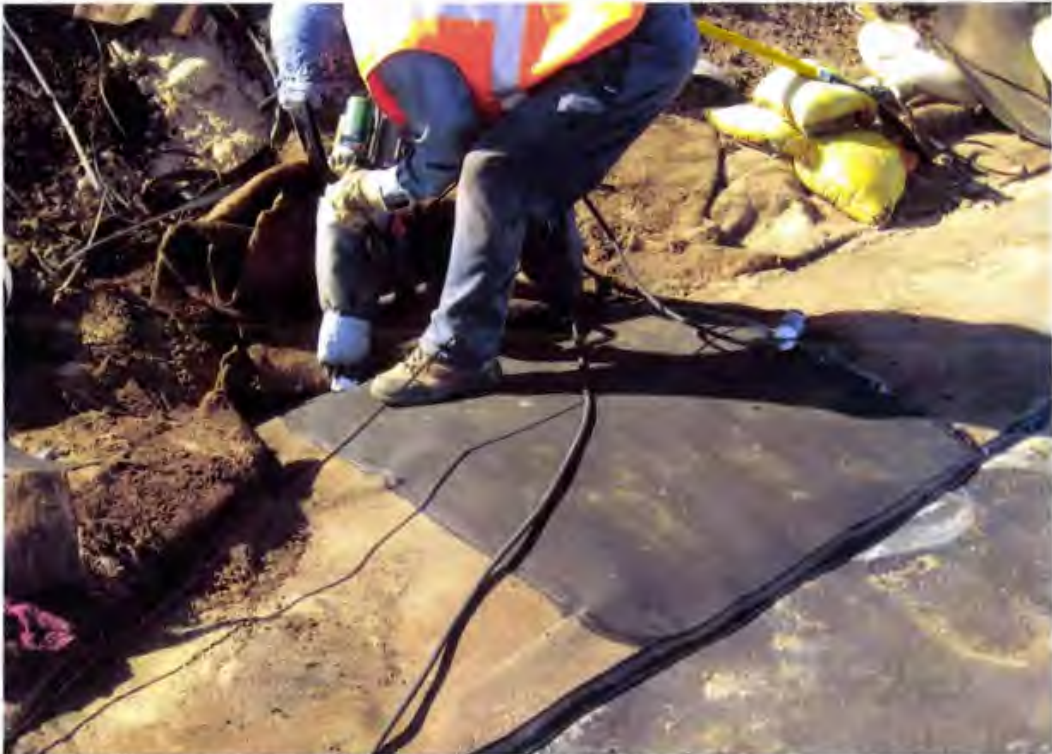
Photo 96. A repair patch is constructed over each destructive seam sample location once the sample is removed

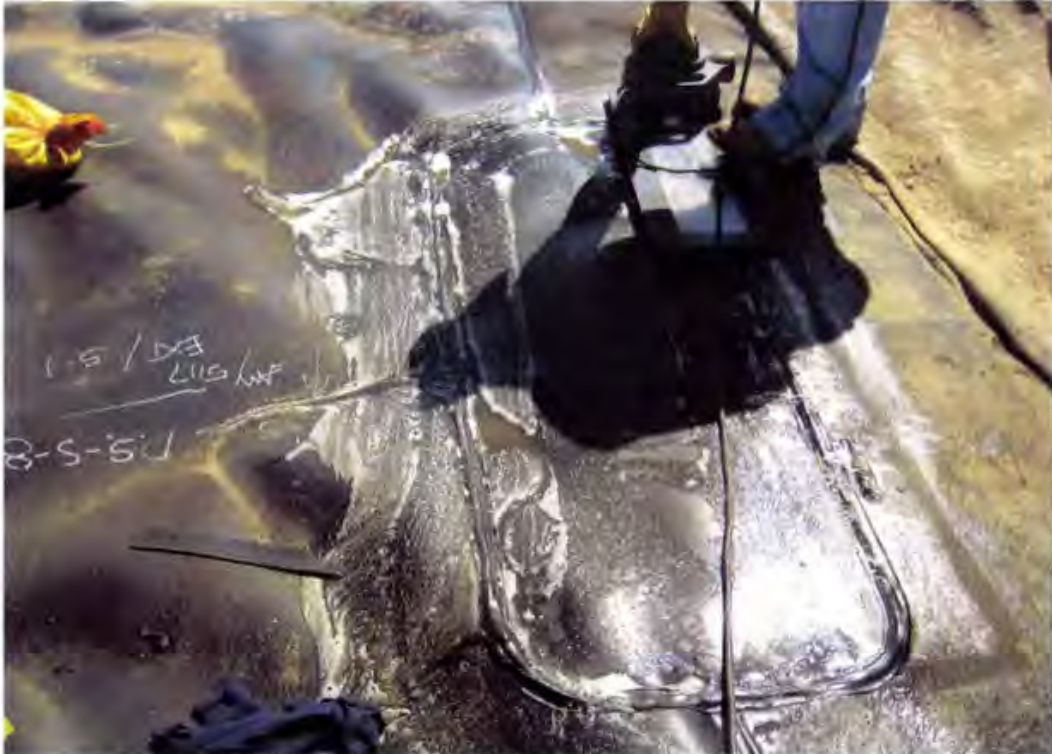
Photo 97. Extrusion welding a repair patch on the existing Phase II geomembrane

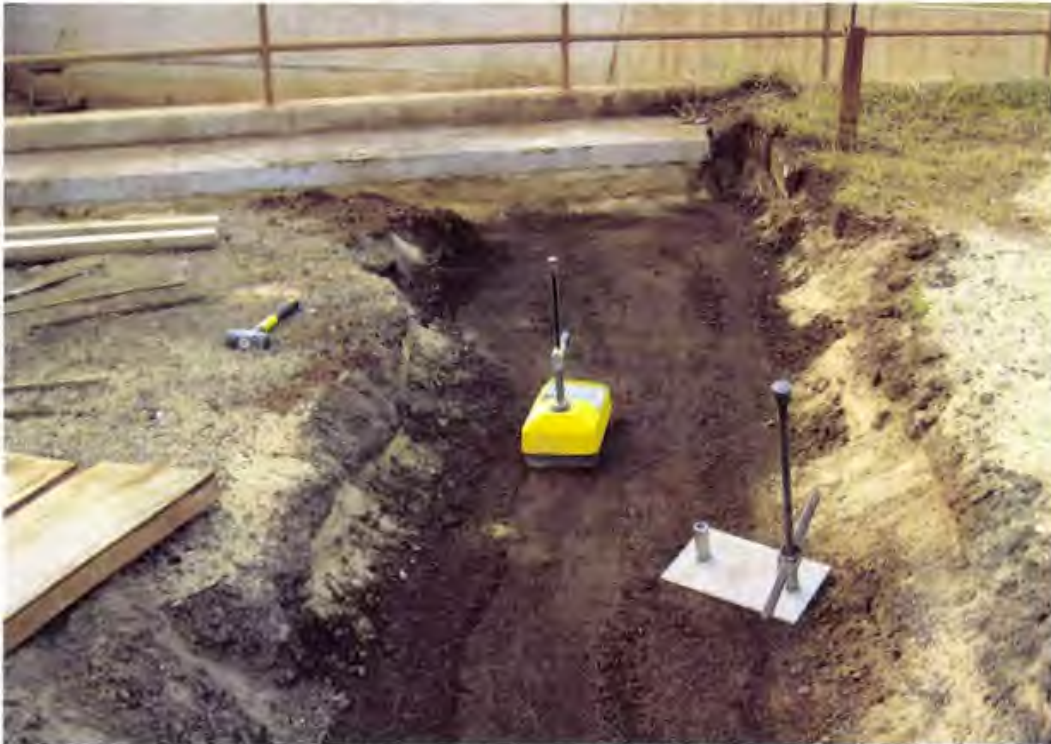
Photo 144. The excavation is backfilled with compacted new aggregate base course
