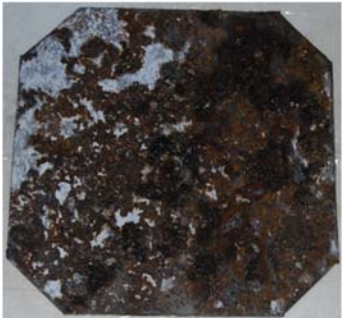
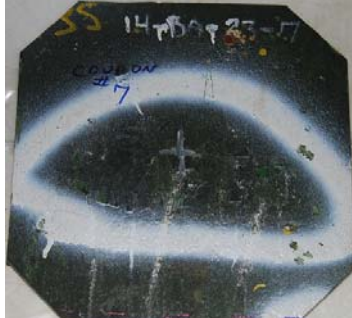
COUPON SPECIFICS		
Coupon ID	7	<b>7</b>
Coupon Location	14-BA-23-7-38-49	
Coupon Dimensions	12" * 12"	
Coupon Thickness	¼" (NDE: minimum 0.157")	Prove-up: minimum 0.135"
Locations of Welds	None

Checks	Observations	
	Exterior	Interior
Deposits, Coatings, Debris	Lots of general corrosion	Standard coating
Scale	Yes, thick, varied	None
Observed Biological Material	None	None
Wet or Dry	Wet	Dry
Smell	Burnt, damp	Burnt
Presence of petroleum product between steel and concrete surface, and on or above the leg of the angle backer bar embedded in the concrete	No	No
Provide a sketch of the coupon showing all indications. Provide ID#s for all indications on coupon and compare with NDE expected results sketch

Lots of corrosion found, as expected

Presence of corrosion	Yes	Yes
Isolated pitting	Yes	No
Isolated pitting within areas of general corrosion	Yes	No
Linked pitting within areas of general corrosion	No	No
Identify color of corrosion products	Brown, black	Brown
Identify if selected attack at welds	N/A	N/A
