Red Hill – Monitoring Well Fuel Product Gauging Photos

AECOM

12/30/2024

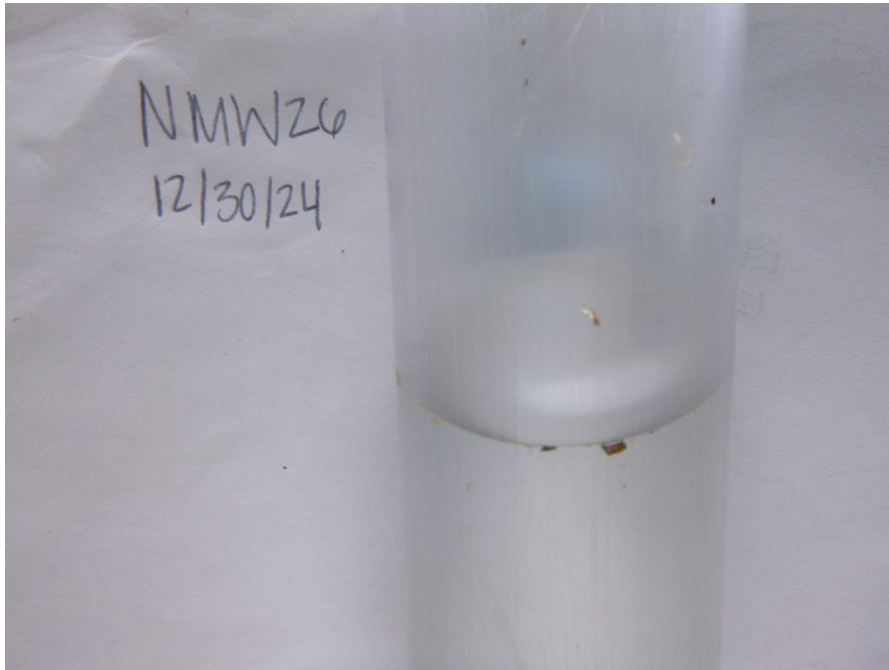
[P1050010.JPG] – NMW26 – 12/30/2024 – 1306

No fuel product observed. Small organic material observed at surface of bailer water.

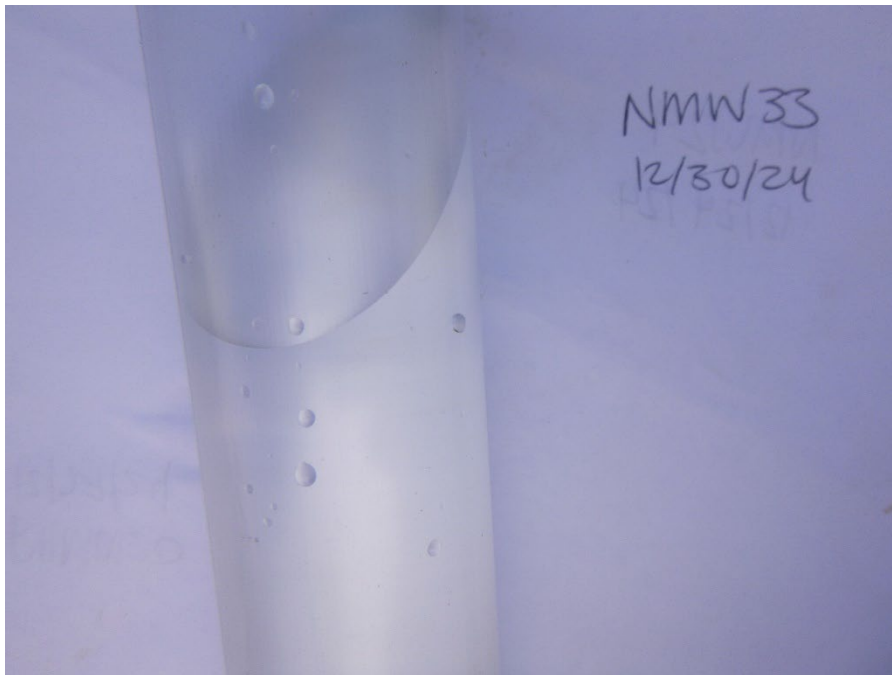
[P1050016.JPG] – NMW33 – 12/30/2024 – 1341

No fuel product observed. Water observed is clear in the bailer sample.
