Activity: Monthly FP & SVM

# Soil Vapor Monitoring Log

Project Title: Long-Term Monitoring, Red Hill Bulk Fuel Storage Facility (RHBFSF)

11/11/2025 Red Hill SVMP Photographs

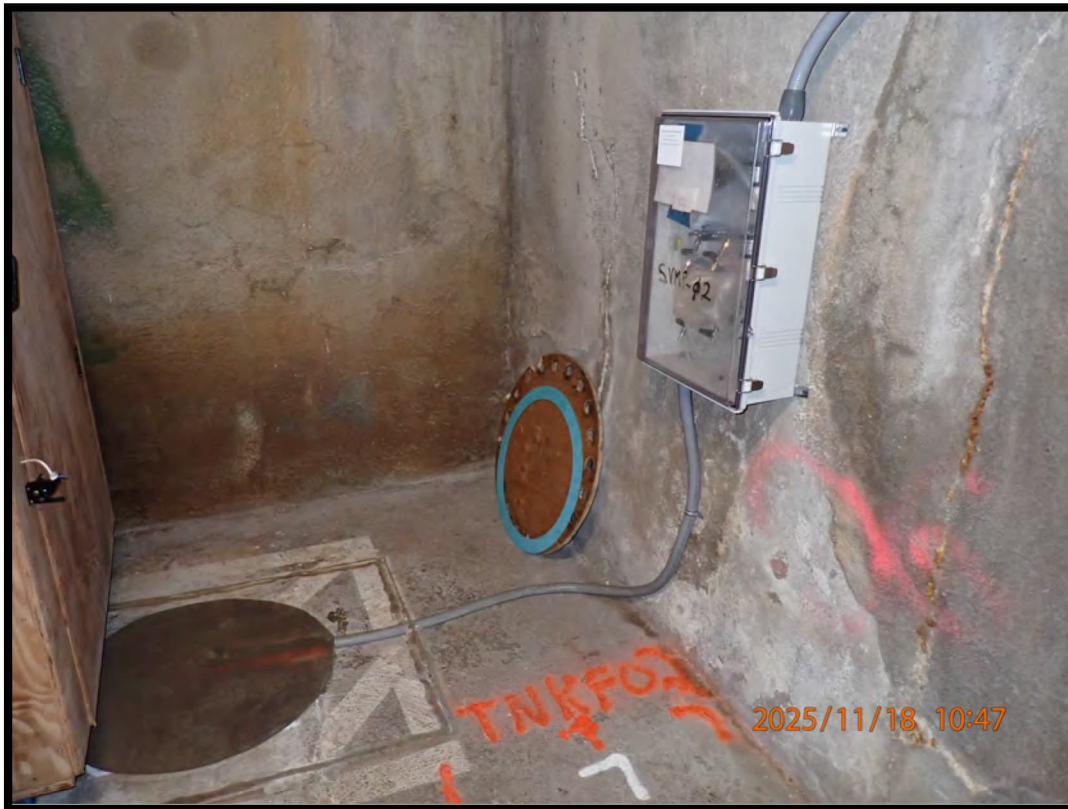
Photo 1. SVMP-02

| SVMP No.<br>(Material) | Purge Start<br>Time | Sample<br>Start Time | PID Reading <sup>2</sup> | | | Reading<br>Time | Background<br>PID Reading | Notes |
|---|---|---|---|---|---|---|---|---|
| SV02 S <sub>(C)</sub> | 10:05 | 10:09 | 83 | 0 | 0 | 10:11 | 119 | |
| SV02 M <sub>(C)</sub> | 10:05 | 10:09 | 0 | 0 | 0 | 10:12 | | |
| SV02 D <sub>(C)</sub> | 10:05 | 10:09 | 0 | 0 | 0 | 10:12 | | |

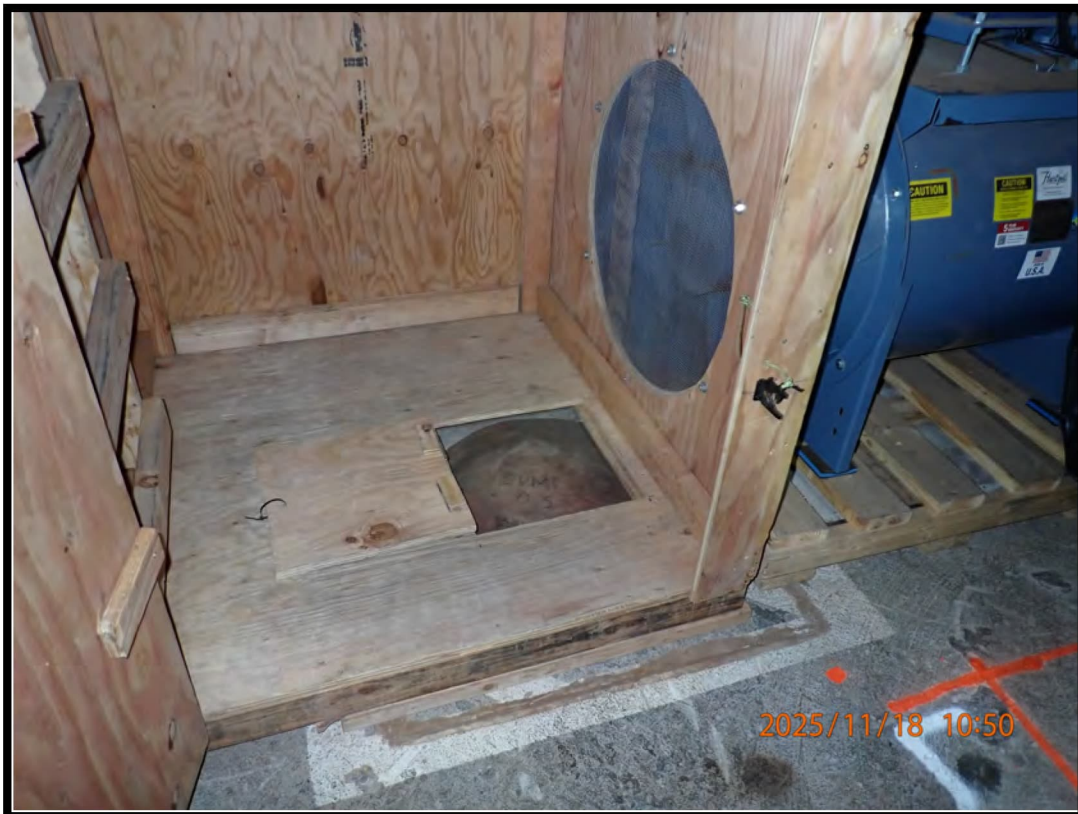
Photo 2. SVMP-03

| SVMP No.<br>(Material) | Purge Start<br>Time | Sample<br>Start Time | PID Reading <sup>2</sup> | | | Reading<br>Time | Background<br>PID Reading | Notes |
|---|---|---|---|---|---|---|---|---|
| SV03 S <sub>(S)</sub> | 10:26 | 10:27 | 43 | 22 | 14 | 10:30 | 291 | |
| SV03 M <sub>(S)</sub> | 10:26 | 10:25 | 10 | 0 | 0 | 10:30 | | |
| SV03 D <sub>(S)</sub> | 10:26 | 10:27 | 21 | 13 | 3 | 10:31 | | |

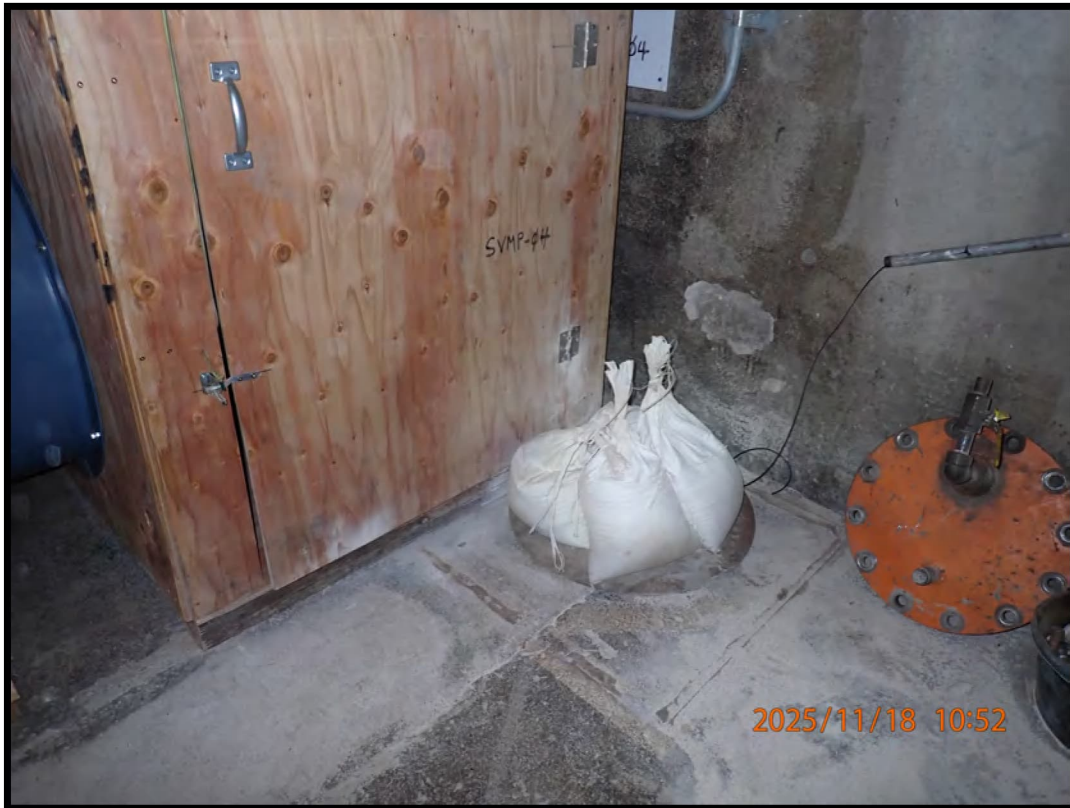
Photo 3. SVMP-04

| SVMP No.<br>(Material) | Purge Start<br>Time | Sample<br>Start Time | PID Reading <sup>2</sup> | | | Reading<br>Time | Background<br>PID Reading | Notes |
|---|---|---|---|---|---|---|---|---|
| SV04 S <sub>(S)</sub> | 10:39 | 10:41 | 10 | 0 | 0 | 10:43 | 144 | |
| SV04 M <sub>(S)</sub> | 10:39 | 10:41 | 0 | 0 | 0 | 10:45 | | |
| SV04 D <sub>(S)</sub> | 10:39 | 10:41 | 0 | 0 | 0 | 10:45 | | |

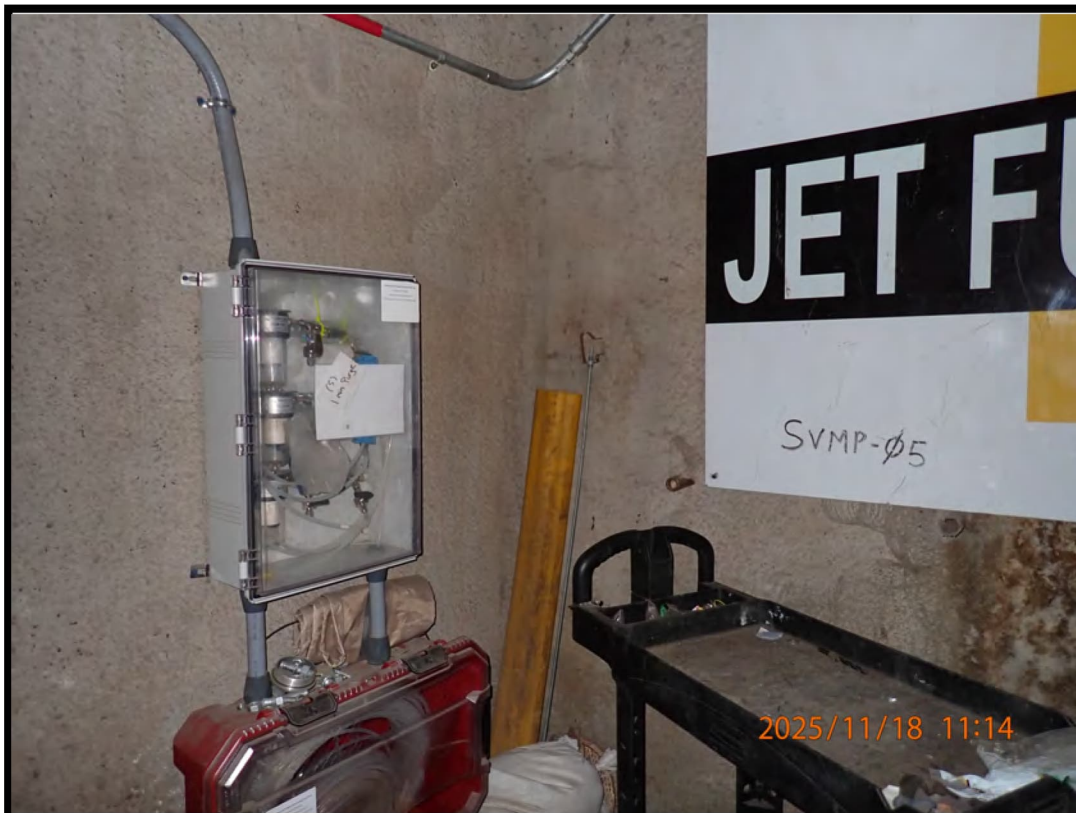
Photo 4. SVMP-05

| SVMP No.<br>(Material) | Purge Start<br>Time | Sample<br>Start Time | PID Reading <sup>2</sup> | | | Reading<br>Time | Background<br>PID Reading | Notes |
|---|---|---|---|---|---|---|---|---|
| SV05 S <sub>(S)</sub> | 10:59 | 11:00 | <del>103</del> 35 | 28 | 20 | 11:12 | 127 | Slow to Fill |
| SV05 M <sub>(S)</sub> | 10:59 | 11:00 | 103 | 97 | 94 | 11:05 | | |
| SV05 D <sub>(S)</sub> | 10:59 | 11:00 | 43 | 0 | 0 | 11:05 | | |

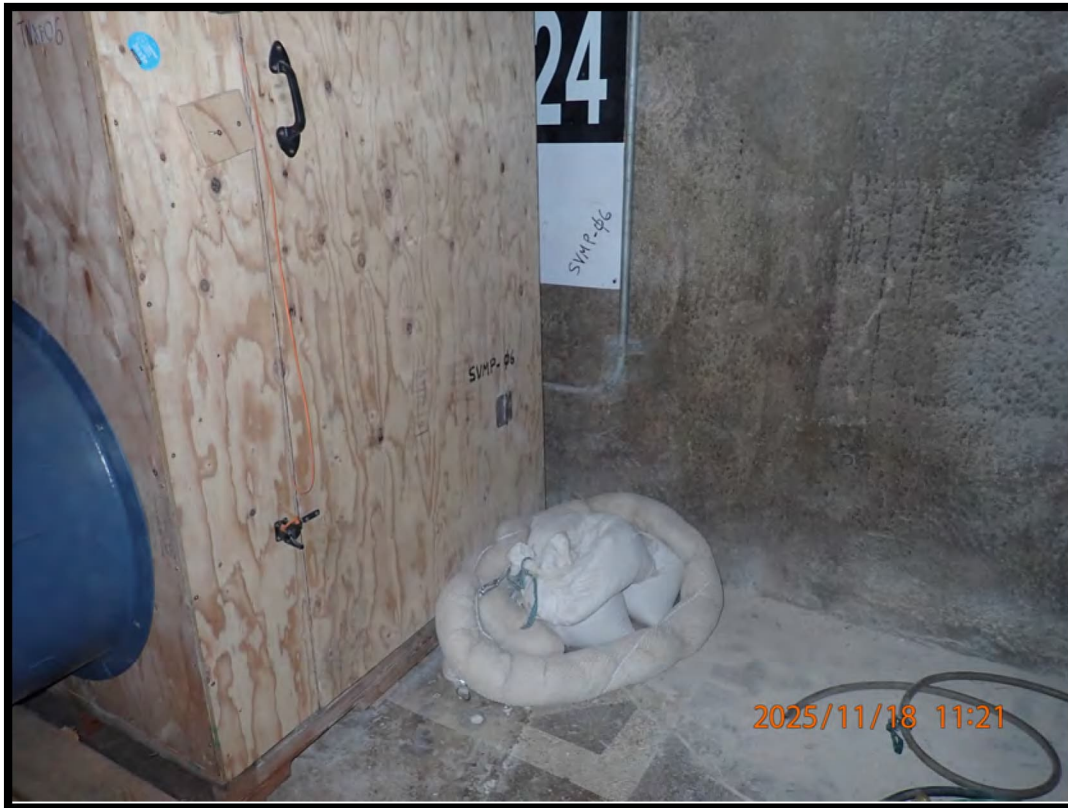
Photo 5. SVMP-06

| SVMP No.<br>(Material) | Purge Start<br>Time | Sample<br>Start Time | PID Reading <sup>2</sup> | | | Reading<br>Time | Background<br>PID Reading | Notes |
|---|---|---|---|---|---|---|---|---|
| SV06 S <sub>(C)</sub> | 11:12 | 11:15 | 2001 | 2188 | 2390 | 11:17 | 289 | |
| SV06 M <sub>(C)</sub> | 11:12 | 11:15 | 930 | 529 | 3065 | 11:17 | | |

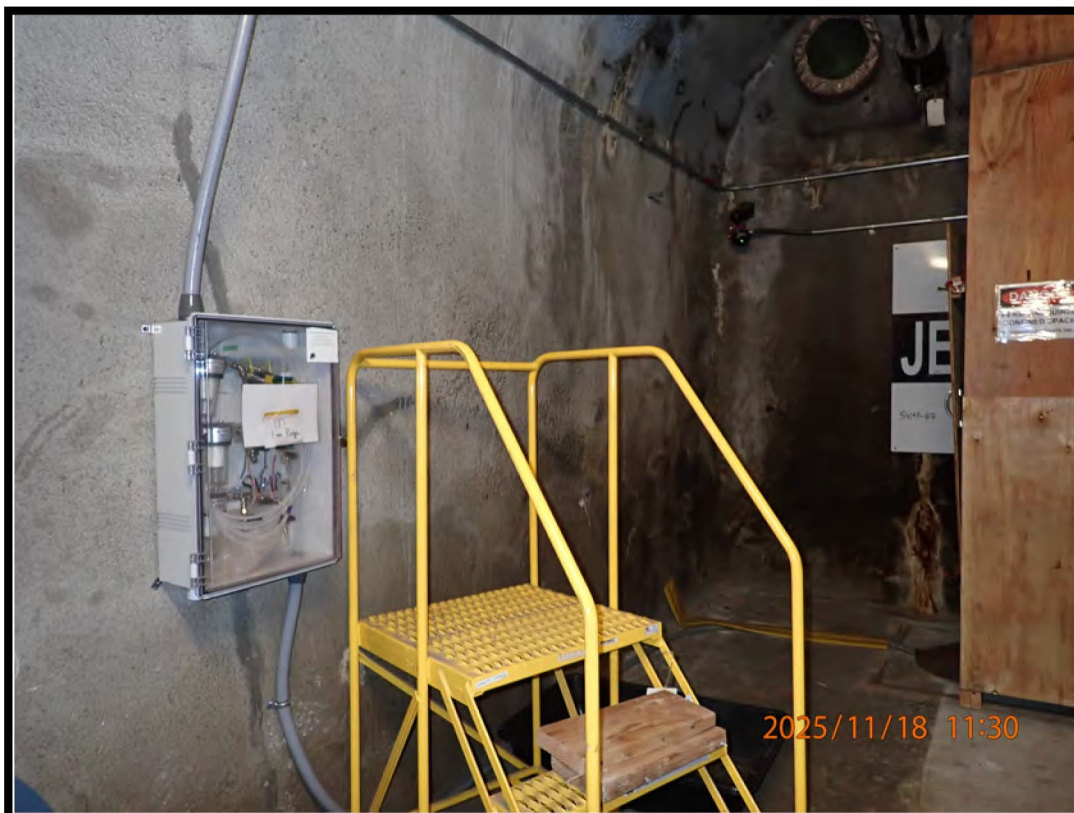
Photo 6. SVMP-07

| SVMP No.<br>(Material) | Purge Start<br>Time | Sample<br>Start Time | PID Reading <sup>2</sup> | | | Reading<br>Time | Background<br>PID Reading | Notes |
|---|---|---|---|---|---|---|---|---|
| SV07 S <sub>(S)</sub> | 11:19 | 11:21 | 90 | 80 | 69 | 11:25 | 380 | |
| SV07 M <sub>(S)</sub> | 11:19 | 11:21 | 81 | 75 | 72 | 11:25 | | |
| SV07 D <sub>(S)</sub> | 11:19 | 11:21 | 123 | 117 | 114 | 11:25 | | |

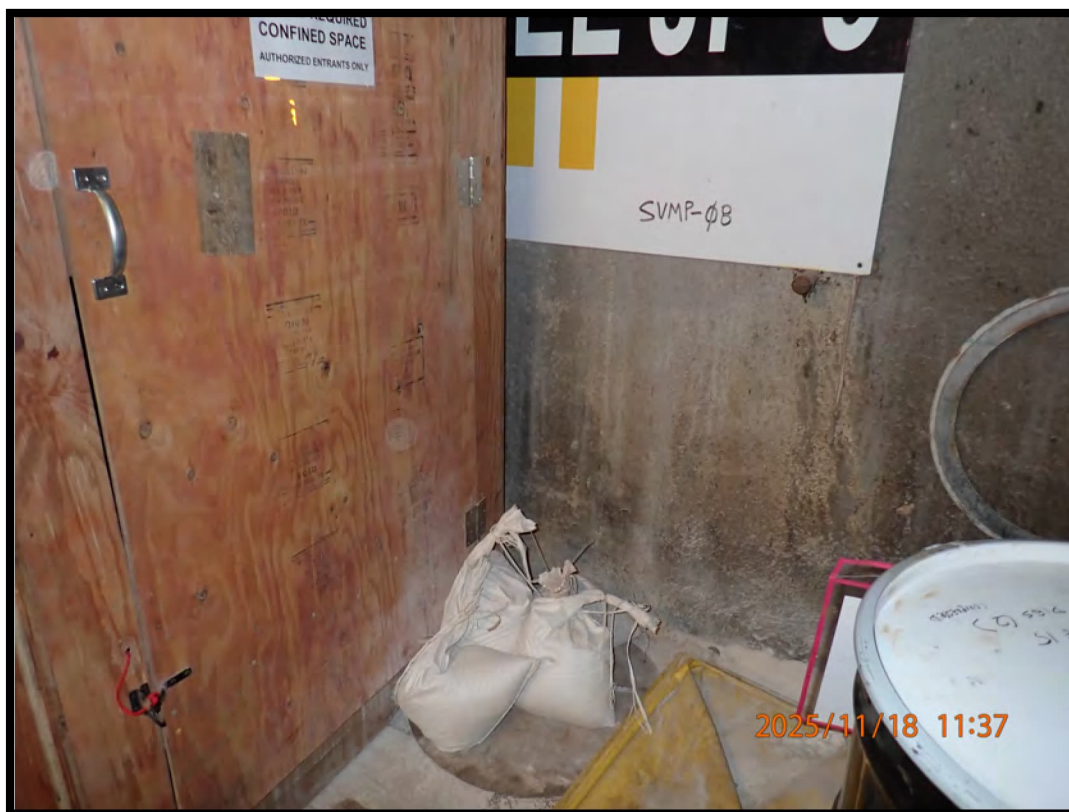
Photo 7. SVMP-08

| SVMP No.<br>(Material) | Purge Start<br>Time | Sample<br>Start Time | PID Reading <sup>2</sup> | | | Reading<br>Time | Background<br>PID Reading | Notes |
|---|---|---|---|---|---|---|---|---|
| SV08 S <sub>(S)</sub> | 11:26 | 11:27 | 185 | 156 | 125 | 11:32 | 349 | |
| SV08 M <sub>(S)</sub> | 11:26 | 11:27 | 135 | 116 | 108 | 11:32 | | |
| SV08 D <sub>(S)</sub> | 11:26 | 11:27 | 105 | 99 | 90 | 11:32 | | |

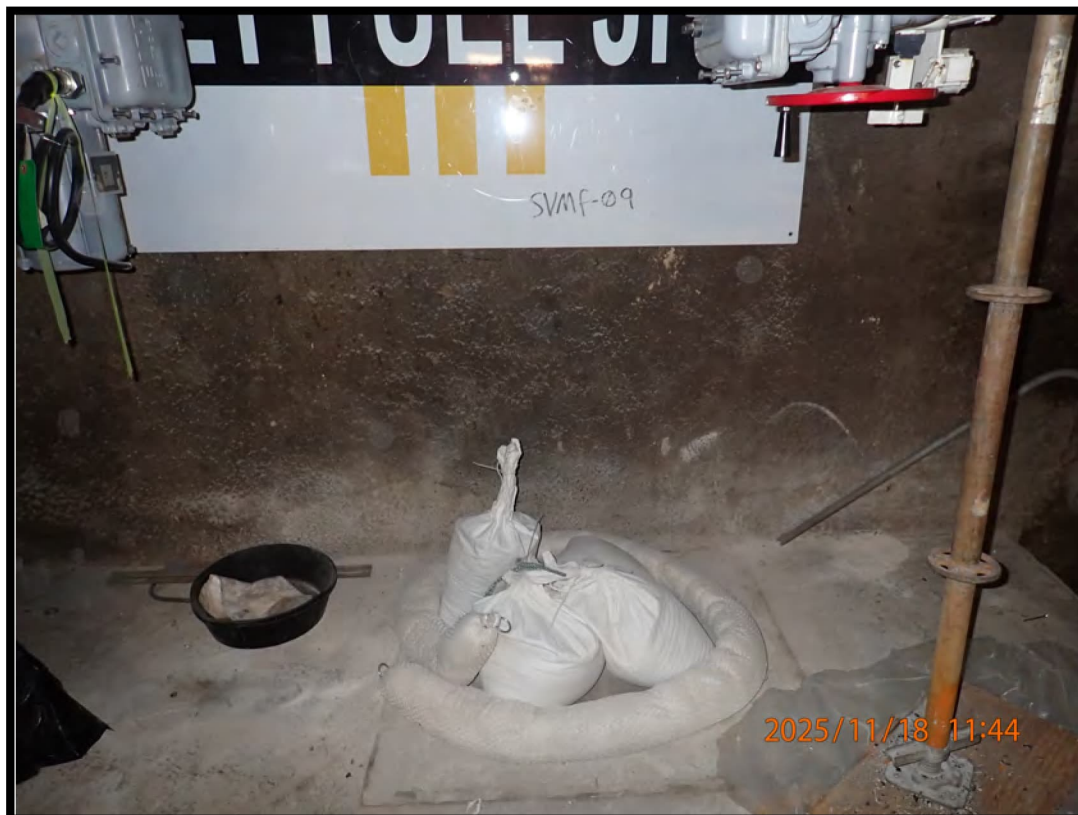
Photo 8. SVMP-09

| SVMP No.<br>(Material) | Purge Start<br>Time | Sample<br>Start Time | PID Reading <sup>2</sup> | | | Reading<br>Time | Background<br>PID Reading | Notes |
|---|---|---|---|---|---|---|---|---|
| SV09 S <sub>(S)</sub> | 11:35 | 11:37 | 95 | 83 | 71 | 11:41 | 323 | |
| SV09 M <sub>(S)</sub> | 11:35 | 11:37 | 197 | 148 | 123 | 11:40 | | |
| SV09 D <sub>(S)</sub> | 11:35 | 11:37 | 68 | 60 | 56 | 11:41 | | |

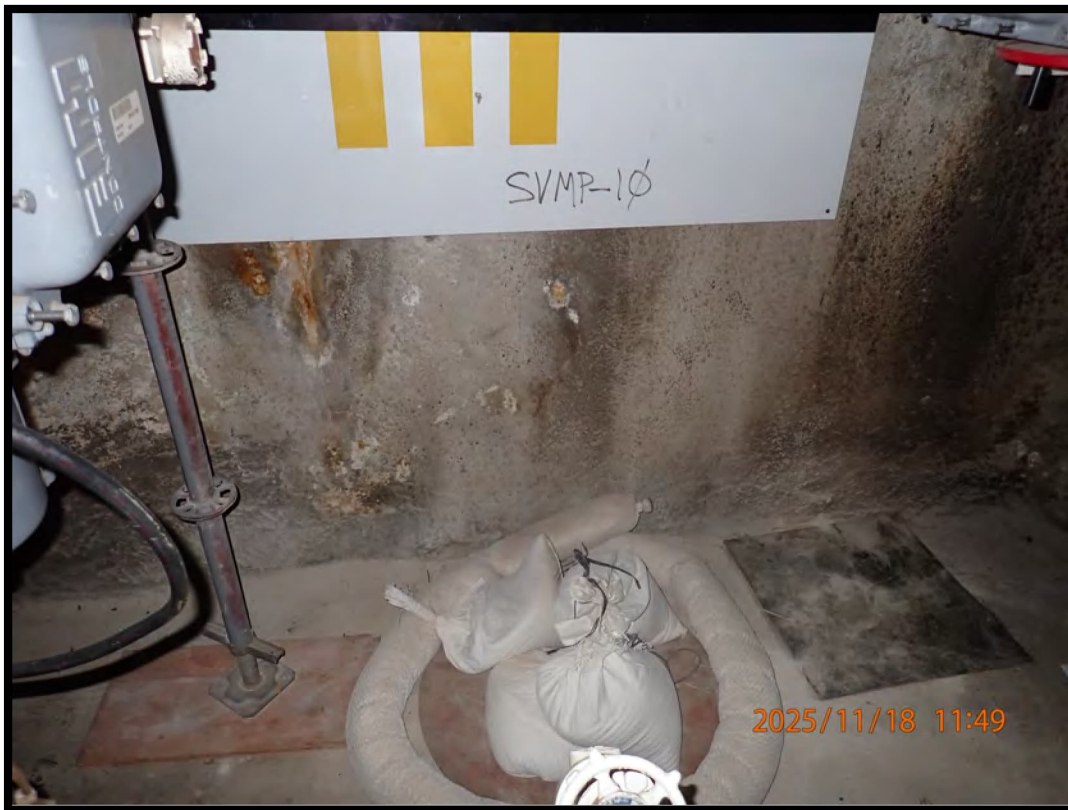
Photo 9. SVMP-10

| SVMP No.<br>(Material) | Purge Start<br>Time | Sample<br>Start Time | PID Reading <sup>2</sup> | | | Reading<br>Time | Background<br>PID Reading | Notes |
|---|---|---|---|---|---|---|---|---|
| SV10 S <sub>(C)</sub> | 11:43 | 11:45 | 67 | 58 | 54 | 11:47 | 280 | |
| SV10 M/D <sub>(C)</sub> | 11:43 | 11:45 | 60 | 58 | 52 | 11:47 | | |

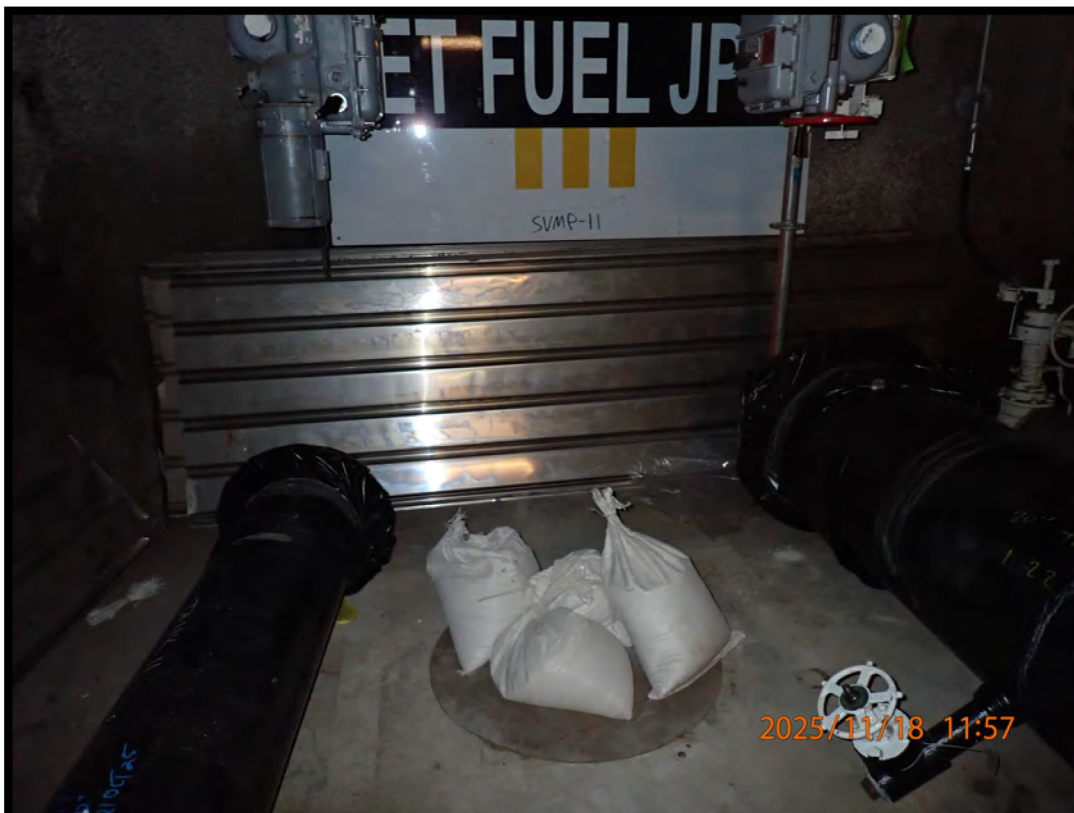
Photo 10. SVMP-11

| SVMP No. | Purge Start Time | Sample Start Time | PID Reading <sup>2</sup> | | | Reading Time | Background PID Reading | Notes |
|---|---|---|---|---|---|---|---|---|
| SV11 S <sub>(C)</sub> | 1150 | 1152 | 271 | 224 | 206 | 11:53 | 858 | |
| SV11 M/D <sub>(C)</sub> | 1150 | 1152 | 212 | 187 | 115 | 11:53 | | |

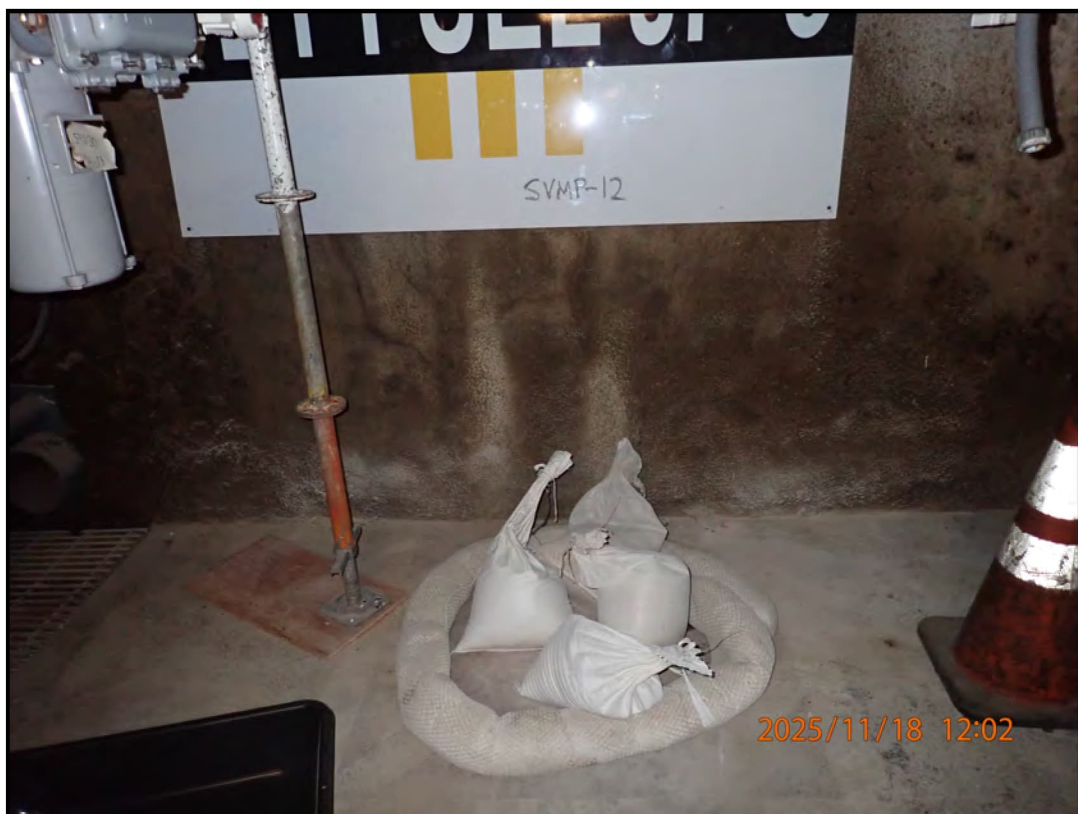
Photo 11. SVMP-12

| SVMP No. | Purge Start Time | Sample Start Time | PID Reading <sup>2</sup> | | | Reading Time | Background PID Reading | Notes |
|---|---|---|---|---|---|---|---|---|
| SV12 S <sub>(C)</sub> | 1159 | 1155 | 196 | 185 | 175 | 11:59 | 505 | |
| SV12 M <sub>(C)</sub> | 1159 | 1155 | 169 | 158 | 149 | 11:59 | | |
| SV12 D <sub>(C)</sub> | 1159 | 1155 | 162 | 159 | 152 | 11:59 | | |

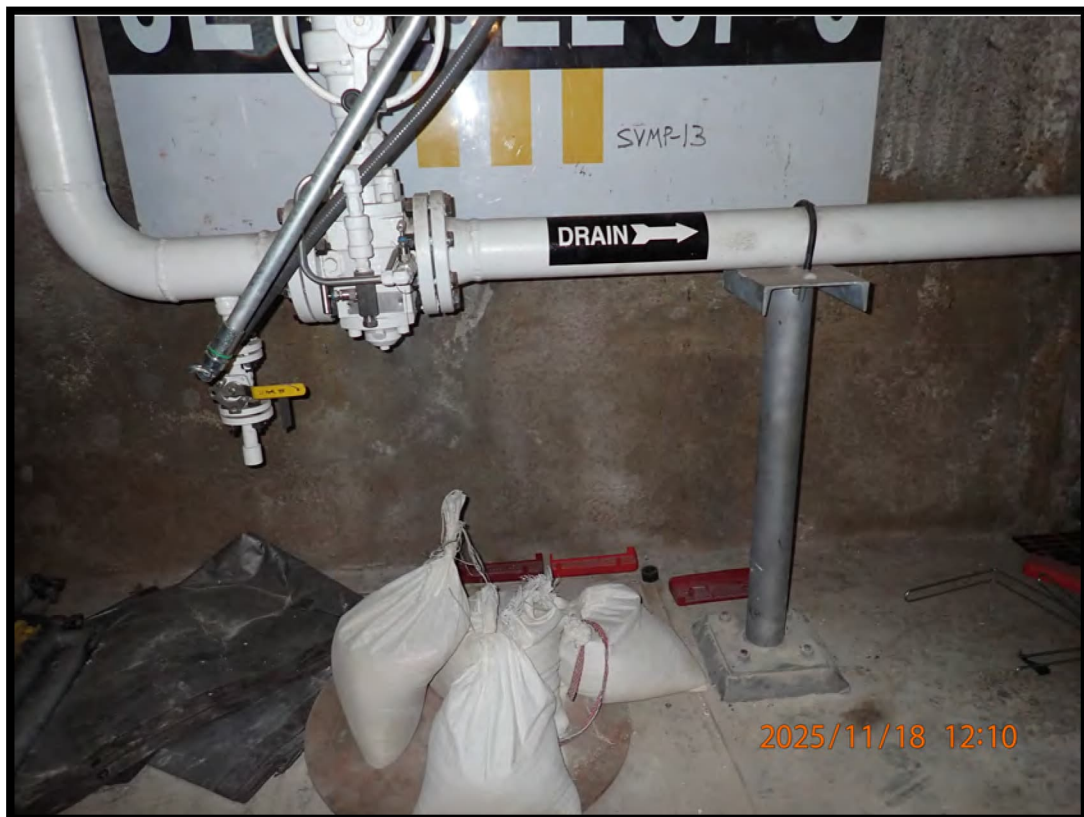
Photo 12. SVMP-13

| SVMP No. | Purge Start Time | Sample Start Time | PID Reading <sup>2</sup> | | | Reading Time | Background PID Reading | Notes |
|---|---|---|---|---|---|---|---|---|
| SV13 S <sub>(S)</sub> | 12:01 | 12:02 | 107 | 100 | 99 | 12:01 | 260 | |
| SV13 M <sub>(S)</sub> | 12:01 | 12:02 | 101 | 98 | 96 | 12:01 | | |
| SV13 D <sub>(S)</sub> | 12:01 | 12:02 | 117 | 107 | 104 | 12:01 | | |

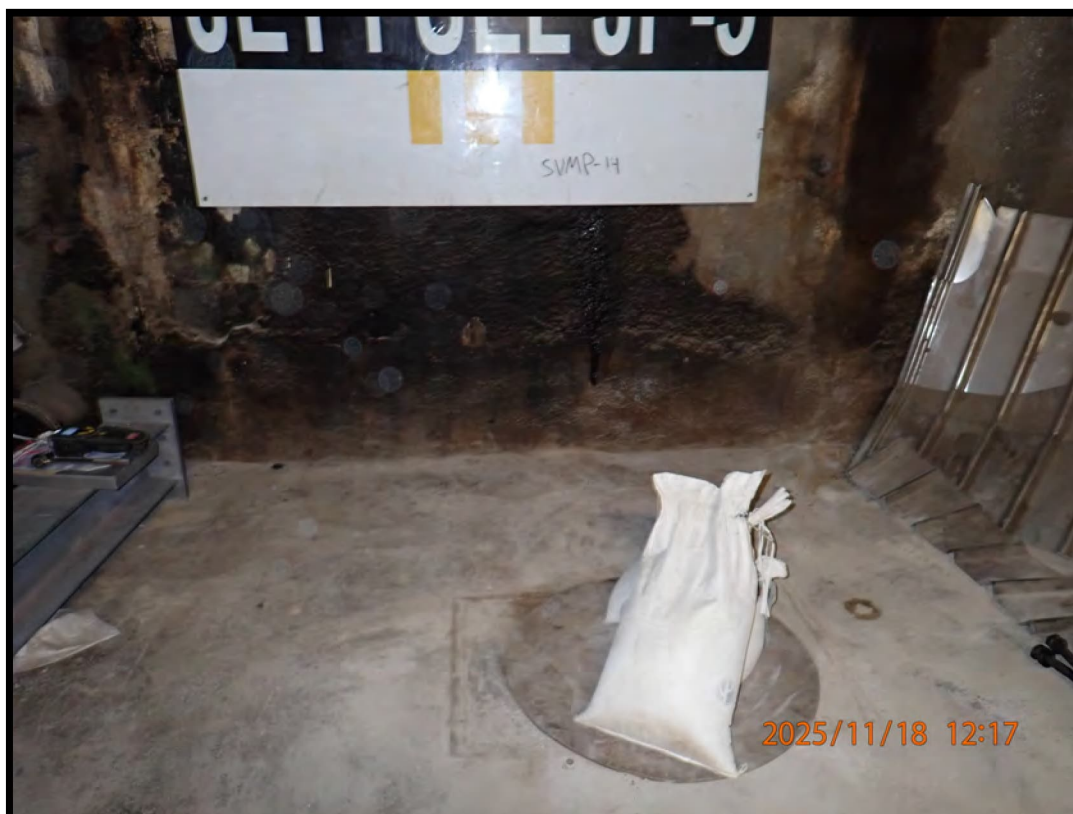
Photo 13. SVMP-14

| SVMP No. | Purge Start Time | Sample Start Time | PID Reading <sup>2</sup> | | | Reading Time | Background PID Reading | Notes |
|---|---|---|---|---|---|---|---|---|
| SV14 S <sub>(C)</sub> | 1208 | 1210 | 188 | 167 | 168 | 1214 | 266 | |
| SV14 M <sub>(C)</sub> | 1208 | 1210 | 135 | 137 | 139 | 1214 | | |
| SV14 D <sub>(C)</sub> | 1208 | 1210 | 180 | 167 | 158 | 1214 | | |

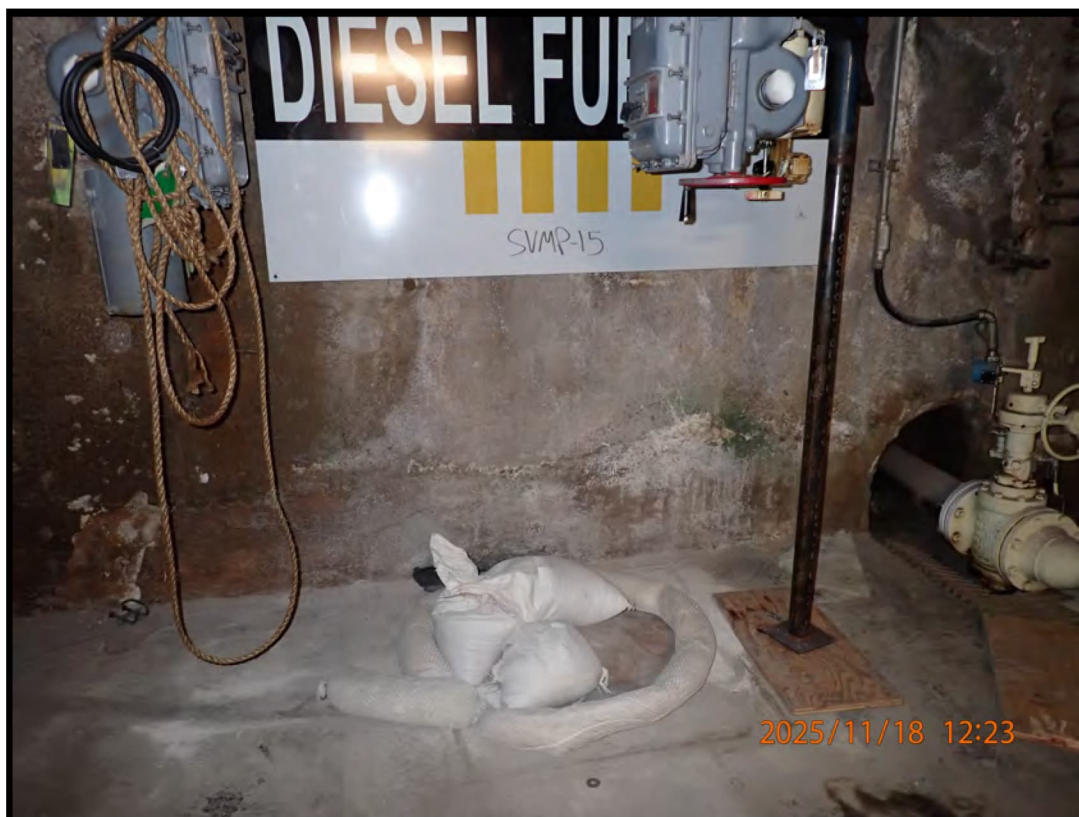
Photo 14. SVMP-15

| SVMP No. | Purge Start Time | Sample Start Time | PID Reading <sup>2</sup> | | | Reading Time | Background PID Reading | Notes |
|---|---|---|---|---|---|---|---|---|
| MD SV15 S <sub>(S)</sub> | 1218 | 1219 | 120 | 115 | 113 | 1220 | 297 | |
| MD SV15 D <sub>(S)</sub> | 1218 | 1219 | 125 | 122 | 123 | 1220 | | |

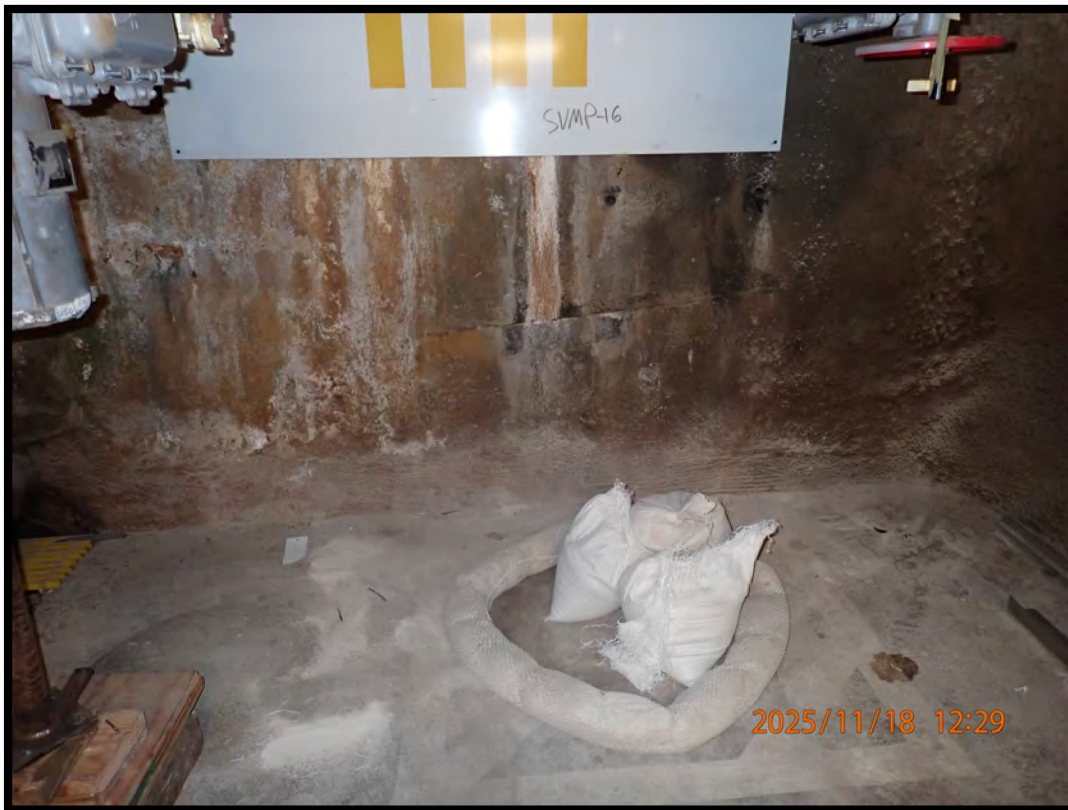
Photo 15. SVMP-16

| SVMP No. | Purge Start Time | Sample Start Time | PID Reading <sup>2</sup> | | | Reading Time | Background PID Reading | Notes |
|---|---|---|---|---|---|---|---|---|
| MD SV16 M <sub>(C)</sub> | 1222 | 1224 | 144 | 139 | 136 | 1225 | | |
| MD SV16 D <sub>(C)</sub> | 1222 | 1224 | 149 | 144 | 143 | 1225 | | |

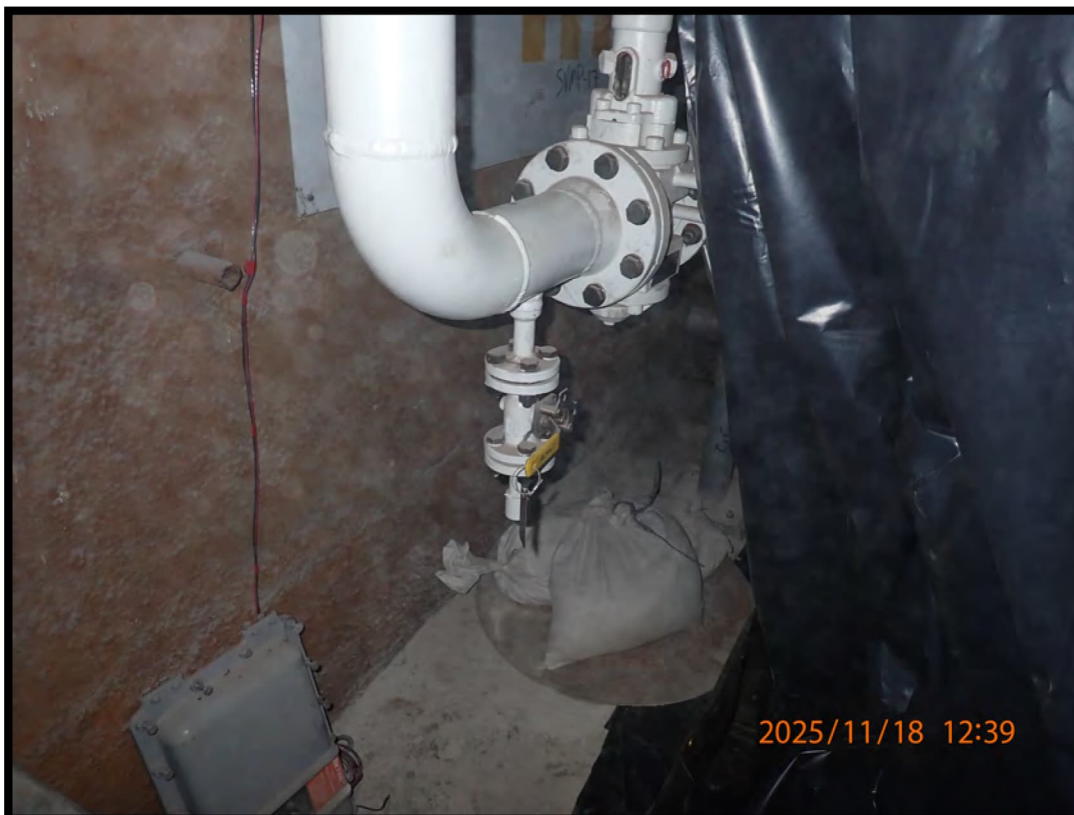
Photo 16. SVMP-17

| SVMP No. | Purge Start Time | Sample Start Time | PID Reading <sup>2</sup> | | | Reading Time | Background PID Reading | Notes |
|---|---|---|---|---|---|---|---|---|
| SV17 S <sub>(S)</sub> | 1229 | 1230 | 93 | 83 | 81 | 12:35 | 403 | |
| SV17 M <sub>(S)</sub> | 1229 | 1230 | 91 | 85 | 84 | 12:35 | | |
| SV17 D <sub>(S)</sub> | 1229 | 1230 | 129 | 112 | 103 | 12:35 | | |

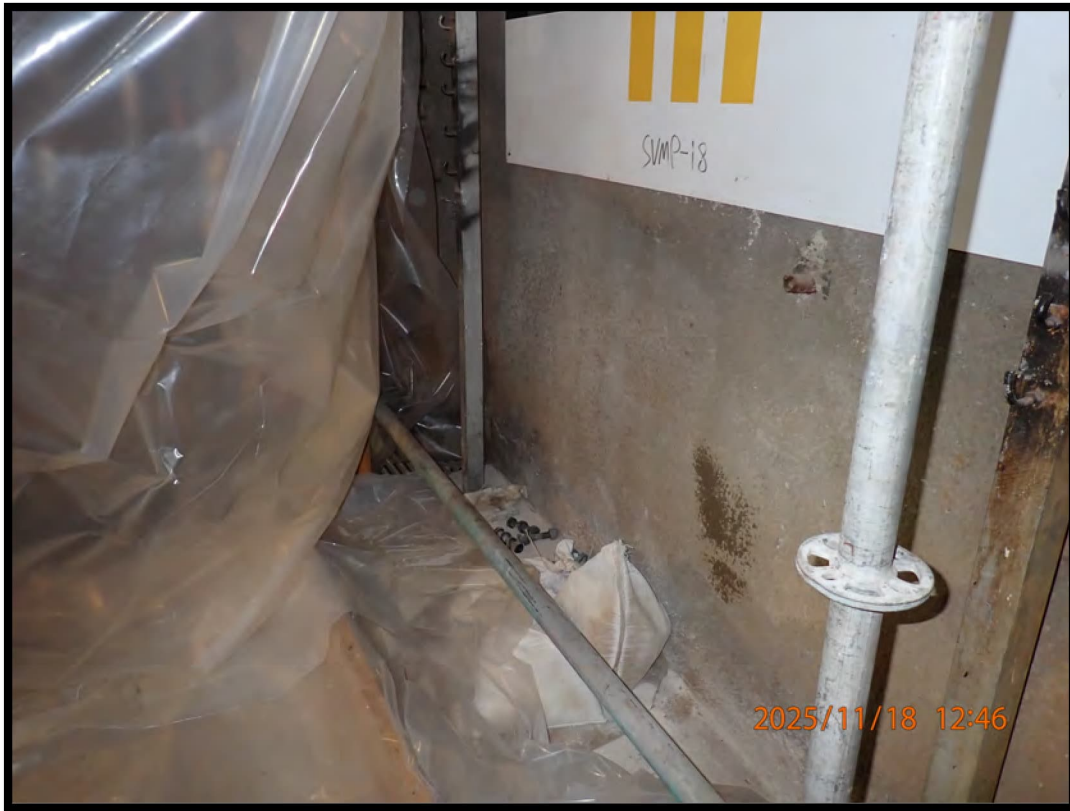
Photo 17. SVMP-18

| SVMP No. | Purge Start Time | Sample Start Time | PID Reading <sup>2</sup> | | | Reading Time | Background PID Reading | Notes |
|---|---|---|---|---|---|---|---|---|
| SV18 S <sub>(S)</sub> | 12:38 | 1240 | 245 | 261 | 262 | 12:45 | 365 | |
| SV18 D <sub>(S)</sub> | 1238 | 1240 | 224 | 224 | 225 | 1245 | | |
