FILE NAME: N39430-15-D-1632 TO-0005 Sub 107.1 T14 OOS Inspection Report

CONTRACT NO	TITLE Fill in Project Title/Location Here
N39430-15-D-1632 / TO #0005	Clean, Inspect, Repair POL Storage Tanks 14 17 & 18 Red Hill, Pearl Harbor, HI

ENCL. NO.	NO. OF COPIES	DESCRIPTION	SPEC. SEC.PARA./DWG.NO.	SCHEDULE ACTIVITY NO.	CQC CODE
1	1	Tank 14 Out of Scope Pre-Repair Inspection Report	01 33 10.05 20/3.1	CI0701-080

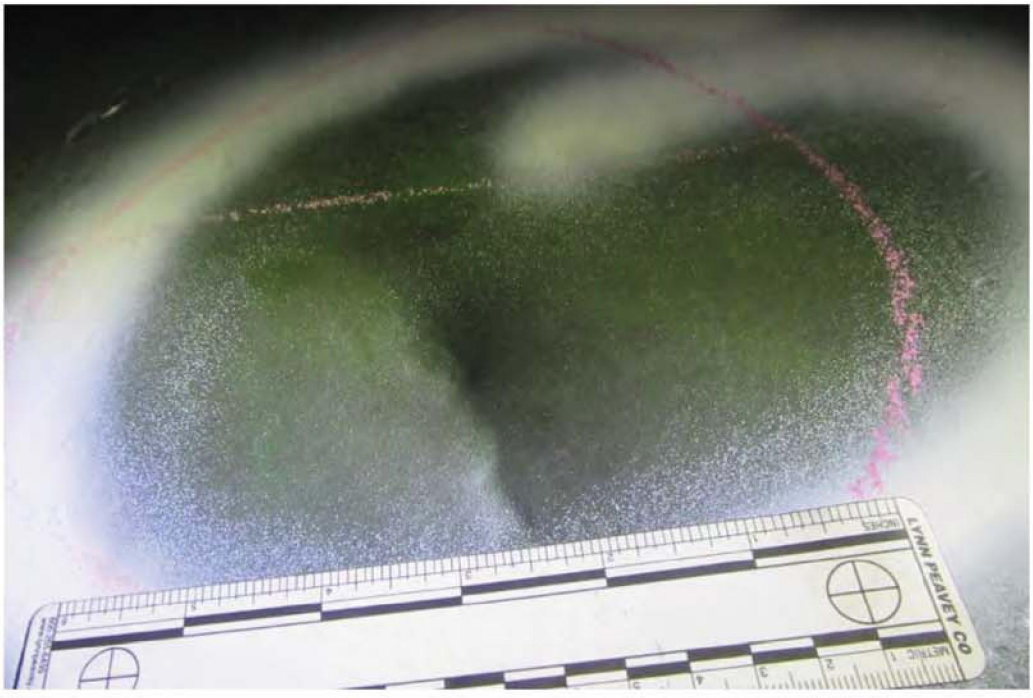
Photo 11: Dent in barrel plate

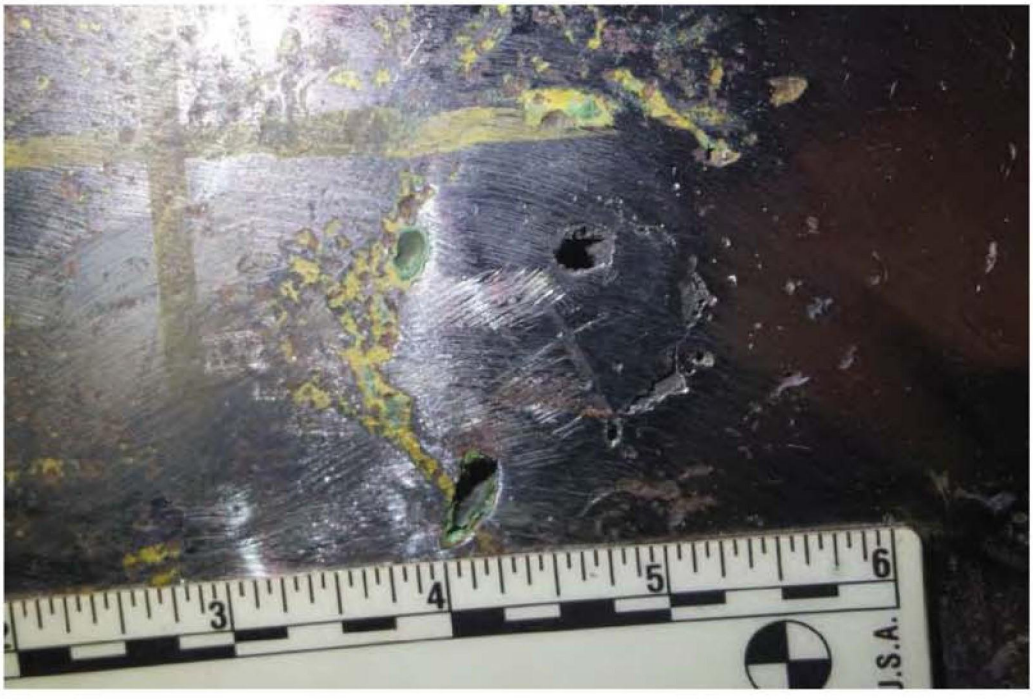
Photo 12: Pitting in lower dome after being ground down for repair

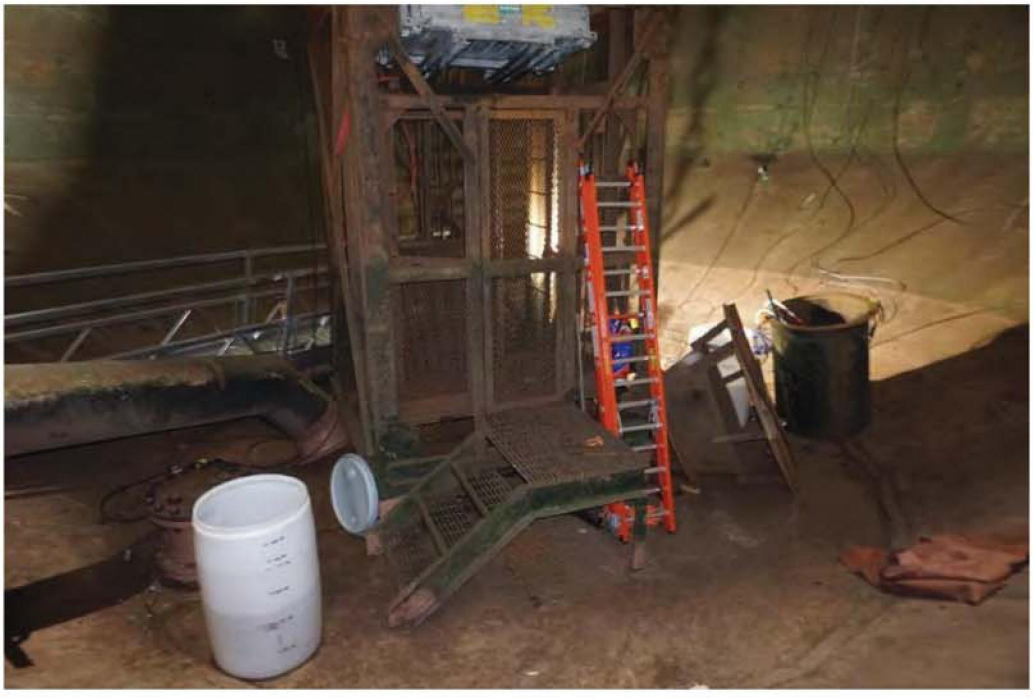
Photo 13: Tank floor and base of center tower

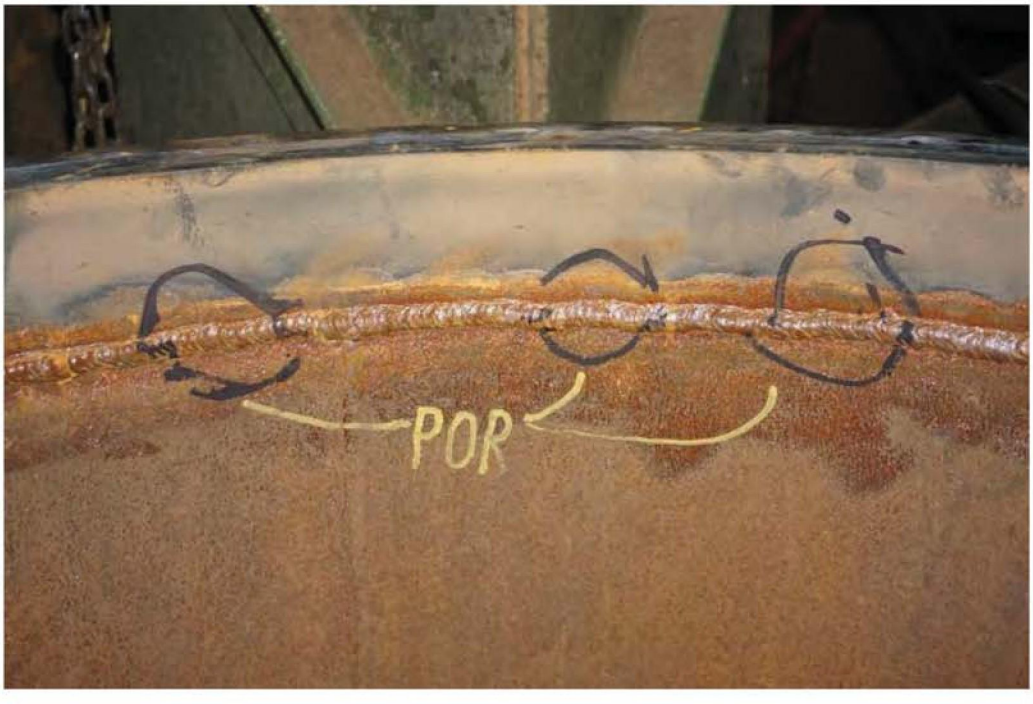
Photo 18: Porosity along flange weld of 32-inch piping at tank floor

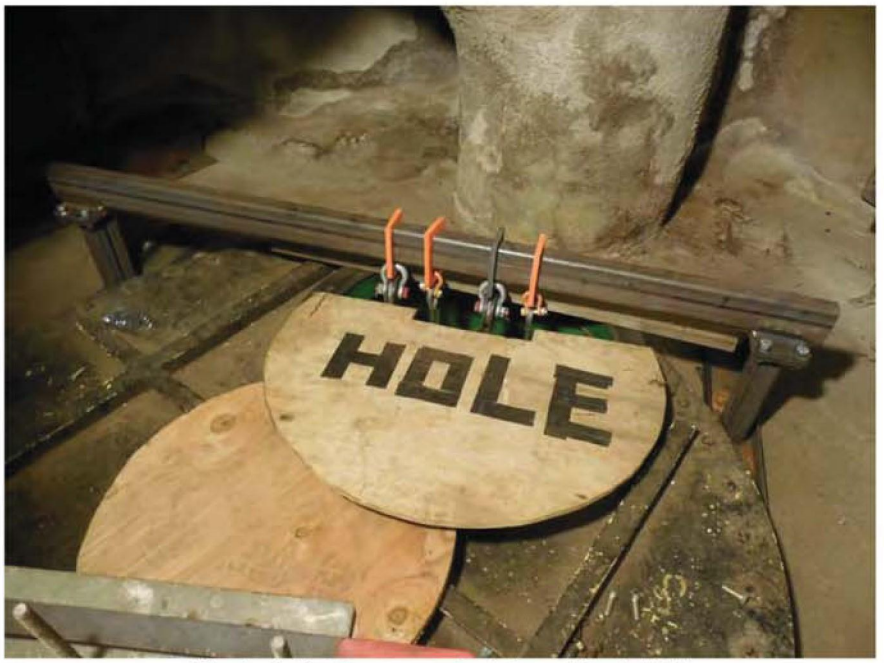
Photo 1: Spider support at top of Tank #14

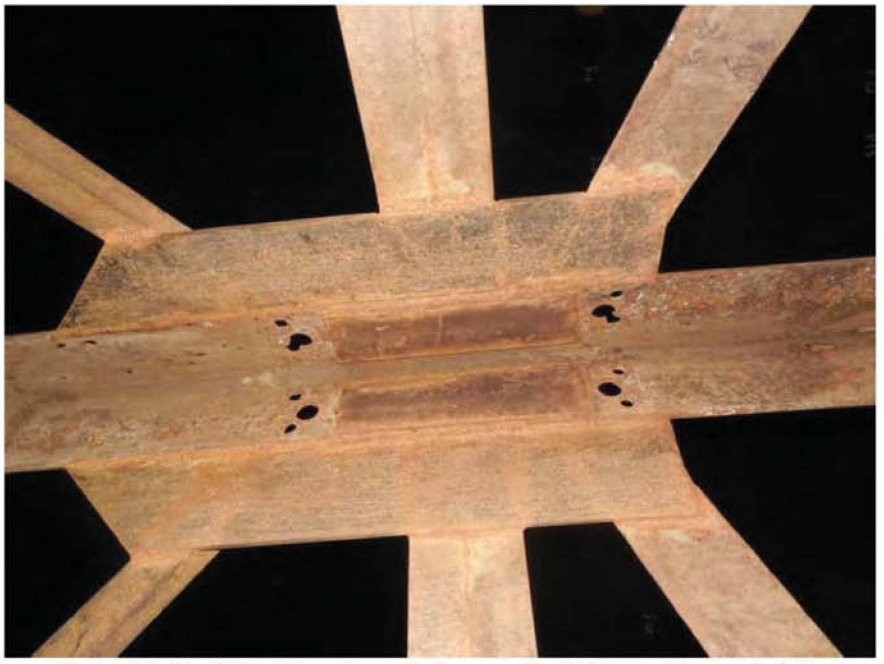
Photo 13: Tank #14 framing – Holes need patching with steel plate

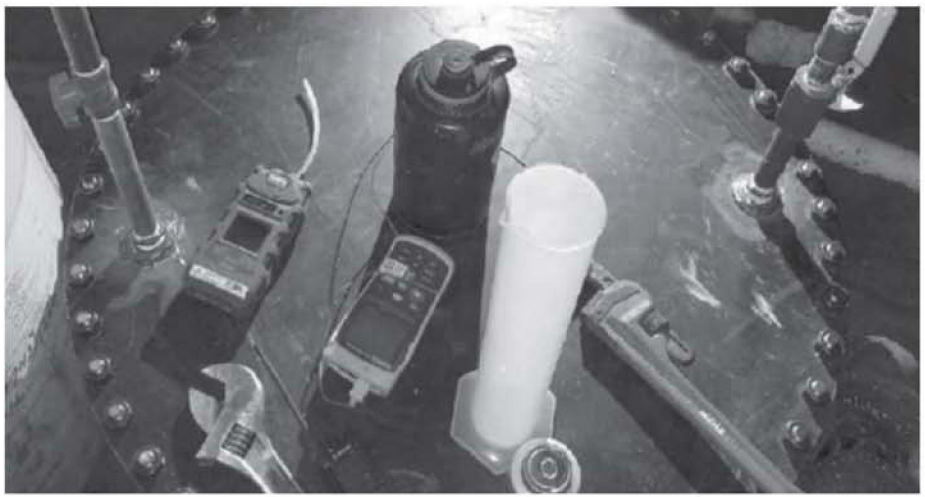
Time (Military Time)	Gauge Pressure psig	Inner Blind or Blind Flange, Temp F	Ambient Temp Temp, F	Volume Added Gallons	Volume Subtracted Gallons	Notes
824	166	79.5	80	-	-	Start Strength Test
839	166	79.5	81	-	-	
854	166	79.6	78.4	-	-	
909	166	79.4	77.9	-	-	
924	166	79.4	77.9	-	-	
939	166	79.3	77.7	-	-	
954	166	79.2	77.9	-	-	
1009	166	79.4	77.8	-	-	
1024	166	79.3	78.4	-	-	
1039	166	79.3	78.4	-	-	
1054	166	79.1	78.7	-	-	
1109	166	79.1	77.8	-	-	
1124	166	79.1	77.7	-	-	
1139	166	79.1	77.2	-	-	
1154	166	79.1	77.7	-	-	
1209	166	79.1	77.1	-	-	
1224	166	79.1	77.1	-	-	End Strength Test
						Passed Per ECY

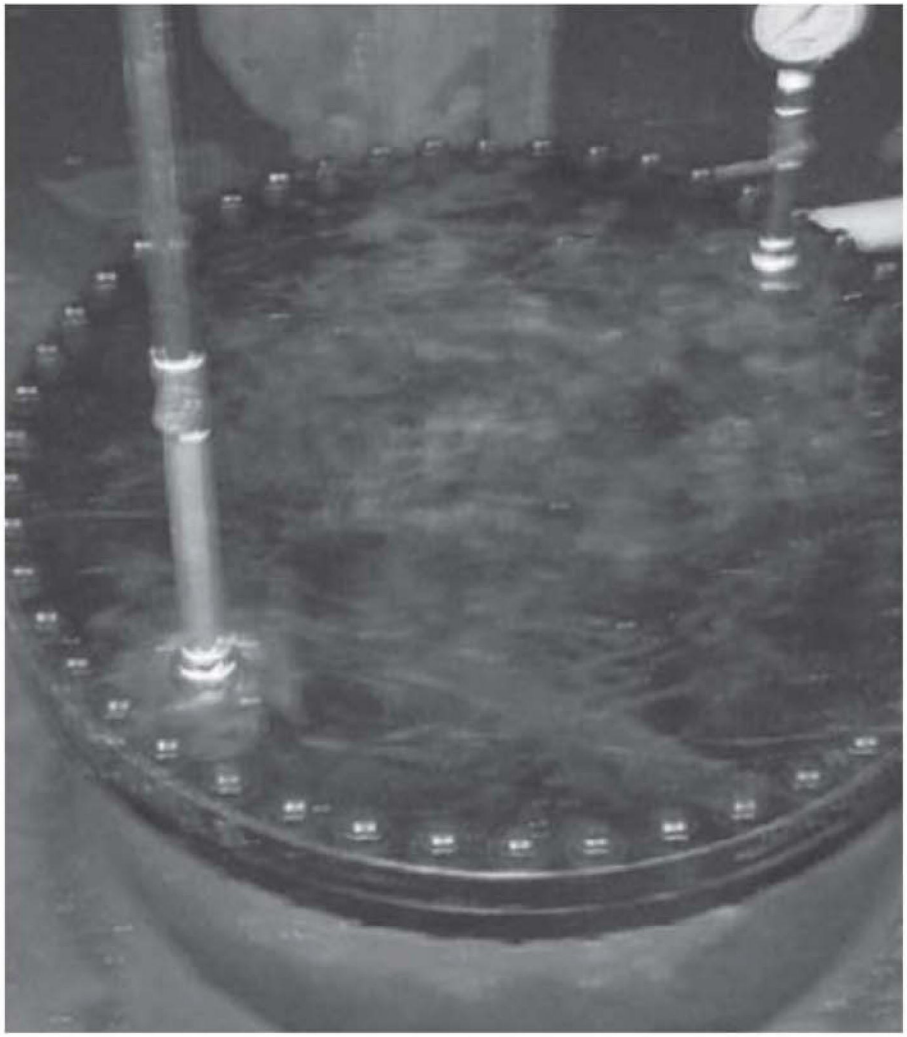
** Drips from known leak being caught from 2" B/V on 20" Flange will measure at end = 30 ml @ end of test.
