In the Matter of the Emergency Order to
UNITED STATES NAVY

For Emergency Change-In-Service and
Defueling of 20 Underground Storage
Tanks, Red Hill Bulk Fuel Storage Facility

WRITTEN TESTIMONY OF DAVID M.
NORFLEET; CERTIFICATE OF SERVICE

Report No.: O-AP-LIS / DNOR (10202111)
December 29, 2020

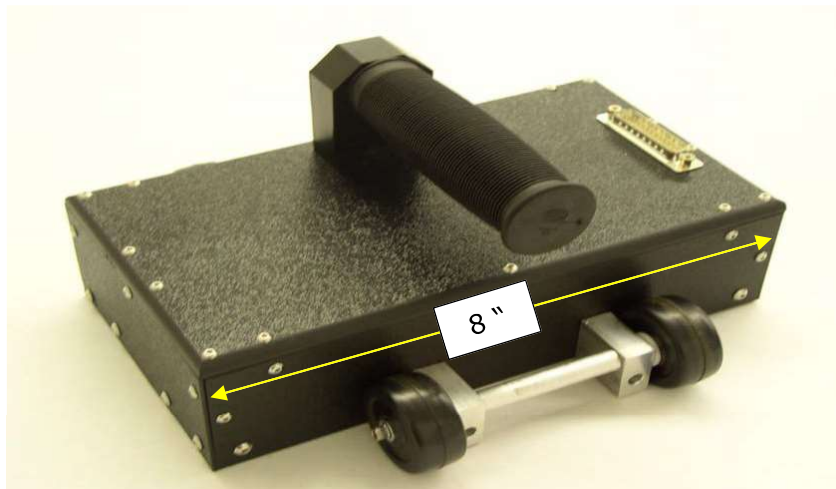
Figure 1. Photograph showing the 8-inch wide hand-held scanner used to perform LFET.

The hand-held LFET scanner used to scan a significant portion of that area is pictured Figure 1 and is described in the report to be 8 inches wide. The system is reported to be capable of detecting backside corrosion pits as small as 0.062 inches in diameter. The inspector is responsible for moving the hand scanner while monitoring the computer screen readout to detect flaws/ defects while working off a suspended scaffolding with the work area illuminated by artificial lights. In addition, per the testimony of Navy witness Mr. Frank Kern the inspector must also move the scanner in the “same direction” while performing the inspection in an

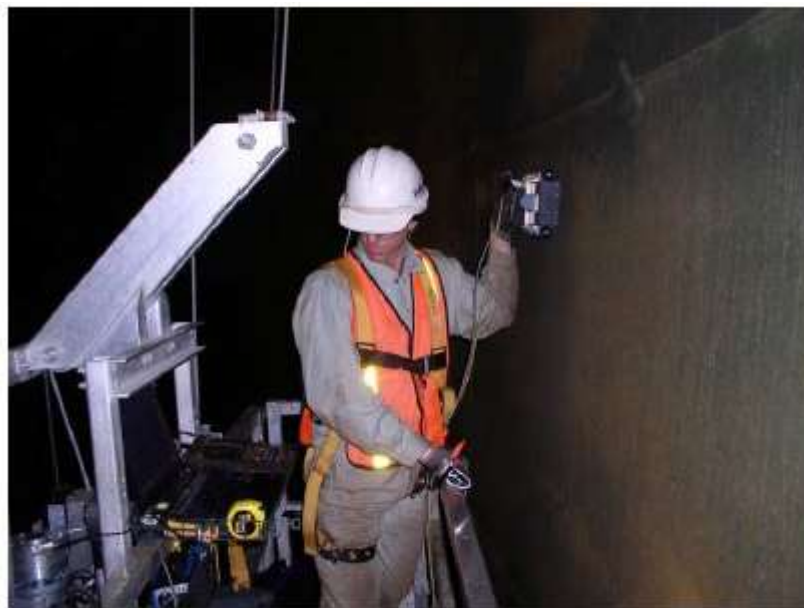
Figure 2. Photograph showing the application of the hand-held scanner used to perform LFET [B-190].

effort to improve the inspection process. A representative photograph showing the working conditions is presented in Figure 2. This is a laborious task and the inspection of these USTs can take 4 weeks or more to complete. The interior of the tank liner is predominately covered with a coating that precludes the direct contact of the scanner with the steel surface. One of the benefits noted by the inspection contractor in using the LFET for scanning the steel liner is that direct contact with the steel is not required. However, the presence of the internal coating does impede any visual inspection of the steel surface which, if it could be visually inspected, may assist in the detection of any flaws or defects in the steel liner.

Shows LFET scanning under the catwalk.

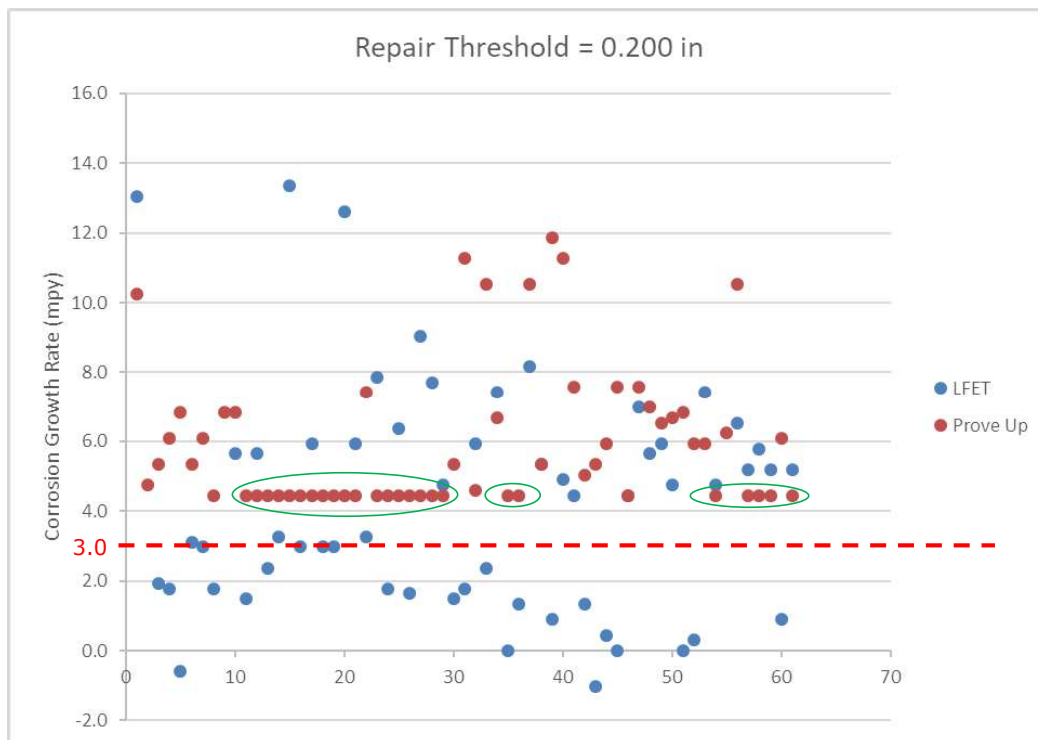
Essentially measuring the corrosion growth that has occurred over the 6.74 years between the measurements. Figure 16 is a plot of the calculated corrosion growth rates for the backside corrosion anomalies identified during the 2017 API inspection. The data show CGRs between 0 and 13.4 mpy, with an average of 5.1 mpy. The results indicate that the CGRs for the tank may be much higher than anticipated by the Navy (3 mpy) and/or illustrate the inaccuracies of the methods and practices the Navy is utilizing to assess backside corrosion on the USTs.

Figure 16. Plot showing the calculated corrosion growth rates for backside corrosion anomalies identified during the 2017 API 653 inspection for Tank 5. Navy's adopted corrosion growth rate tied to reinspection intervals. Note – Data circled in green correspond to measurements that were only reported as "<0.160", such that the data are lower bounds.

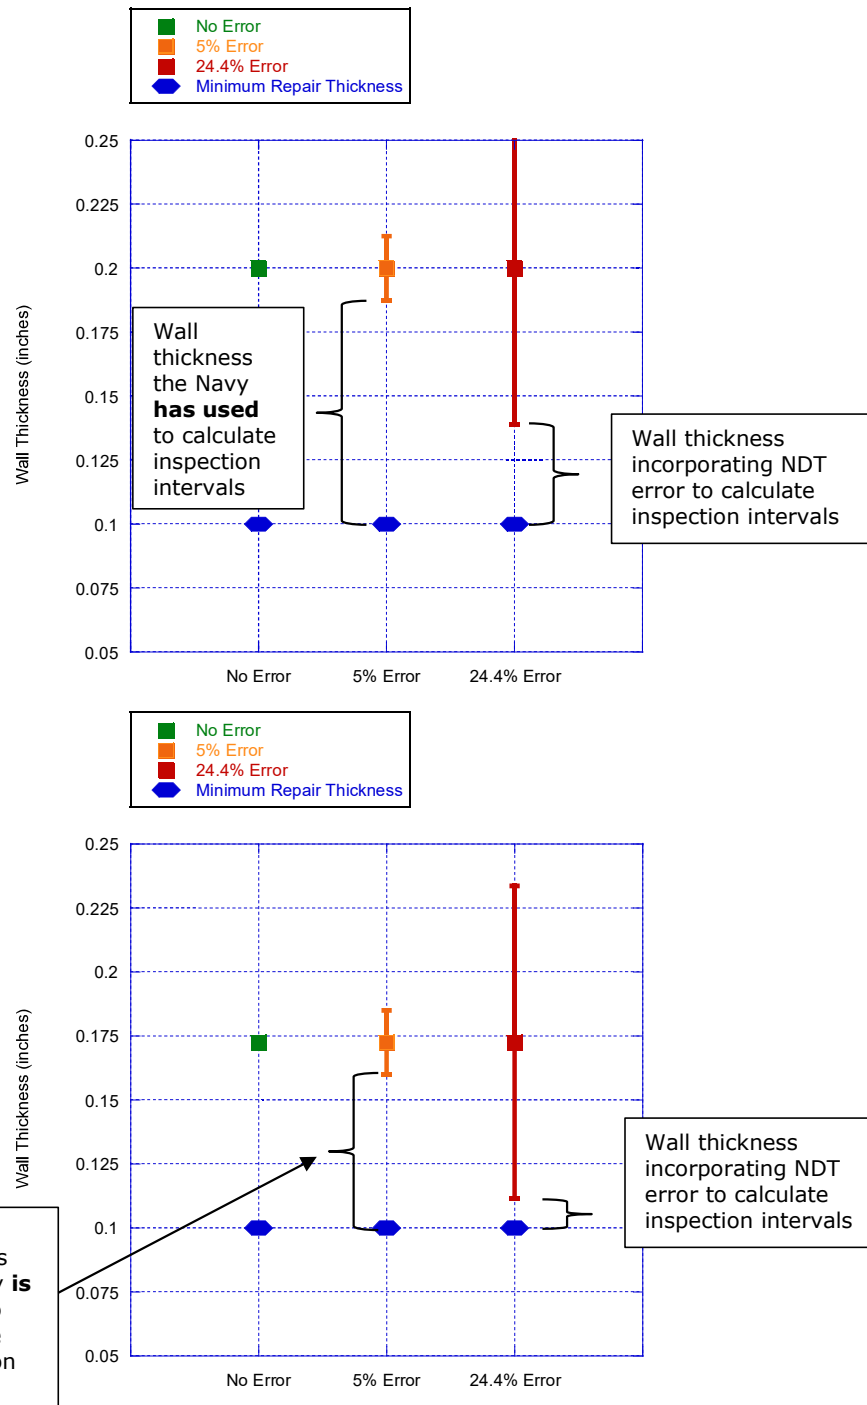
As shown and discussed above, the NDE practices failed to meet the performance metric, $\pm 8\%$ (20 mils), or tool tolerance of $\pm 5\%$. An analysis was performed to determine the tool tolerance whereby the current LFET NDE results would pass the API 1163 criteria. It was determined that the tool tolerance must be extended from $\pm 5\%$ to $\pm 24.4\%$ to meet this standard. LFET methodology is used to scan 100% of the liner plates and find areas that do not meet a set thickness criterion for follow up PAUT prove up measurements. If the accuracy of the LFET methodology is much less than stated – which is apparent based on the destructive testing conducted to date – then there is a probability that areas of the liner with less than the target remediation thickness are left unmitigated in the tank. This is represented graphically in Figure 19. To account for the large potential errors in the NDE technique, the actual reinspection interval must be reduced dramatically to prevent areas from corroding below the minimum thickness level required and potentially developing through wall defects. For example, using the parameters from the 2017/2018 Tank 14 inspection, a 20-year reinspection interval is reduced to 3.8 years; less than 1/5th of the current planned reinspection interval of 20 years.

In summary, the Navy continues to reduce the repair threshold for its USTs even though they have demonstrated the inaccuracies of their inspection methodology. These inaccuracies combined with the resulted thinner wall left unrepaired increase the risk of unmitigated underside corrosion resulting in a through-wall defect and a release of stored materials to the environment. Thus, the Navy has not and cannot demonstrate that it can safely operate the RHBFSF USTs without fuel releases for the operational life of the tank system, a requirement not only in the State of Hawaii but for all other operators in the oil and gas industry.

Figure 19. Plots showing API Inspection repair thresholds from 2005/2006 (top) and 2017/2018 (bottom) incorporating error associated with the NDE measurements from Tank 14 destructive testing results.
