For Emergency Change-In-Service and  
Defueling of 20 Underground Storage  
Tanks, Red Hill Bulk Fuel Storage Facility

UPDATED WRITTEN TESTIMONY OF  
DAVID M. NORFLEET; CERTIFICATE OF  
SERVICE

Report No.: O-AP-LIS / DNOR (10202111)  
December 29, 2020

| Project Name: | Red Hill Bulk Fuel Storage Facility –<br>Contested Case Hearing | DNV GL USA, INC. (Oil and Gas)<br>Pipeline Services Department<br>Incident Investigation |

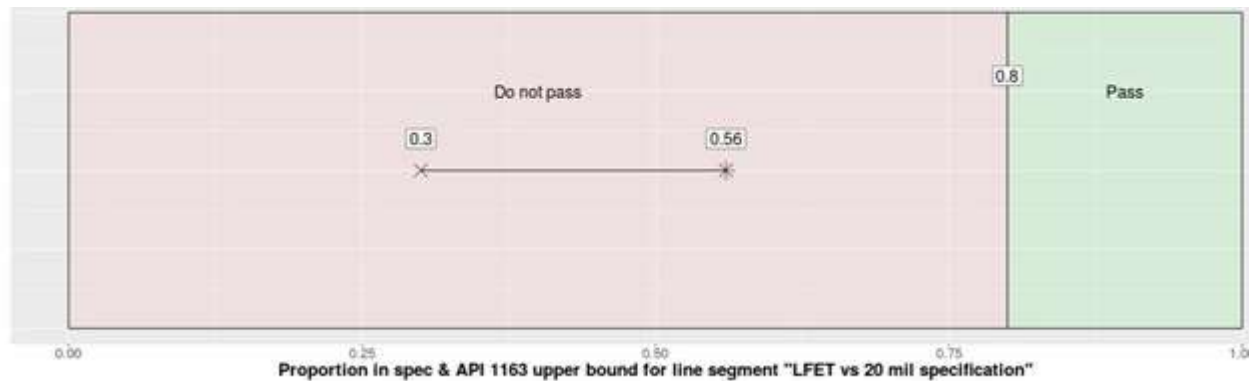
Table 4 summarizes the results of the destructive testing performed on the ten coupons removed from Tank 14, incorporating comparisons between the NDE methods (LFET, PAUT) and the actual corrosion depth measurements determined from destructive testing. As seen in this table, the specification limit is 20 mils for backside pitting. A LFET or PAUT measurement would be a success (within specification) if its value is within  $\pm 20$  mils of the actual matching destructive testing depth.

Of the ten match pairs, three of the LFET measurements are within the specification of 20 mils. For PAUT, one of six measurements are within 20 mils with four as “maybe”. The four “maybe” designations are a result if prove-up measurements that were performed, but the actual values were not noted. Two of the four “maybe” values were below the repair threshold of 0.160 inches and no measurement was noted. The remaining two “maybe” values were either greater than 0.200 inches or no wall-loss features were identified. In the below API 1163 analysis, the “maybe” values will be counted as successes of being within 20 mils giving the PAUT tool the benefit of doubt.

| In Spec | Matched Pairs | Proportion | Confidence Interval | API 1163 Upper Bound | Vendor Spec | Pass / Fail |
|---|---|---|---|---|---|---|
| 3 | 10 | 0.30 | 0.95 | 0.56 | 0.80 | Fail |

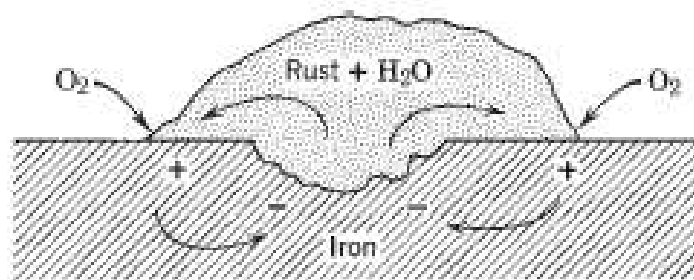
Figure 20. Illustration showing the corrosion process on carbon steel. [Uhlig Corrosion and Corrosion Control, Fourth Edition, 2008].

Corrosion is an irreversible deterioration process of a material resulting from a chemical or electrochemical reaction with its local environment. At temperatures near ambient, the corrosion process is almost always electrochemical in nature. In carbon steels, the corrosion process can be illustrated as shown in Figure 20. This process requires an electrolyte (such as water [H<sub>2</sub>O] as illustrated), a cathodic reaction such as water reduction (in neutral pH deaerated water) or oxygen (O<sub>2</sub>) reduction (in aerated water), and transfer of current (electrons) between the anodic (-) to the cathodic (+) reactions. The process for corrosion of iron (Fe) can be summarized as the combination of two electrochemical reactions, one anodic and one cathodic.
