Naval Audit Service

Audit Report

Department of the Navy Red Hill and Upper Tank Farm Fuel Storage Facilities

N2010-0049
16 August 2010

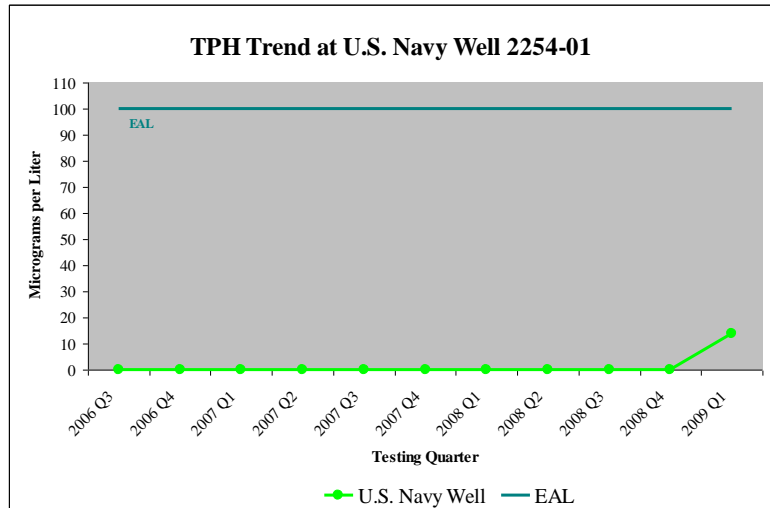
U.S. Navy Well 2254-01

In the 1st quarter of 2009, TPH contaminants were also detected at the Navy Well. Although the concentration that was detected was below the EAL,¹¹ this sampling event was the first time that TPH had been detected since the Navy began testing for the contaminant in 2006. As mentioned above, the recent detection of contaminants at the Navy Well may indicate migration

of fuel released from RH. The detection of contaminants at the Navy Well pumping station poses an immediate risk to the potable water sources in the RH area. If the Navy Well becomes contaminated beyond acceptable levels, the Navy and the island of Oahu could potentially lose an important source of drinking water. If this occurs, the Pearl Harbor Water System would be reduced by approximately 24 percent. Further, the Navy would be responsible for providing an alternate water source at the Navy Well as indicated in the GPP.

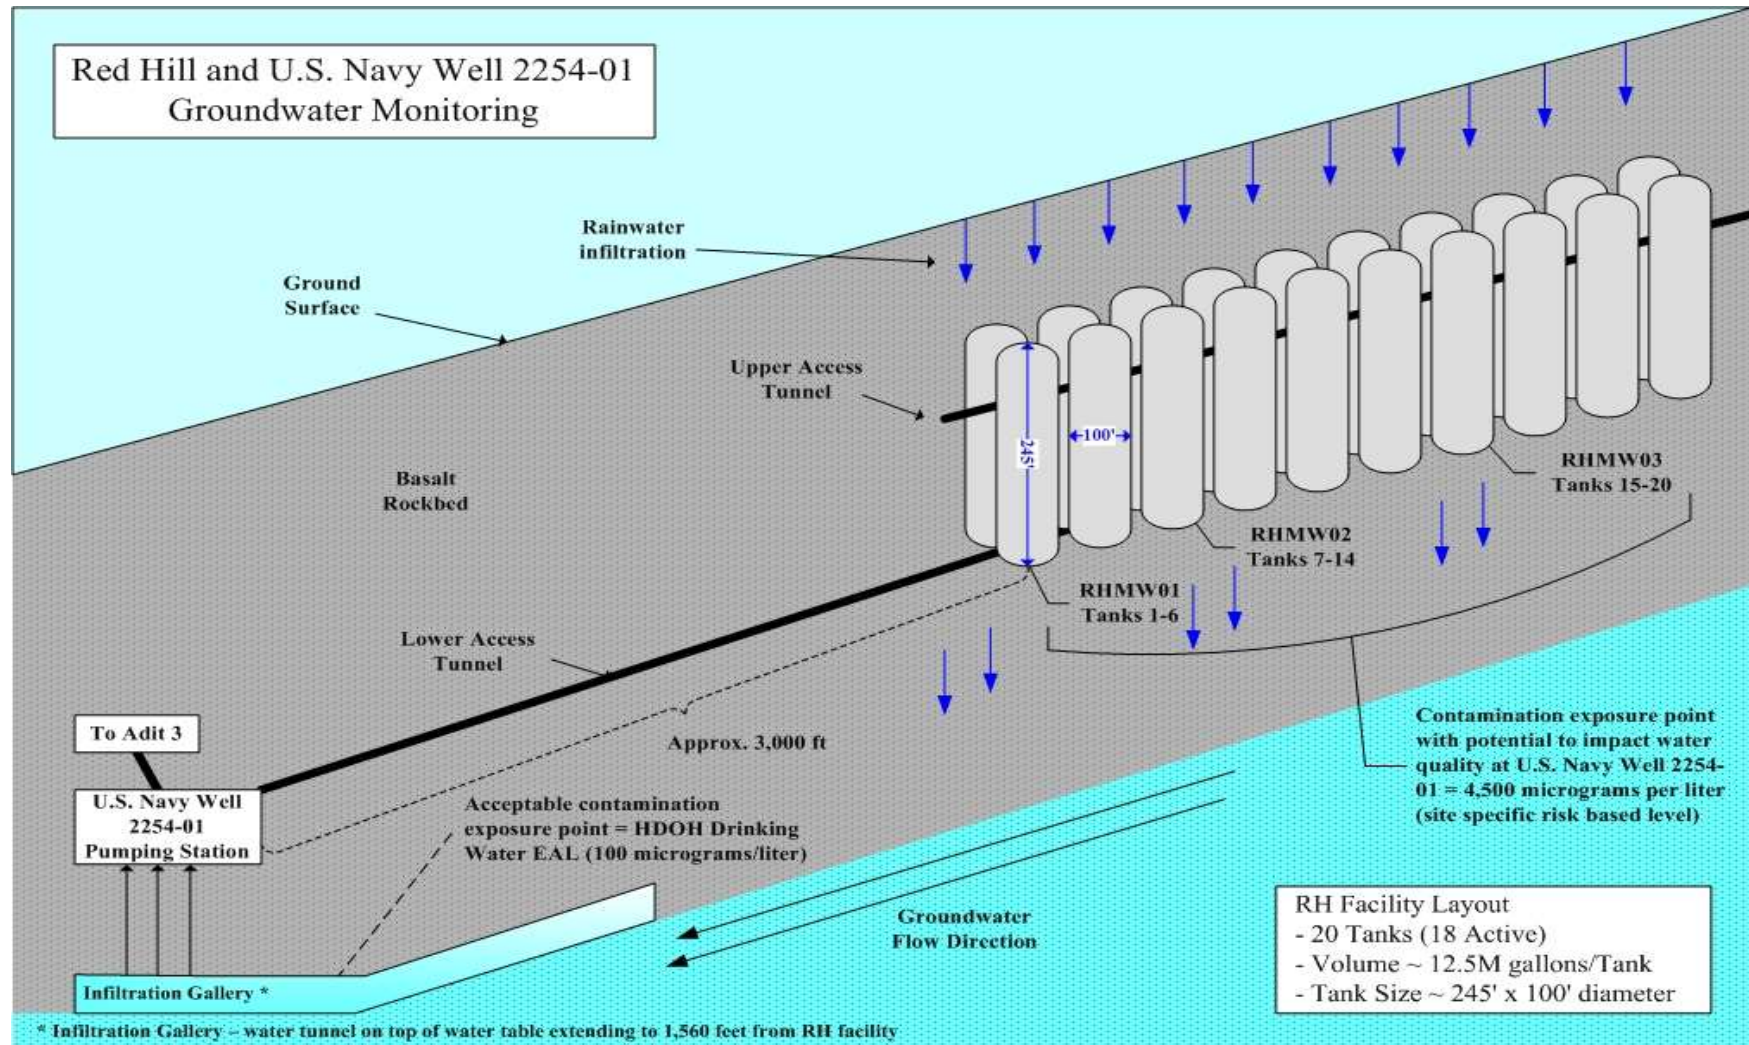
Exhibit E:

Groundwater Monitoring Wells
