**ENGINEERING SURVEY OF
U.S. NAVY PETROLEUM FACILITIES
AT PEARL HARBOR**

BECHTEL CORPORATION

12, May 1949

Subj: Engineering Survey of U. S. Navy Petroleum Facilities
at Pearl Harbor, Report on

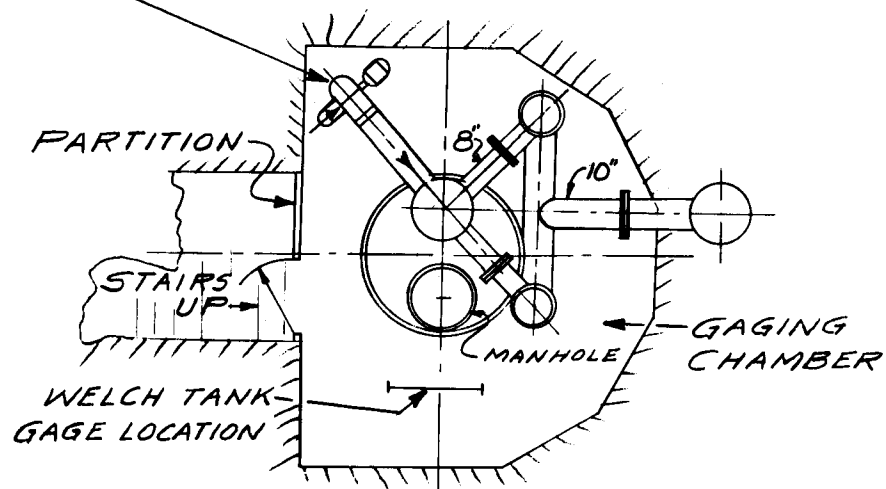
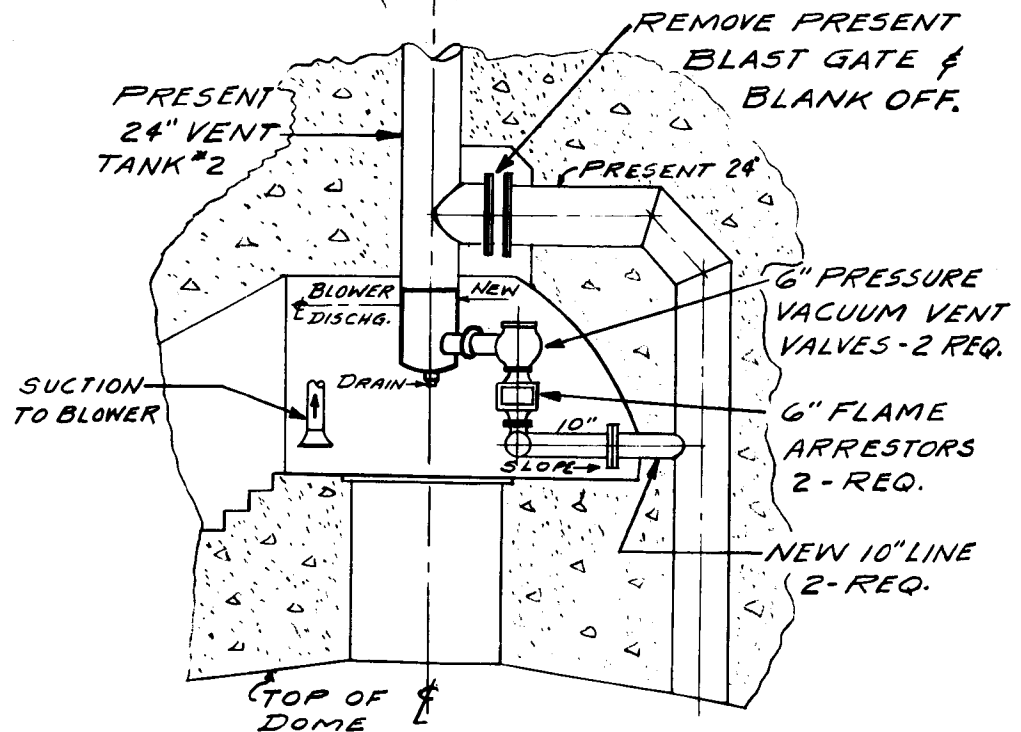
REVISION OF TANK VENTS

(5) A continuous gas sampling system would be required to automatically determine whether an explosive mixture exists in the atmosphere in the gaging chamber of Tanks 1 and 2 and at bottom valve chamber area in the lower tunnel.

TANK NO 2 SHOWN

1500 CFM BLOWER &
EXPLOSION PROOF MOTOR
INSTALL AS HIGH AS POSSIBLE.

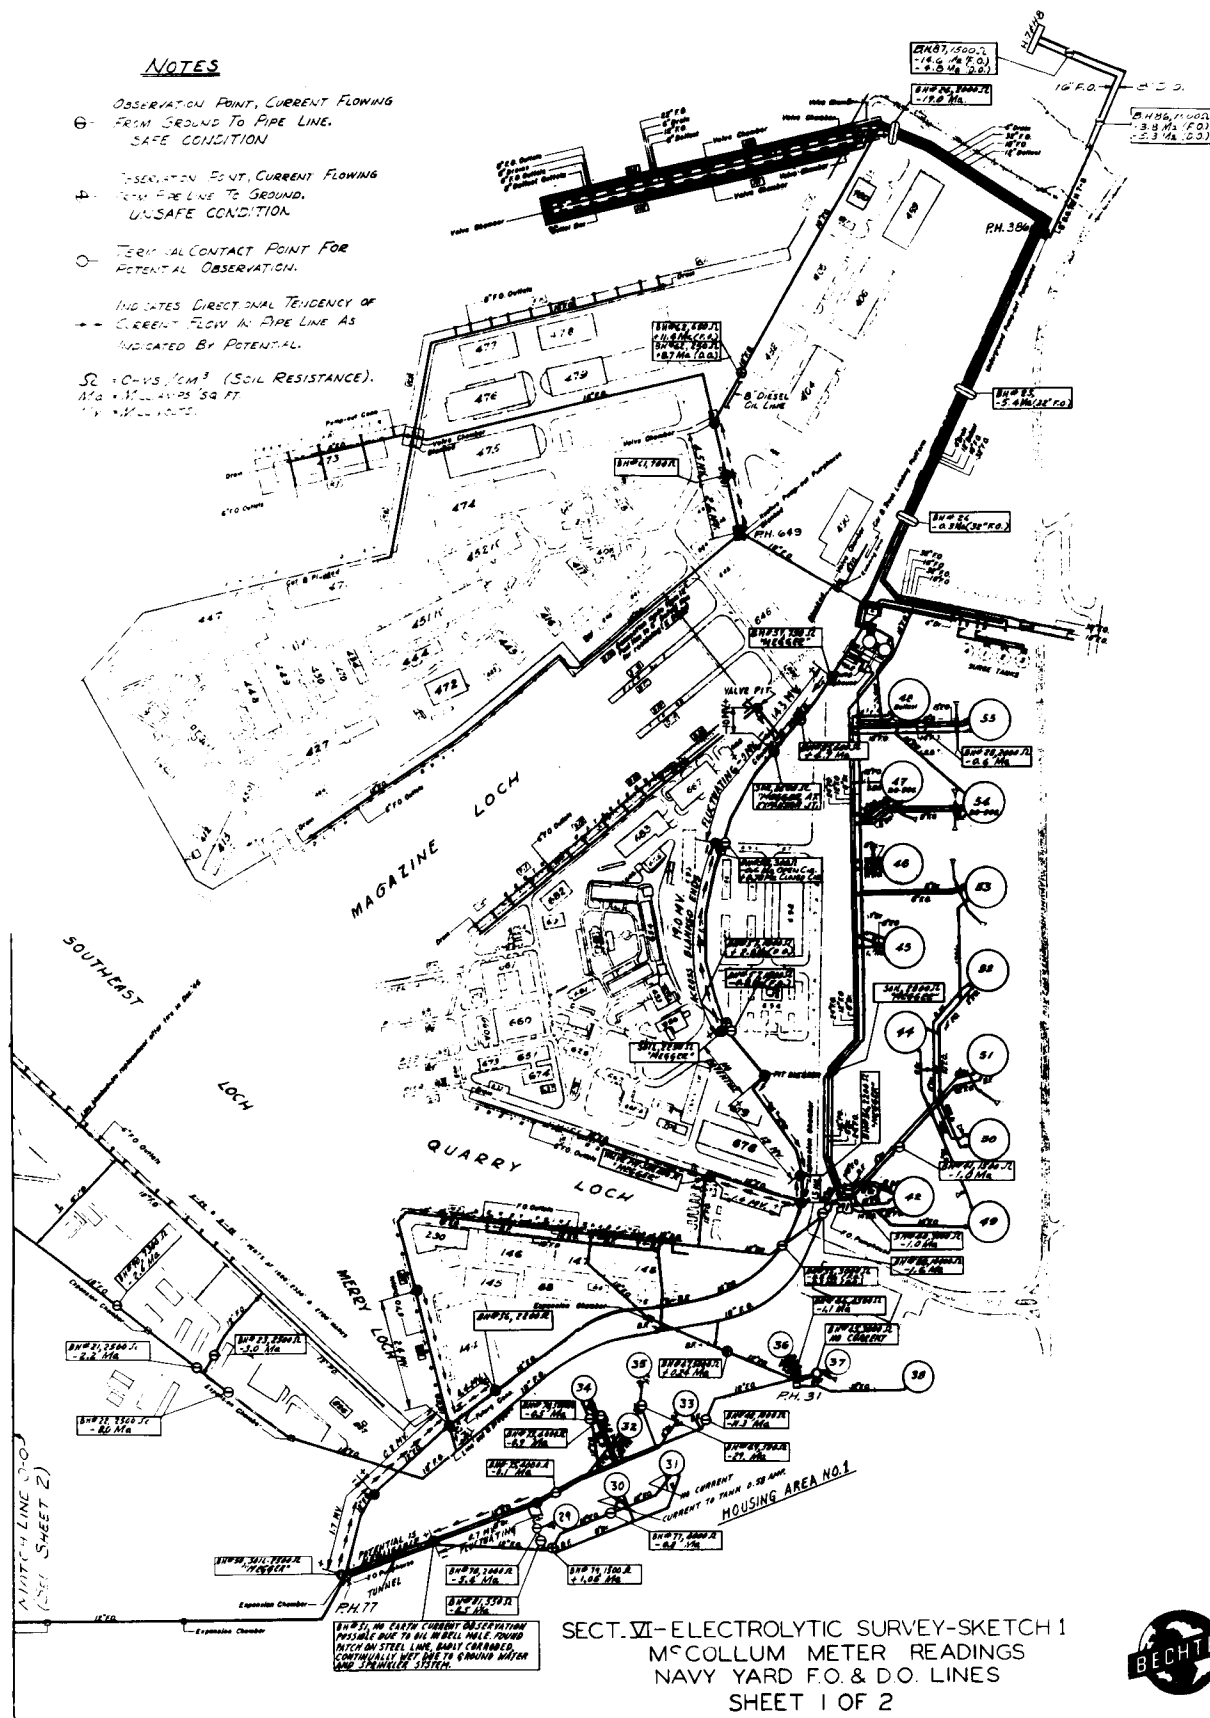
SECT. VI - ELECTROLYTIC SURVEY - SKETCH 1
NAVY YARD F.O. & D.O. LINES
SHEET 1 OF 2

--- INDICATES DIRECTIONAL TENDENCY OF
CURRENT FLOW IN PIPE LINE AS
INDICATED BY POTENTIAL.
