**ENGINEERING SURVEY OF  
U.S. NAVY PETROLEUM FACILITIES  
AT PEARL HARBOR**

12, May 1949

Subj: Engineering Survey of U. S. Navy Petroleum Facilities  
at Pearl Harbor, Report on

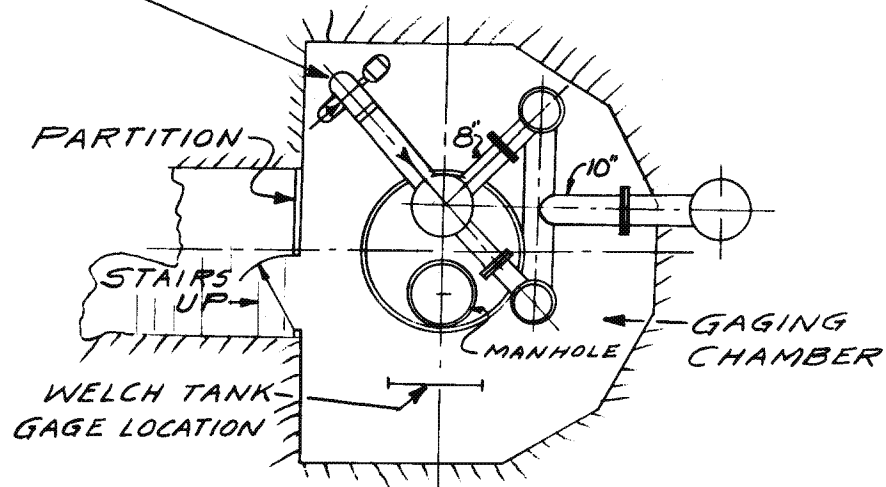
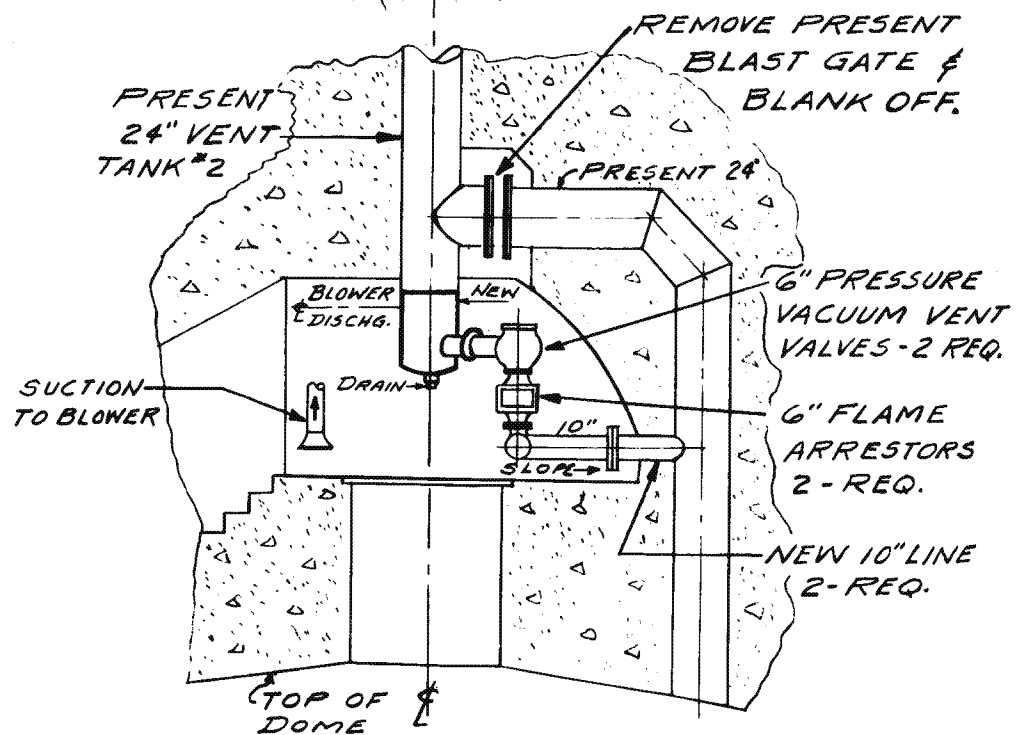
### REVISION OF TANK VENTS

(5) A continuous gas sampling system would be required to automatically determine whether an explosive mixture exists in the atmosphere in the gaging chamber of Tanks 1 and 2 and at bottom valve chamber area in the lower tunnel.

1500 CFM BLOWER &  
EXPLOSION PROOF MOTOR  
INSTALL AS HIGH AS POSSIBLE.

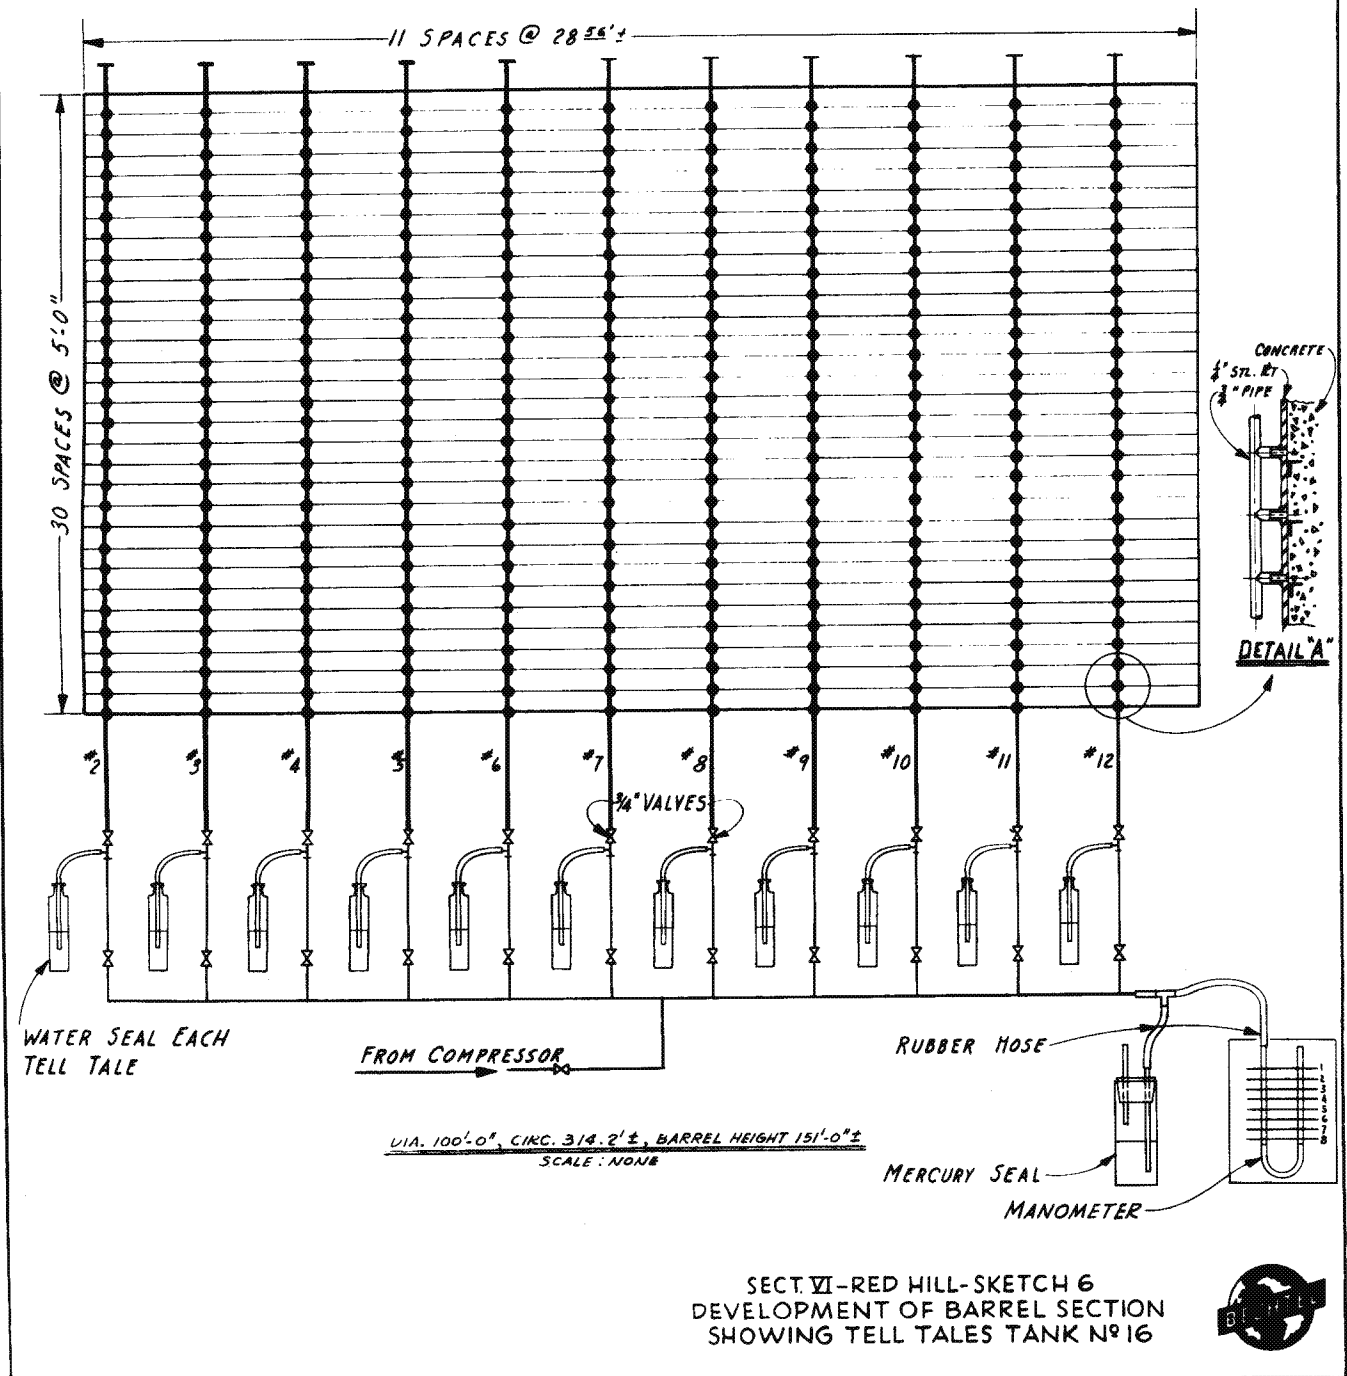
This vessel was suspected of leaking in the bottom dome because of oil seepage spots on the face in the lower gallery. Test holes were driven into the gunite at this location without materially affecting the flow which was continuous at approximately 4 oz. per day.

Inspection of the interface between the sheets in the bottom and first course and the concrete indicated minor quantities of oil at several locations. No defects were found in the sheets or welds up to the half way mark, where a standing test verified the examination by showing no drop in water level during a test period of five days.

Approximately 50 percent of the sheet area in this zone was covered with cement adhesions ranging from 1/32 to 2" in thickness and tightly adherent. Beneath this coating the sheets were as installed and the blue mill finish intact. Where the seams had been buffed at the time of construction and the mill finish damaged, superficial rusting had occurred.

On the bottom plate and under cement spatter which was not firmly affixed, pitting was apparent to a maximum depth of 0.05 inches. Corrosion products from these localities were high in sulphides and suggestive of anaerobic activity.
